Fast Facts

Validation of Aurora Solar's Remote Measurement Capabilities

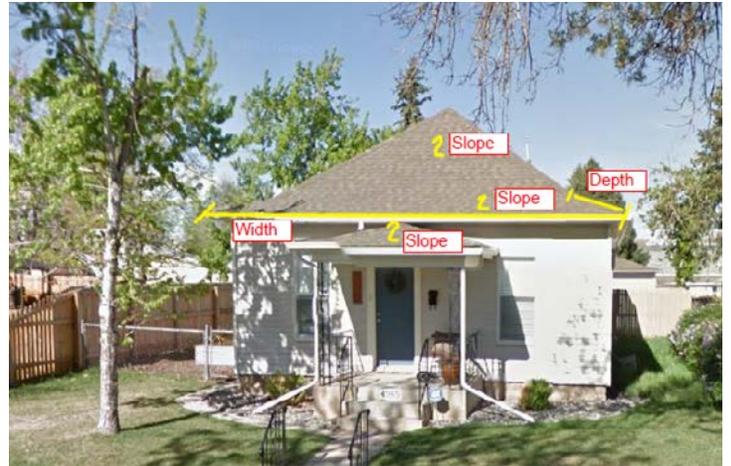
Figure 2: Roof that resulted in inaccurate measurement

Of all measurements collected and compared to Aurora's calculations, only one was noncompliant. The roof in which the maximum slope difference was

7.33 degrees, exceeding the 5-degree stated limit, was built in 1908 and had a measured main roof slope of 36.2 degrees. Aurora's software calculated the roof slope to be 43.53 degrees. The Aurora team evaluated this discrepancy and pinpointed the source of the error as poor site visibility from Google Street View.
