# From Modules to Atoms: Techniques and Characterization for Identifying and Understanding Device-Level Photovoltaic Degradation Mechanisms

**Technical Report**  
NREL/TP-5K00-72541  
October 2019

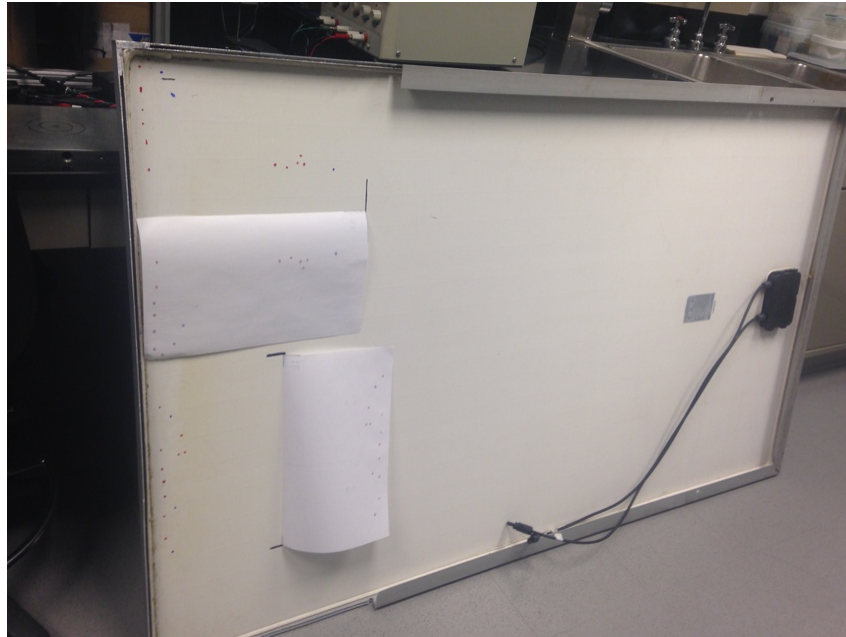
**Figure 5. Regions of interest for coring are marked directly on the backsheet of a silicon module. Paper duplicate maps are taped in place so that the regions can be accurately relocated after removing the backsheet in the coring locations.**

Since the front glass is typically tempered or strengthened, which shatters across the entire area when mechanically penetrated or cut, we developed an alternate method of only cutting through the backsheet and silicon cell. The defect locations are marked on the backsheet of the module as shown in Fig. 5. Because the backsheet will be removed at the defect areas, a duplicate paper map is taped in place such that it can be folded away and then back over to overlay on the areas of interest. The defect areas can then be relocated after backsheet removal.

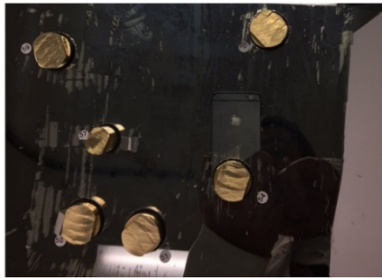
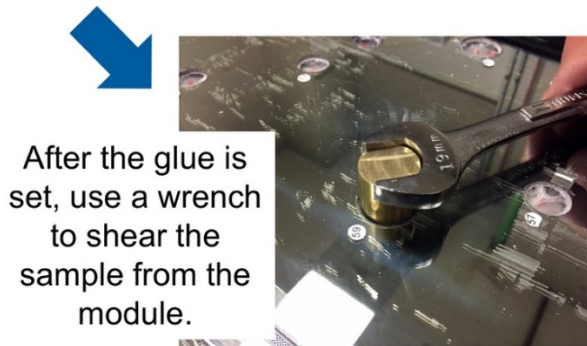
Use diamond-based coring bit to cut through glass and thin film, and then glue posts to cored glass.

Soak in acetone to dissolve Super Glue and remove post. Or, use a short post that fits in measurement tools and does not need to be removed.

Cored samples:  
~12 to 25 mm diameter

**Figure 9. Coring procedure to extract defect-containing samples from a module.**

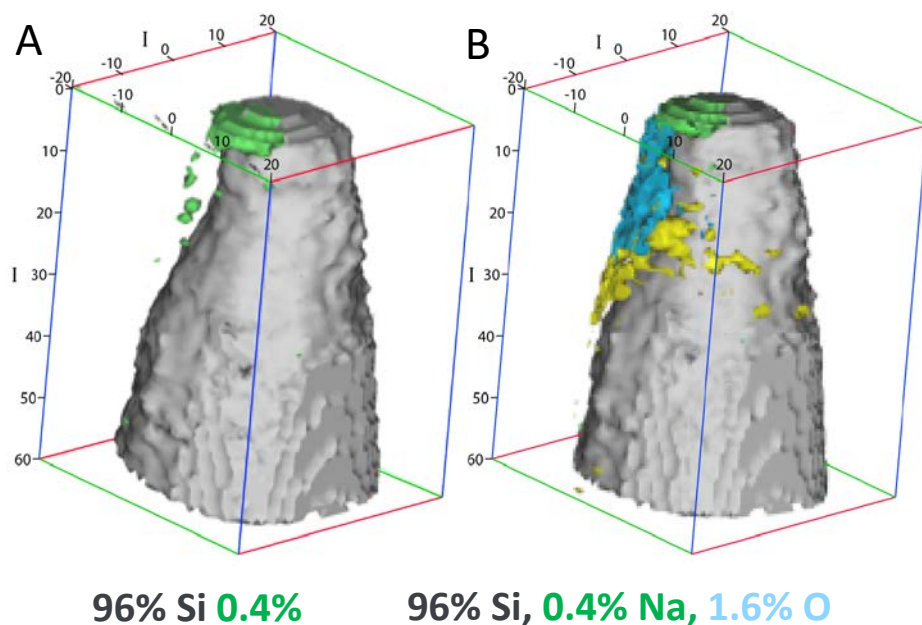
**Figure 12. 3-D reconstruction of atom-probe analysis of a PID-related {111} planar defect identified with the TEM. A) Silicon (gray) and sodium (green) isosurface. B) The results reveal Na (green), O (blue), and Ga (yellow) (likely contamination from FIB sample preparation) present at the defect consistent with the STEM results.**

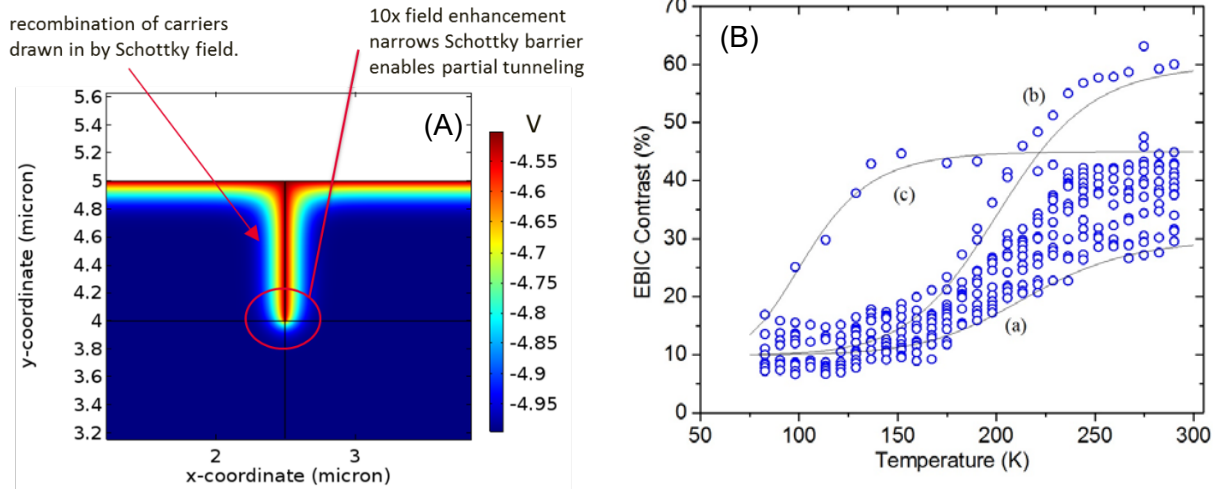
**Figure 15. (A) Electric potential (in volts) due to the Schottky contact of a 2-nm-thick metal plane, 1  $\mu\text{m}$  deep in silicon. The color gradient near the top surface is the typical p-n junction depletion region. Significant electric-field enhancement at the edge of the plane enables thermionic field emission of charge carriers and enhanced recombination. (B) EBIC contrast versus temperature data (circles) for thirteen defects identified as PID-induced shunts. Solid lines are model fits with (a)  $C_{max} = 0.30$ ,  $\phi_b = 0.40$  eV; (b)  $C_{max} = 0.60$ ,  $\phi_b = 0.50$  eV; and (c)  $C_{max} = 0.45$ ,  $\phi_b = 0.35$  eV.**

The observations of near-surface stacking faults heavily contaminated with Na extending through the p-n junction combined with the I-V characteristics exhibiting shunting behavior all suggest that a metal-like precipitate forms that causes ohmic shunting. Given that these shunts do not extend through the entire device, it is not immediately clear how they exhibit ohmic behavior because a Schottky barrier would form at the metal/semiconductor interface. Furthermore, enhanced recombination or barrier-lowering effects would be manifested primarily as  $V_{oc}$  loss, which is not the case in PID-s. Since ohmic shunting through fully metallic pathways is not consistent with the observed device characteristics, our hypothesis is instead based on the idea of semi-shunts [32], which allow for thermionic field emission (TFE) at the edge of the metal protrusion due to the enhanced electric field there. Figure 15(A) shows numerical calculation of the electric potential near a 1- $\mu\text{m}$ -deep metal plane through the Si p-n junction. A 10-fold electric-field enhancement at the tip relative to the typical built-in field is evident.

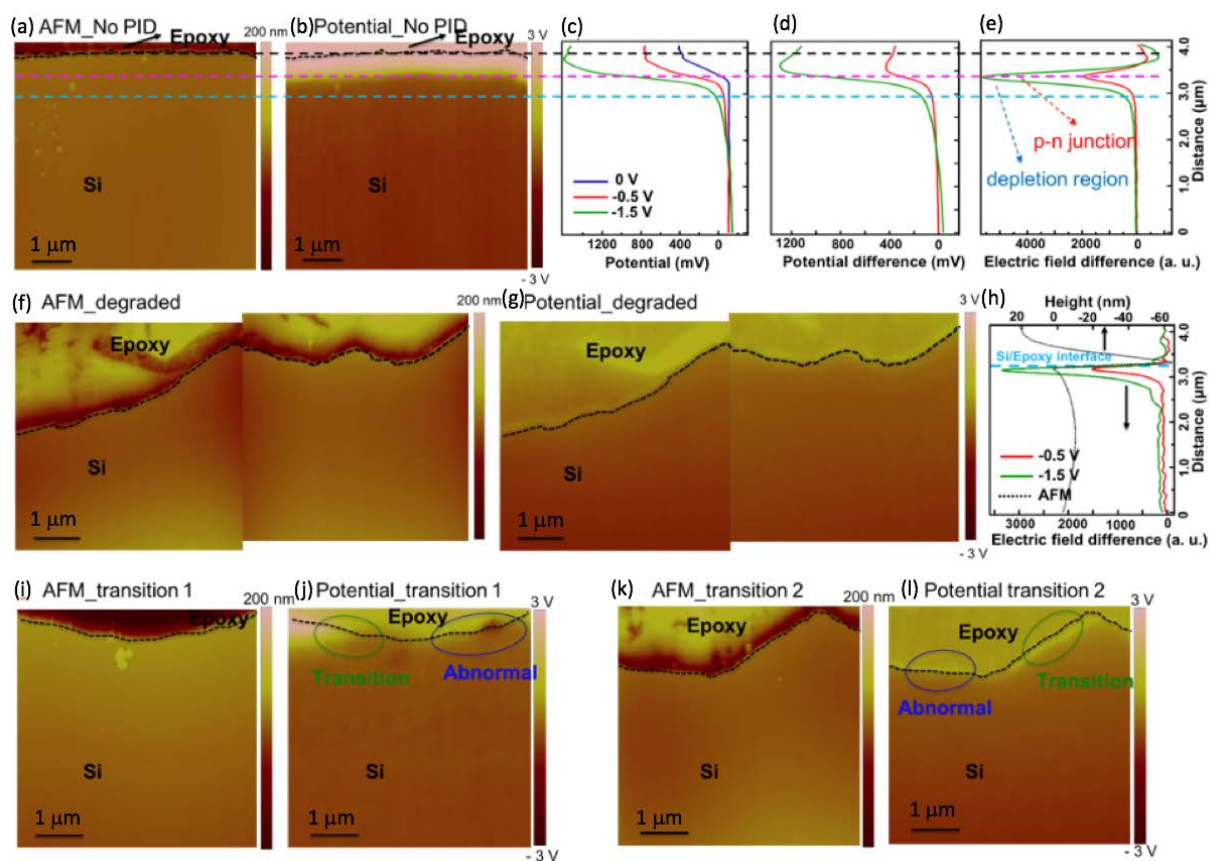
**Figure 18.** (a) An AFM of a non-degraded area with a normal p-n junction; (b) the KPFM image at  $-1.5 \text{ V}$  corresponding to (a); (c) potential profiles of an area in (b); (d) potential difference curves; (e) electric-field difference curves showing a good p-n junction characteristic; (f) AFM of a PID-affected area; (g) the KPFM potential image at  $-1.5 \text{ V}$  corresponding to (f); (h) electric-field difference curves showing an abnormal p-n junction characteristic; the electric field peak is at the epoxy/Si interface instead of junction; (i)–(l) AFM and the corresponding KPFM of two types of normal/abnormal junction transition area.

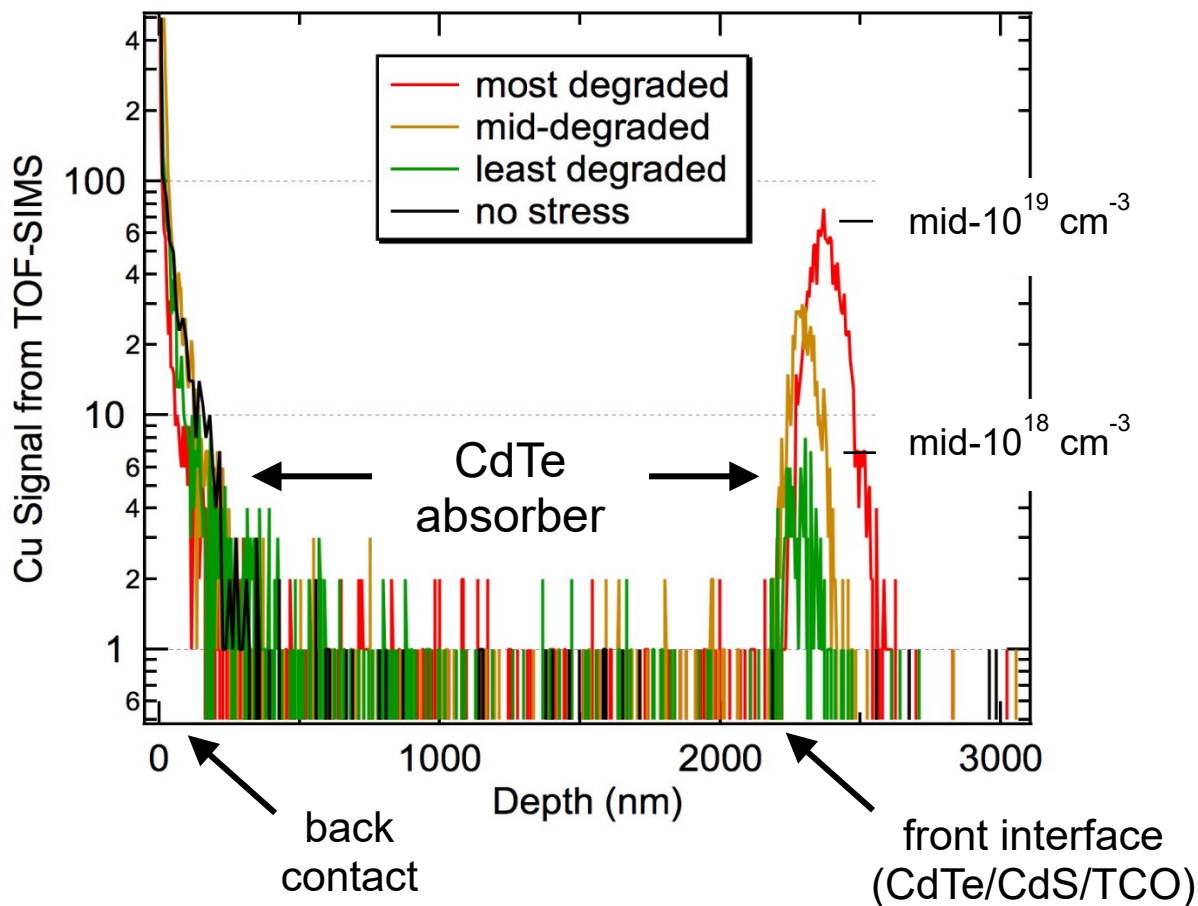
**Figure 21. TOF-SIMS shows depth profiles of Cu on selected regions of the cored CdTe samples. The back contact corresponds to zero depth, and the thickness of the CdTe absorber layer is about 2,000 nm. There is no Cu at the interface of the sample without stress.**

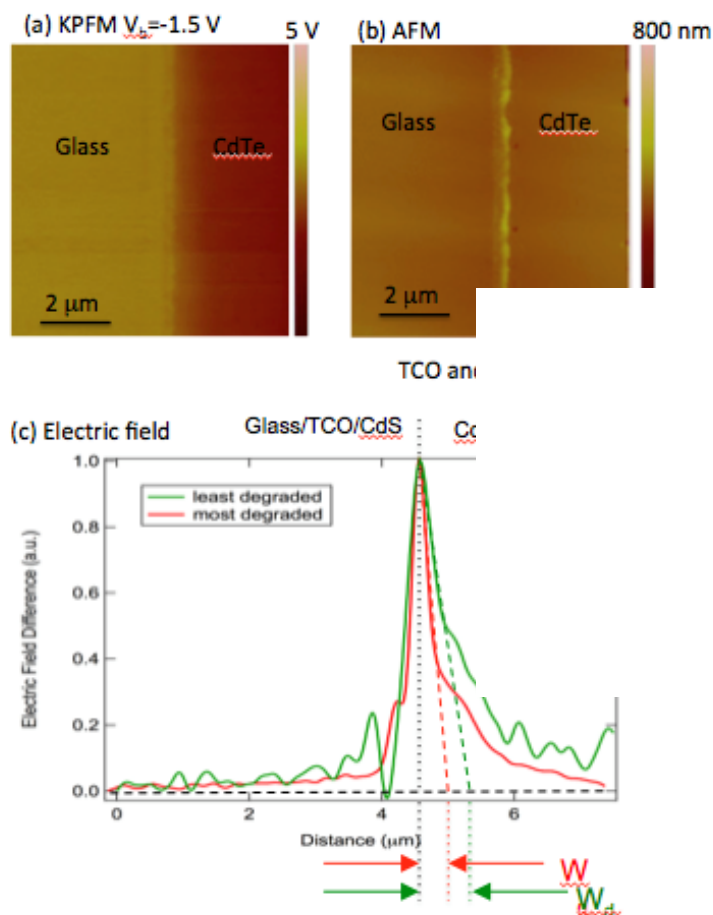
**Figure 22. (a) A KPFM potential image taken with  $V_b = -1.5$  V and (b) the corresponding AFM image. (c) shows profiles of the electric field on the most (red) and least (green) degraded samples, deduced from the potential imaging. Dashed lines show extrapolation of the electric field, assuming a constant carrier concentration. Depletion width obtained from the extrapolation are indicated.**

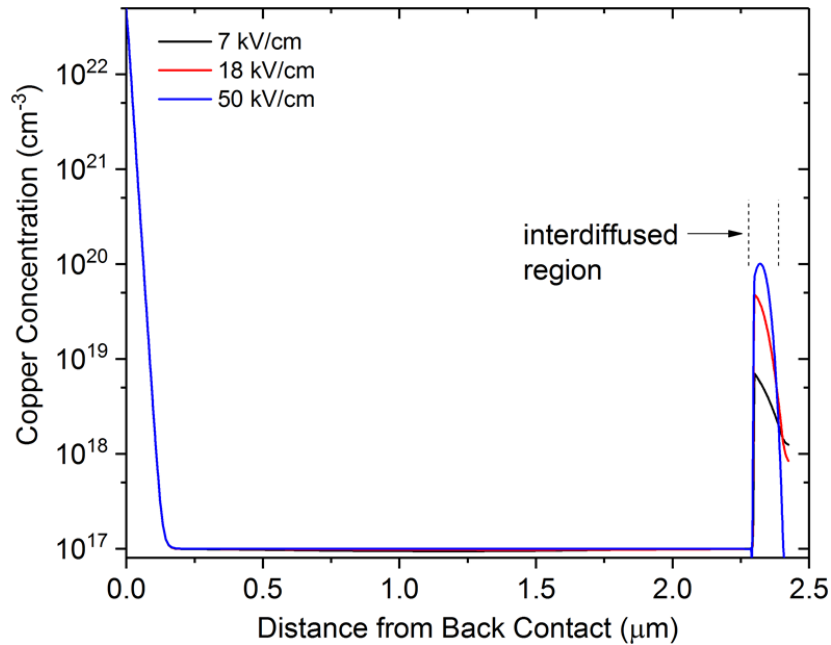
**Figure 24. Simulated copper concentrations in the bulk and CdTe/CdS interface region for various electric fields near the interface. Increasing shallow-acceptor concentrations with stress time correspond to a larger electric field, narrower depletion width, and greater copper accumulation. Calculations are shown for  $T = 100^\circ\text{C}$  at  $t = 1$  h.**

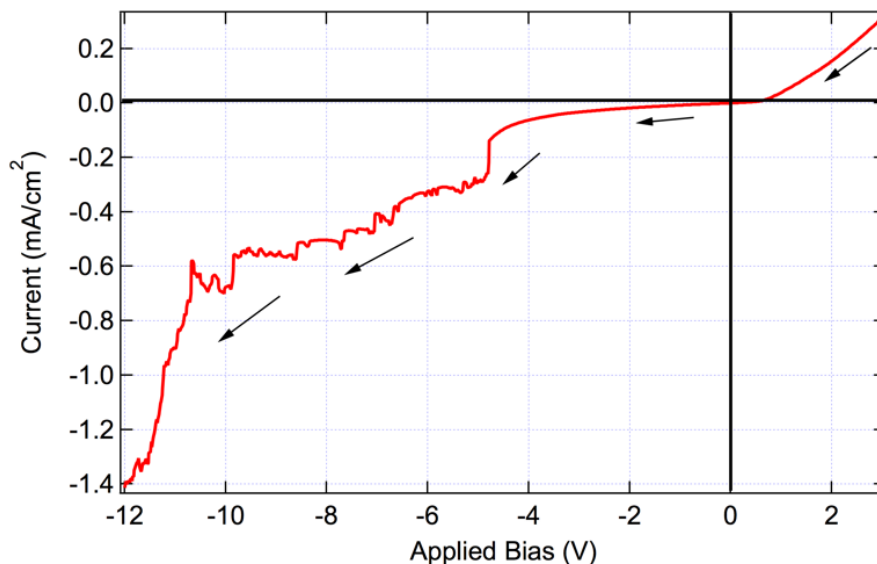
**Figure 31. An I-V curve collected during stressing.** The applied voltage begins in forward bias and progresses to increasing reverse bias. The graph shows jumps in reverse current as wormlike defects are formed and propagate.

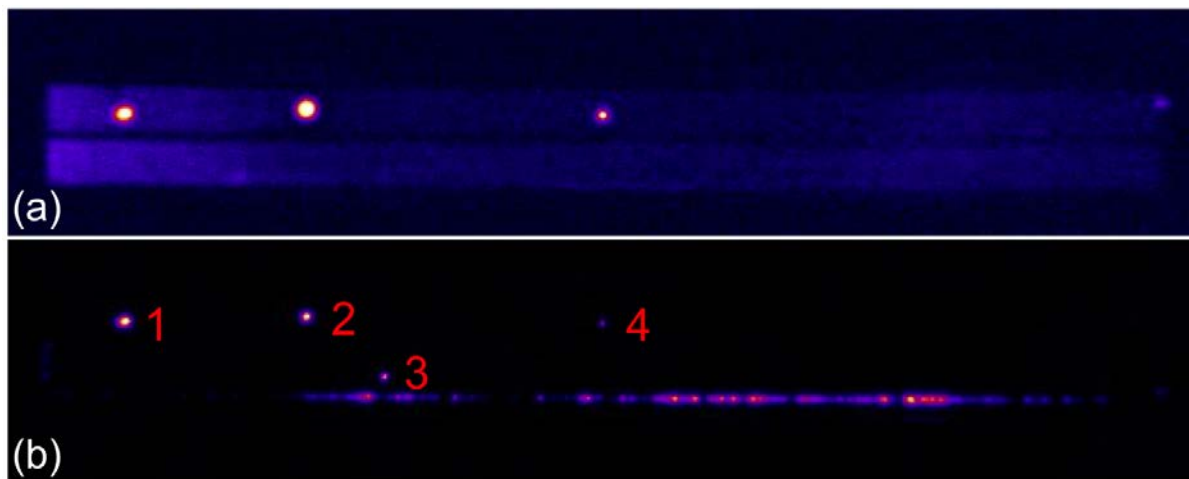
**Figure 34. (a) DLIT images for a pair of cells show localized heating at defects in forward bias and (b) reverse bias. A current limit of 0.2 mA/cm<sup>2</sup> protects the defects from damaging breakdown conditions. Defects 1, 2, and 4 are observed in both forward and reverse bias, whereas defect 3 is only detected with reverse bias.**

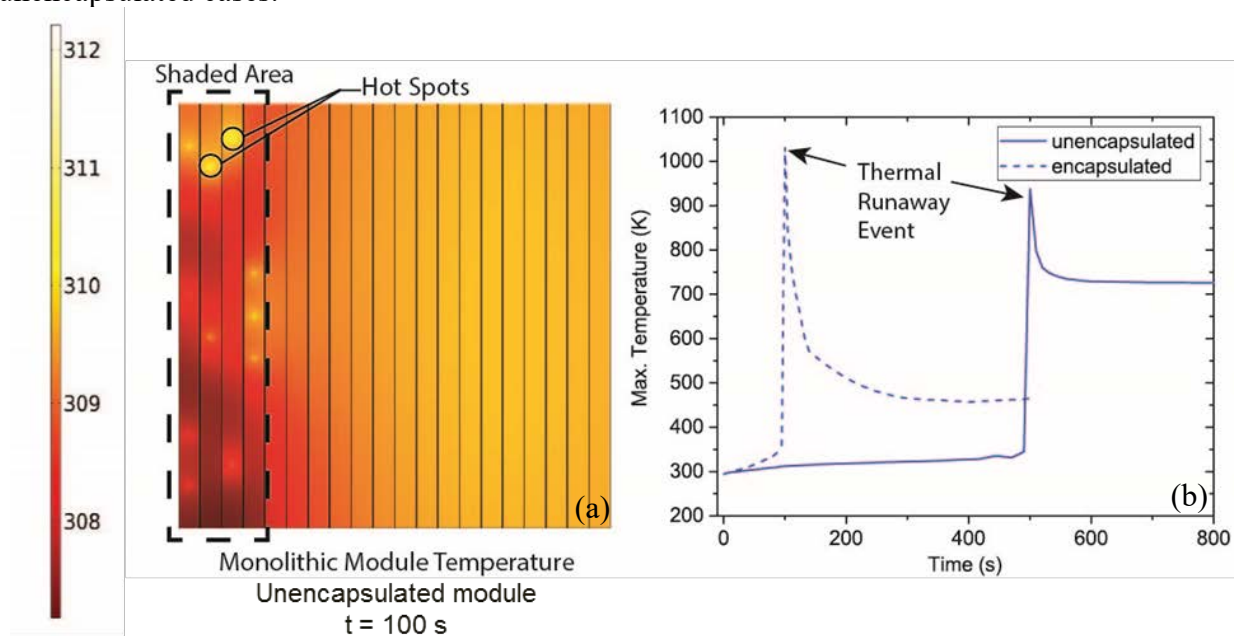
**Figure 38. (a) Temperature distributions (in K) in a 20%-shaded, unencapsulated mini-module with non-ohmic shunts (hotspots in the shaded area) at 100 s after turning on the light source of  $1,000\text{ W/m}^2$  intensity at  $J_{sc}$  condition (before thermal runaway). Dashed box delineates shaded region. (b) Maximum temperature in the module over time showing the thermal-runaway event for encapsulated and unencapsulated modules.**

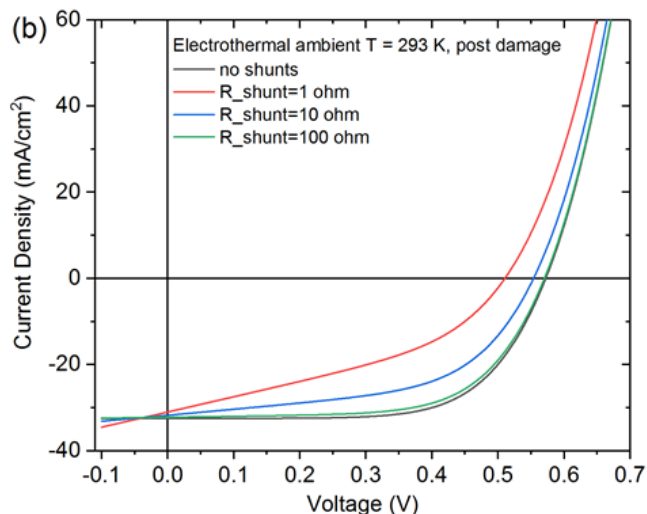
**Figure 40. Light I-V curves for a cell with no shunt and one large-area shunt to represent the post-damage scenario. Various shunt resistances are shown for field conditions of 1-sun light intensity and  $T = 293$  K.**
