Review of observed degradation modes and mechanisms from fielded modules

Lifetime prediction requires field experience

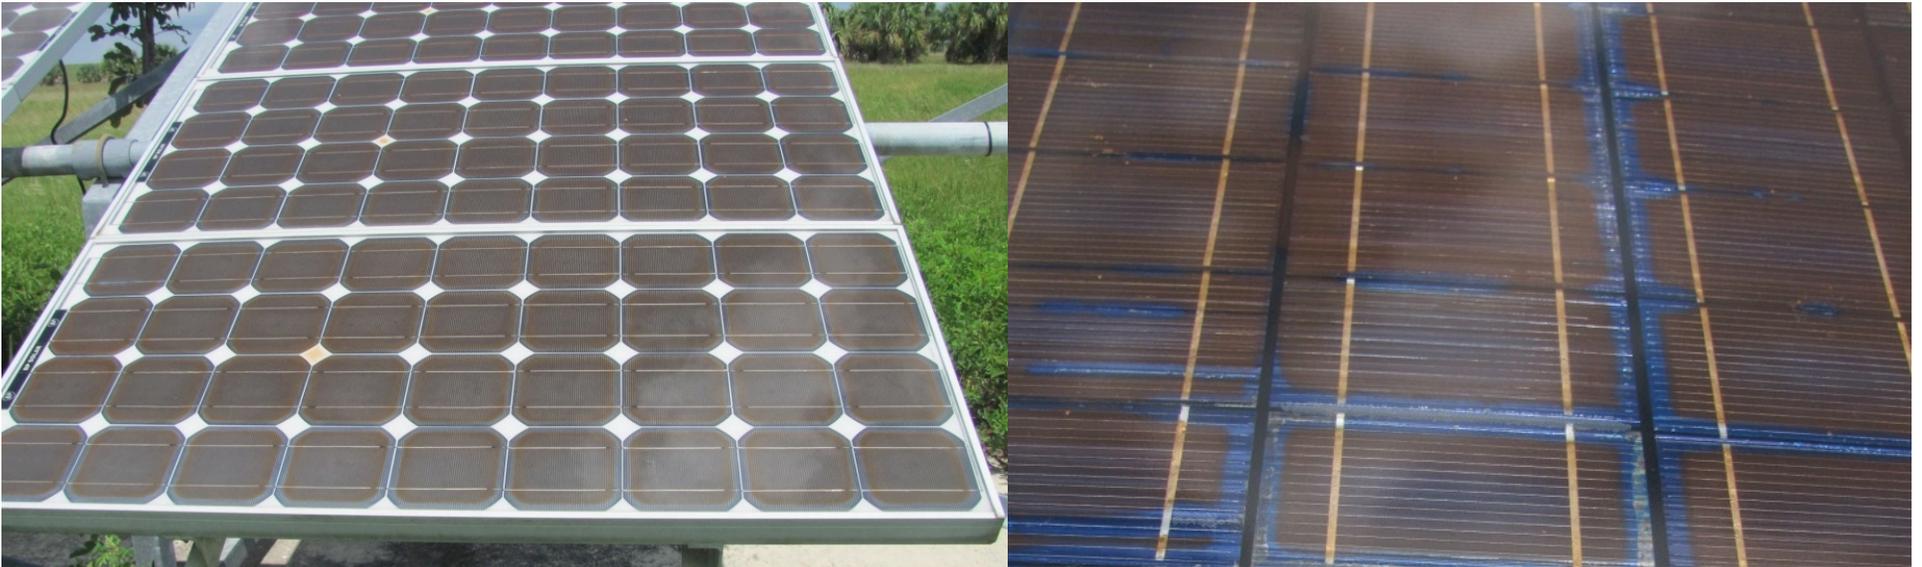
Discoloration

mono-Si (left) and EFG Si (right) after 23 years in Marin County, Florida (warm temperate/fully humid/hot summer)

Encapsulant can get very dark, reducing short-circuit current

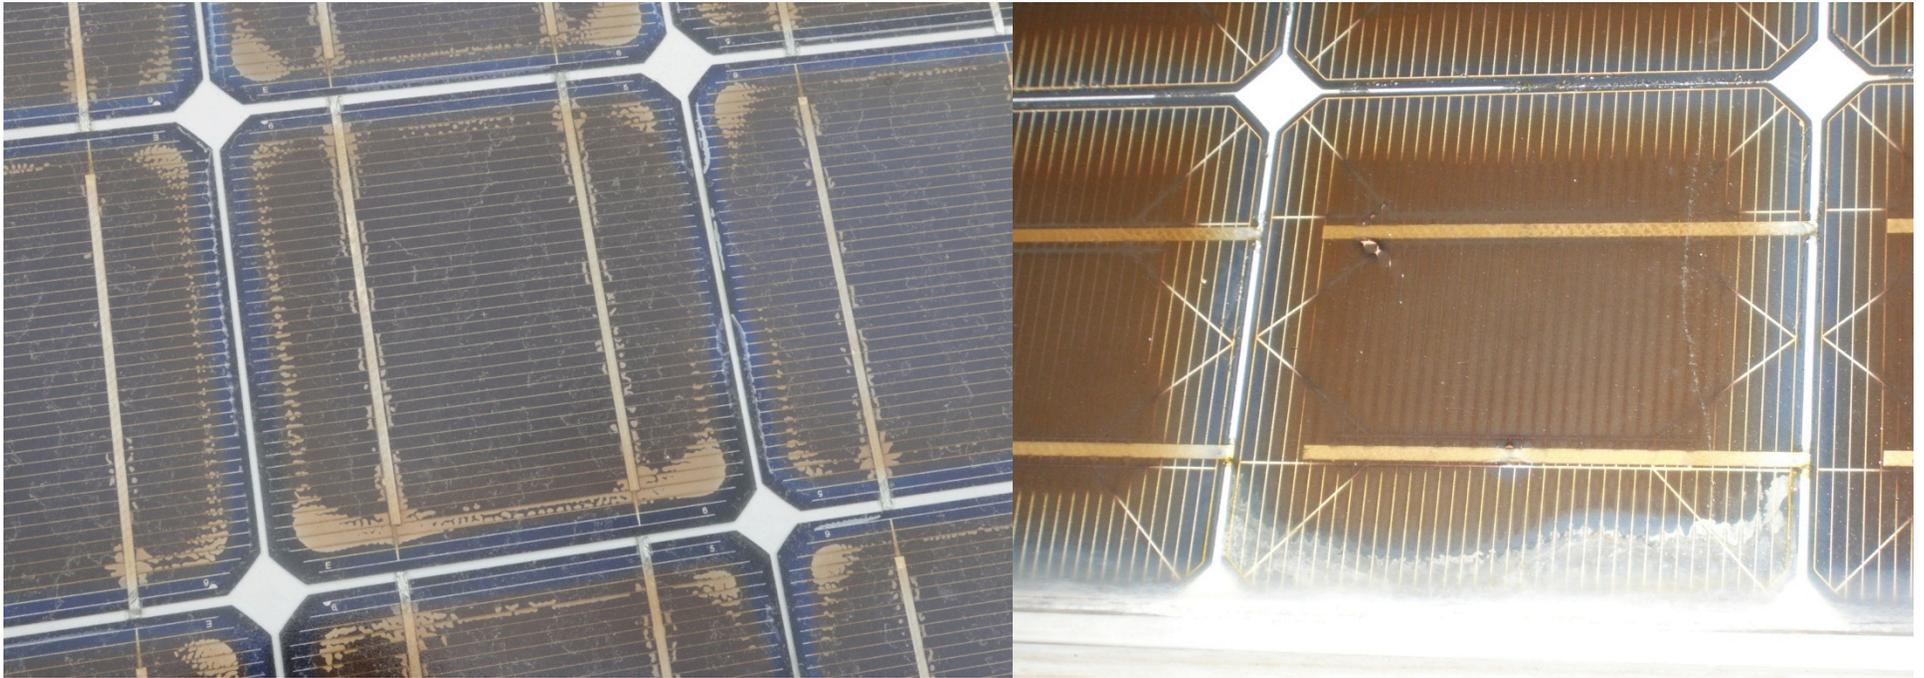
Discoloration

mono-Si after 18 years (left) and 27 years (right) in Sacramento (warm temperate/
summer dry/hot summer)

Delamination can accompany discoloration

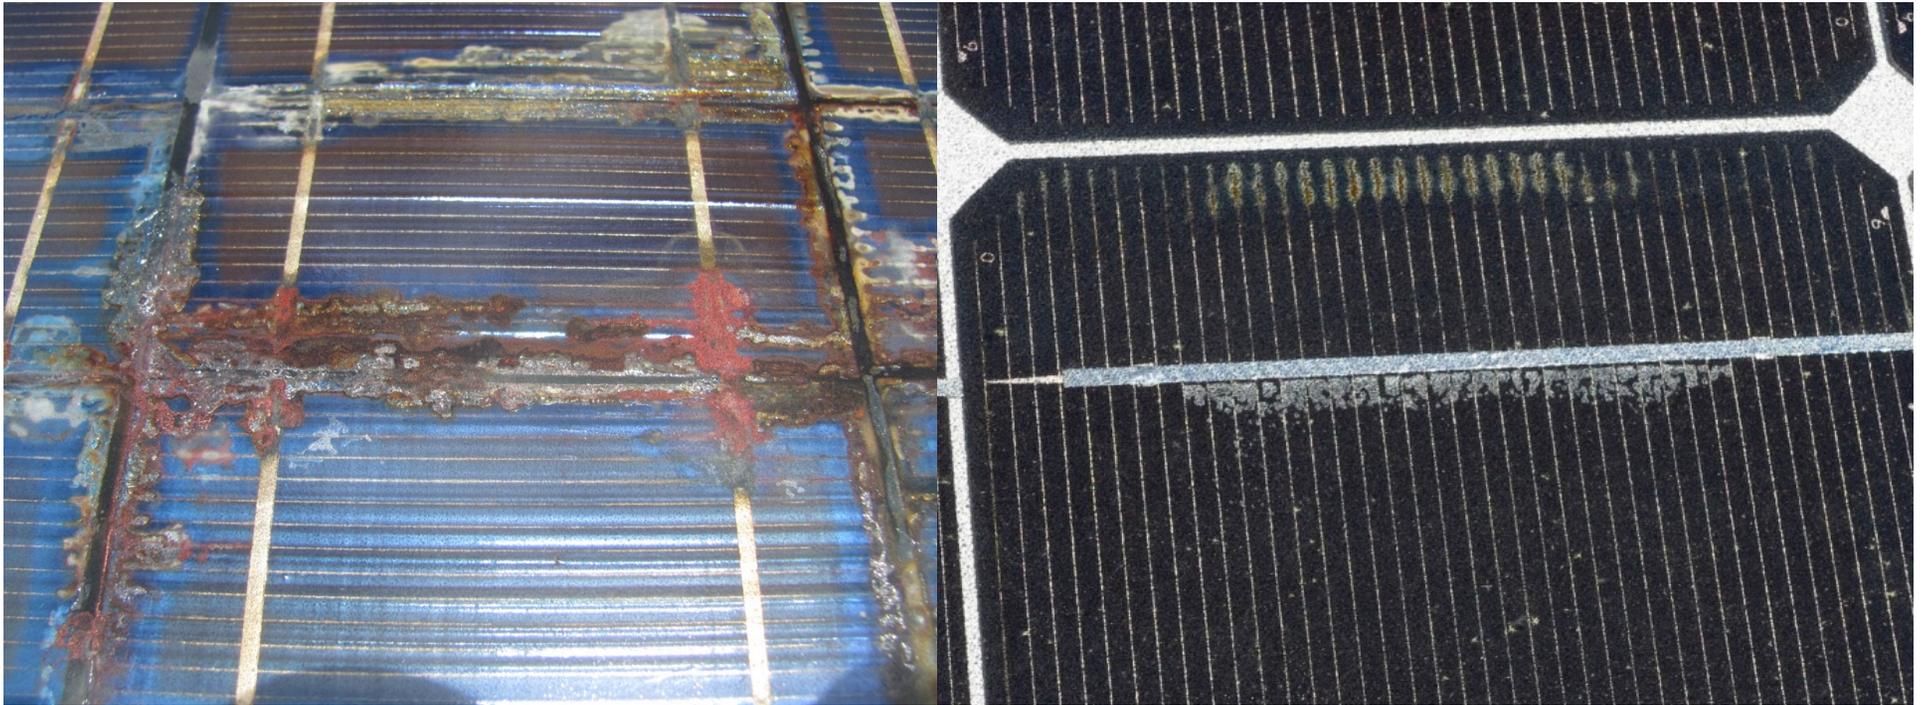
Corrosion

EFG Si after 23 years in Marin County, Florida

mono-Si after 15 years in Cocoa, Florida

Delamination can let in moisture, causing corrosion, but some corrosion occurs without delamination

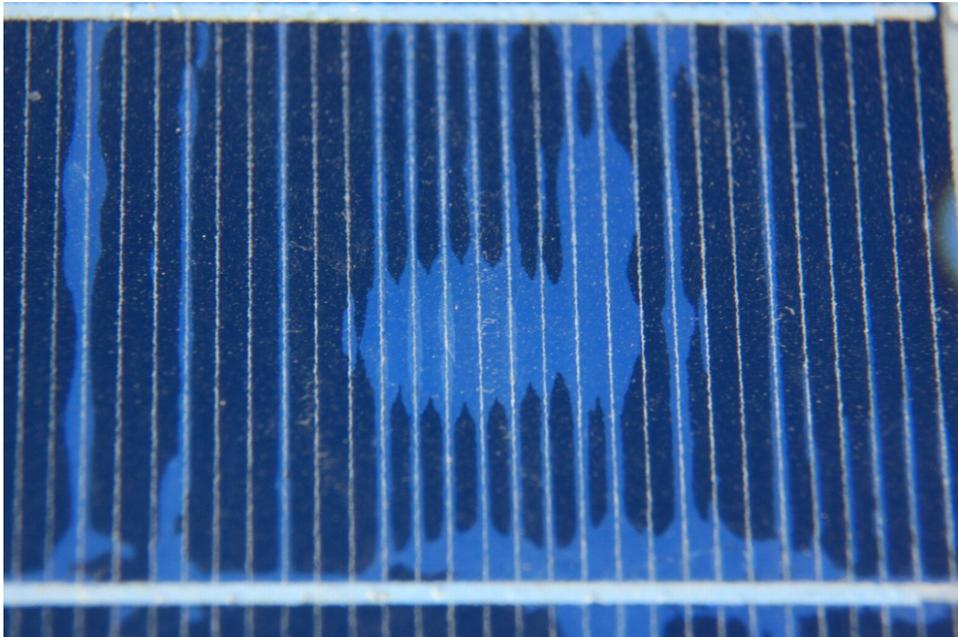
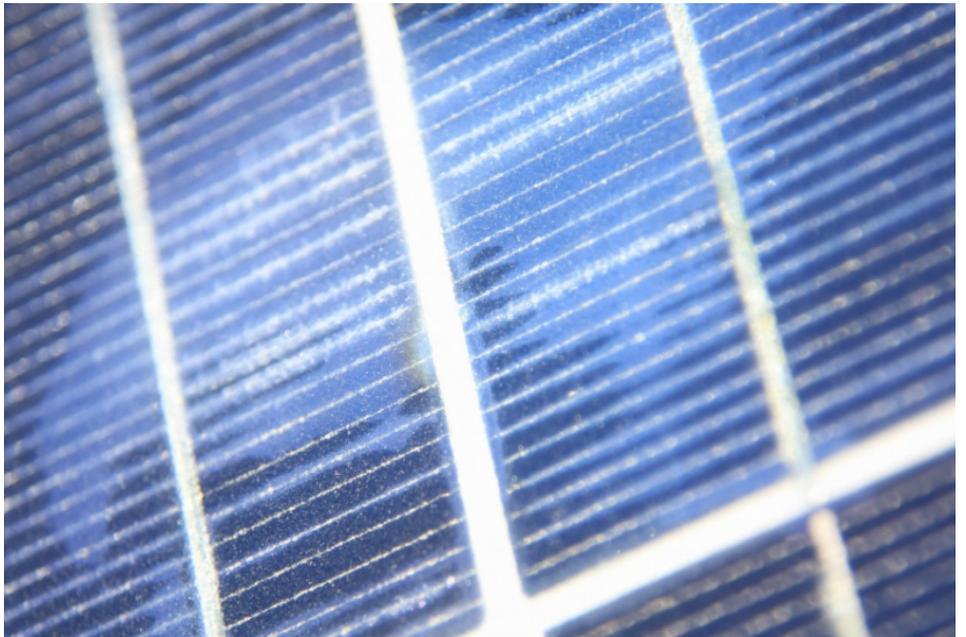
Delamination

EFG Si after 11 years in Springerville

EFG Si after 13 years in Tucson

An ionomer encapsulant showed delamination along fingers at two sites

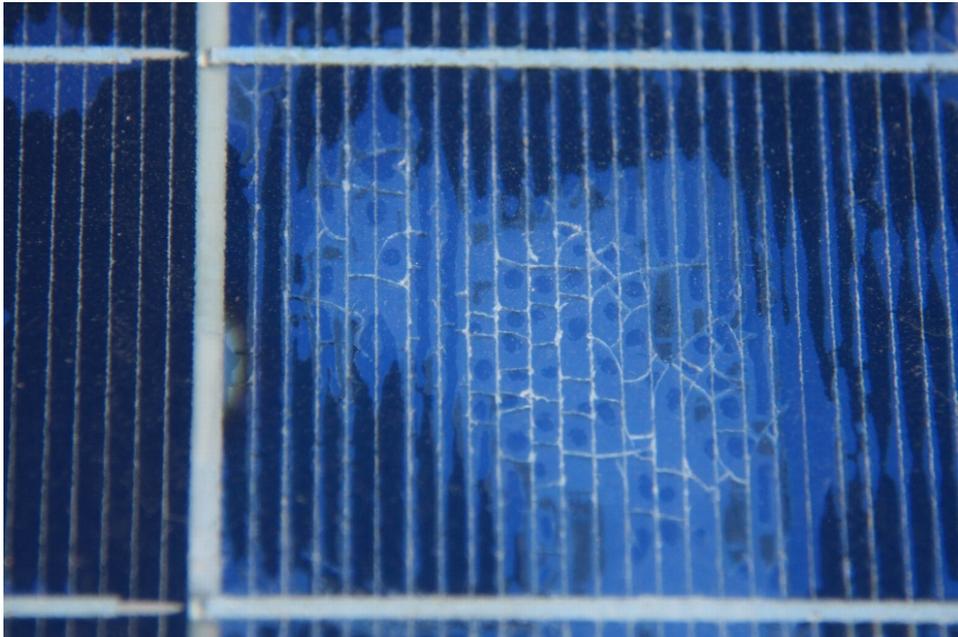
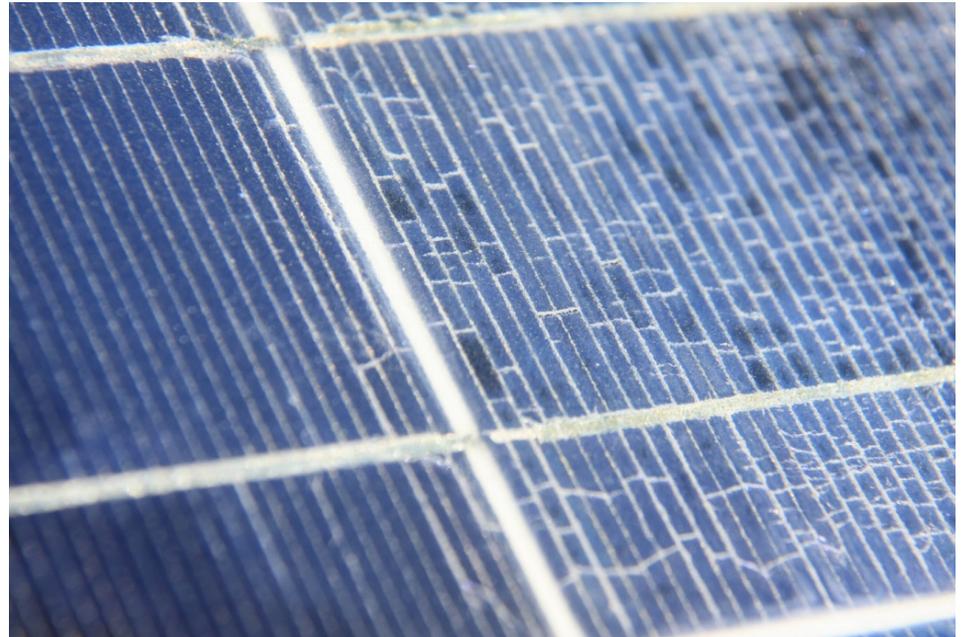
Delamination

EFG Si after 11 years in Springerville

EFG Si after 13 years in Tucson

At the junction box, it showed cohesive failure, too

This was fixed with a reformulation of the ionomer

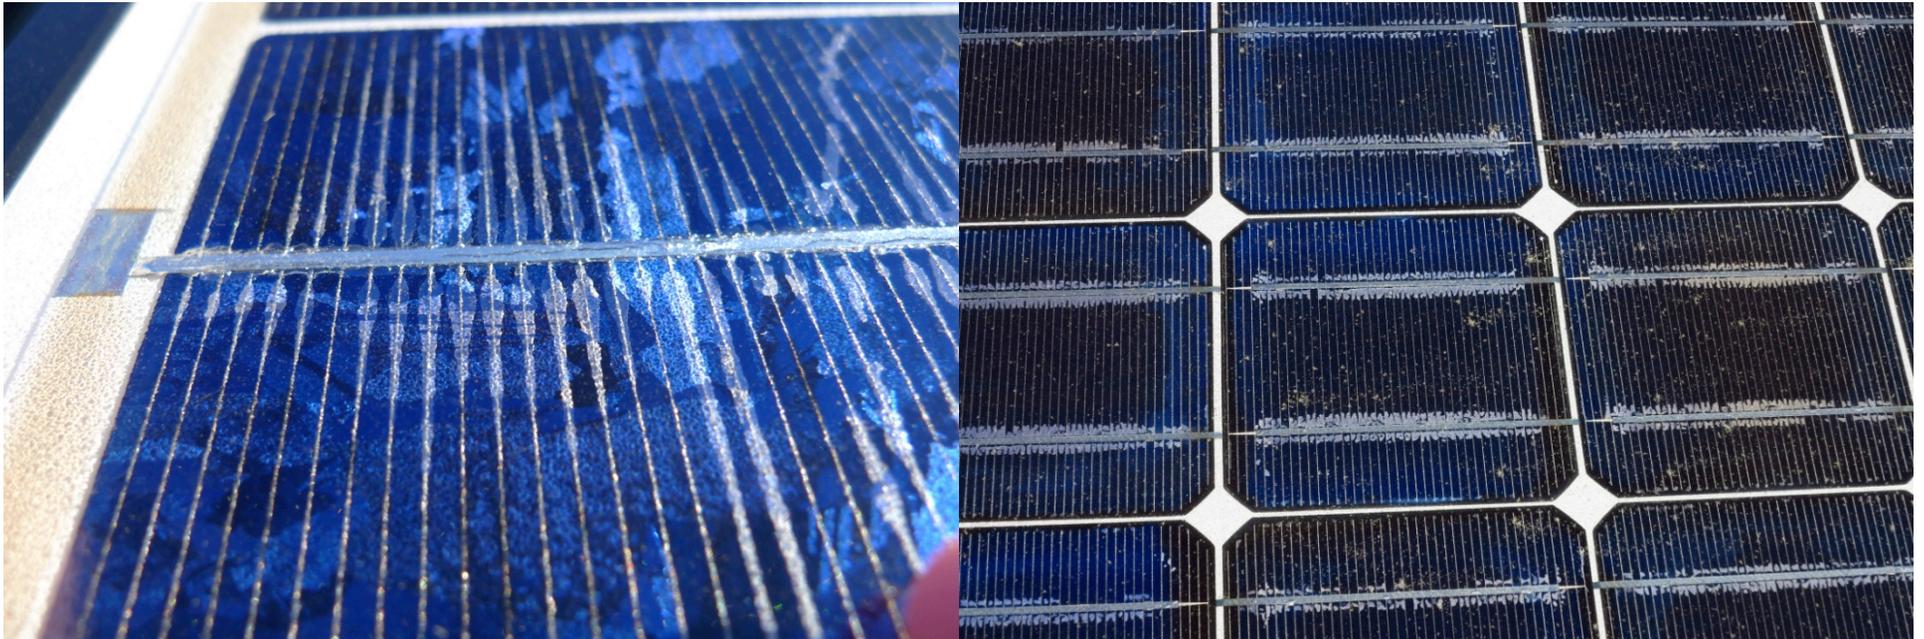
multi-Si after 10 years in Perrysburg, Ohio

mono-Si after 15 years in Cocoa, Florida

Delamination at the encapsulant-cell interface often follows ribbons and grid fingers

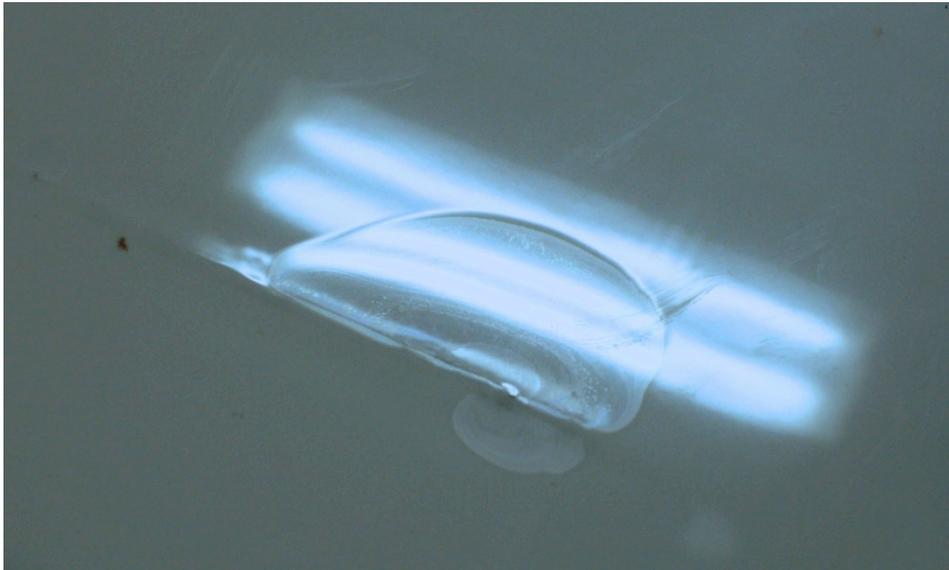
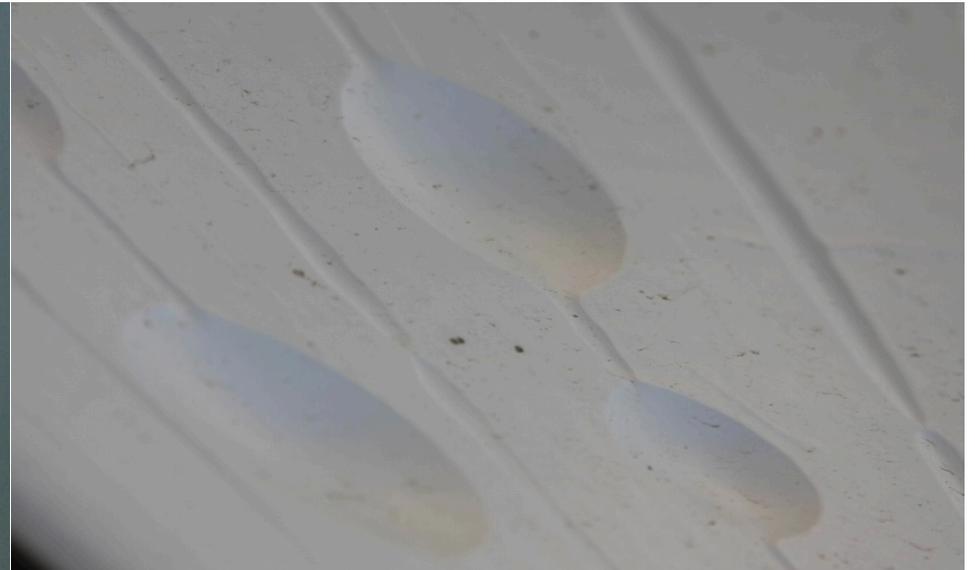
Delamination

multi-Si after 10 years in Perrysburg

HIT after 10 years in Tucson
Al-containing backsheet traps outgassing

Backsheet layers can separate from each other or from the encapsulant

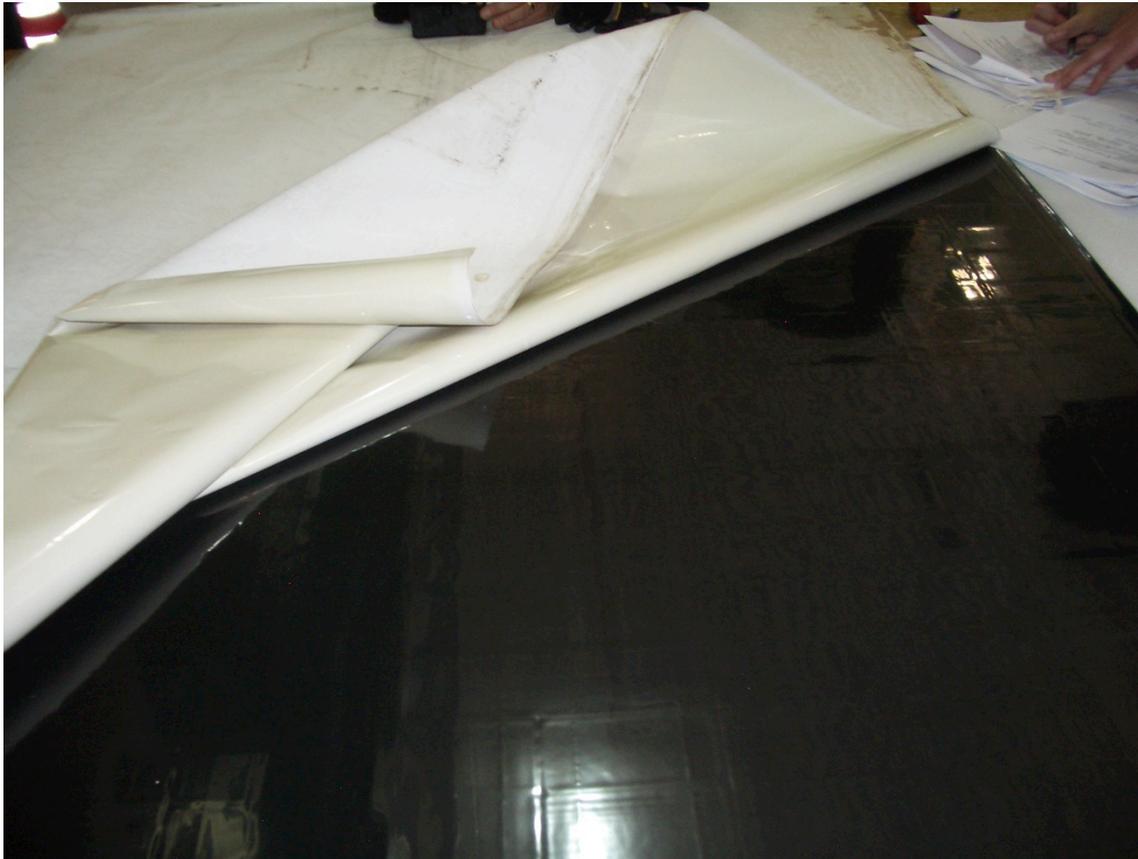
Delamination

Or they can
flee the module
entirely

EFG Si after 27 years in Sacramento

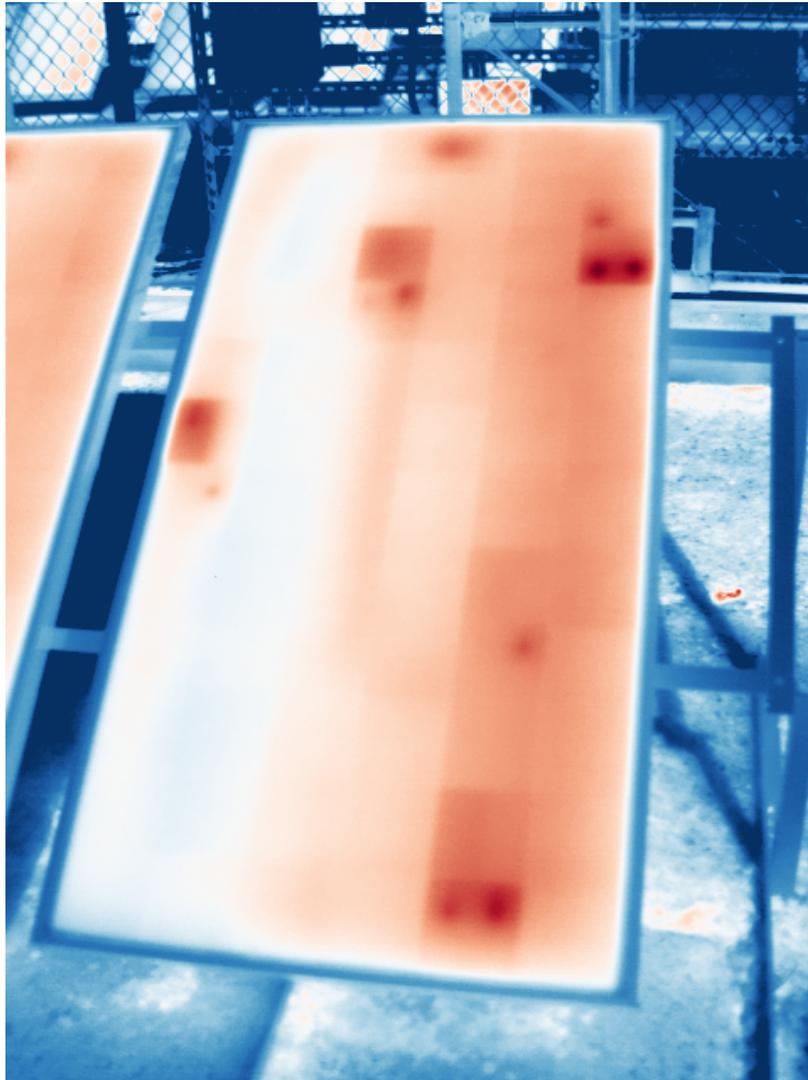
Interconnect degradation

Broken solder bonds lead to high series resistance and loss of FF

They also result in highly localized dissipation of heat

mono-Si after 8 years in Tucson

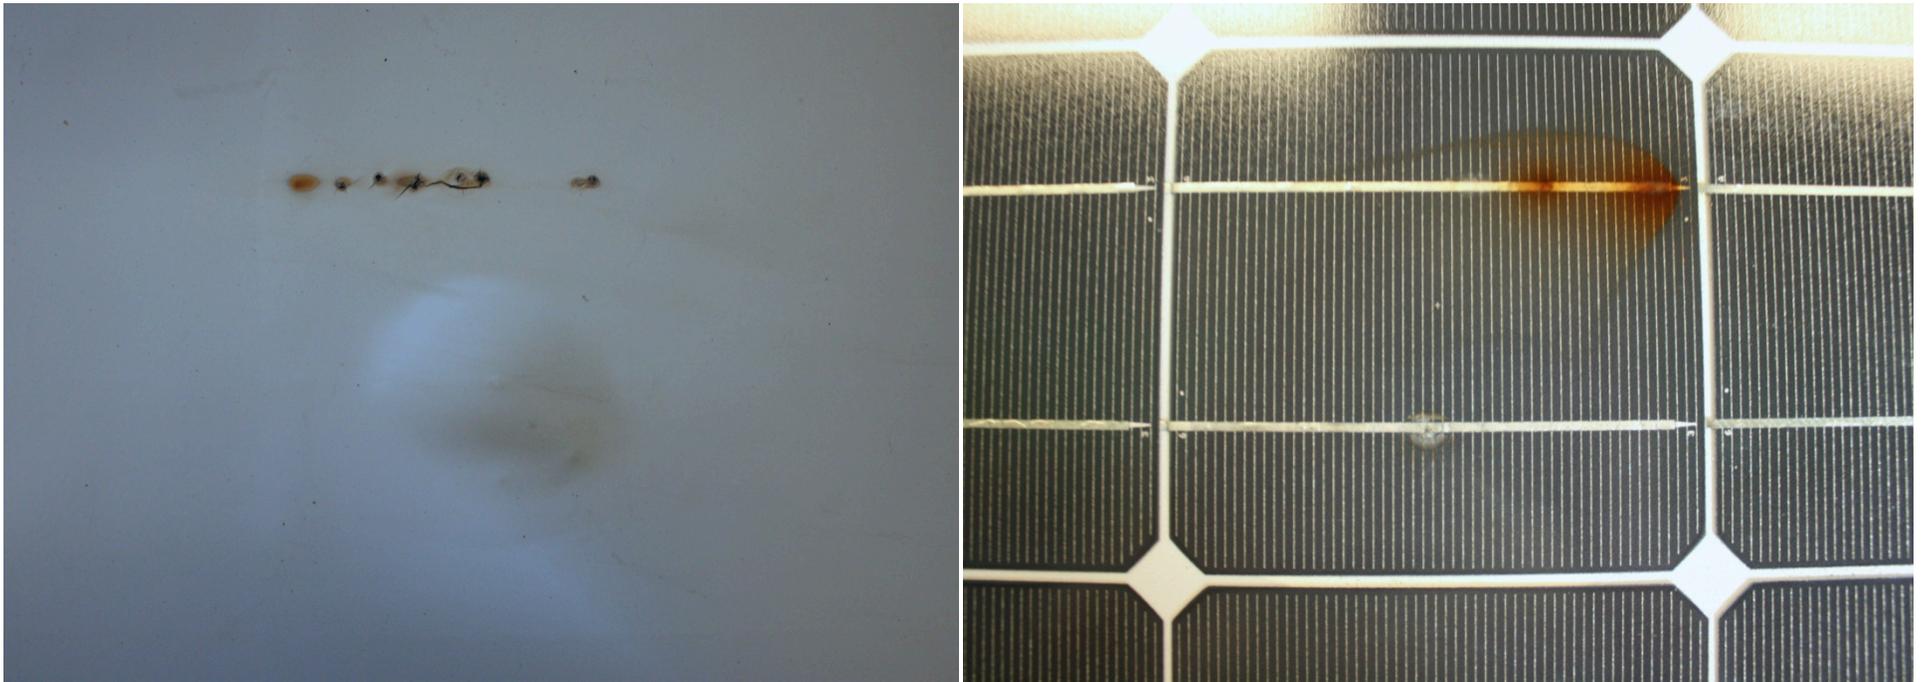
Interconnect degradation

mono-Si after 10 years in Perrysburg, Ohio

Highly localized heating from broken solder bonds damages adjacent materials

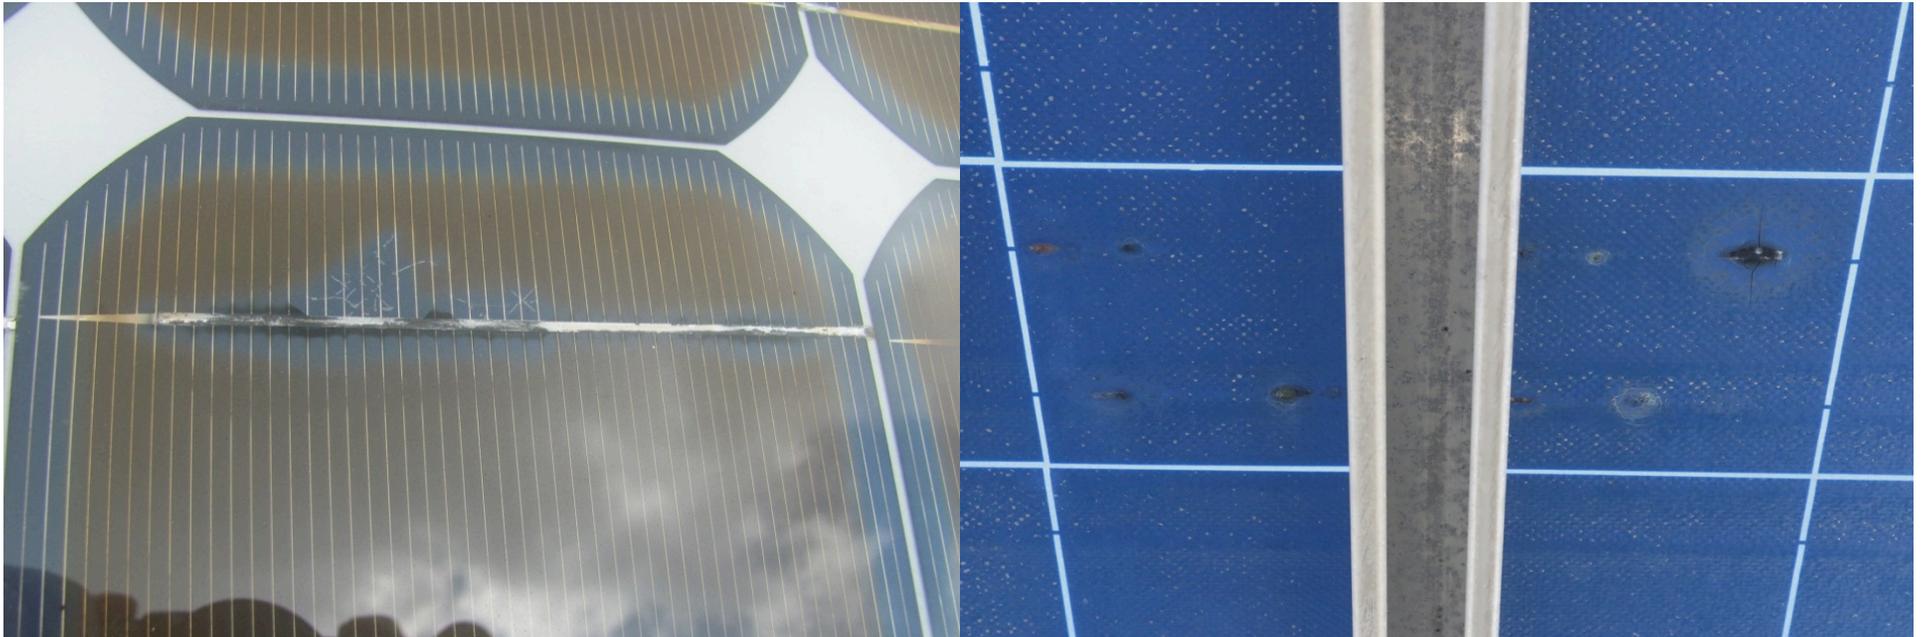
Interconnect degradation

23 years in Marin County, Florida

16 years in Sacramento

Highly localized heating from broken solder bonds damages adjacent materials

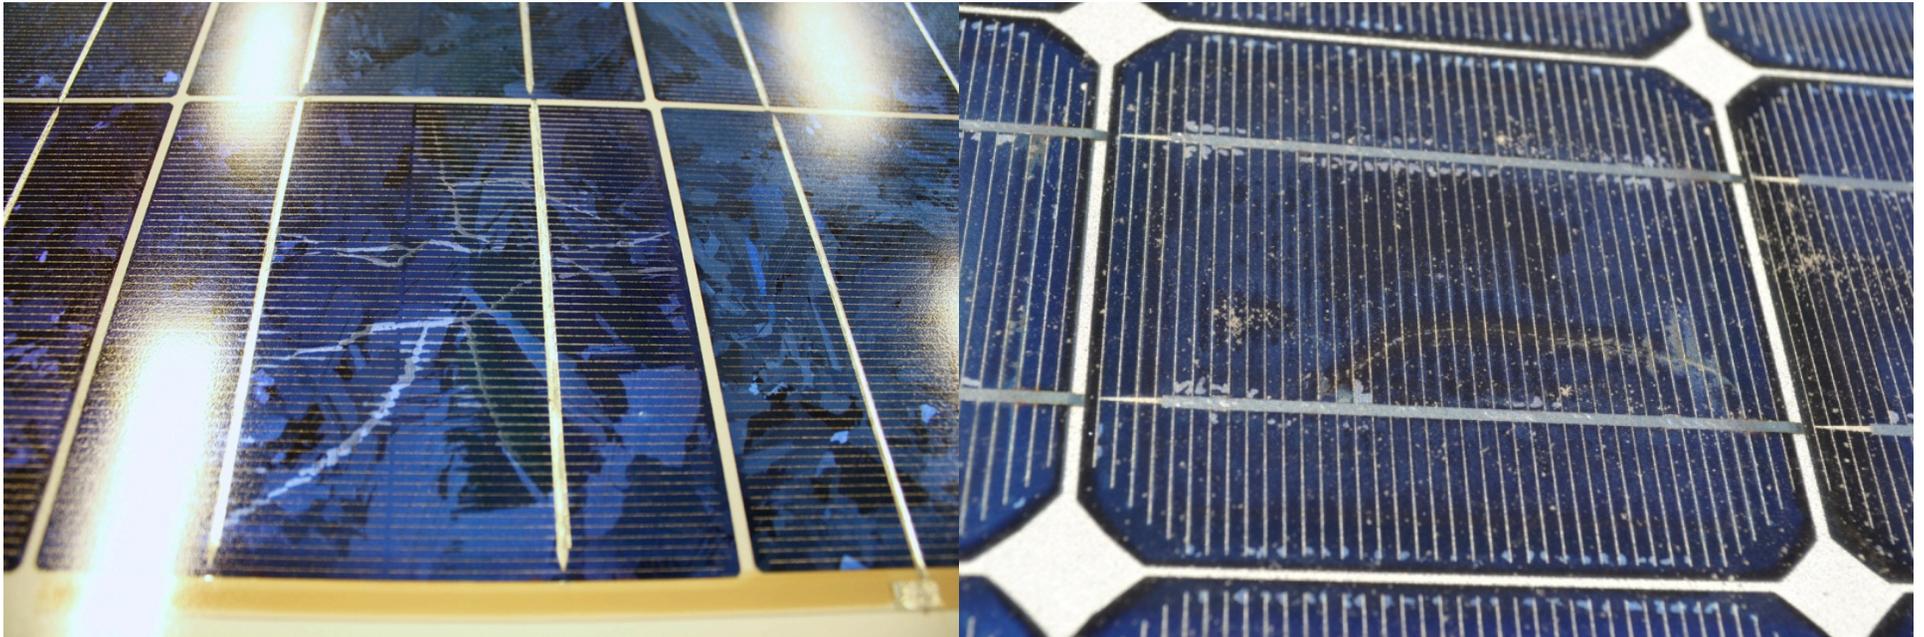
multi-Si after 10 years in Perrysburg

mono-Si after 15 years in Cocoa

Broken cells can become visible when they permit delamination along cracks

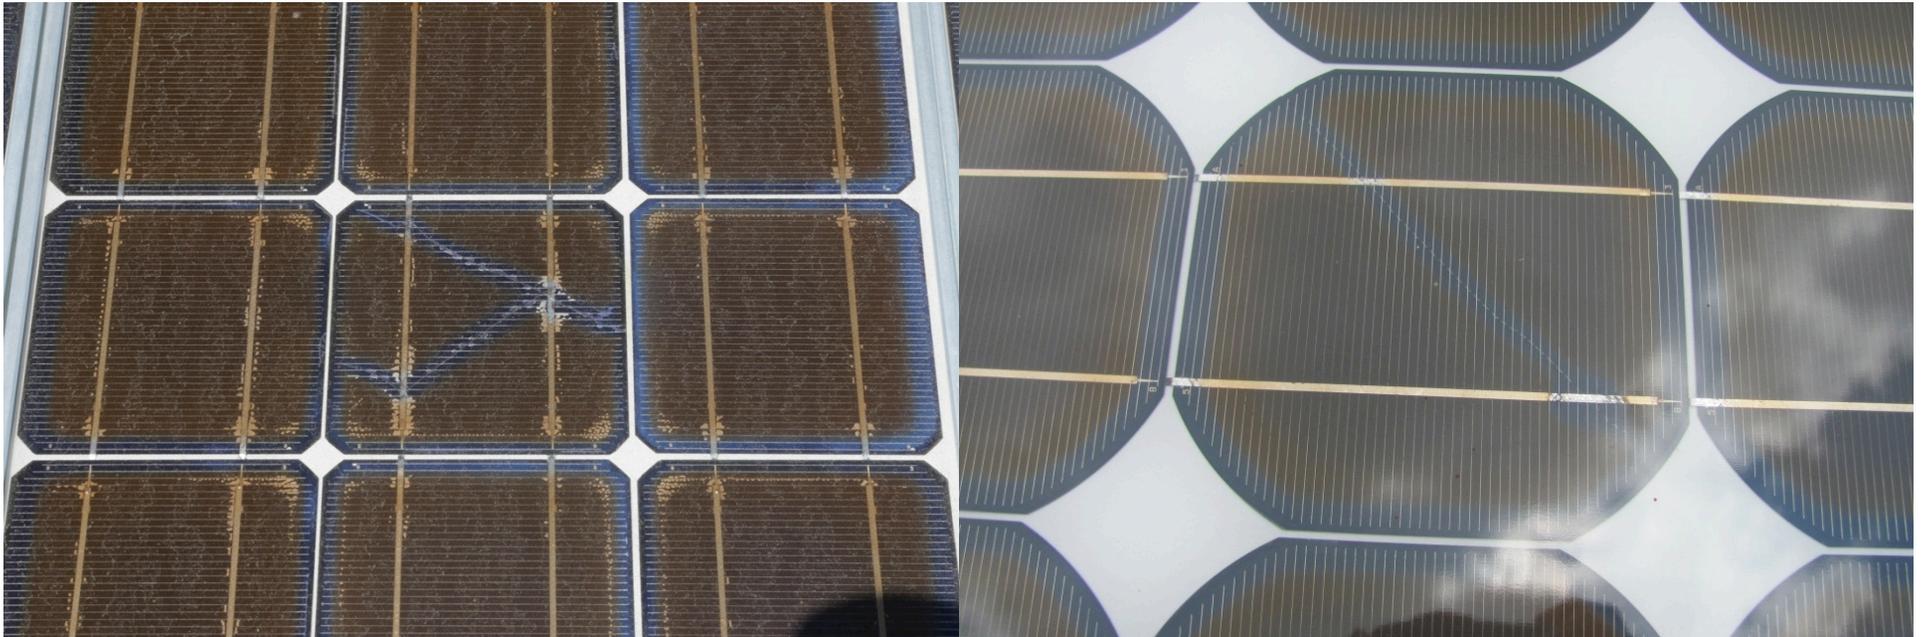
Broken cells

mono-Si after 18 years in Sacramento

mono-Si after 23 years in Marin County, Florida

In modules with highly discolored encapsulant, the cracks permit photooxidative bleaching to occur

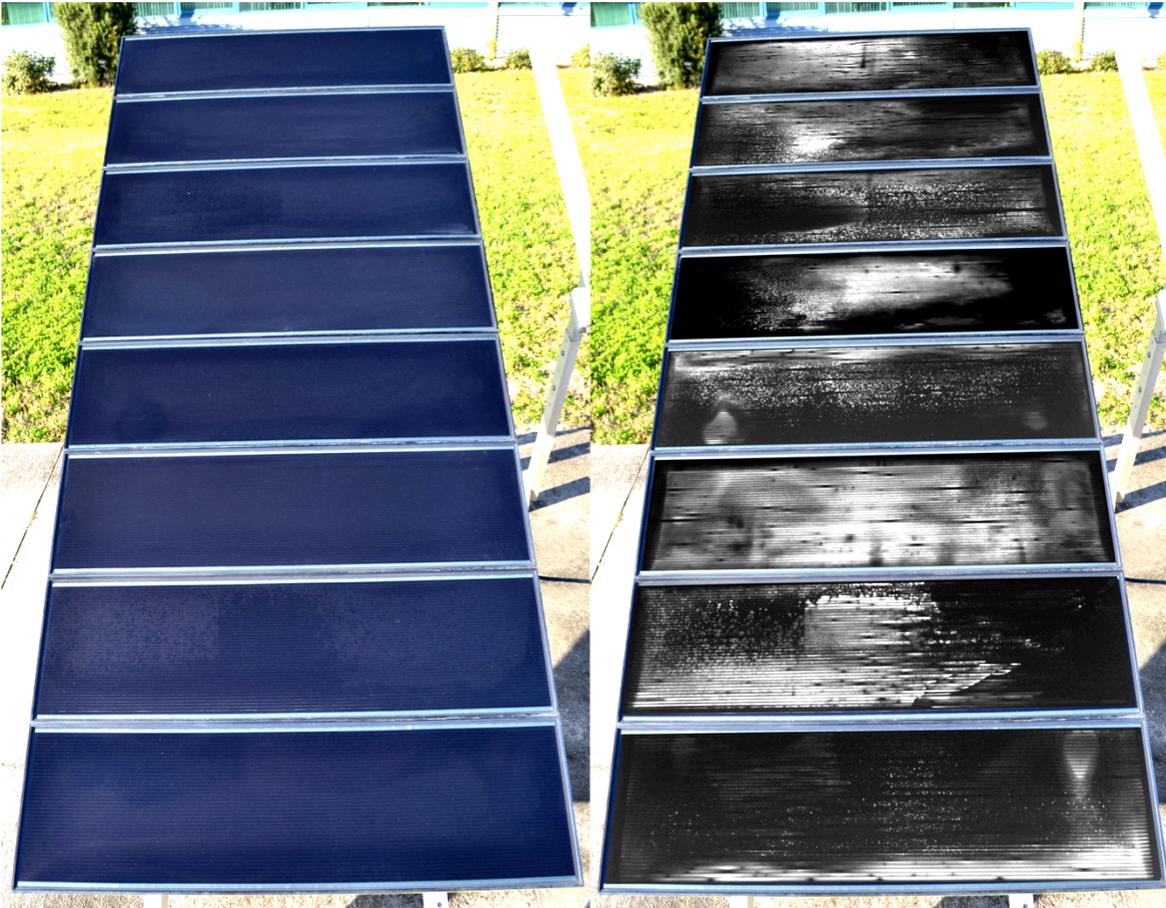
Corrosion

CIGS after 12 years in Cocoa (image courtesy FSEC)

TCO corrosion causes visible lightening and loss of emission in EL

The increased series resistance is linked to loss of FF

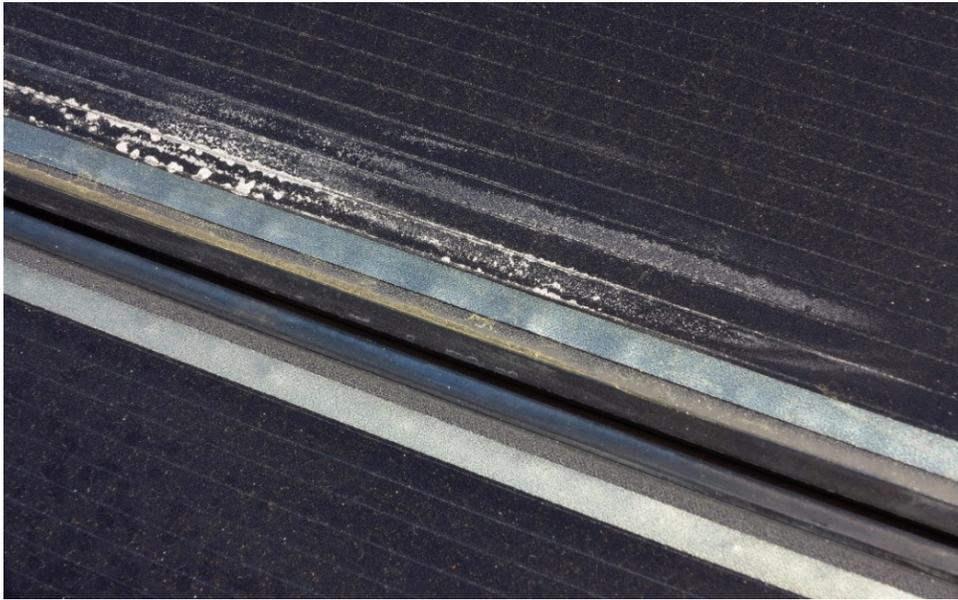
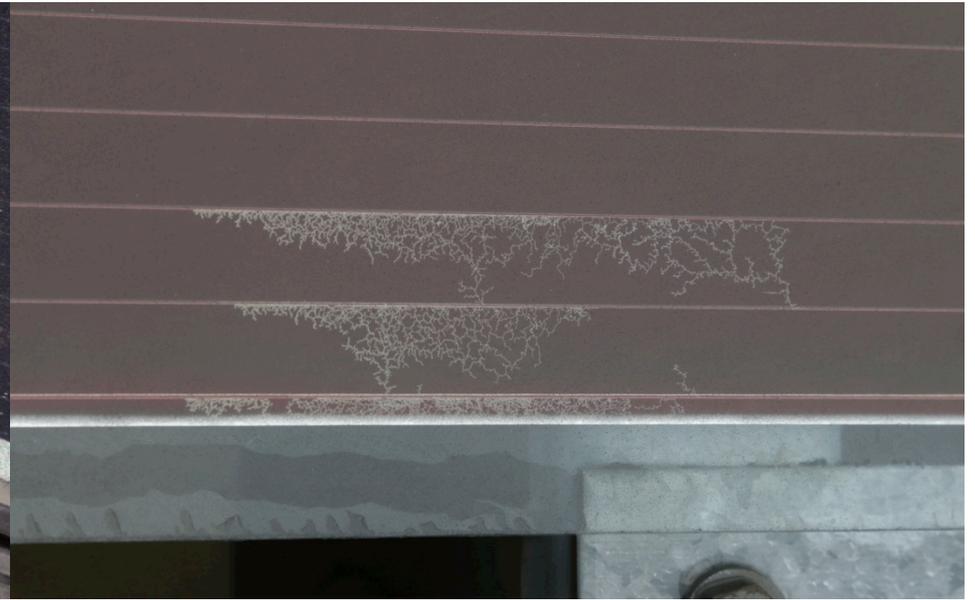
Corrosion

CIGS after 12 years in Cocoa

a-Si after 19 years in Sacramento

TCO/absorber corrosion can also interact with scribe lines

The dendritic form on the right is linked to voltage stress

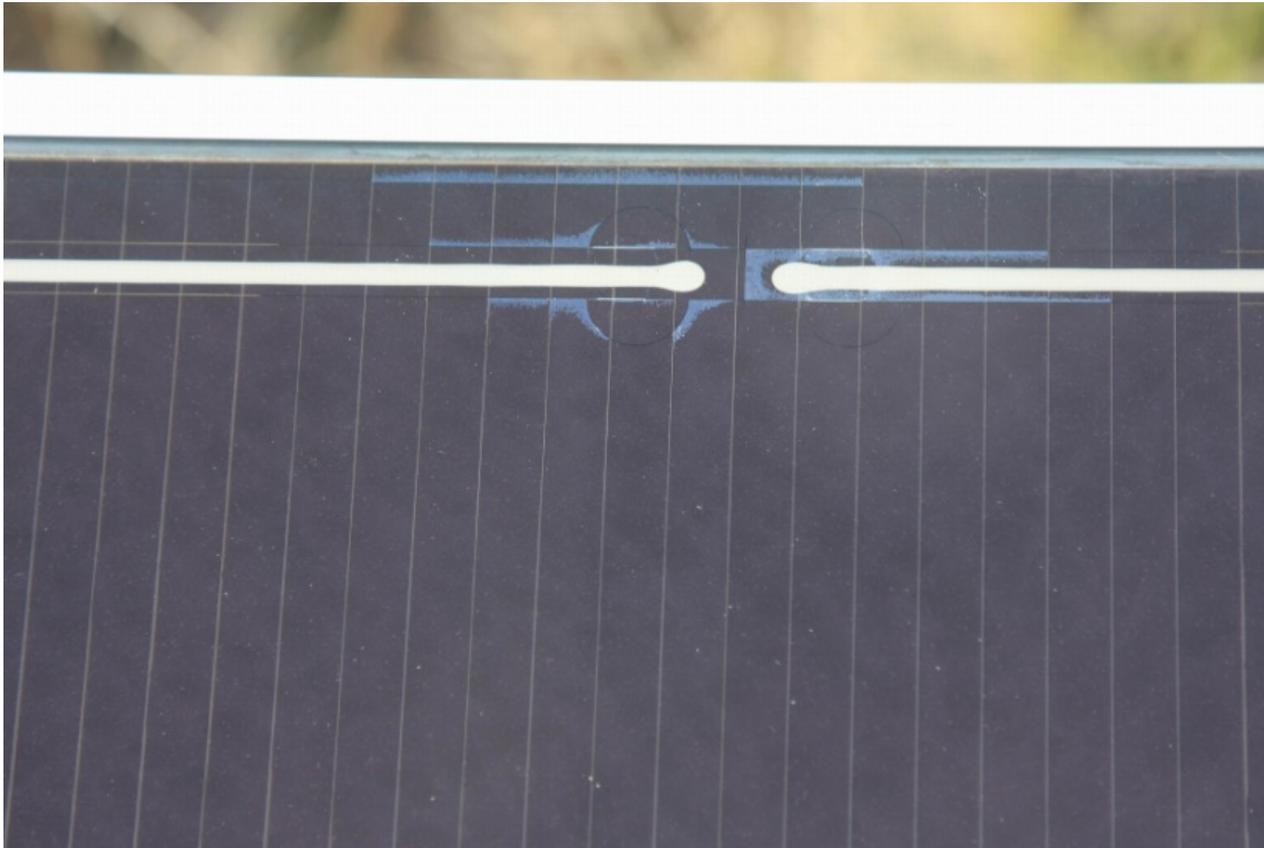
Corrosion

a-Si after 11–12 years in Springerville, Arizona

This TCO corrosion near the junction box appears to depend on polarity, suggesting an electric field mechanism

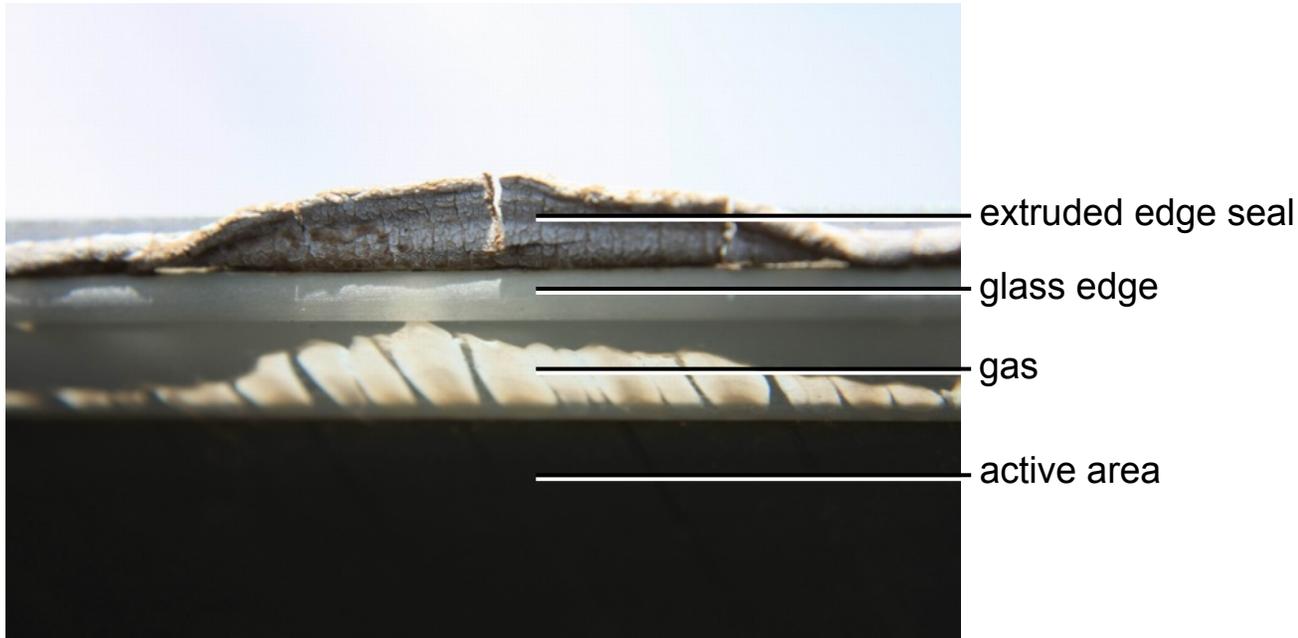
Seal deformation

CdTe after 9–11 years in Springerville, Arizona

Internal pressure can push edge seals outward

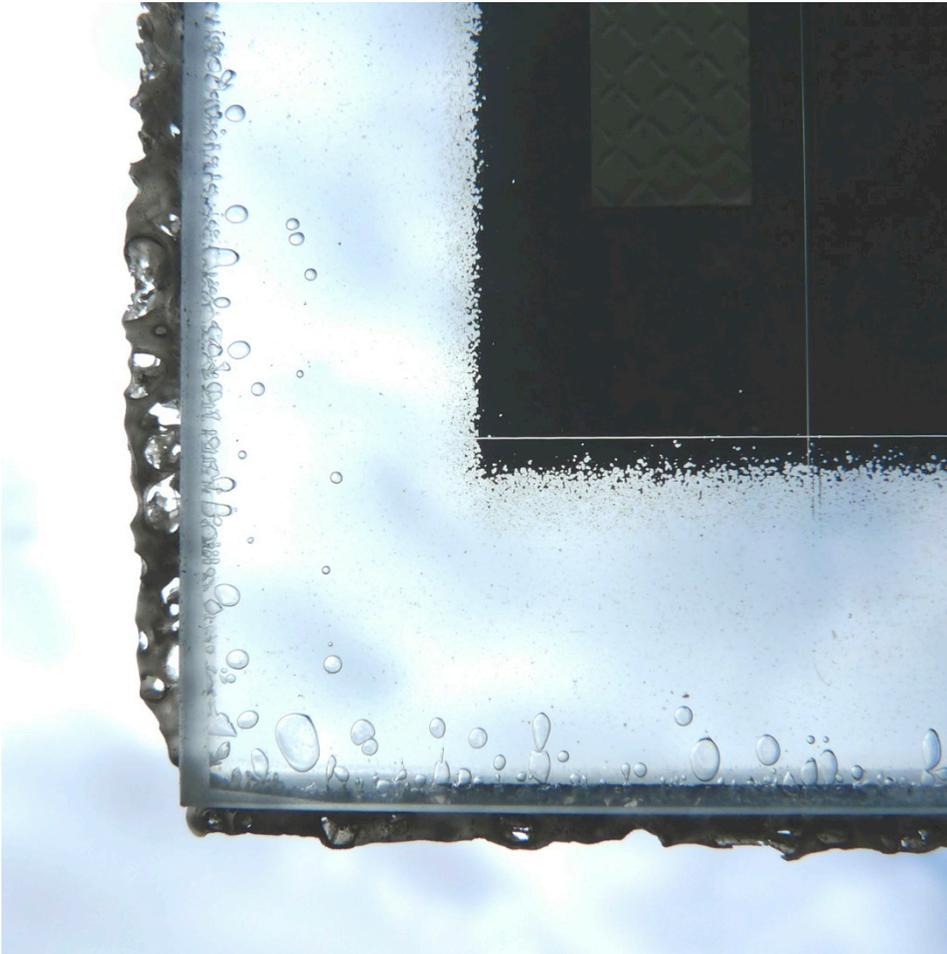
Not seal deformation

CdTe after 8 years in Toledo, Ohio

A band of seal or encapsulant material can be pushed out during production

This extrusion is not a field failure

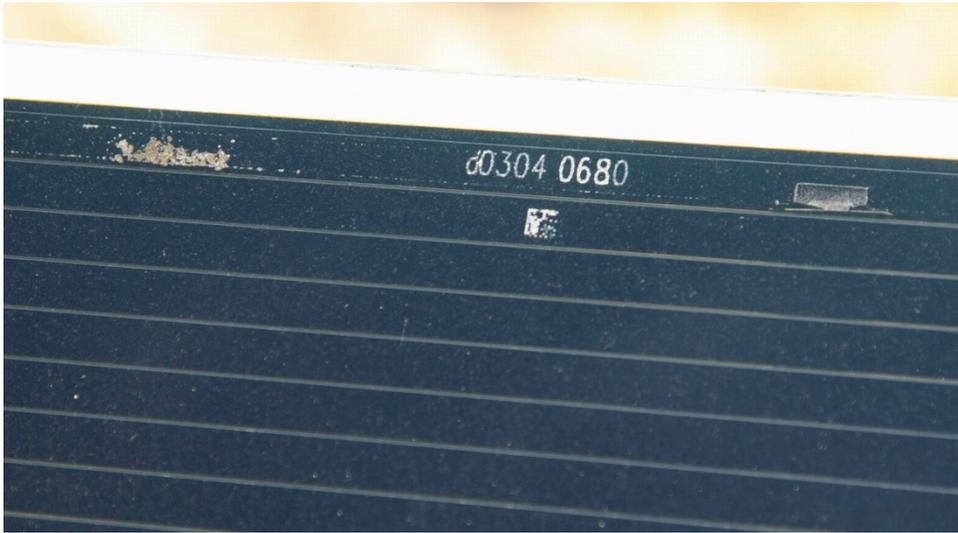
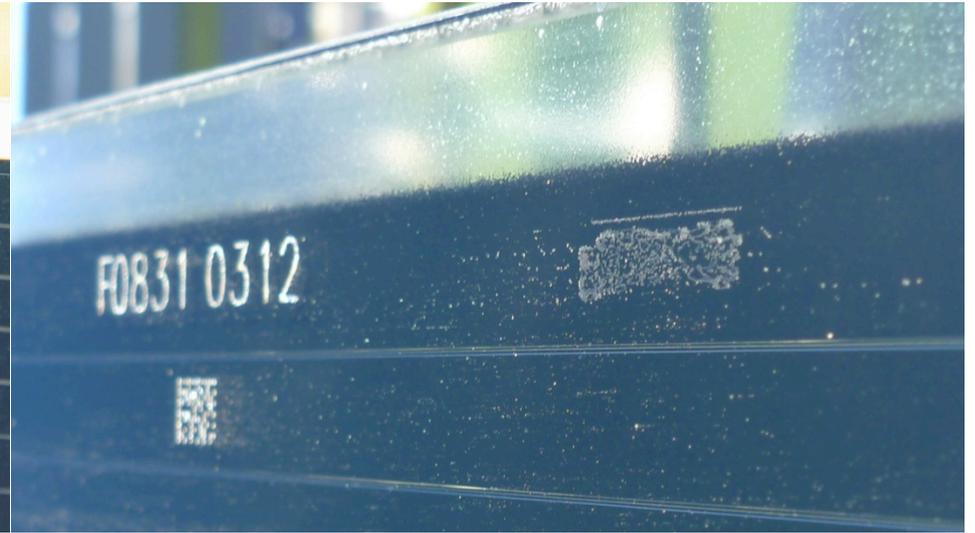
Interconnect degradation

8–11 years in Springerville, Arizona

8 years in Toledo, Ohio

Delamination of the bus tape caused a partial failure of the interconnect

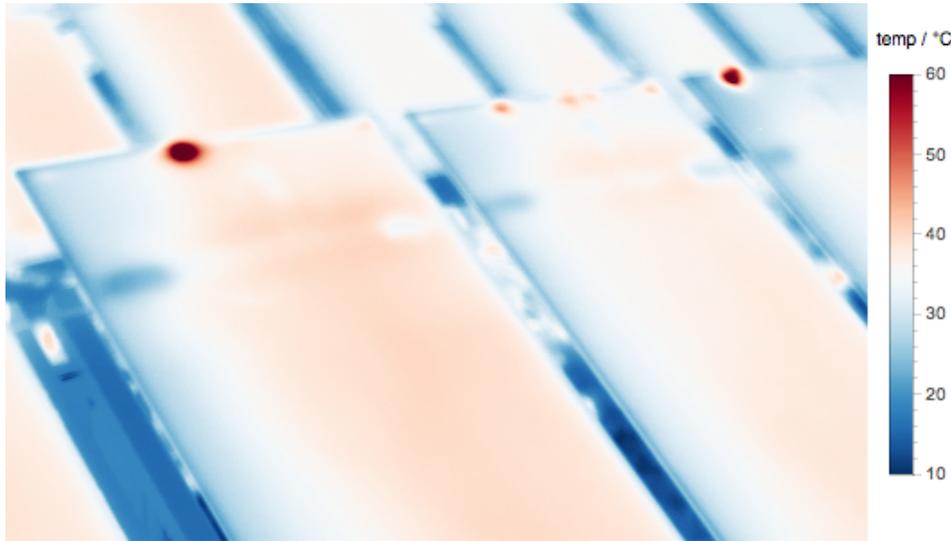
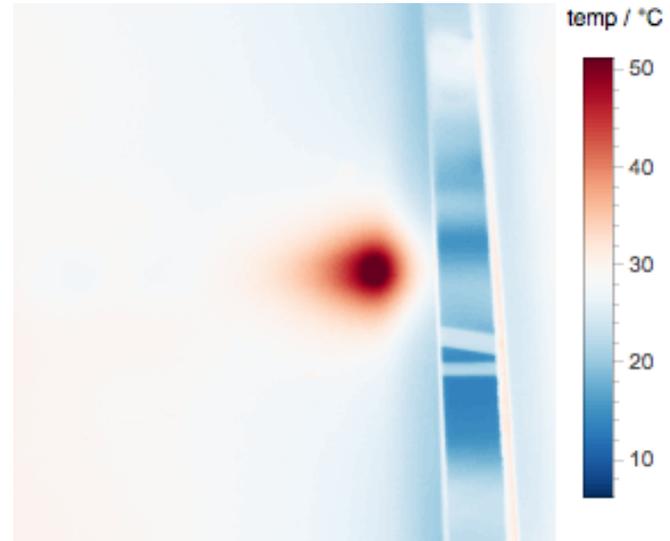
Interconnect degradation

8–11 years in Springerville, Arizona

8 years in Toledo, Ohio

The delamination causes an increase in series resistance, leading to lost power and increased heat dissipation
