Review of observed degradation modes and mechanisms from fielded modules

Lifetime prediction requires field experience

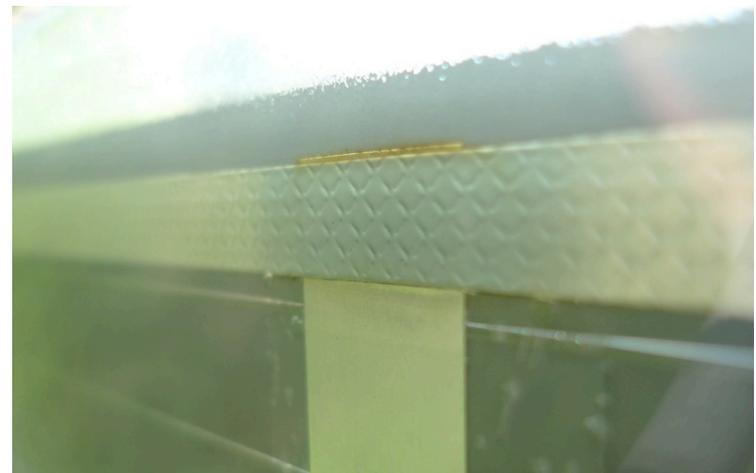
8 years in Toledo, Ohio

Interconnect degradation

The delamination causes an increase in series resistance, leading to lost power and increased heat dissipation

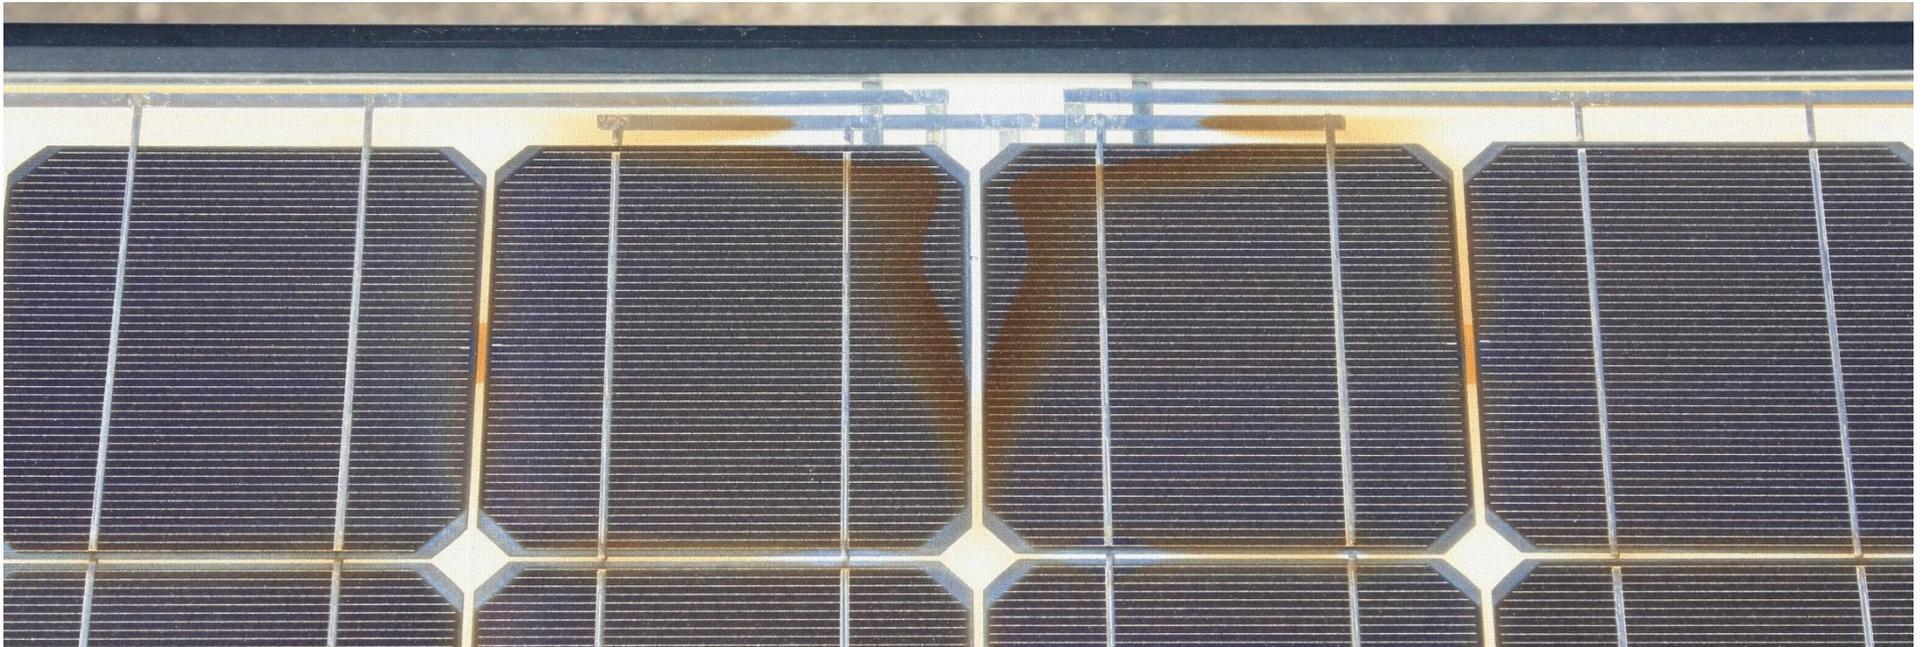
Discoloration

HIT after 10 years in Tucson (arid/steppe/hot arid)

Encapsulant and “beauty strips” turned brown near the junction box due to elevated temperature

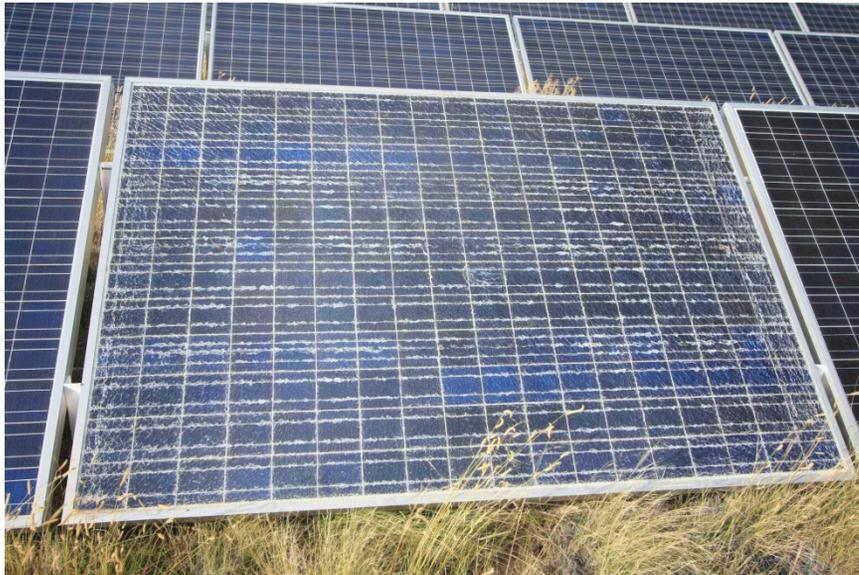
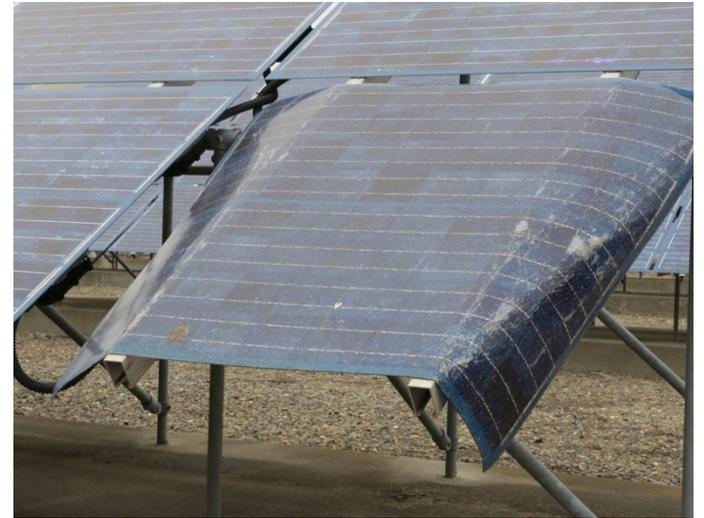
Broken glass

16 years in Sacramento
<1% affected

11 years in Springerville, 2%, mostly just back glass broken

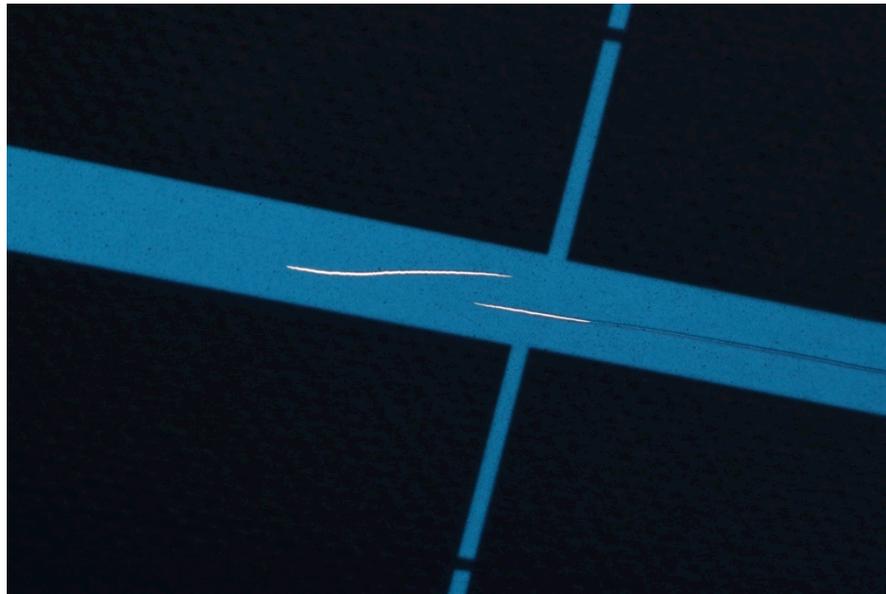
Broken backsheet

16 years in Sacramento

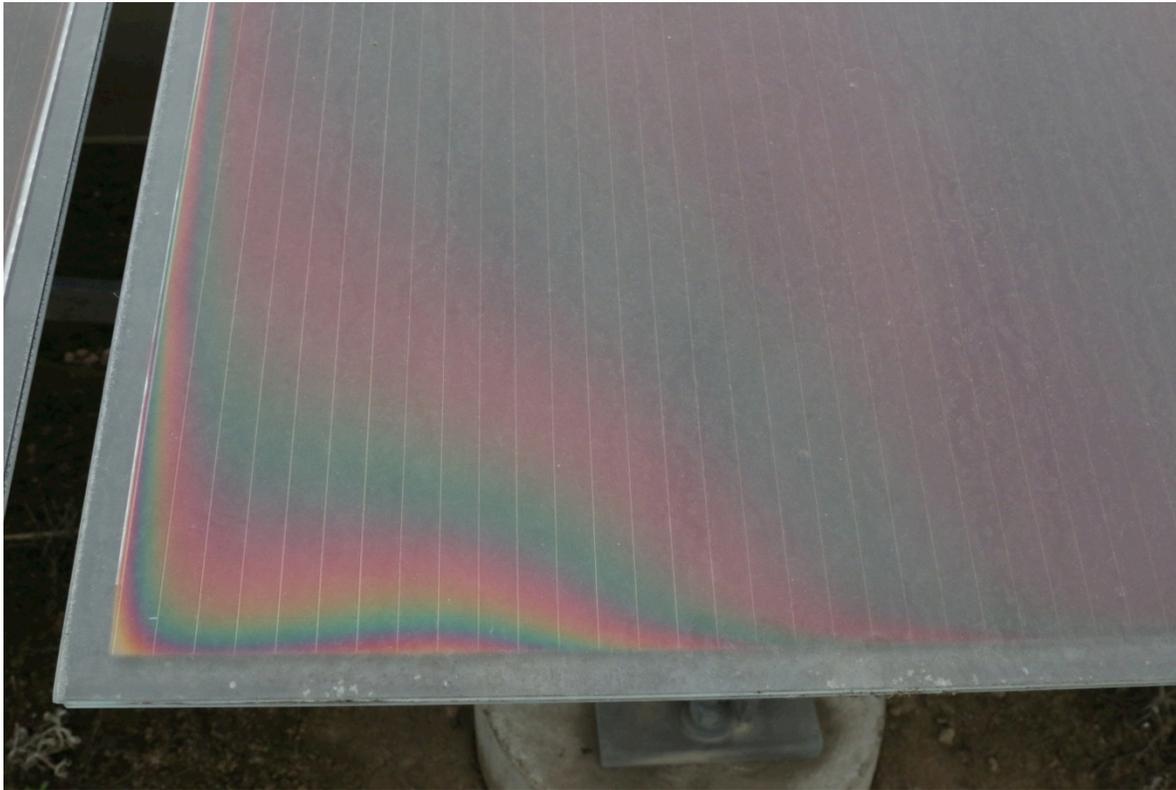
Corrosion

Local TCO corrosion can appear as interference fringes

a-Si after 19 years in Sacramento

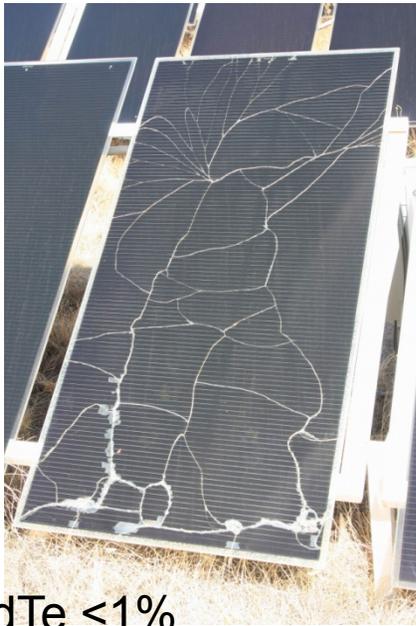
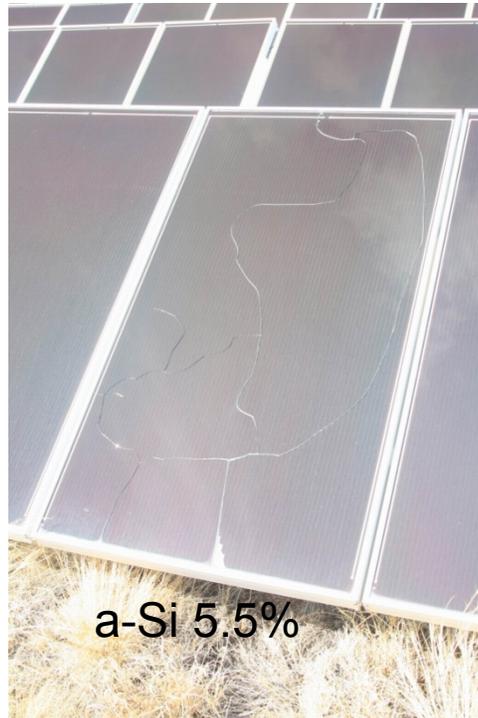
Broken glass

8–11 years in Springerville, Arizona
(warm temperate/summer dry, warm)

CdTe <1%

a-Si 5.5%

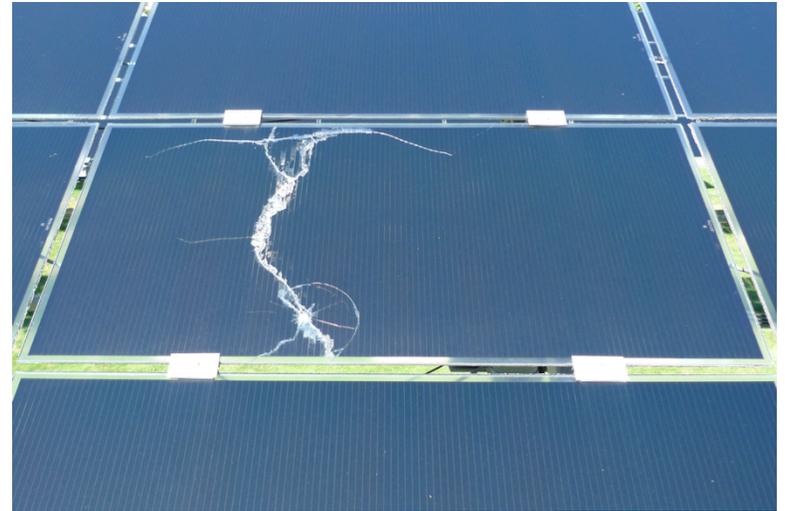
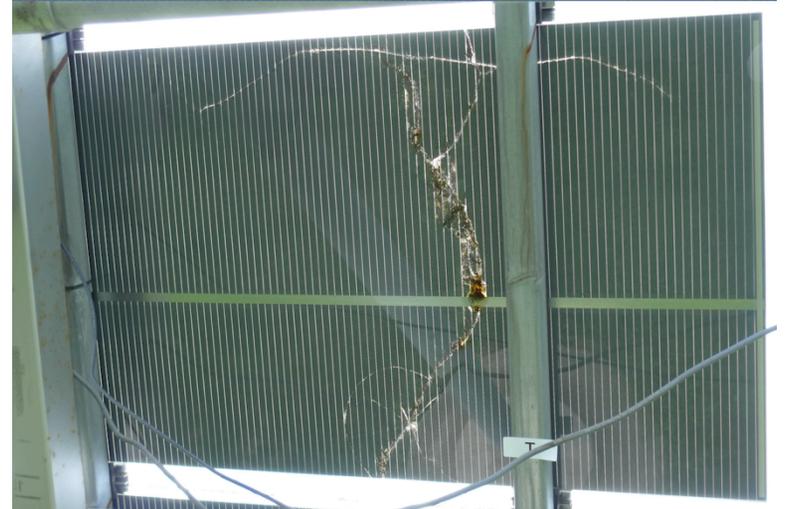
CdTe, 8 years in Toledo, Ohio
(snow/fully humid/hot summer)

1.4%
