Wind Turbine Generator System Duration Test Report for the Gaia-Wind 11 kW Wind Turbine

Technical Report
NREL/TP-500-49069
August 2010

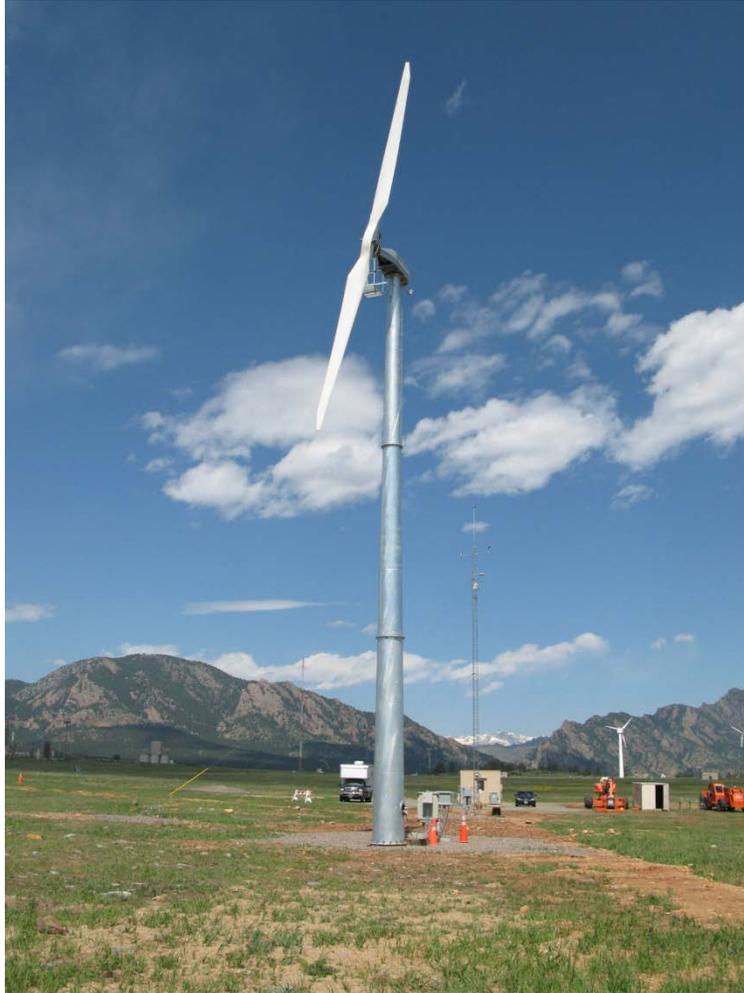
Figure 1. The Gaia-Wind 11 kW wind turbine. PIX # 17673

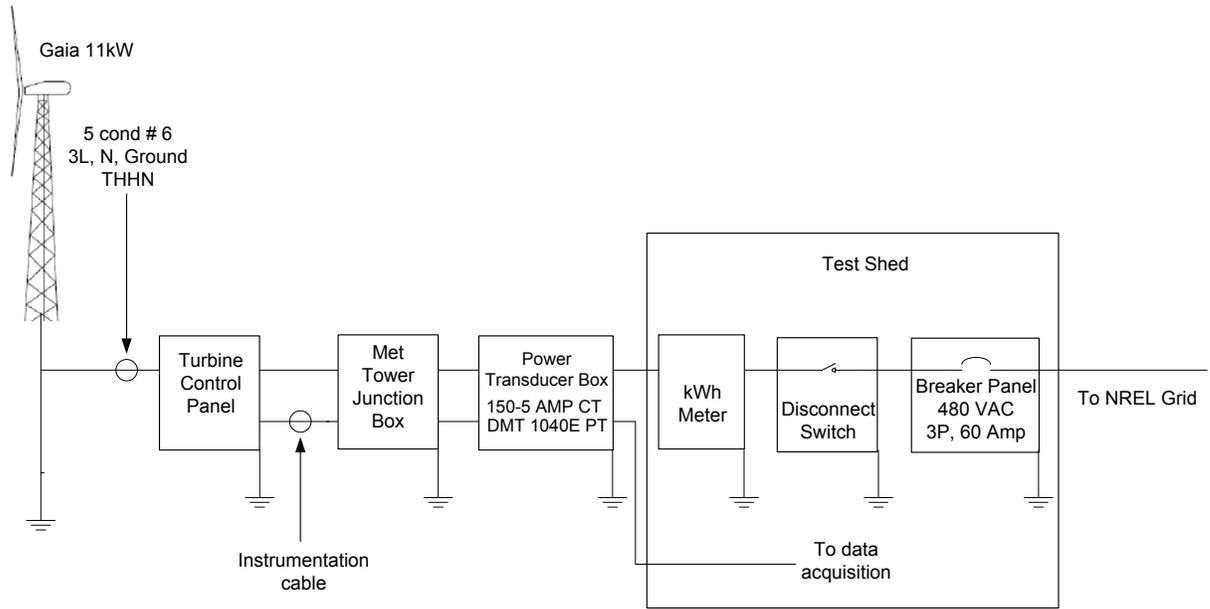
The test configuration consists of the turbine mounted on a tubular tower, the controller, the meteorological tower, associated wiring and junction boxes, and a data shed containing the data acquisition instrumentation. The turbine is installed on a standalone 18 meter, tubular tower. The wire that runs from the base of the tower to the data shed is approximately 64 meters of #6 AWG wire. Inside the data shed there is a disconnect switch and a breaker panel on the turbine side of the transformer. Figure 2 shows the general electrical arrangement.

Figure 2. General electrical arrangement

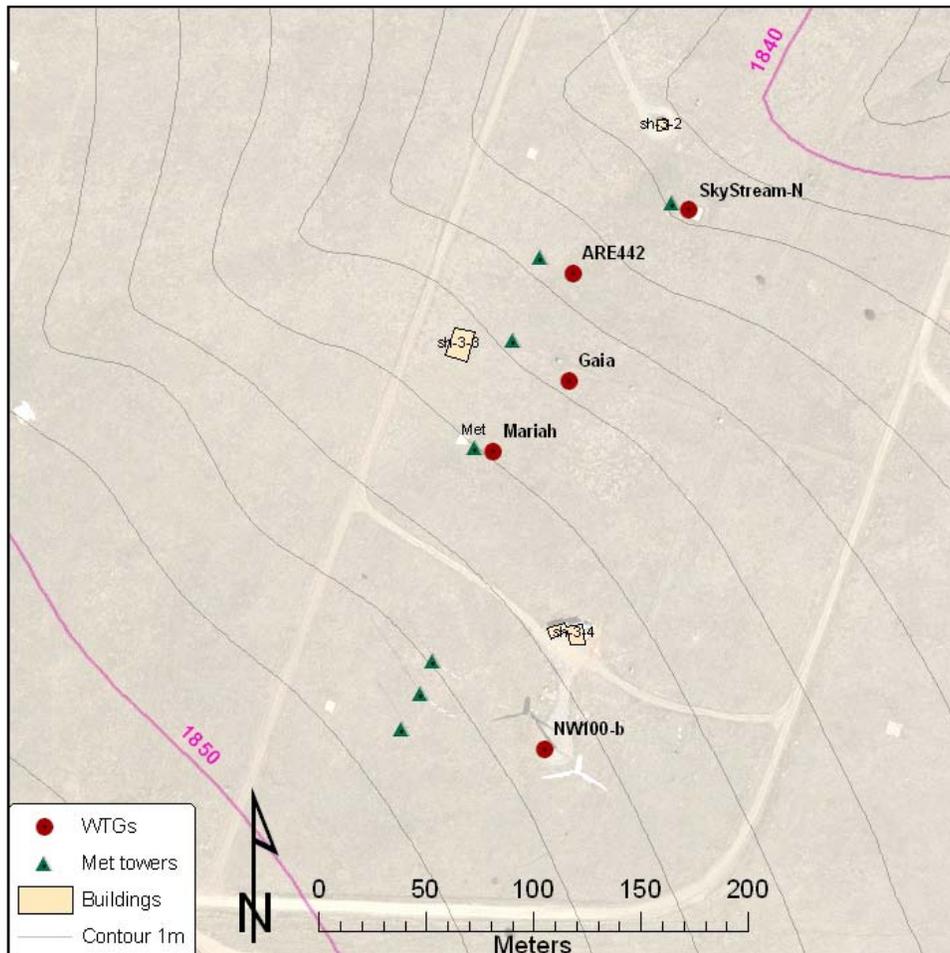
Figure 3. Map of the test site

The Gaia-Wind 11 kW wind turbine was located at Test Site 3.3B at the National Wind Technology Center (hereafter referred to as the test site), approximately 8 km south of Boulder, Colorado. The site is located on level terrain at an approximate elevation of 1845 m above sea level. Figure 3 shows a plot plan of the test site with topography lines listed in meters above sea level.

The meteorological tower is a 16.4 meter Rohn, 25 G lattice tower located 32.8 m (about 2.5 rotor diameters) from the test turbine at an azimuth of 297° true.

For measurements, where it is important to accurately measure wind speed, NREL used data obtained when the wind direction was between 258° to 331° with respect to true north, thus including all westerly winds. In this measurement sector, established in accordance with IEC 61400-12-1, the influence of terrain and obstructions on the anemometer and turbine are small. The closest operating turbine to the test turbine was a 10 kW Abundant Renewable Energy, ARE 442, turbine located on a 30.5 meter tower. It was located approximately 48.0 meters north of the test turbine at site 3.3A.

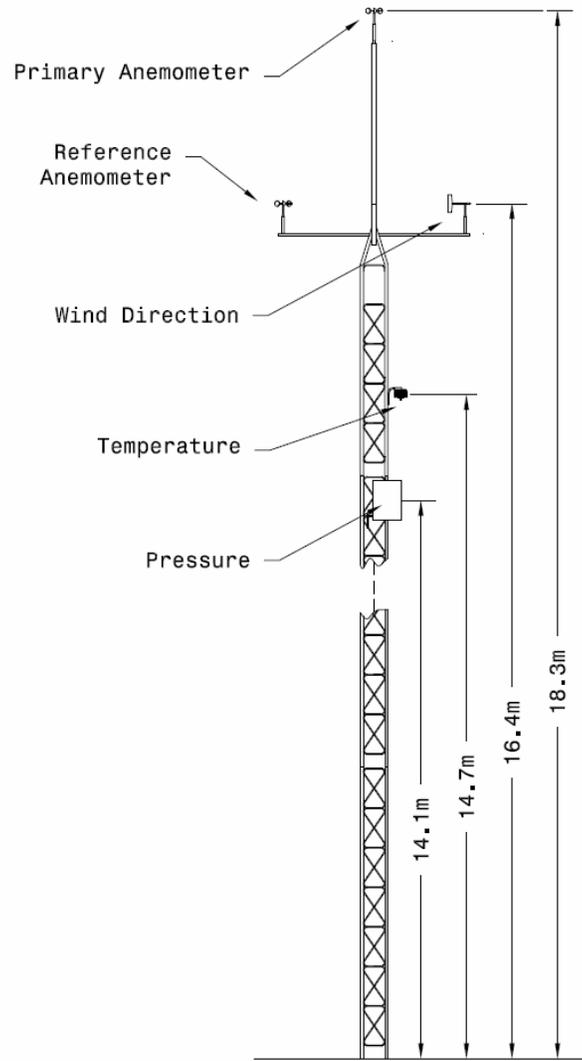
Figure 4 gives the location of the met tower instruments and Table 2 gives an equipment list that provides the specifications for each of the instruments used. Per the power performance standard IEC 61400-12-1, the primary anemometer was sent out for recalibration after the test period. The difference between the two calibrations was within the tolerances allowed by the power performance standard.

Figure 4. Location of the data acquisition sensors

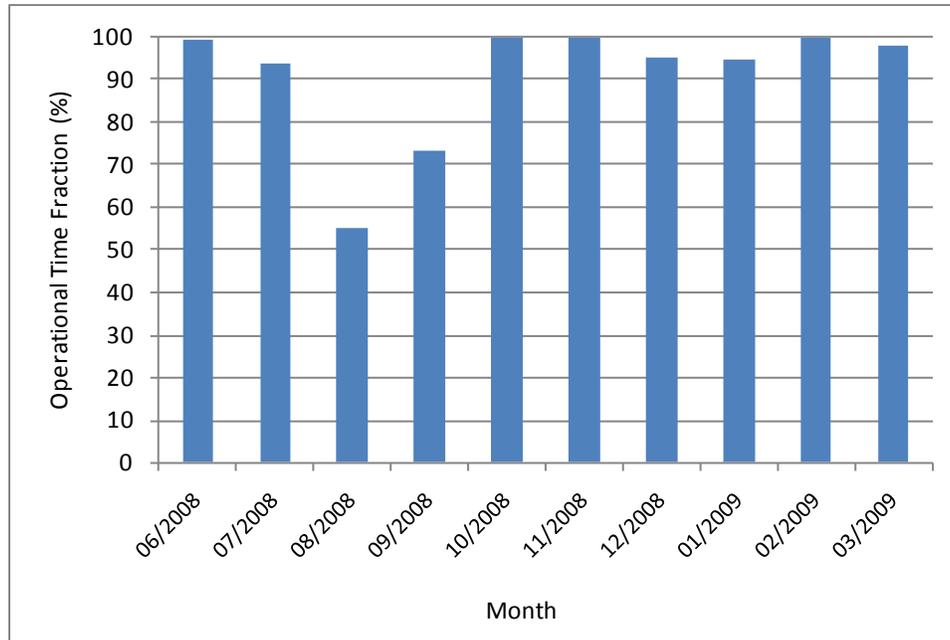
The overall operational time fraction of the combined wind turbine system (wind turbine, tower, and controller) in the total test period was 90.8%. Figure 5 and Table 3 show the operational time fraction per month. Figure 6 shows a scatter plot of power versus wind speed during the test.

Figure 5. Operational time fraction for each month

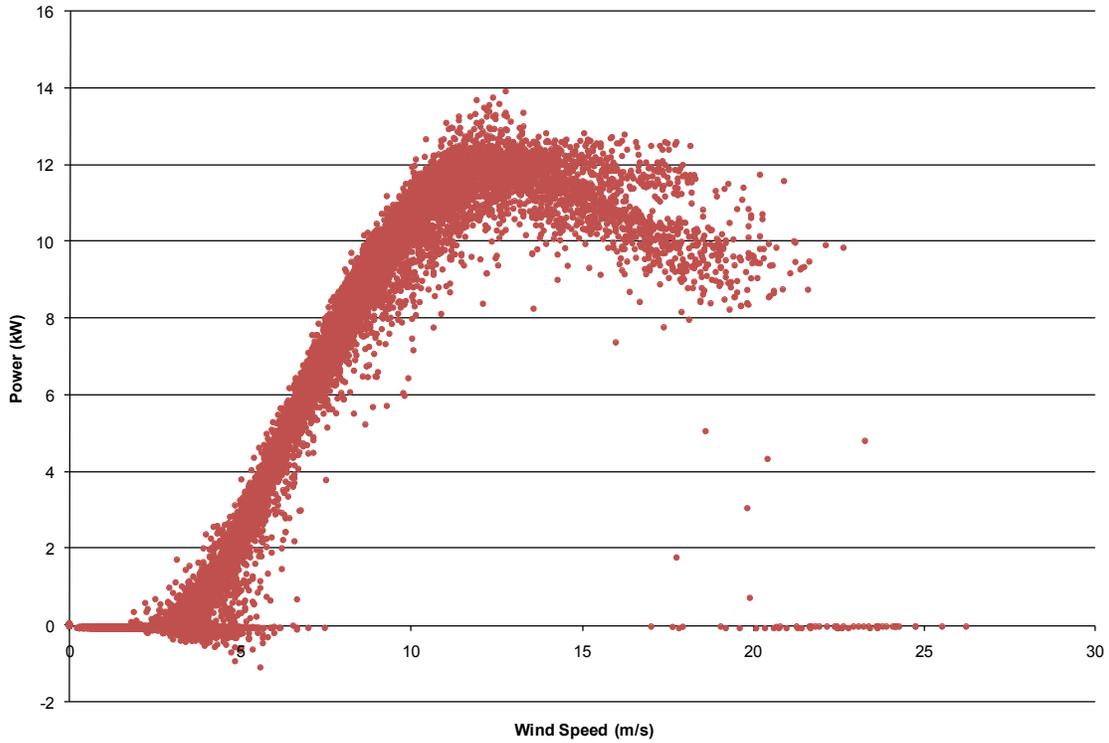
Figure 6. Scatter plot of power versus wind speed (10-minute averages)

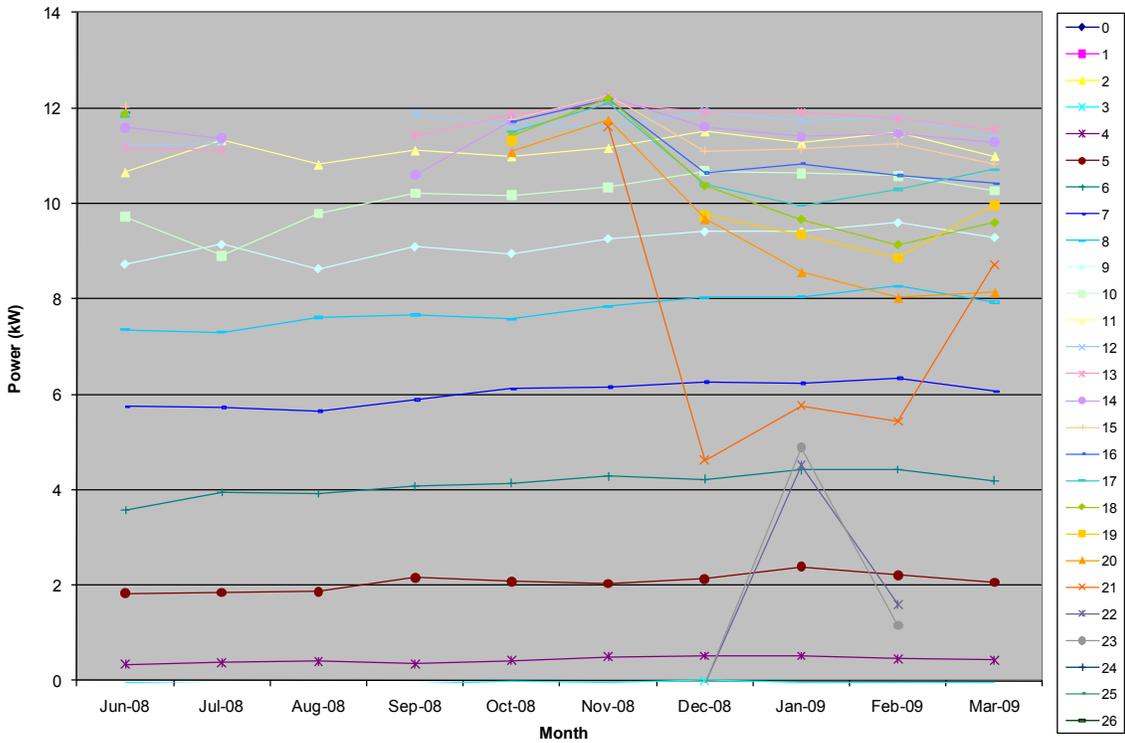
Figure 7 shows the power degradation plot, which gives the power level in individual wind speed bins for each month. Variations in the power levels from season to season are caused by air density variations. The apparent degradation in power for winds above 13 m/s in December 2008 through March 2009 was caused by the turbine reaching high wind cut-out. This resulted in a lower average power at higher wind speeds, but is not considered power degradation.

Figure 7. Power level in several wind speed bins (in m/s) as a function of time

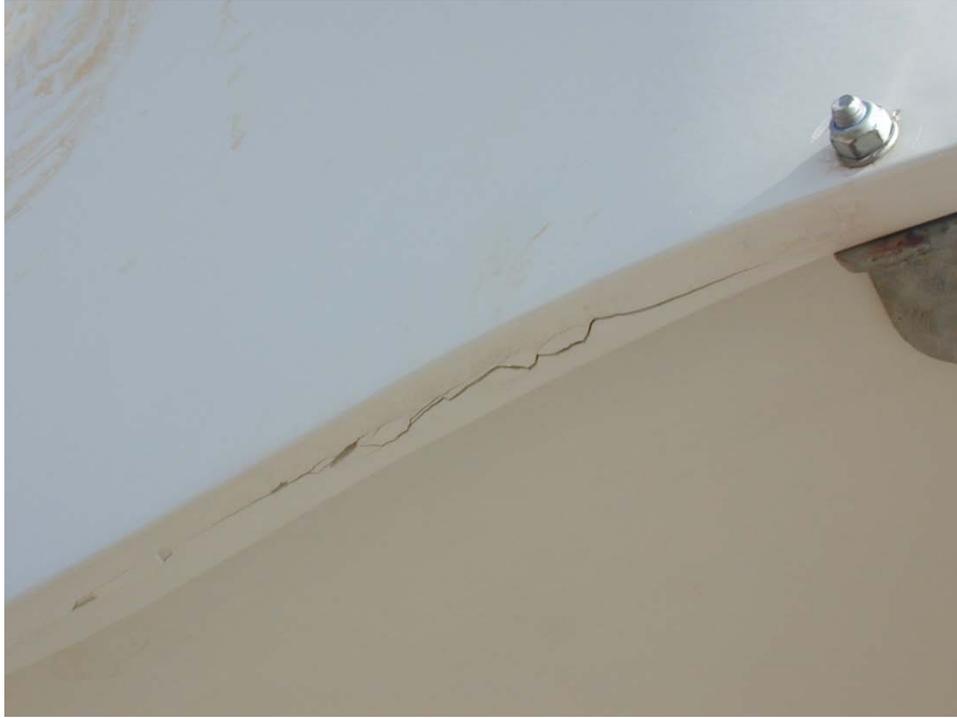
The tear down inspection was performed on May 10, 2010. The results are documented in Appendix C. The main finding was a crack along the seam between the two halves of both blades, see Figure C.1.

Both blades had cracks along the seam between the two halves near the hub, see Figure C.1. The putty at the blade ends, where the tip brakes are located, had deteriorated slightly, see Figure C.2. One of the blades was chipped, see Figure C.3.

Figure C.1 Crack in blade along seam. PIX # 17672.

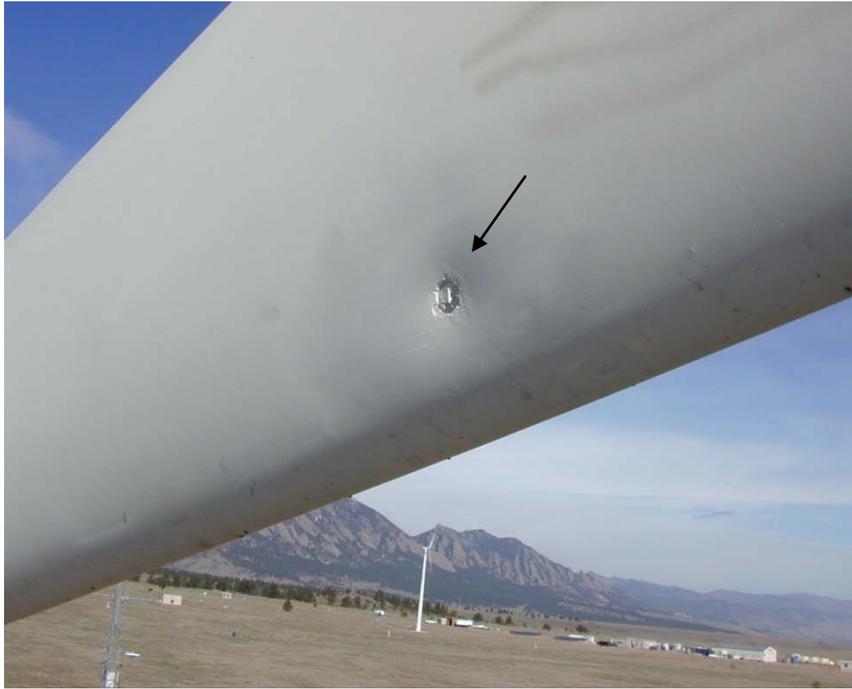
Figure C.2 Deteriorating putty on tip brake. PIX #17676.

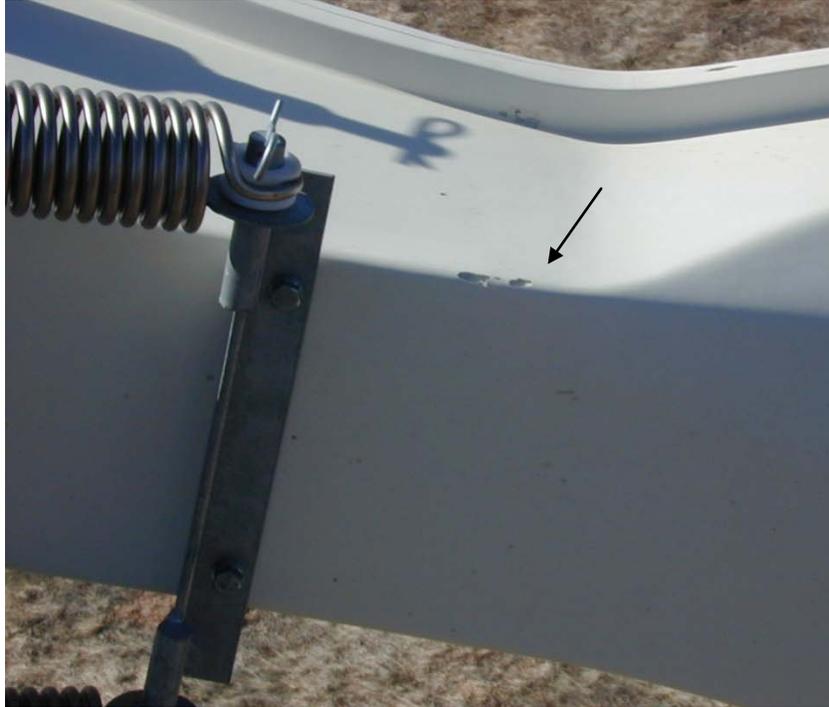
Figure C.3 Chip in blade. PIX #17669.

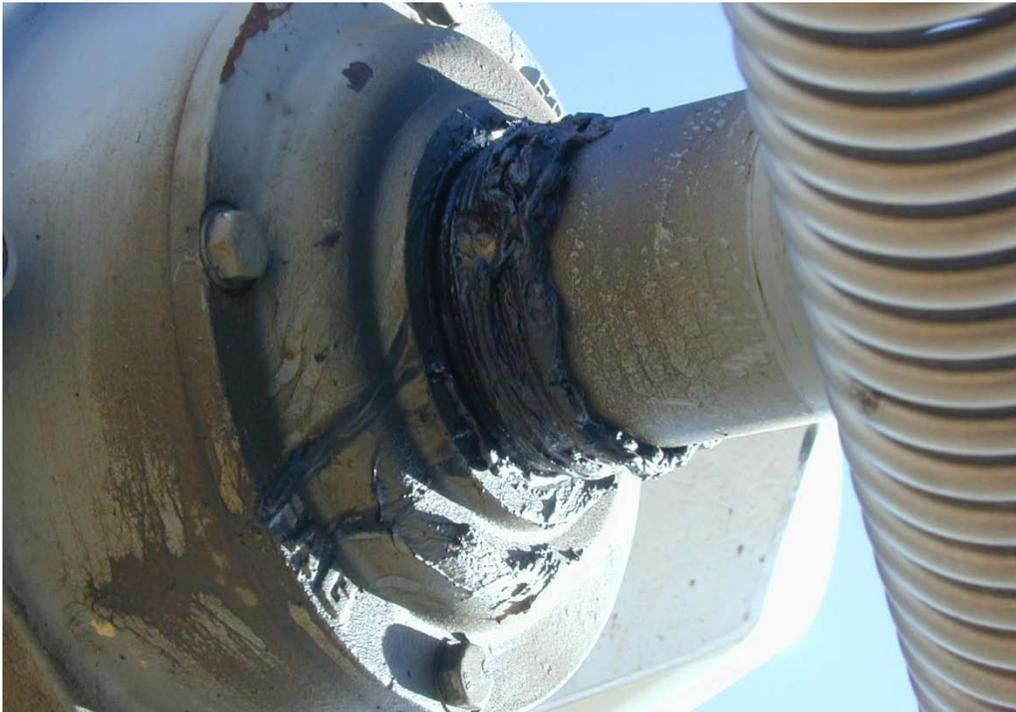
The nacelle cover was in good condition. Some grease was observed around the rotor shaft, see Figure C.4. Some slight rust on the rotor plate and rotor assembly was discovered, see Figure C.5.

Figure C.4 Grease on shaft. PIX #17670.

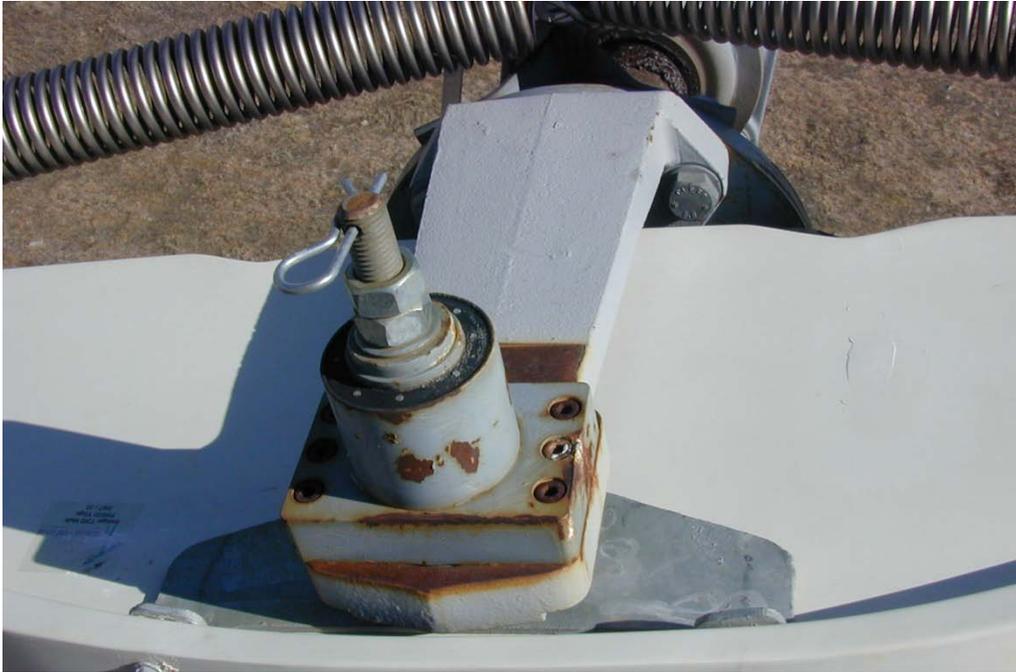
Figure C.5 Rust on rotor assembly. PIX #17671.

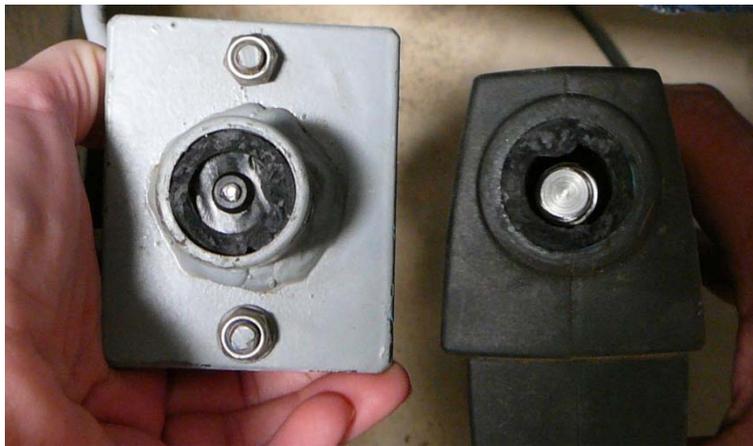
Part of the brake actuator system was damaged during uninstal. The brake pad assembly was removed and the brake pads were measured. The brake pad on the rotor side measured 0.72 inches. The brake pad on the generator side measured 0.78 inches. The original brake pad measured 0.805 inches. The pins on the brake caliper were inspected; no wear was observed. The brake caliper arms appeared free of rust and binding.

Figure C.6 Broken brake actuator. PIX #17675.

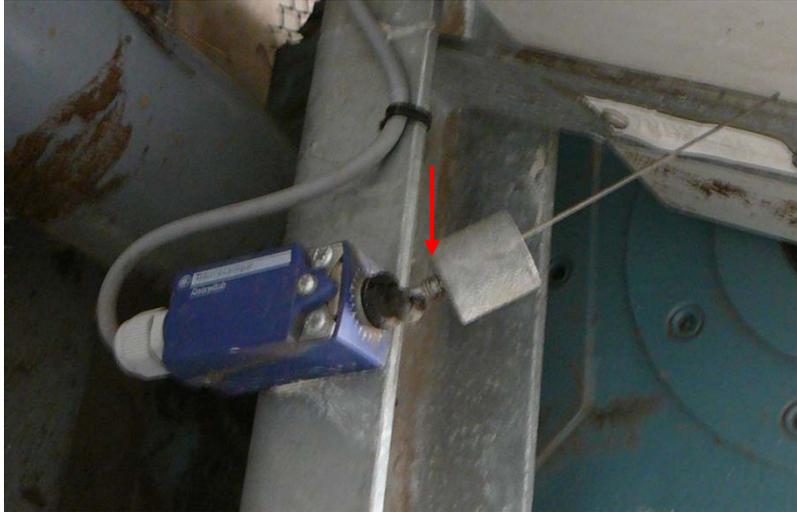
The rubber seal on the vibration sensor was degraded and partially ripped, see Figure C.7. It was noted that during uninstal, the vibration sensor was damaged and was no longer in a vertical position. However, the degradation of the rubber seal does not seem to have been caused by this.

Figure C.7 Broken vibration sensor and deteriorating rubber seal. PIX #17674.
