# **Summary of Chariton Valley Switchgrass Co-Fire Testing at the Ottumwa Generating Station in Chillicothe, Iowa**

## **Milestone Completion Report**

*Prepared for the U.S. Department of Energy's Biomass  
Power Program and the Chariton Valley Biomass  
Project*

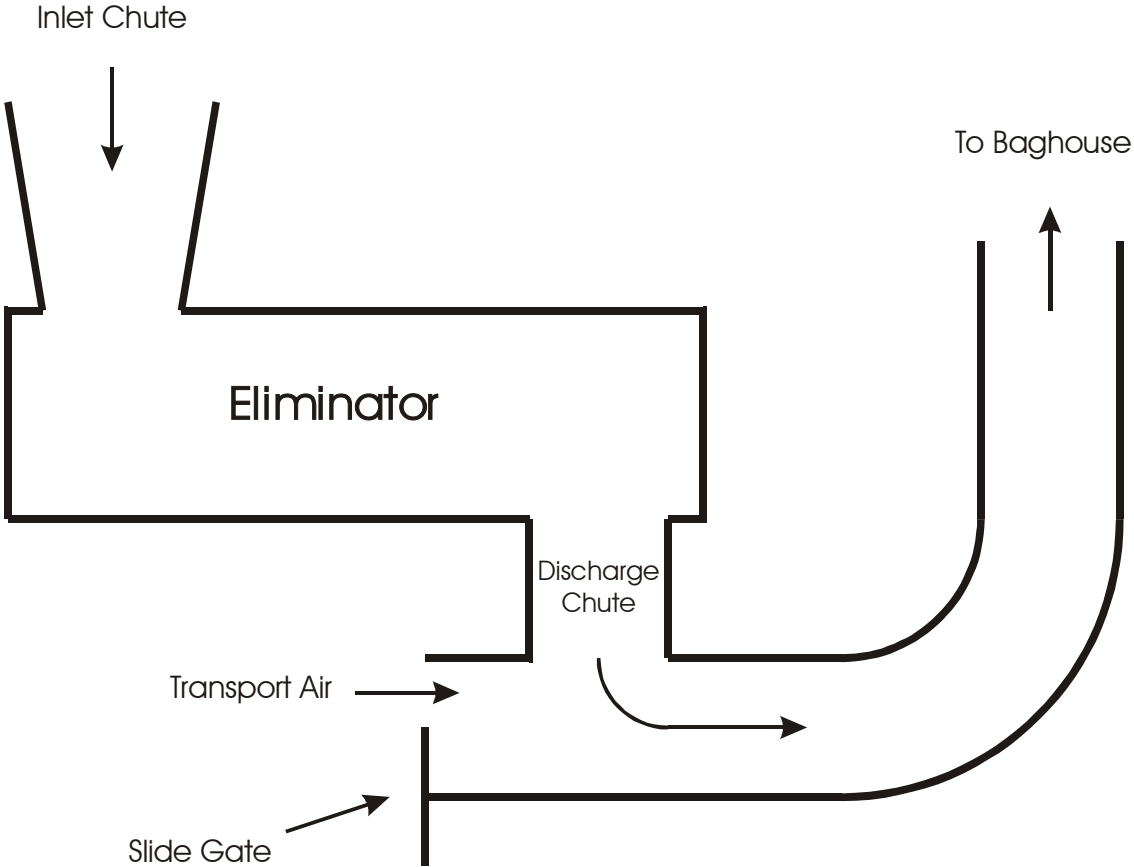
**Figure 1.3– Diagram of Eliminator Discharge Chute**

At the outlet of the Eliminator, a 26-in. (0.7-m) duct from the baghouse pulled a partial vacuum on the Eliminator. The Eliminator was originally designed for granular material, and pulling a suction on it was required to help move the lighter switchgrass through the unit. Additional transport air was admitted to the duct through an adjustable slide gate located under the Eliminator. See Figure 1.3 for the details of this equipment arrangement. Under normal operating conditions, the suction at the Eliminator discharge was approximately 8-10 in. of water. The suction at the inlet chute of the Eliminator was approximately 2-4 in. of water.

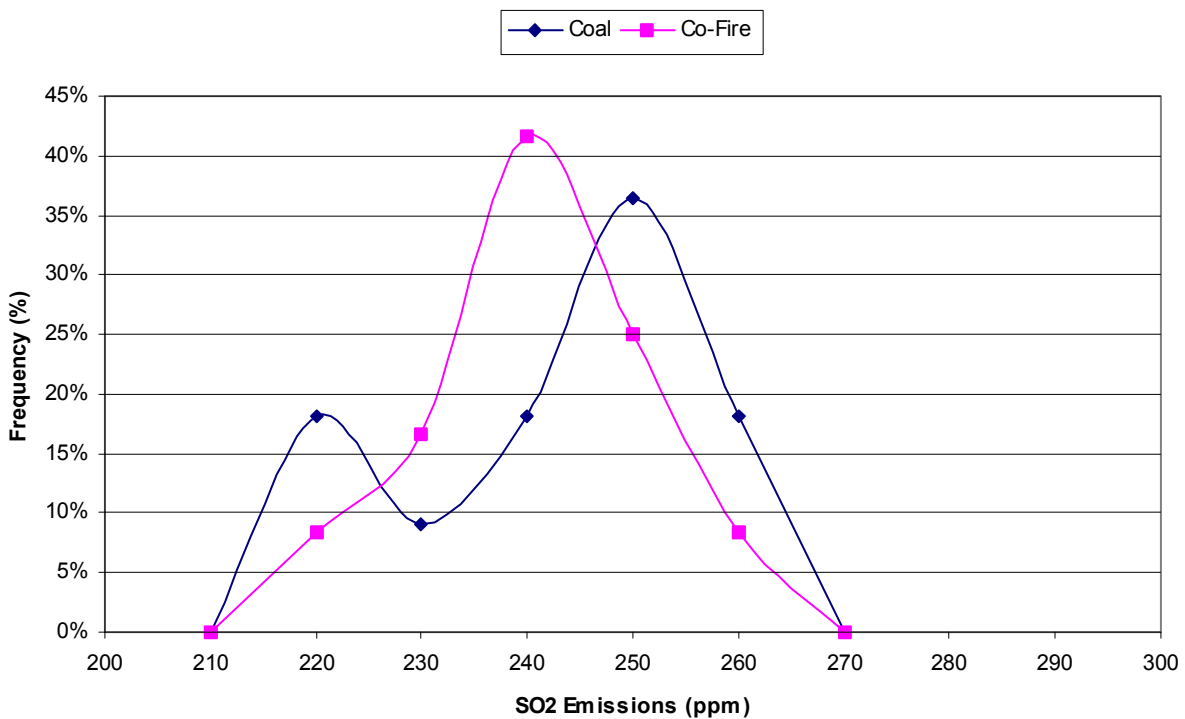
**Figure 2.1 – Comparison of SO<sub>2</sub> Emissions when Co-Firing**

Because of the variations in emissions caused by weather, fouling, and changes in boiler operation from day-to-day, it is also useful to compare the distributions of SO<sub>2</sub>, NO<sub>x</sub>, and opacity to see the overall effect of co-firing. Figure 2.1 shows a slight decrease in average daily SO<sub>2</sub> emissions when co-firing switchgrass, as expected. Figure 2.2 compares the NO<sub>x</sub> emissions when co-firing with the coal-only values, and there appears to be an increase in NO<sub>x</sub> emissions, although the spread in the data indicates that the boiler was also less stable when running switchgrass. This is true because the switchgrass system was not always consistent in supplying switchgrass to the boiler so the coal flow ramped up and down in response to the changes in switchgrass flow. It is also important to understand that co-firing occurred mostly during the week, when the boiler was running at full capacity, and many of the non-co-fire, coal-only days were weekends when the boiler was running at reduced load. Because both NO<sub>x</sub> and SO<sub>2</sub> emissions increase with load, part of the increased emissions in Table 2.8 and in Figure 2.2 are due to the higher loads. Figure 2.3 shows that the opacity was virtually unchanged when burning switchgrass.

The continuous emission monitoring equipment at OGS records SO<sub>2</sub>, NO<sub>x</sub>, and opacity levels leaving the stack. The system records information continuously and it is apparent from examining the details of the raw data that major changes up or down in fuel flow result in large changes in emissions during the transition period. Table 2.8 shows the average daily SO<sub>2</sub>, NO<sub>x</sub>, and opacity levels for the month of January, as recorded by the CEM system. **Bold** numbers indicate days when only coal was being burned. The data from January is of the most interest because the equipment redesign had been completed, so the switchgrass system could be operated at rates of over 15 ton/h (13.6 tonne/h). Data from January 4, 2001, were excluded from the averages due to abnormal boiler operation.
