Industrial Materials for the Future R&D Strategies: A Case Study of Boiler Materials for the Pulp and Paper Industry

**Industrial Materials for the Future Program
Industrial Technologies Program
U.S. Department of Energy**

October 2002

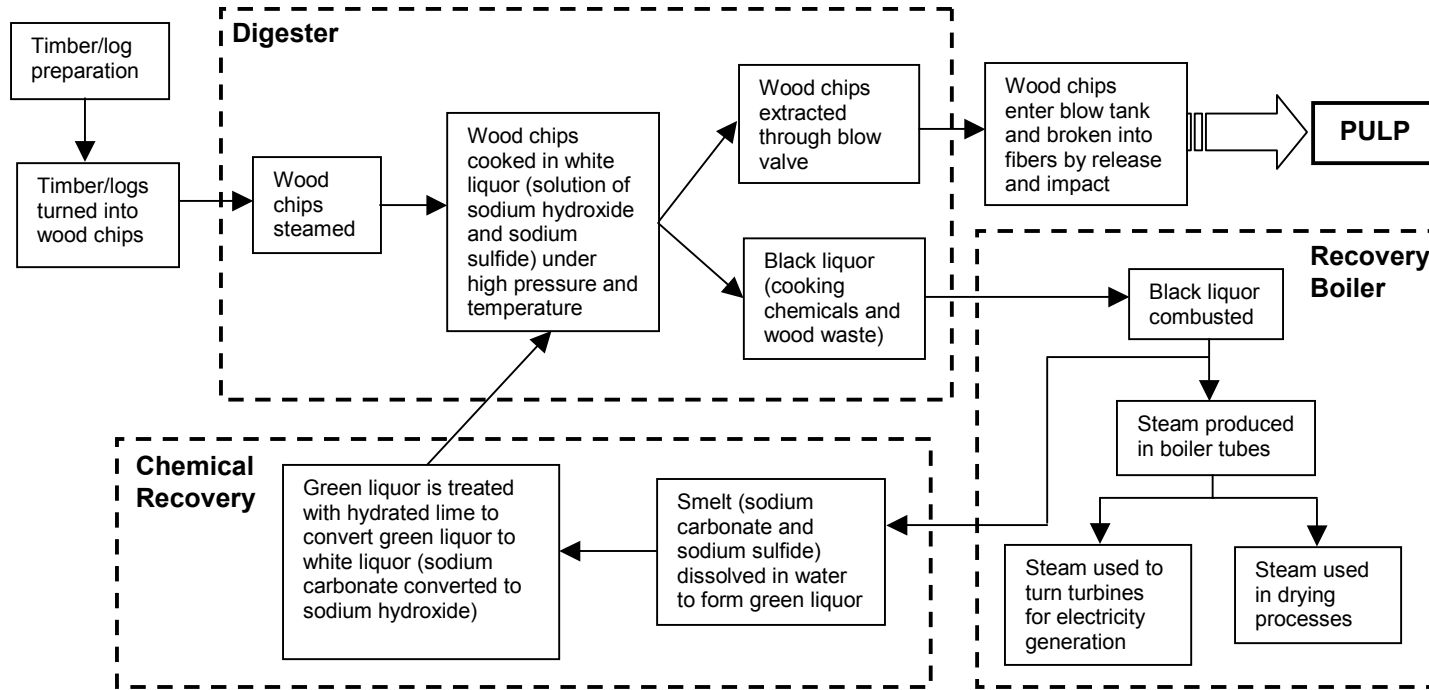
Figure 9: The Kraft Chemical Pulping Process

The kraft pulping process begins with cutting timber in the wood yard to reduce it to a manageable size (10–30 mm long and 3–6 mm thick) for the pulping process.²³ Next, the logs are put into a cylindrical container that rotates them. The friction from the logs rotating against each other and the sidewalls of the cylinder removes the bark from the logs. The bark escapes through slots in the cylinder and is burned for energy recovery in other plant processes. It is necessary to remove the outer bark, which is a contaminant in pulp and paper, because it does not contain any fibrous materials. Then, the logs are further reduced by chipping the logs with a large rotating disk (or drum) that has knives on the face of the disk (or wall of the drum). The knives slice the logs into wood chips that escape through slots in the disk (or wall of the drum). The chips are then passed through a screen to filter out large knots and oversized chips.²⁴

The wood chips that have been reduced to a manageable size are sent to the digester. The digester steams and cooks the wood chips in a solution of sodium hydroxide and sodium sulfide, known as white liquor, under high pressure and temperature. The wood chips are then broken into individual fibers by release and impact through a blow valve into the blow tank. These fibers are called the pulp and can be used for papermaking. The leftover substance composed of chemical materials and wood impurities (consisting of mostly lignin) is called black liquor.²⁵

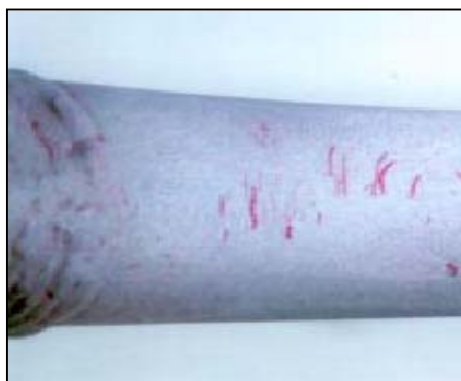
Figure 12a: Circumferential Cracking

If a boiler tube cracks, it can cause an unplanned shutdown and additional damage to the boiler. Photographs of two types of cracking commonly found in recovery boiler floor tubes are shown in Figure 12 (this figure is described in more detail in Appendix A).³⁶ When cracks in the boiler tubes extend deep enough to allow water and steam to leak into the molten smelt environment of the recovery boiler, a large explosion can occur. In a 1998 review of recovery boiler accidents, David Parrish (P.E. of the Factory Mutual Research Corporation) noted that the instantaneous vaporization of one pound of

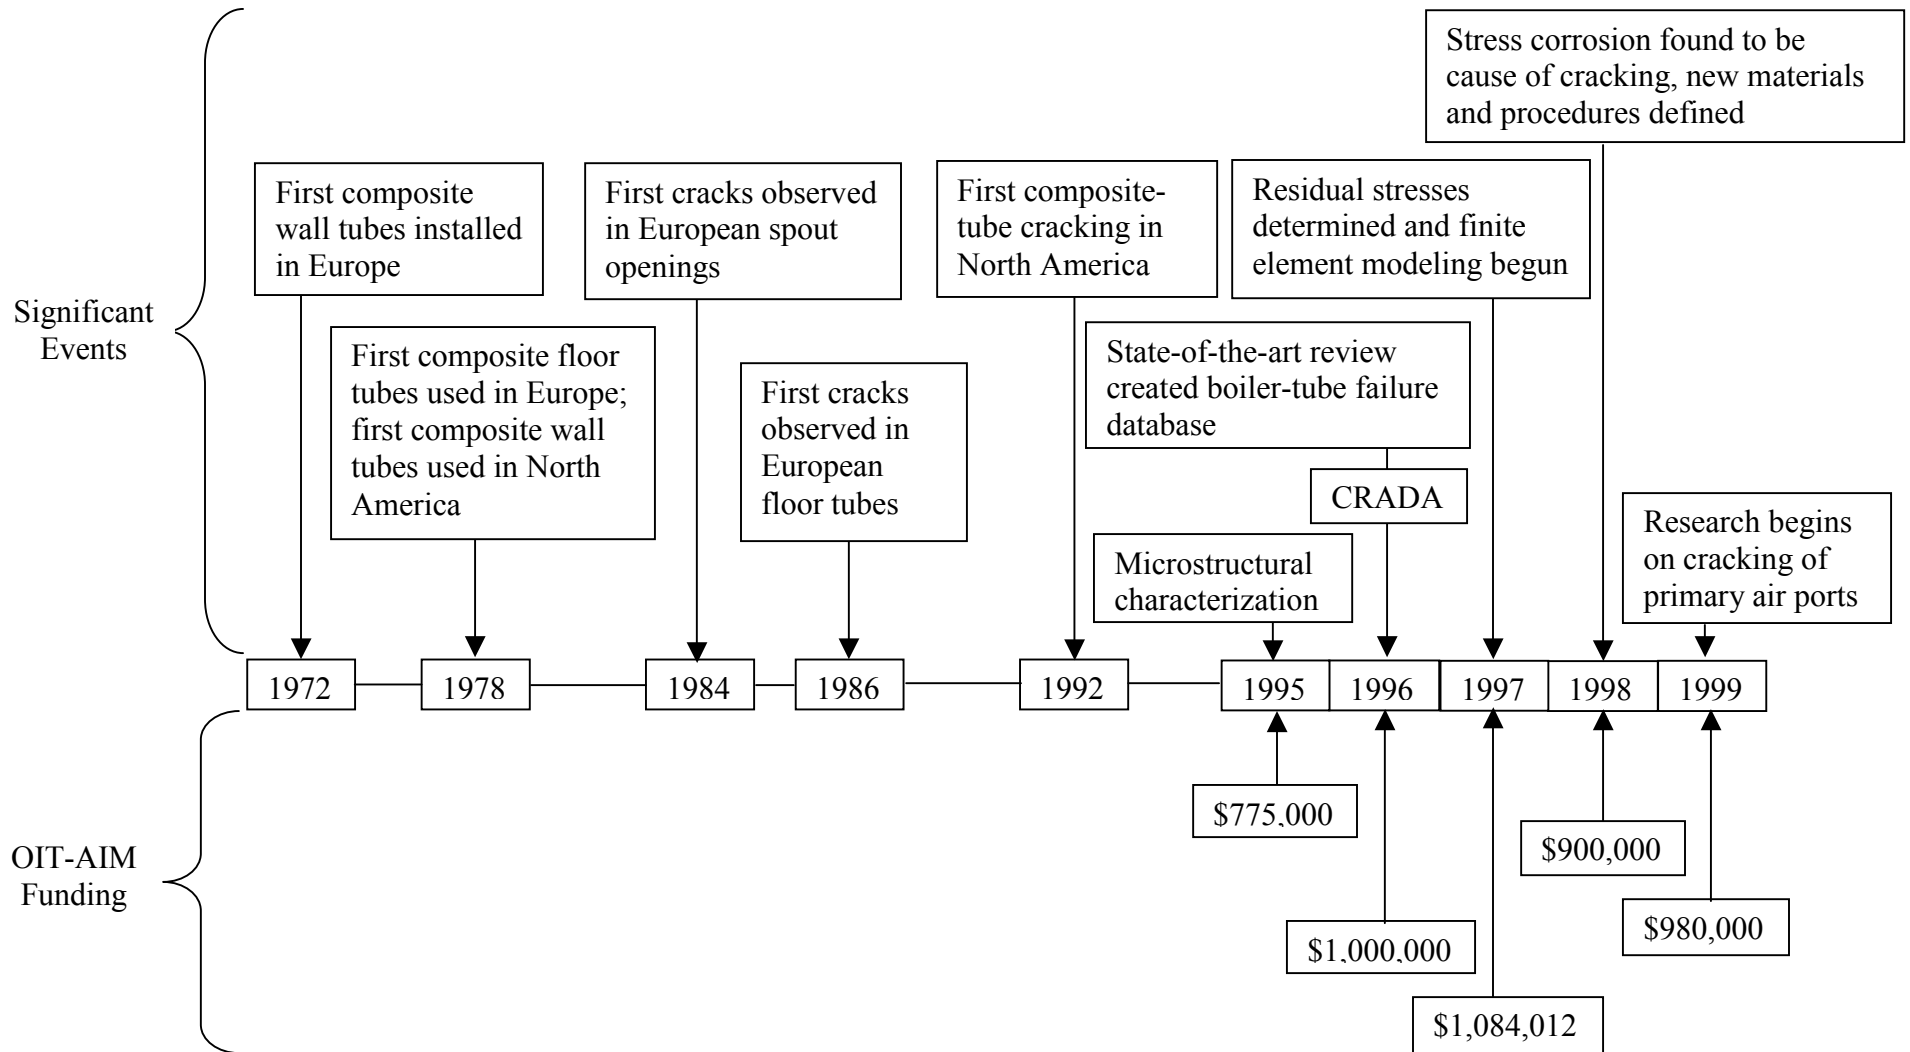
Figure 13: Timeline for Composite Tube Failures and DOE R&D Program⁴⁰

As noted in Figure 13, the first composite tubes were installed in the walls of a recovery boiler in 1972 in Scandinavia. In 1978, composite tubes were used as recovery boiler floor tubes in Scandinavia. The first composite wall tubes used in North America, were installed in 1978. Composite floor tubes were commonplace in paper mills by the mid-1980s.⁴³

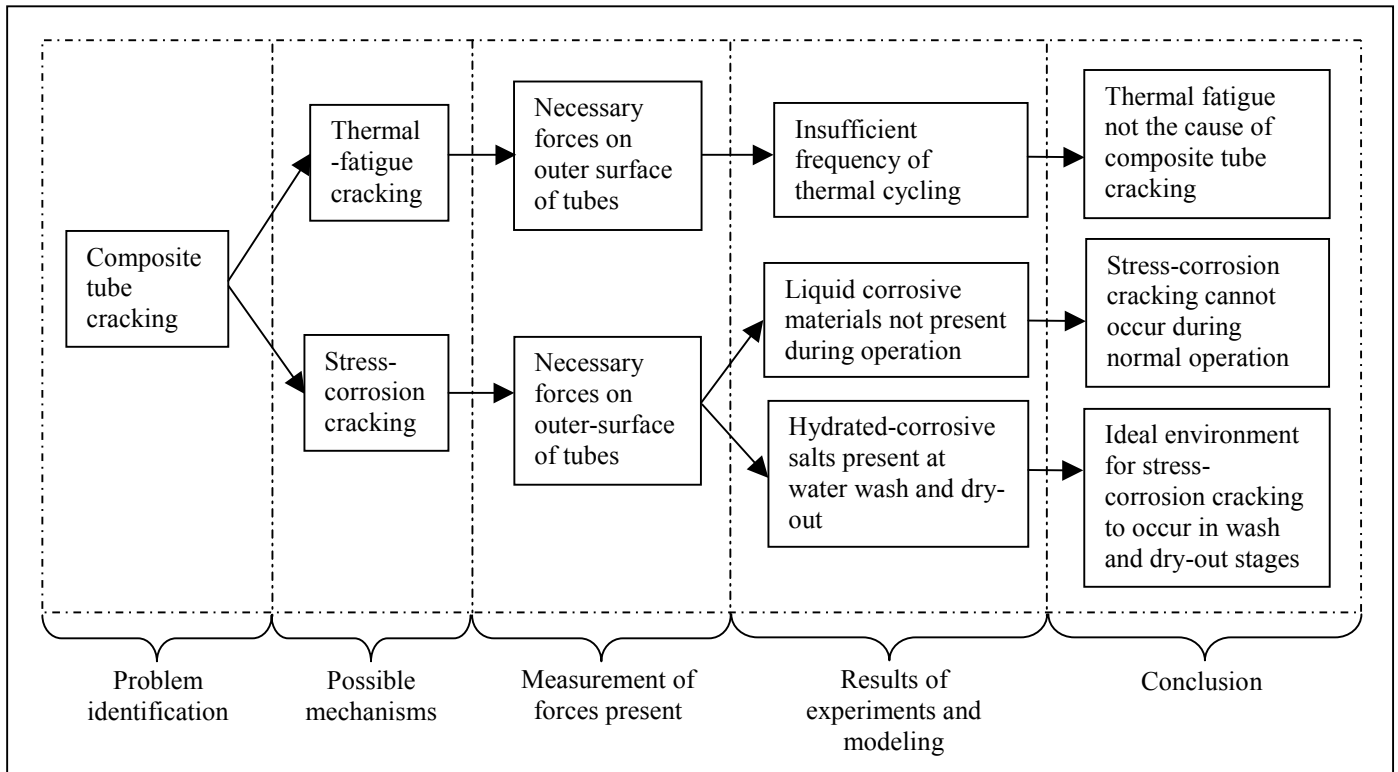
Figure 17: Determination of Cracking Mechanism

Returning to our earlier analogy of a stretched rubber band that has a small piece of rubber cut out of it, we notice that there are three physical characteristics (materials properties) that are inextricably linked together: (1) the amount that the rubber band is stretched, (2) the strength of the rubber band, and (3) the severity of the piece cut out of the rubber band. Similarly, the boiler floor tubes possess three physical characteristics that are linked together: (1) the differences in expansion and contraction rates between the inner and outer layers (coefficient of thermal expansion), (2) the yield strength, and (3) the resistance to corrosion. The first characteristic determines the magnitude of the force applied on the surface of the tube when the boiler is heated and cooled. The second characteristic determines how well the material will be able to resist the forces applied from the first characteristic (i.e. whether a tensile stress will result). The third characteristic determines how effectively a corrosive substance can attack the material. Notice that no single undesirable characteristic can cause stress-corrosion cracking. This set of intimately connected physical characteristics is referred to as a suite of materials properties. Figure 18 a, b, and c show a schematic of the materials properties suites for the materials examined in this study.

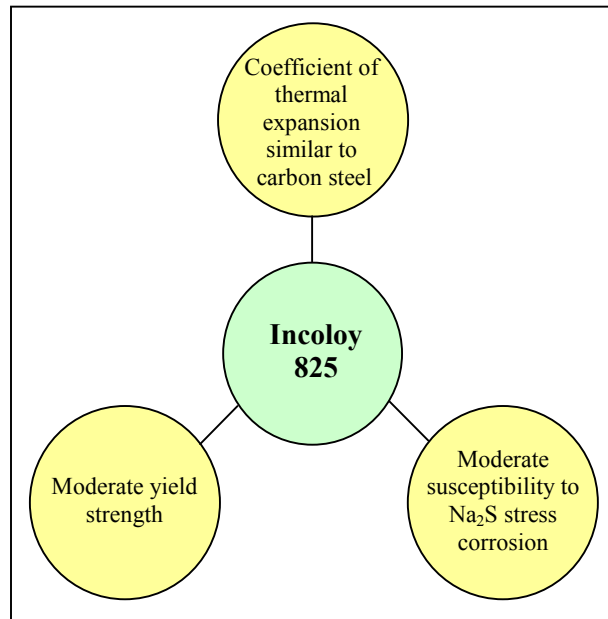
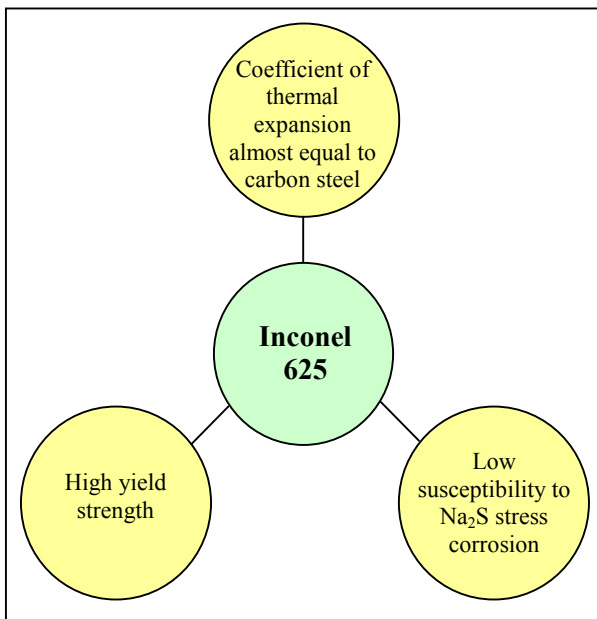
Figure 18a: Suite of Materials Properties for 304L Stainless Steel

Figure 18b: Suite of Materials Properties for Incoloy 825

Figure 18c: Suite of Materials Properties for Inconel 625

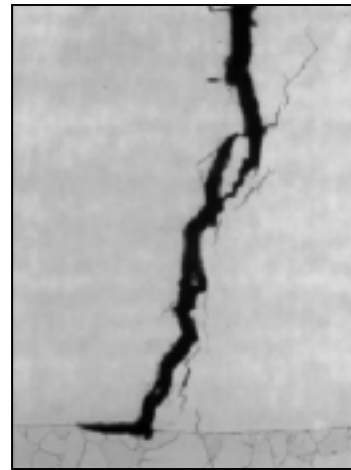
Figure A2a: Representative Sketch of Stress-Corrosion Cracking

Figure A2b: Microscopic Photograph of Floor Tube Crack

The results of these studies defined the general characteristics of composite tube cracking.⁶⁸ These general characteristics suggested two potential cracking mechanisms. The first possibility is thermal fatigue. Thermal-fatigue cracking requires thermal variations that create stresses that exceed the yield strength of the composite tube. The second possibility is stress-corrosion cracking. This requires both a tensile stress and a liquid corrosive material to be present in the critical temperature range. Both of these mechanisms require tensile stresses to be present at the outer layer of the composite tube, which suggested the importance of residual stress measurements.⁶⁹

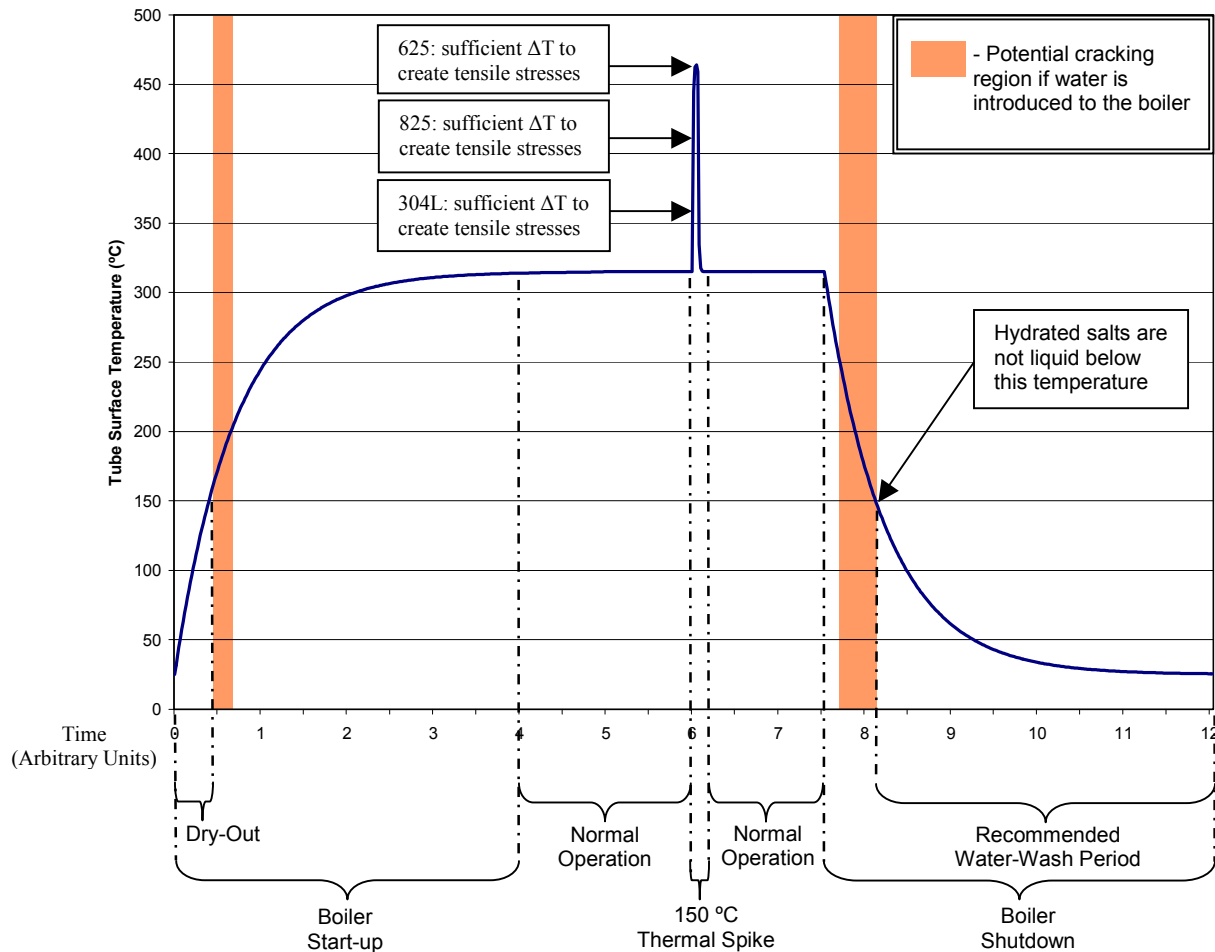
Figure A4: Temperature of Composite Tube Surface during Operation with a Thermal Fluctuation

Table A3: Stress State and Corrosive Materials Present during Operation with a Thermal Fluctuation

Material	Dry-Out	Boiler Start -Up	Normal Operation	Thermal Spike	Normal Operation (after thermal spike)	Boiler Shutdown	
						Pre-Water-Wash	Water-Wash
304L	Compressive	Compressive	Compressive → Slightly Compressive (relieved due to plastic deformation)	Slightly Compressive → Tensile if $\Delta T \geq \sim 50^\circ\text{C}$	Tensile	Tensile	Tensile
825	Compressive	Compressive	Compressive	Compressive → Tensile if $\Delta T \geq \sim 100^\circ\text{C}$	Tensile	Tensile	Tensile
625	Compressive	Compressive	Compressive	Compressive → Tensile if $\Delta T \geq \sim 150^\circ\text{C}$	Tensile	Tensile	Tensile
Liquid corrosive materials present if water is added	Aqueous solution containing Na_2S , NaOH , Na_2SO_4 , and Na_2CO_3	Na_2S , NaOH , and Na_2CO_3	-	-	-	Na_2S , Na_2SO_4 , and Na_2CO_3	Aqueous solution containing Na_2S , NaOH , Na_2SO_4 , and Na_2CO_3

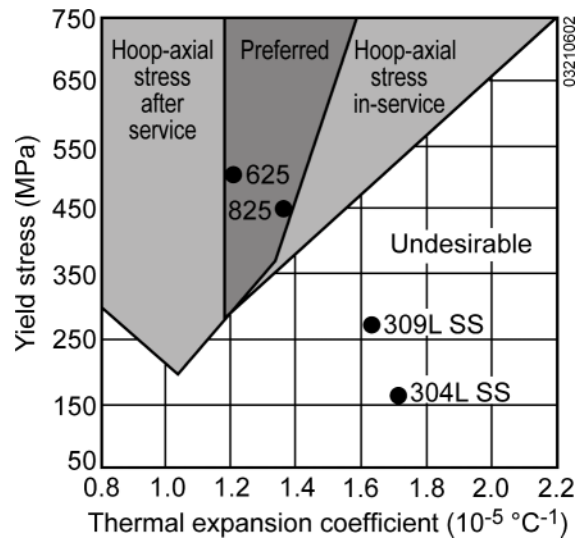
Figure A5: Yield Stress versus Thermal Expansion Coefficient for Selected Materials⁸²

Stresses generated in coextruded tube materials at various thermal expansion coefficients and yield stresses for the outer clad layer. Alloys 625 and 825 have properties that result in less severe stresses being developed than with 304L or 309L.
