# **Accelerated Stress Testing of Thin-Film Modules with SnO<sub>2</sub>:F Transparent Conductors**

C.R. Osterwald, T.J. McMahon, J.A. del Cueto,  
J. Adelstein, and J. Pruet

*Presented at the National Center for Photovoltaics and  
Solar Program Review Meeting  
Denver, Colorado  
March 24-26, 2003*

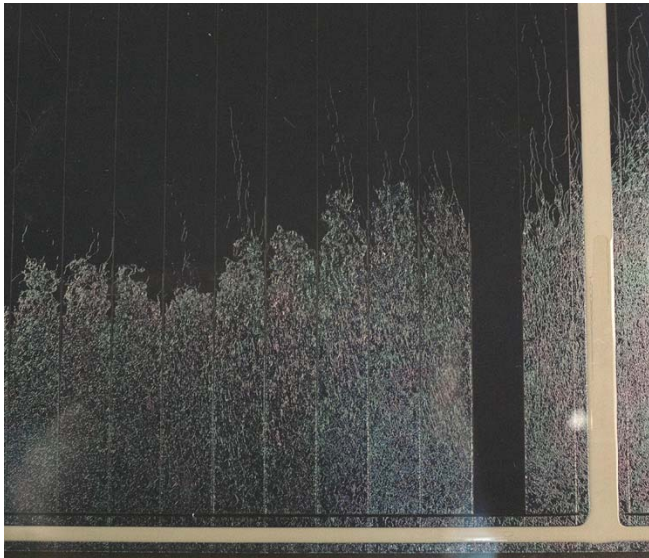
Figure 1. Front surface of a-Si module after 200 h at 85°C, 85% RH, and -600 V bias.

+600 V polarity, while the opposite polarity caused a large amount of so-called “bar graphing,” as seen in Fig. 1. These visual effects are actually cracks in the TCO that extend through all of the semiconductor layers and the rear metallization.

Optical micrographs of partly damaged regions through the top glass superstrate also yielded some interesting results. These are areas where the cracking has begun, but has not yet progressed to complete delamination. An example of such a region is visible in Fig. 1 where the long tendrils seem to extend out from the highly crazed whitish areas. When a partly damaged region was examined with optical microscopy, the cracks are seen, but in areas away from the cracks, interference fringes are visible (Fig. 5). This seems to indicate that the delamination process involves more than just the cracking.

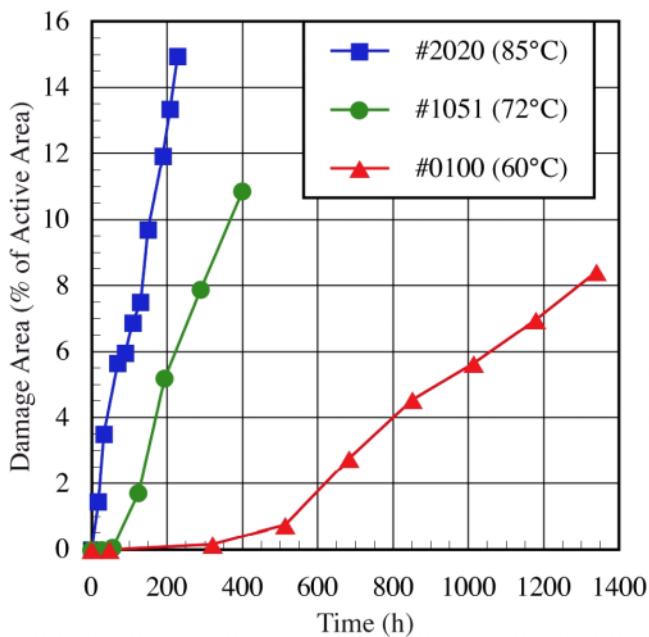
Figure 2. Active module area damaged by -600 V biased damp heat exposure as a function of time.

Three a-Si modules were subjected to biased damp heat in succession with varying chamber temperatures of 85°, 72°, and 60°C. At periodic intervals, the modules were removed from the chamber and the damage area measured. These results are presented in Fig. 2, from which we obtained an activation energy of 0.78 eV [4]. Typical activation energies for the electrical conductivity of soda-lime glass are in the 0.80–0.82-eV range, and our value compares closely to the one reported by EPV, 0.79 eV [5].

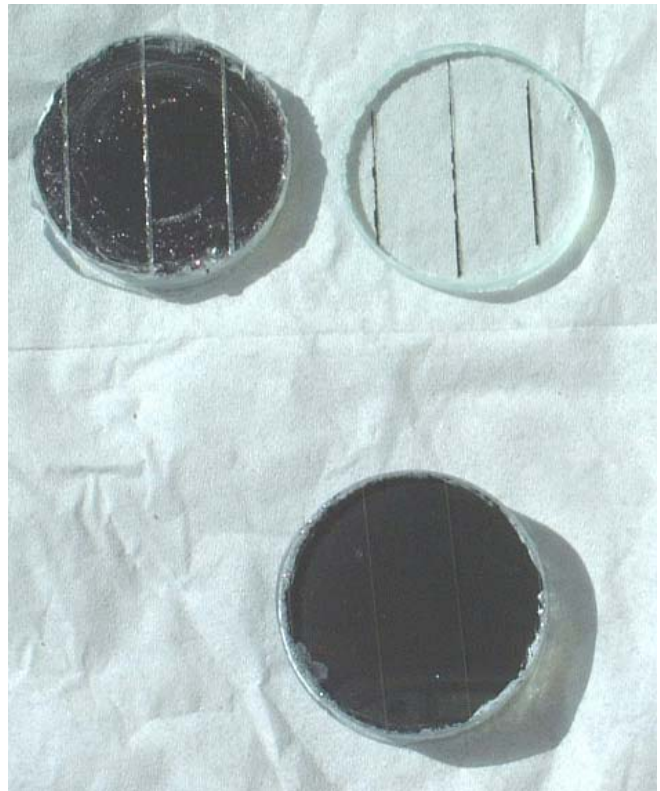
Figure 3. Two cored sections 25 mm in diameter from an a-Si module subjected to biased damp heat. This module design was a glass superstrate laminated with EVA to a glass backsheet. The bottom core was from a location that did not have visible damage, whereas the top core was from a region of total delamination of the SnO<sub>2</sub> from the top glass. Thus, the top right section is the superstrate glass, whereas the top left section is the backsheet with all the thin film layers adhering to the EVA.

At this point, it seemed desirable to examine the damage as closely as possible to help understand what is happening to the TCO layers. Core samples were cut from modules exposed to biased damp heat, in both damaged and undamaged areas. Figure 3 shows two of these core samples. In undamaged areas (Fig. 3 bottom), the TCO adhesion is still very high, and it is quite difficult to separate the top and bottom glasses. On the other hand, there is almost zero adhesion of the tin oxide to the glass superstrate in completely damaged regions (Fig. 3 top). Figure 4 is a 50× micrograph of the superstrate of the top core sample in Fig. 3, and shows that no TCO remains on the glass surface *except* near the TCO laser scribe lines. Apparently, the TCO laser ablation process modifies the TCO adjacent to the scribe line in a way that prevents electrochemical corrosion.

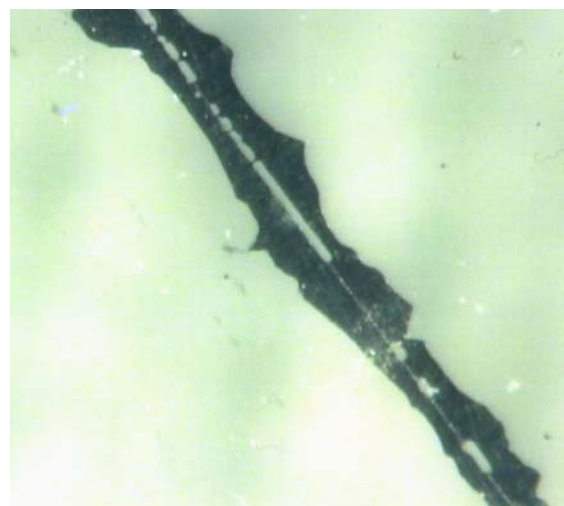
Figure 4. A 50× optical micrograph of the top glass superstrate shown in Fig. 5, along one of the TCO laser scribe lines. Away from the scribe line, no TCO remains on the glass surface.

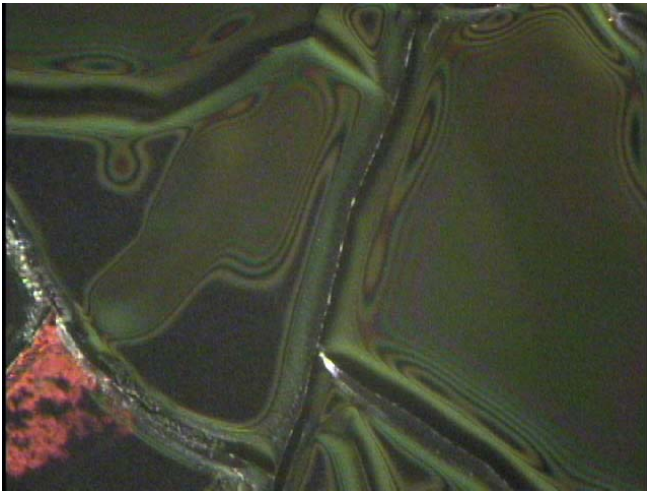
Figure 5. A 100× optical micrograph through the top glass of an a-Si module in an area only partly damaged by the TCO corrosion.

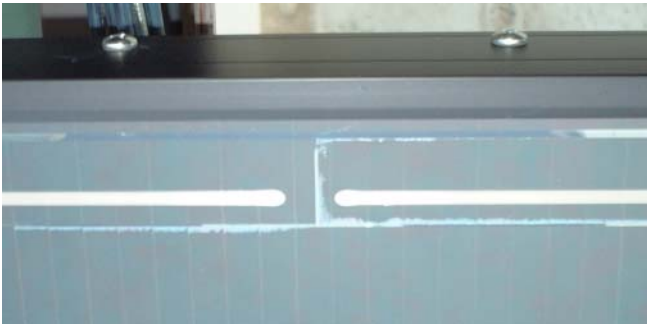
Figure 6. A photograph of the front surface of an a-Si module installed in a 1-kW PV system at NREL for about 3 years.

During discussions of the tin oxide problem, BP Solar suggested using the facilities available at NREL to verify the validity of the biased damp heat test [7]. Because there is no light on the test modules, it can be argued the test is an artificial one that produces stresses that will not occur in actual use. However, a-Si modules installed outdoors in PV systems do show TCO corrosion, as illustrated in Fig. 6, although without the extreme bar graphing. This module operates at about 60 V, which results in an internal electric field between the two white electrical bus (frit) lines.

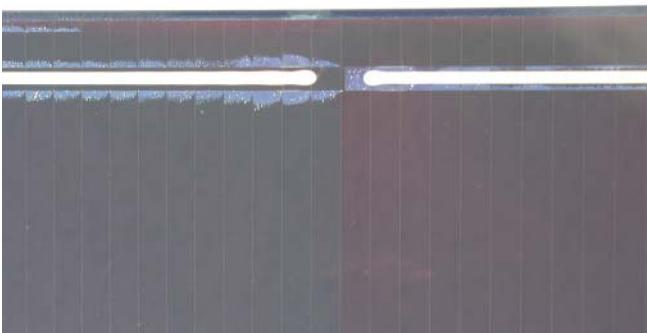
Figure 7. TCO corrosion in an a-Si module after 500 h of exposure to 1-sun, 85% RH, and 85°C module temperature.

Using our Atlas XR-260 environmental chamber that features four 1-kW Xe arc lamps, we began a test to see if similar damage can be replicated indoors. A resistive load was placed across the module leads, and the chamber controls were set to give 1-sun irradiance at 85% RH and 48°C. Note that this lower ambient temperature was needed to obtain a module temperature of 85°C under illumination. After 500 h, similar damage was observed, as seen in Fig. 7 (this module had a different laser scribing pattern). The polar nature of the corrosion is clearly evident in this image.

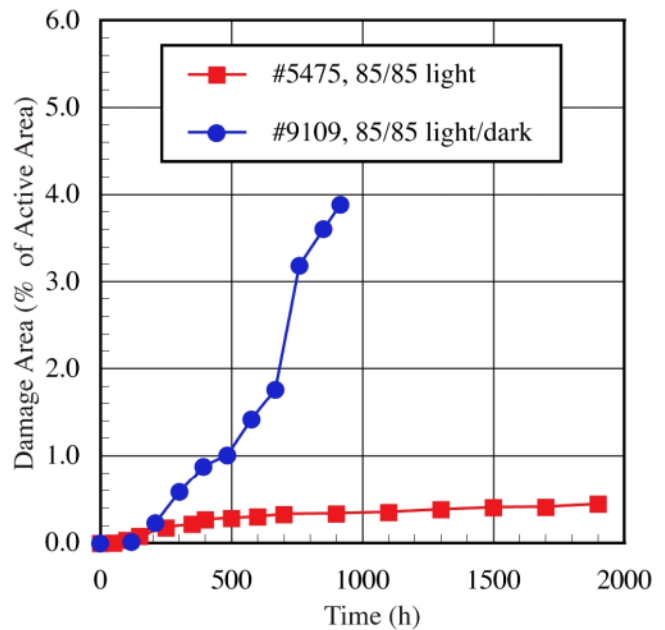
Figure 8. TCO damage area as a function of exposure time in an illuminated damp heat environment (see text).

After nearly 2000 h of exposure, the corrosion around the exit leads was again seen, plus bar graphing at the opposite end of the module that progressed very slowly (see Fig. 8).

Therefore, the following test was devised. Identical conditions were used for a 2-h light cycle, i.e., 48°C ambient temperature, 85% RH, 1-sun. Following this cycle, the illumination was turned off and the ambient temperature raised to 85°C for 2 h. The –600 V bias was applied during both cycles. The damage area was measured, and the results are plotted in Fig. 8 (note that in Fig. 8 the number of cycles completed has been converted to time). Visually, the damage to module #9109 was very similar to that of module #5475 (light-only), but the bar graph corrosion progressed at a rate about 30 times faster, although the corrosion rate is not linear.
