# **Lessons Learned from Field Evaluation of Six High- Performance Buildings**

P.A. Torcellini, M. Deru, B. Griffith, N. Long,  
S. Pless, and R. Judkoff  
*National Renewable Energy Laboratory*

*To be presented at the ACEEE Summer Study  
on Energy Efficiency in Buildings  
Pacific Grove, California  
August 22-27, 2004*

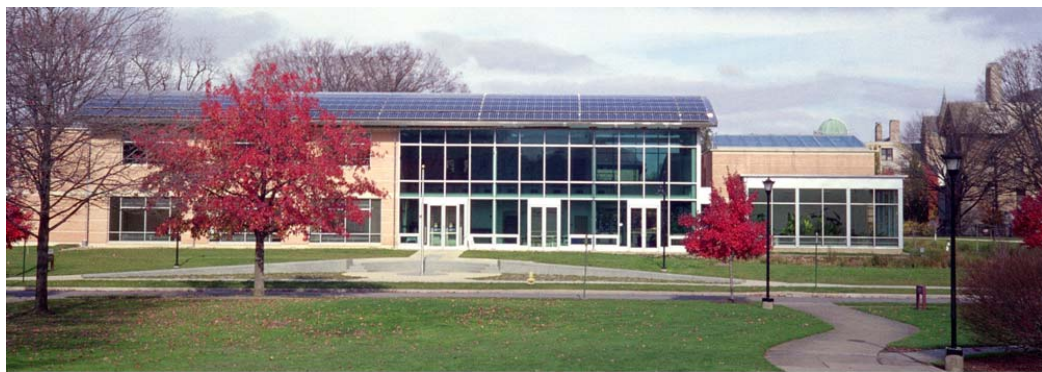
The Oberlin College Lewis Center for Environmental Studies is a two-story, 13,600-ft<sup>2</sup> classroom and laboratory building (Figure 1). The building contains four classrooms, a small auditorium, atrium, staff offices, and kitchenette. The vision for this building was to create a building that has the potential to be a net-zero-energy building either now or in the future as technologies improve. The building was funded through private donations and although cost was a concern, it was not a primary driver. The object was to promote technologies and serve as an educational tool for the Environmental Studies Program at the College.

The integrated building design includes daylighting to offset lighting loads, natural ventilation to offset building cooling loads, massive building materials to store passive solar gains, a ground-source heat pump system to meet the cooling and heating loads, an energy management system, and a system to process building waste water without sending the waste to the municipal sewage treatment plant. Because of the zero-energy vision, the building was designed to be all-electric, such that onsite energy could potentially offset 100% of the energy consumed. The building's roof is covered with a grid-tied, 60-kW photovoltaic (PV) array.

**Figure 1. Oberlin South Facade Showing the PV Array on the Roof**

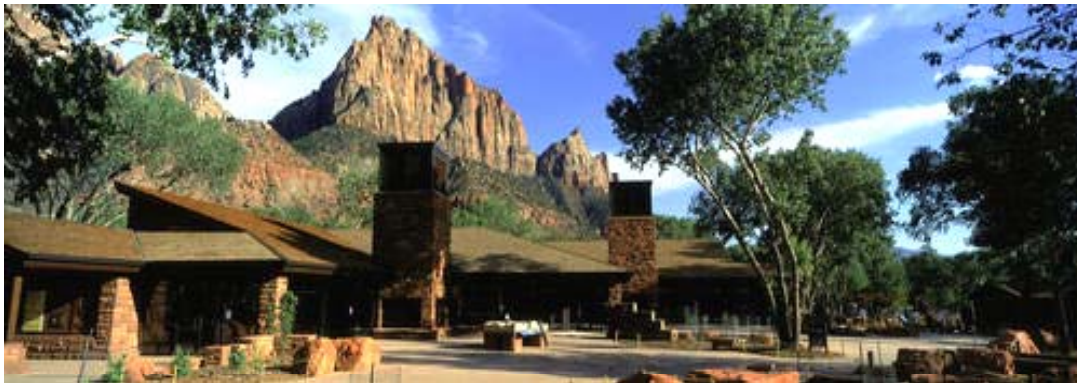
The Visitor Center Complex at Zion National Park (southwest Utah) exemplifies the National Park Service's commitment to promote conservation and to minimize impact on the natural environment. The building design incorporates energy-efficient features including daylighting, natural ventilation, evaporative cooling (using passive cooltowers), passive solar heating, solar load control with engineered overhangs, computerized building controls, and an uninterrupted power supply (UPS) system integrated with the 7.2-kW PV system (Figure 2).

**Figure 2. Zion Visitor Center North Elevation Showing Cooltowers and Plaza**

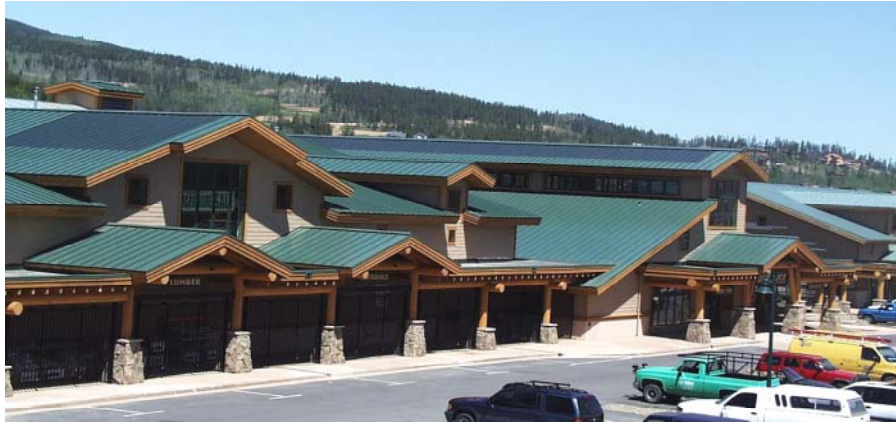
**Figure 3. BigHorn Home Improvement Center**

The BigHorn Home Improvement Center consists of an 18,400-ft<sup>2</sup> hardware store retail area and a 24,000-ft<sup>2</sup> warehouse. The owner was committed to using renewable energy and a building design optimized for minimal energy use. Aggressive daylighting and smart envelope design in the retail area allow the use of natural ventilation to meet all the cooling loads. The lighting load is reduced by extensive use of natural light and switching arrangements of the fluorescent lamps. The retail area uses a hydronic radiant floor system with natural gas-fired

boilers. An energy management system controls the lights, natural ventilation, and heating system. The warehouse is heated by a transpired solar collector and gas radiant heaters.

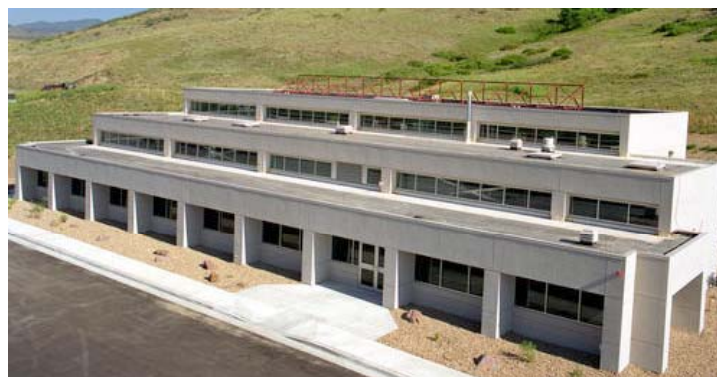
**Figure 4. NREL Thermal Test Facility**

The NREL Thermal Test Facility is a 10,000-ft<sup>2</sup> building located in Golden, Colorado. The building has a steel frame structure typical of many small buildings, including professional buildings, industrial parks, and retail. The building features extensive daylighting through clerestory windows, two-stage evaporative cooling, overhangs for minimizing summer gains, T-8 lights, instantaneous hot-water heaters, and a well-insulated thermal envelope.

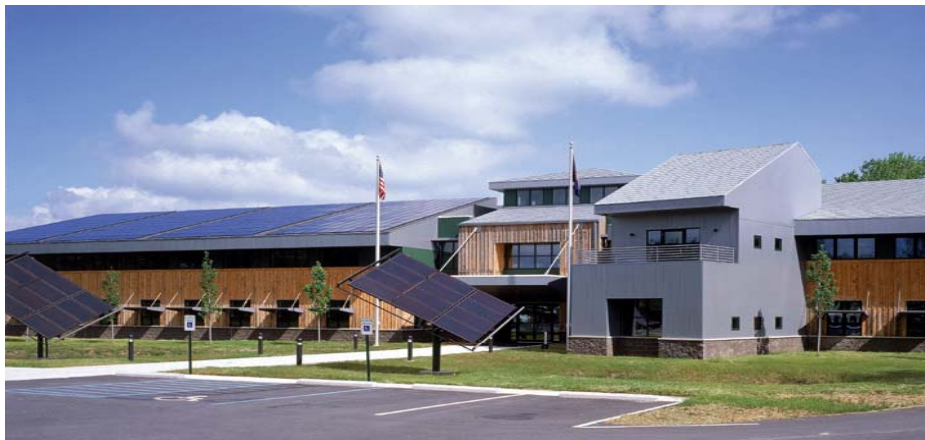
The Cambria Office Building in Ebensburg, Pennsylvania, has an area of 34,500 ft<sup>2</sup> and serves as the district office for Pennsylvania's Department of Environmental Protection (DEP). The design team used the U.S. Green Building Council's LEED 2.0 requirements and standards as design guidelines and goals. Among the low-energy design features used in this building are ground-source heat pumps, an under-floor air distribution system, heat recovery ventilators, an 18.2-kW PV system, daylighting, motion sensors, additional wall and roof insulation, and high-performance windows. The DEP further reduces the impact of the building operations by purchasing 100% utility-based renewable energy. Finishes, including carpets, walls, furniture, and paints were based on recycled content and low-emissions.

**Figure 5. South Facade of the Cambria Office Building**

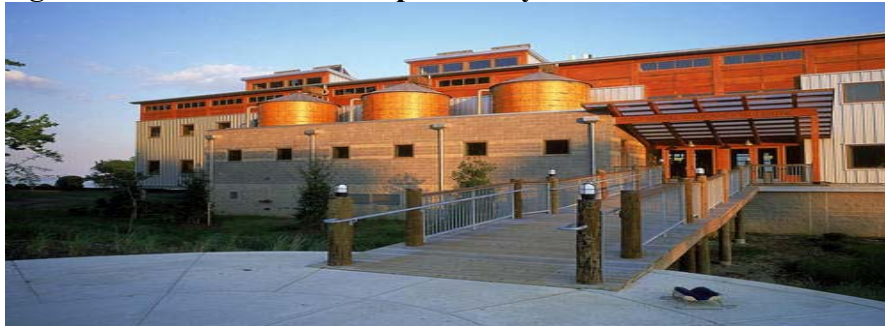
**Figure 6. Photo of the Chesapeake Bay Foundation North Facade**

The Merrill Center uses a ground-source heat pump system for heating and cooling. Forty-eight wells, each 300-ft deep, use the earth as a heat sink in the summer and a heat source in the winter. A glazed wall of windows facing south contributes daylight and passive solar heating. Sensors automatically turn off lights when daylighting is strong. The shed roof allows rainwater to be collected easily and used for fire protection, landscape watering, clothes and hand washing. Composting toilets also minimize water usage. Motor- and manually operated windows allow for natural ventilation. Fans are used to augment the natural ventilation system.

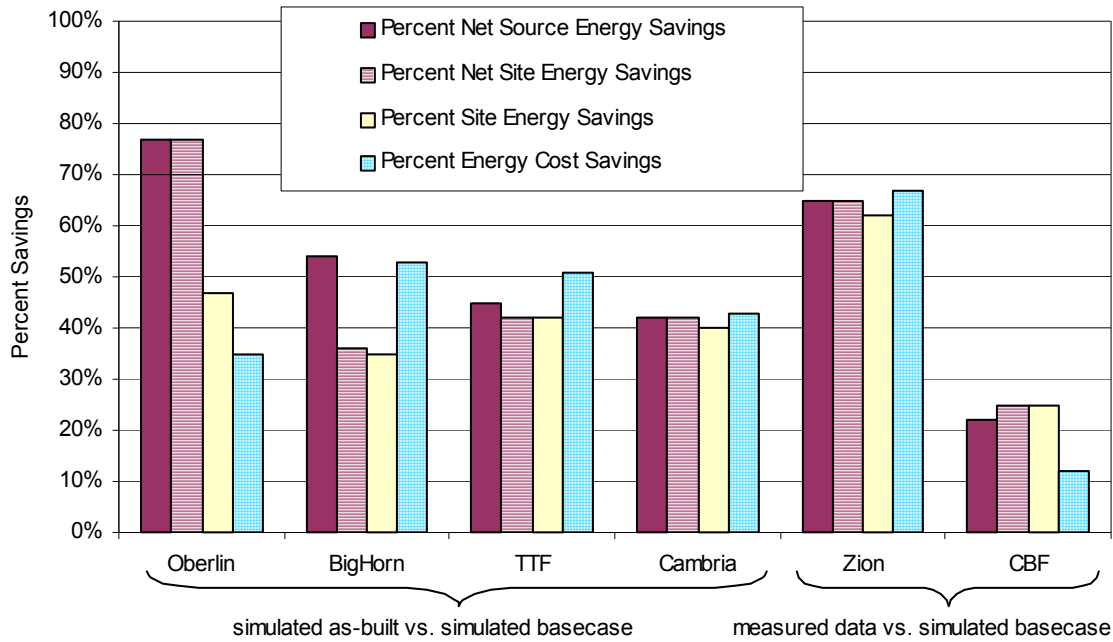
**Figure 7. Summary of Building Energy Savings**

Note: all bars include PV contribution except Percent Site Energy Savings.
