Analysis of the Design and Energy Performance of the Pennsylvania Department of Environmental Protection Cambria Office Building

M. Deru and P. Torcellini
National Renewable Energy Laboratory

M. Sheffer and A. Lau
7group

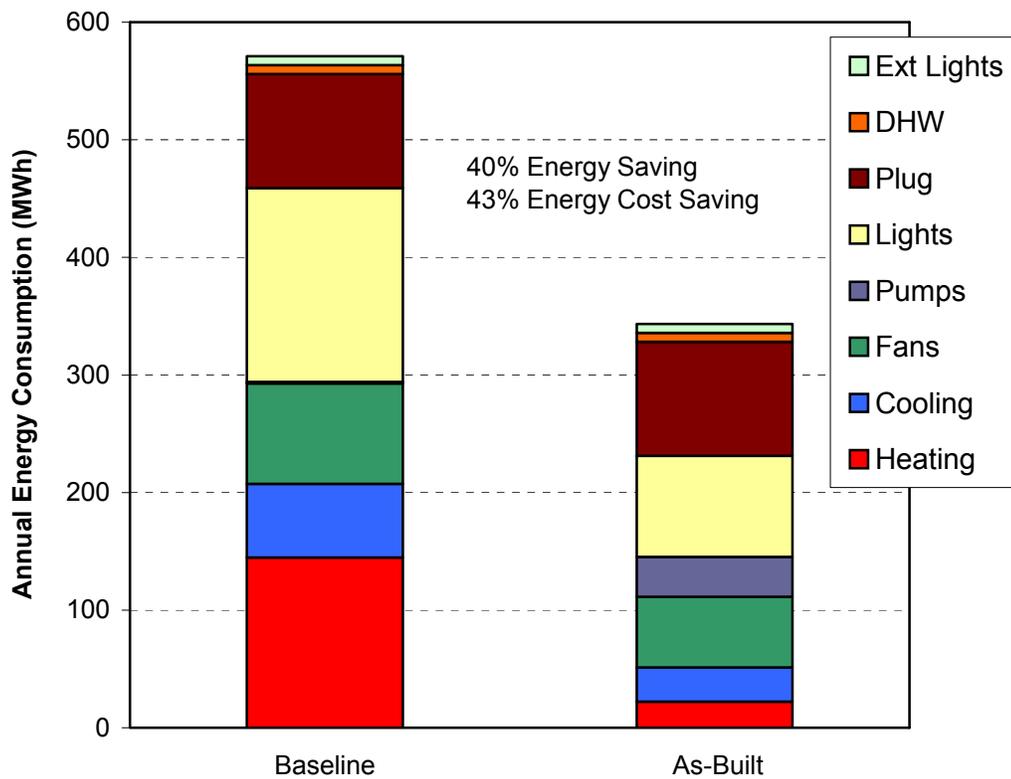
Figure ES-1 Annual site energy consumption for the As-Built Baseline Model and As-Built Model

The Cambria building is an example of a high-performance building produced at a reasonable cost of \$93/ft² (\$1,000/m²). The building (without the PV systems) shows an estimated 40% energy saving and a 43% energy cost saving. These savings are for the total building energy use and were determined with whole-building energy simulations that were calibrated with measured data. The As-Built Baseline Model was compliant with ASHRAE 90.1-2001. The annual energy consumption for the As-Built Baseline Model and As-Built Model is shown in Figure ES-1. Most of the energy savings are from a reduction in the heating and lighting energy. Table ES-1 shows the annual energy performance for site energy, source energy, and energy cost.

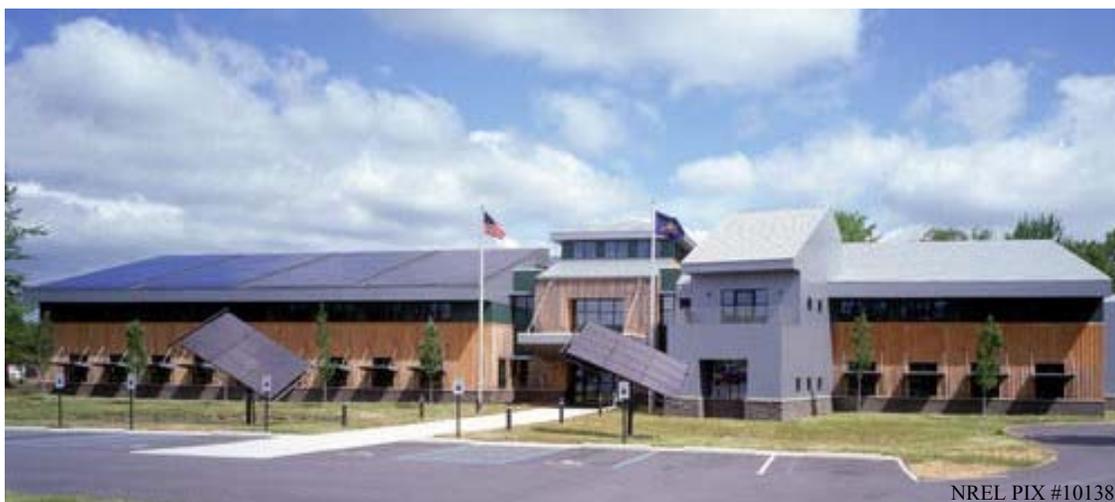
Figure 1-1 South-facing view of the Pennsylvania DEP Cambria building

There are two PV systems on the building. A 17.2-kW system is mounted on the roof with a 15-kW, three-phase commercial grid-tied inverter; there is a 1-kW system mounted on two single-axis trackers in front of the building (Figures 1-1 and 5-1). Both systems use 43-W, amorphous-silicon PV panels to produce electricity. The large system feeds into the main distribution panel through a utility-grade power meter. The output of the inverter for the large system requires an isolation transformer to connect to the power grid. The transformer reduces the output of the system by approximately 3% when the system is operating, and it draws approximately 370 W of power when the PV system is not producing power. The small PV system has a single-phase, 1-kW inverter and feeds into the heating panel on the east side of the building. The energy output of only the large PV system is metered for the purposes of generating revenue.

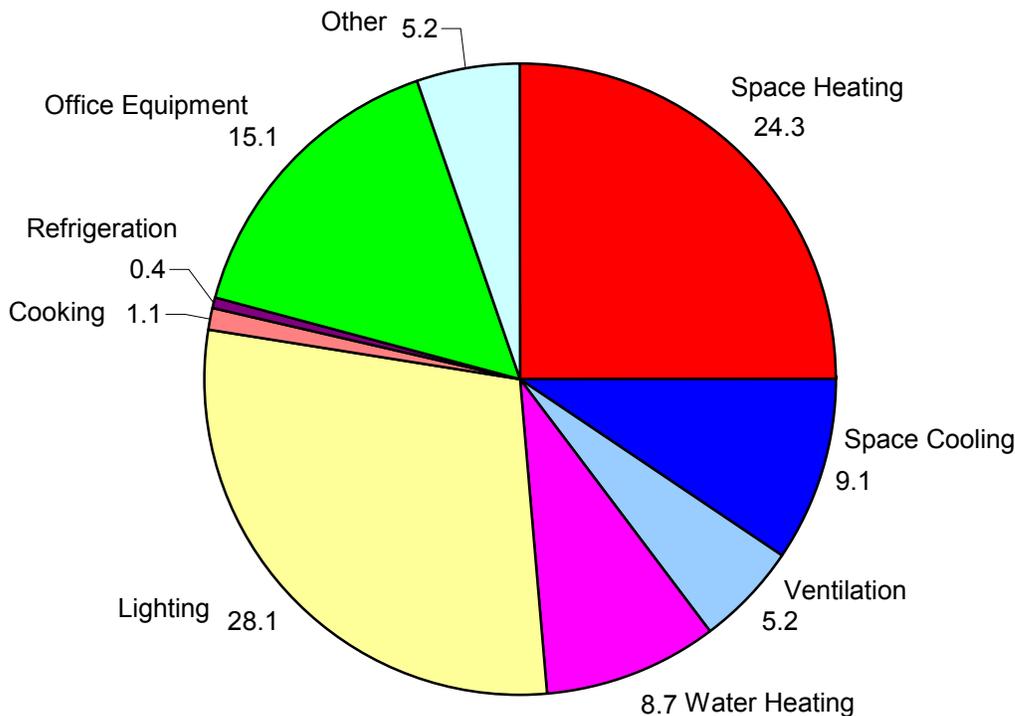
Figure 2-1 Typical site EUIs by end use for office buildings (kBtu/ft²-yr) (DOE 2004)

Typical site energy consumption by end use for office buildings is shown in Figure 2-1 (DOE 2004). The average building site energy use intensity (EUI) is 97.2 kBtu/ft²-yr. These numbers are based on 1995 data collected by EIA. Most of the space heating, water heating, and cooking use natural gas; the rest of the energy consumption is electricity. The primary energy consumed to generate and distribute the electricity is approximately three times the energy used on site. Lighting is the largest primary energy end use; therefore, reduction in lighting loads should be a primary objective in office buildings.

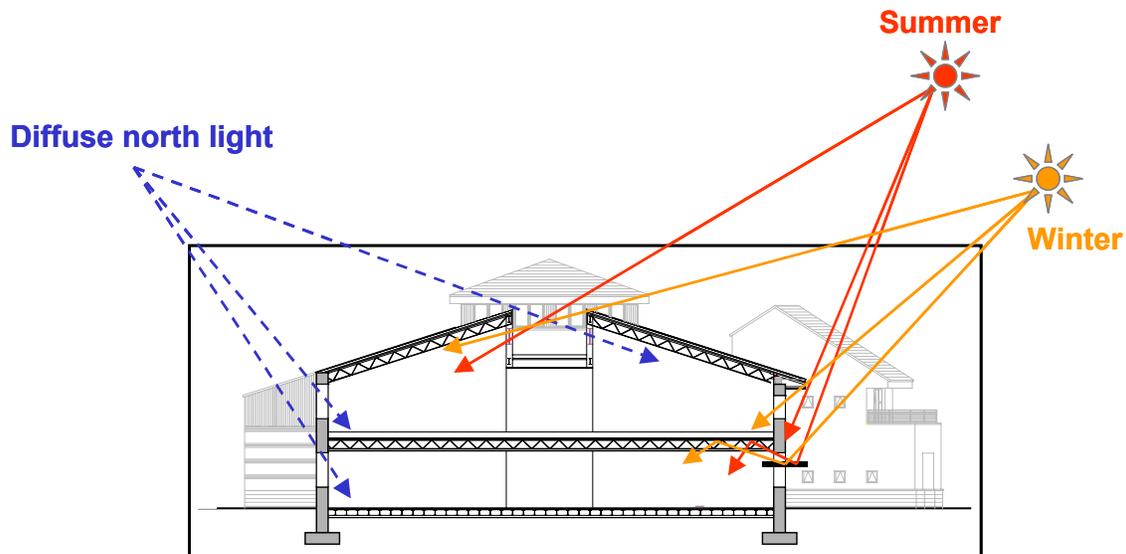
Figure 3-1 Daylighting design features of the Cambria building

The initial lighting design called for a lighting power density (LPD) of 0.82 W/ft² (8.8 W/m²). Subsequent refinement of the lighting system resulted in a final design LPD of 0.75 W/ft² (8 W/m²), not including task lighting. The LPD of the task lighting in the office areas is approximately 0.5 W/ft² (5.4 W/m²).

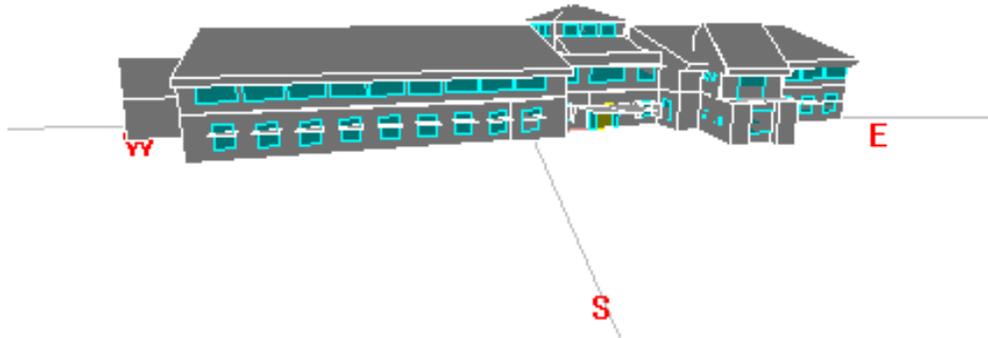
Figure 3-2 Rendering of the Cambria office building used for energy simulation

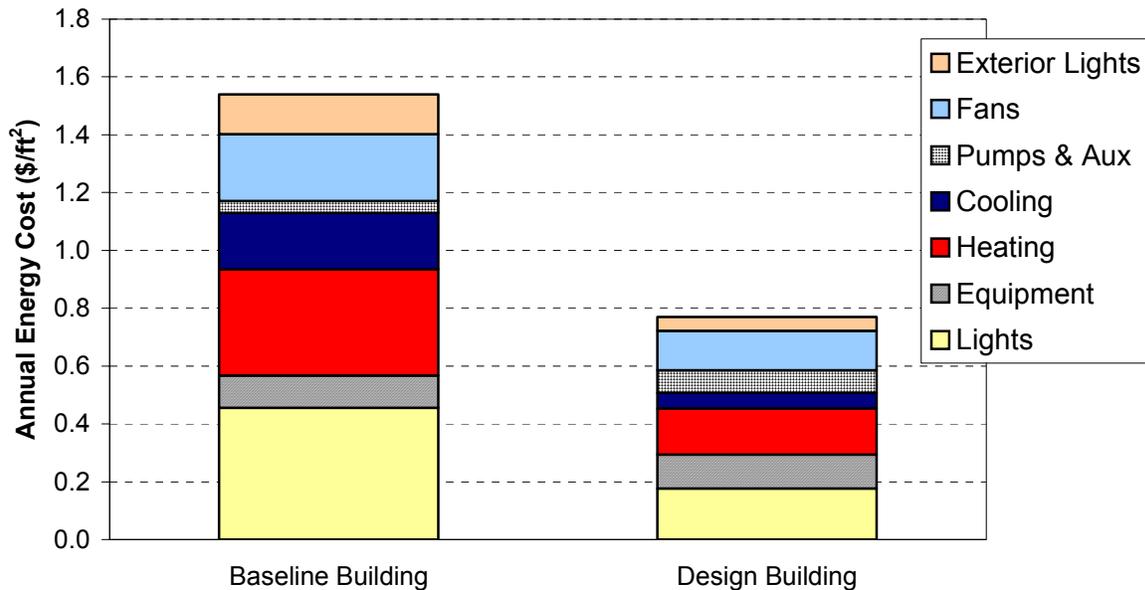
Figure 3-3 Comparison of the energy cost performance of the Design Building Model to the Design Baseline Building Model

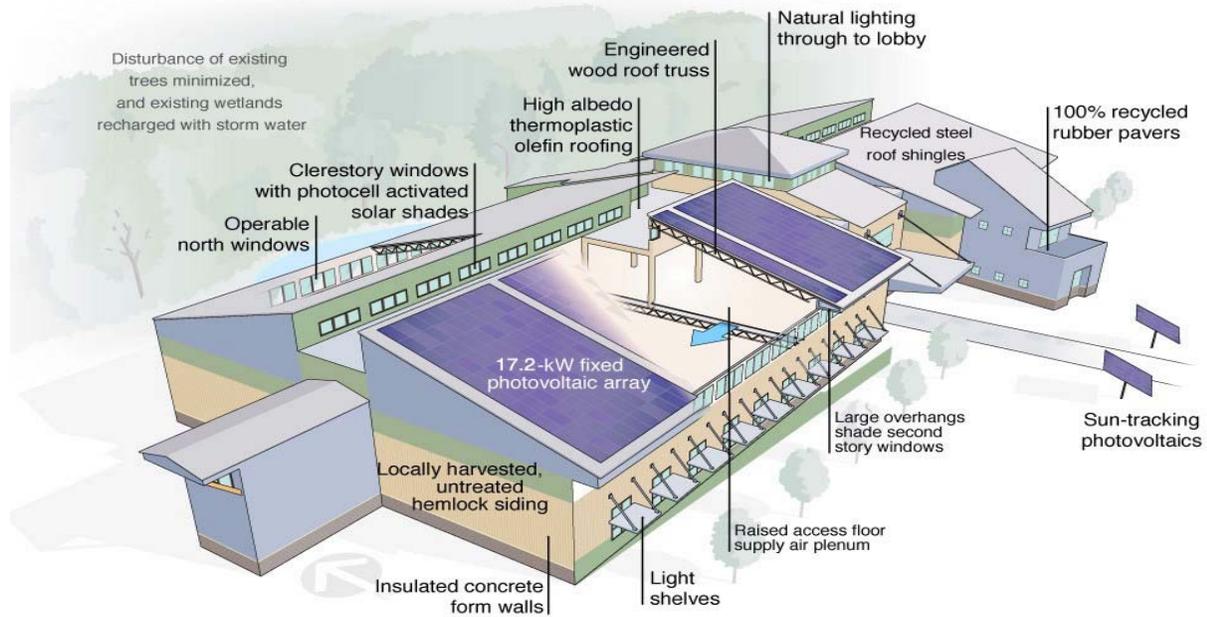
Figure 5-1 Illustration of the high-performance features of the Cambria building

The Cambria building is a two-story, 34,500-ft² (3,205-m²) structure oriented on a long east-west axis, as shown in Figures 5-1 and 5-2. The building contains office space for approximately 100 people, a large file storage area, two small laboratory areas, conference rooms, a break room, and general storage areas.

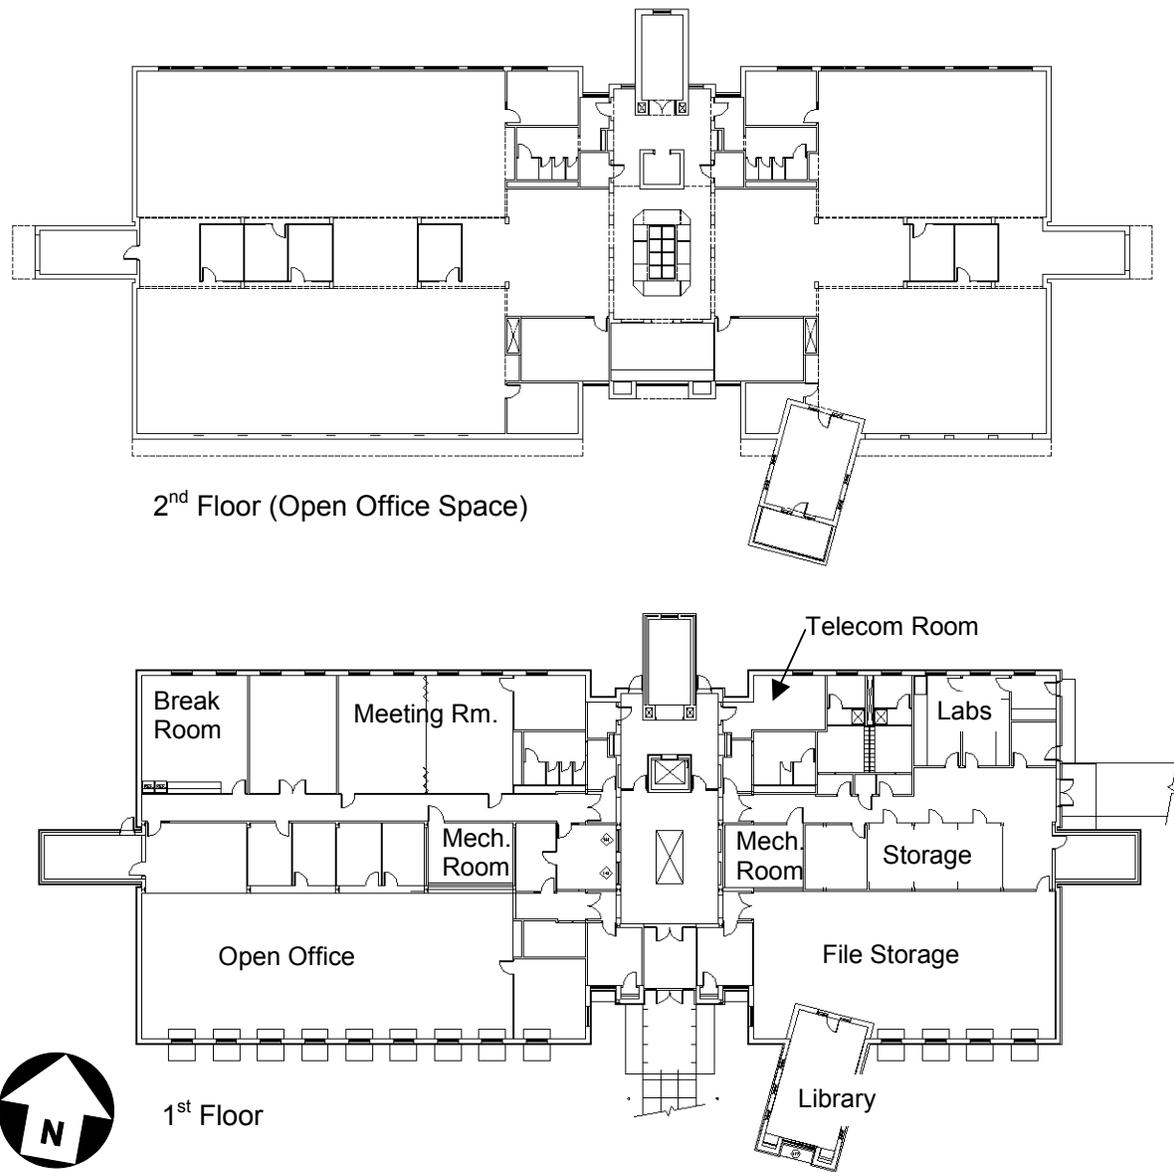
Figure 5-2 Floor plans of the Cambria building

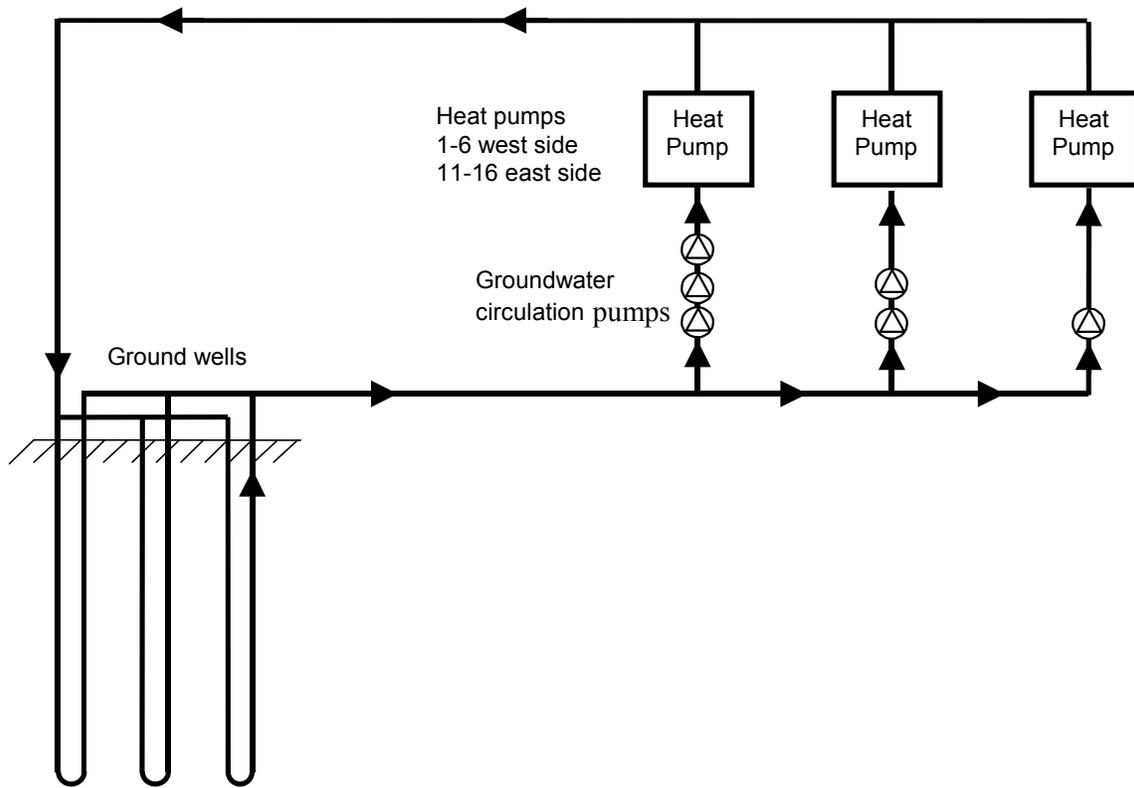
Figure 5-3 HVAC waterside schematic

**Heat pump 16 was added after the first year of operation to provide cooling directly to the Telecom room.

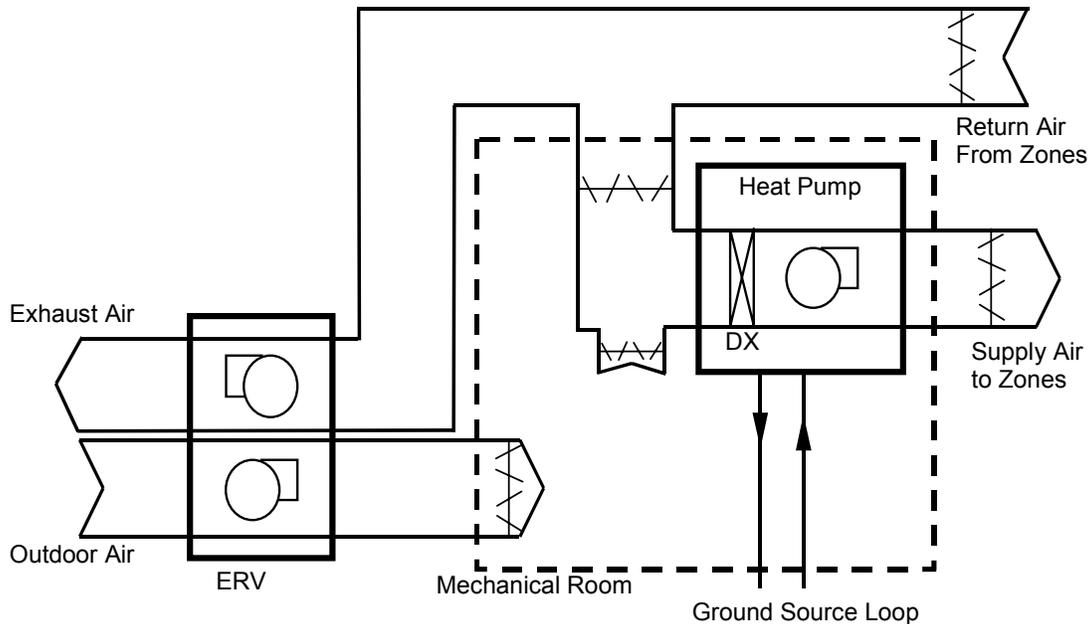
Figure 5-4 HVAC airside schematic

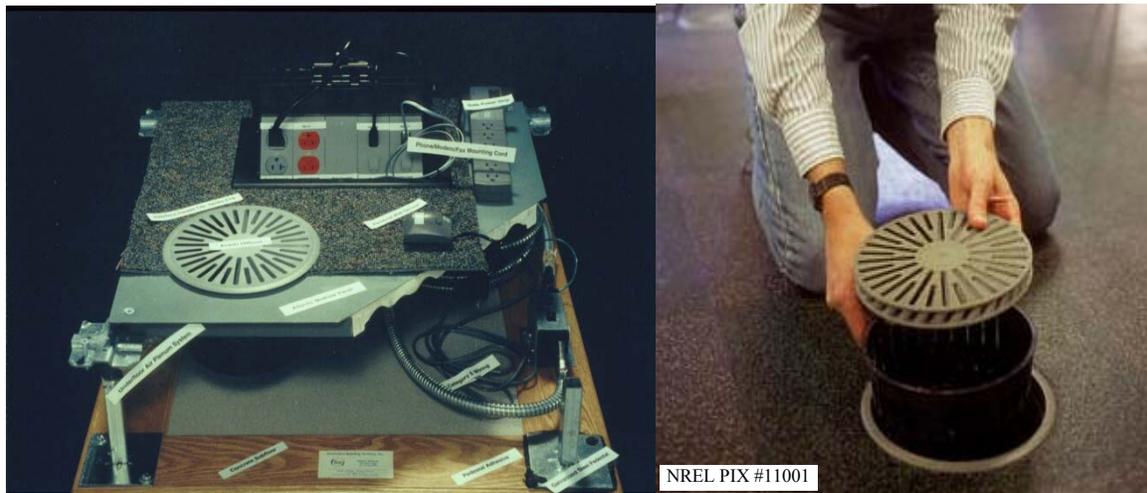
Figure 5-5 Components of the raised floor system

The majority of the building uses a UFAD system with swirl diffusers mounted in the raised floor. The swirl diffusers are located in the common areas and in each office area, and they can be manually adjusted by the occupant to control the amount of air entering his or her workspace. Return air registers are located high in the spaces. The system uses a displacement ventilation principle by supplying fresh air near the occupants and removing the older stale air high in the space. Figure 5-5 shows the components of the raised floor system including a view of the manually operated swirl diffuser.

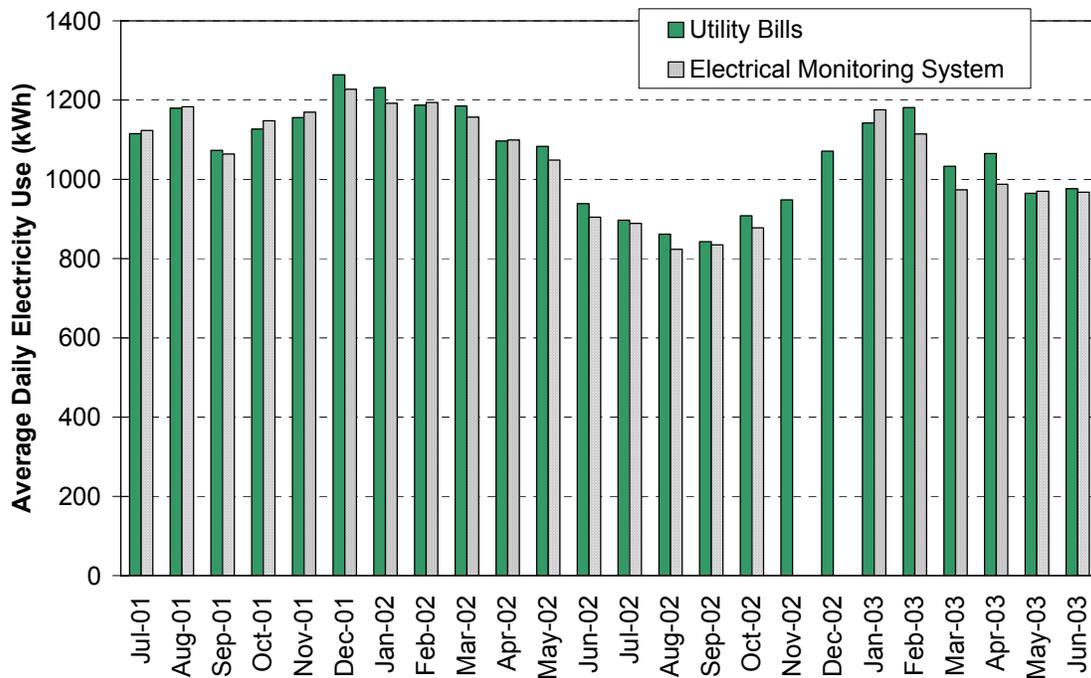
Figure 6-1 Comparison of the monthly daily average total energy consumption

The monthly daily average energy consumption by end use was calculated from the 15-minute instantaneous power readings from the electrical monitoring system assuming an average power for the previous 15-minute period. There are two potential errors with this method. The first is that almost one-third of the data were missing due to failures in the monitoring system, and the second is the assumption that the average power over a 15-minute period may not be represented well by one instantaneous reading. Fortunately, the power levels in this building are relatively constant during the occupied and unoccupied periods, and averaging the values over the period of a month should produce reasonable results. NREL checked this method of predicting the monthly daily average energy totals by comparing the total building energy consumption from the electrical monitoring system to the utility bills plus the energy produced from the PV systems. This comparison is shown in Figure 6-1. The average difference is -1.7% and the largest monthly difference is -7.3% . Therefore, it is reasonable to use the values from the PowerLogic system to estimate the monthly daily average energy consumption of the major end uses for comparison purposes. Note that the data are completely missing for November and December 2002.

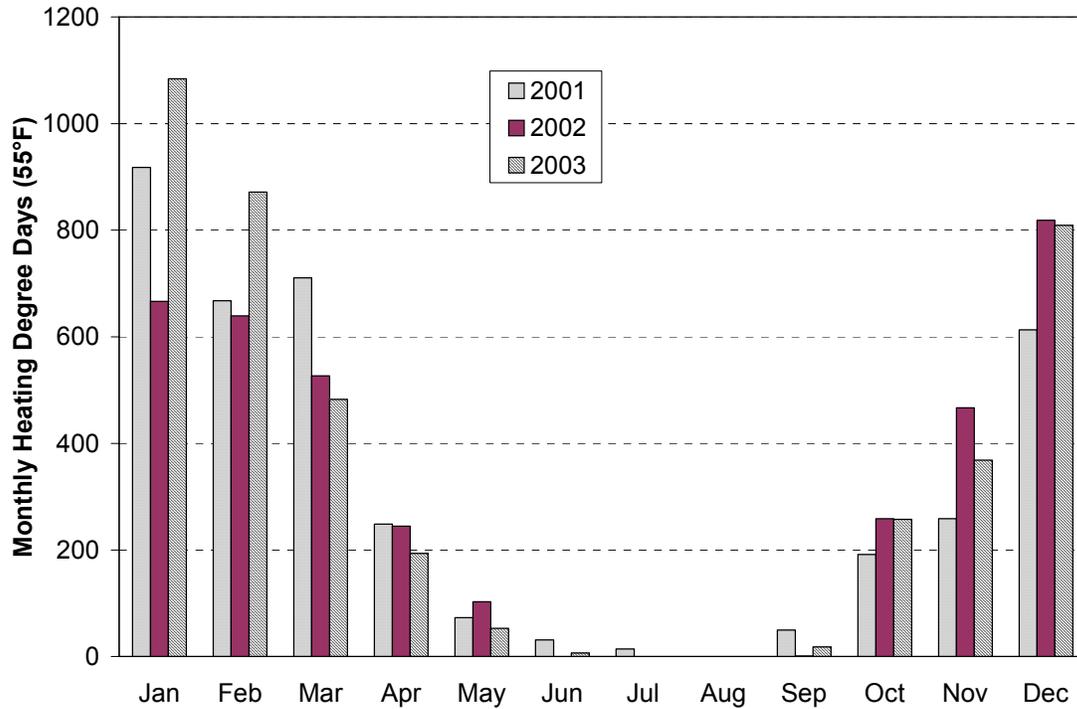
Figure 6-2 Monthly HDDs (base 55°F [13°C])

The weather conditions are important drivers of the energy use in buildings. The monthly HDD (base 55°F [13°C]) and CDD (base 55°F [13°C]) are shown in Figures 6-2 and 6-3. The data for January 2001 to June 2001 is adjusted from a Federal Aviation Administration weather station at the Blair County Airport in Altoona, Pennsylvania (Appendix C). Starting in July 2001, weather data were measured at the building site. Notice that the summer of 2002 was much warmer than the summers of 2001 and 2003, with $1,850^{\circ}\text{F}\cdot\text{days}$ ($1,028^{\circ}\text{C}\cdot\text{days}$) CDD from May to September 2002 versus $1,446^{\circ}\text{F}\cdot\text{days}$ ($803^{\circ}\text{C}\cdot\text{days}$) CDD for 2001, and $1,455^{\circ}\text{F}\cdot\text{days}$ ($808^{\circ}\text{C}\cdot\text{days}$) CDD for 2003. In addition, the winter of 2002–2003 was colder than the winter of 2001–2002, with $3,256^{\circ}\text{F}\cdot\text{days}$ ($1,809^{\circ}\text{C}\cdot\text{days}$) HDD for December to March 2002–2003 versus $2,445^{\circ}\text{F}\cdot\text{days}$ ($1,358^{\circ}\text{C}\cdot\text{days}$) HDD for December to March 2001–2002.

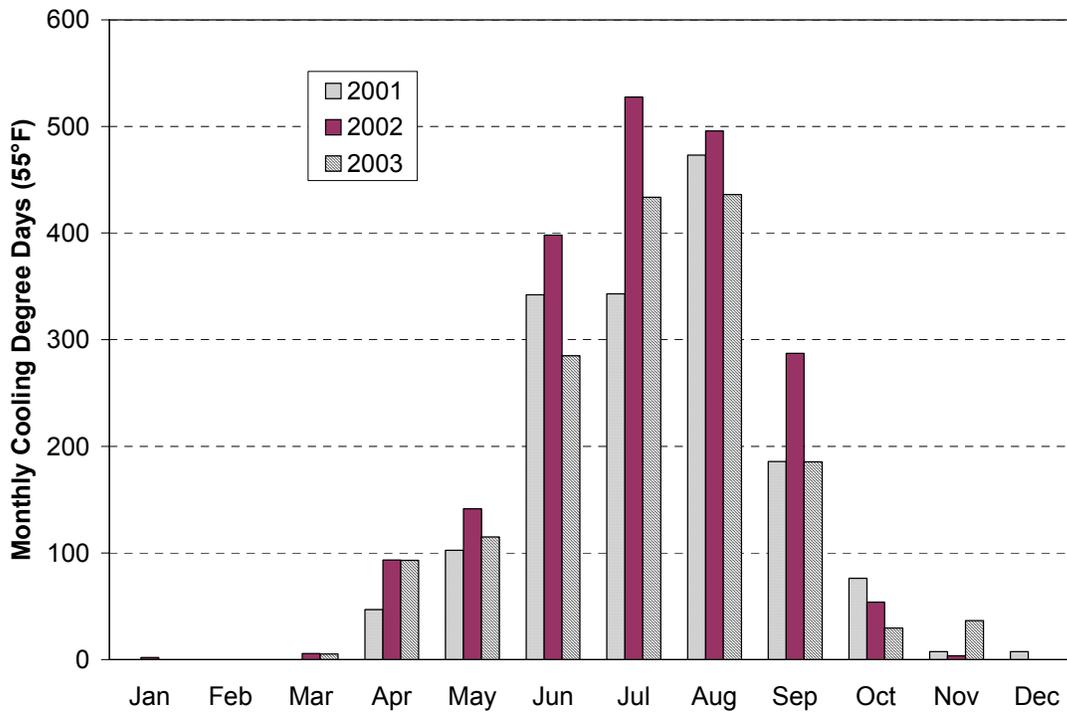
Figure 6-3 Monthly CDDs (base 55°F [13°C])

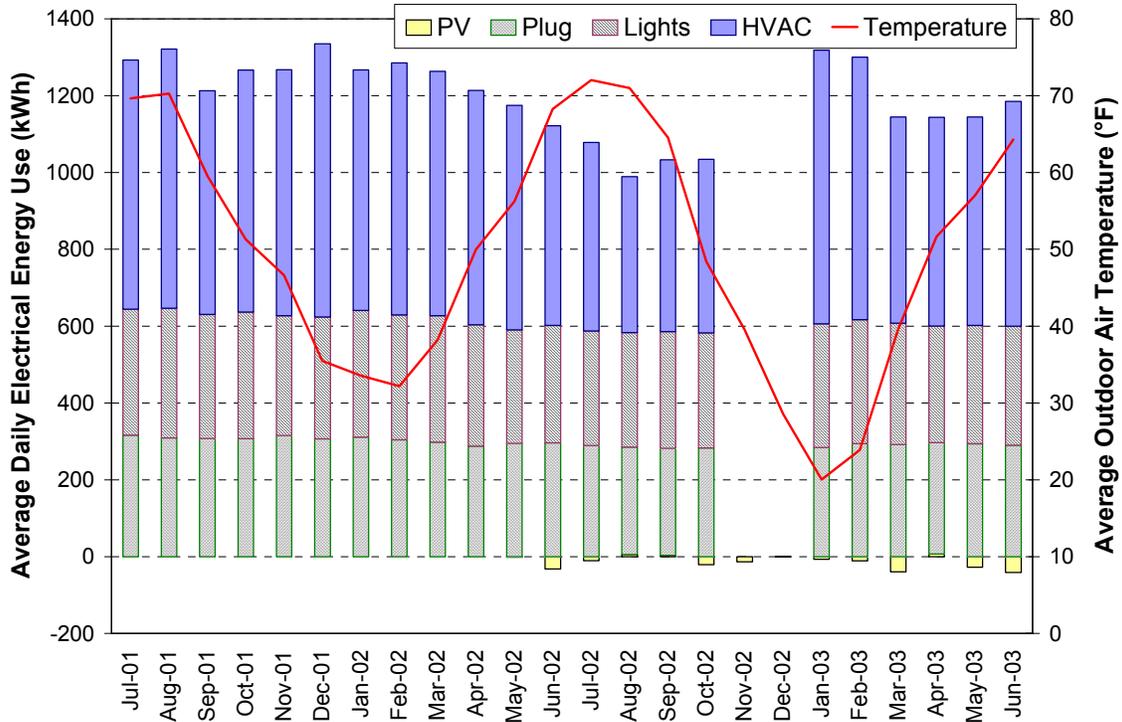
Figure 6-4 Daily average energy use and PV production for weekdays from July 2001 to June 2003 (PV system monitoring began in June 2002)

The breakdown of energy consumption by end use is shown in Figures 6-4 and 6-19, for weekdays and weekends/holidays. These figures show the average daily energy use by month for the HVAC, lighting, and plug loads for July 2001 through June 2003. These graphs also show the energy production by the PV systems. The PV system monitoring began in June 2002 on the Campbell data logger system. In addition, the average monthly outdoor dry-bulb temperature is shown on the graphs.

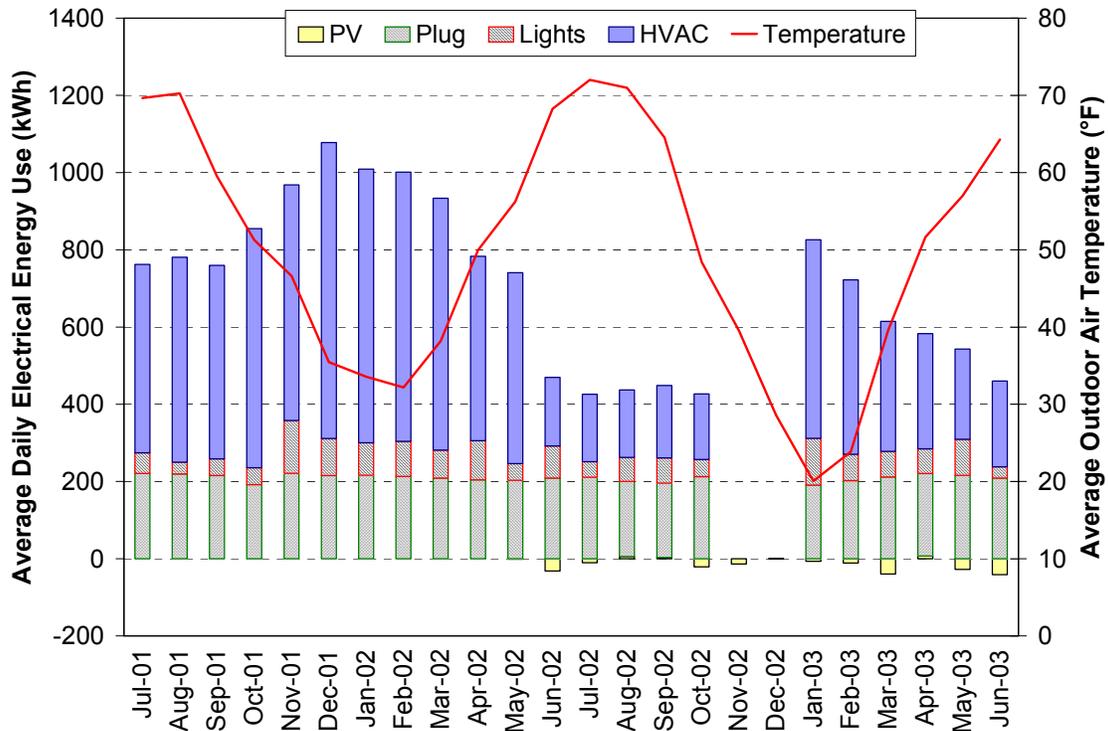
Figure 6-5 Daily average energy use and PV production for weekends/holidays from July 2001 to June 2003 (PV system monitoring began in June 2002)

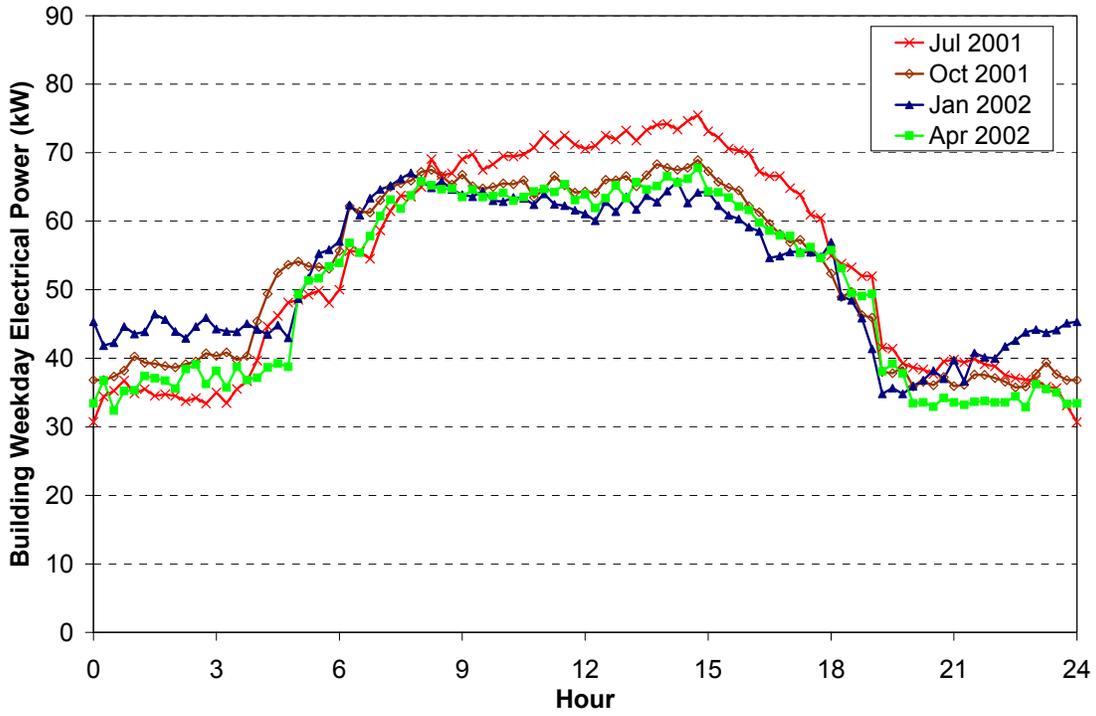
Figure 6-6 Average daily building load profile for weekdays (2001–2002)

Another way to examine energy use is to plot the average daily load profiles by month. This aggregates the monthly data into one graph and allows a view of the daily and seasonal variations. Daily load profiles were created from the PowerLogic data for weekdays and for weekends/holidays for every month during the data-monitoring period. The seasonal variations in the building daily load profiles from 2001 to 2003 are shown in Figures 6-6 and 6-7. The dates for the graphs were set because July 2001 was the first full month of data collection and changes were made to the HVAC control systems in June 2002 that had a significant impact on the energy consumption. The most noticeable differences between the two figures is that the nighttime loads are higher in Figure 6-6 and the daytime loads for July and January are higher in Figure 6-7. Changes to the HVAC control settings (Section 7.1) lowered the nighttime loads. Some of these changes were reversed by January 2003, resulting in an increase in the nighttime loads. The daytime loads are higher in Figure 6-7 because the weather in July and January was more severe (hotter or colder) than in the months in Figure 6-6. The weather differences are seen in the HDD and CDD as shown in Figures 6-2 and 6-3.

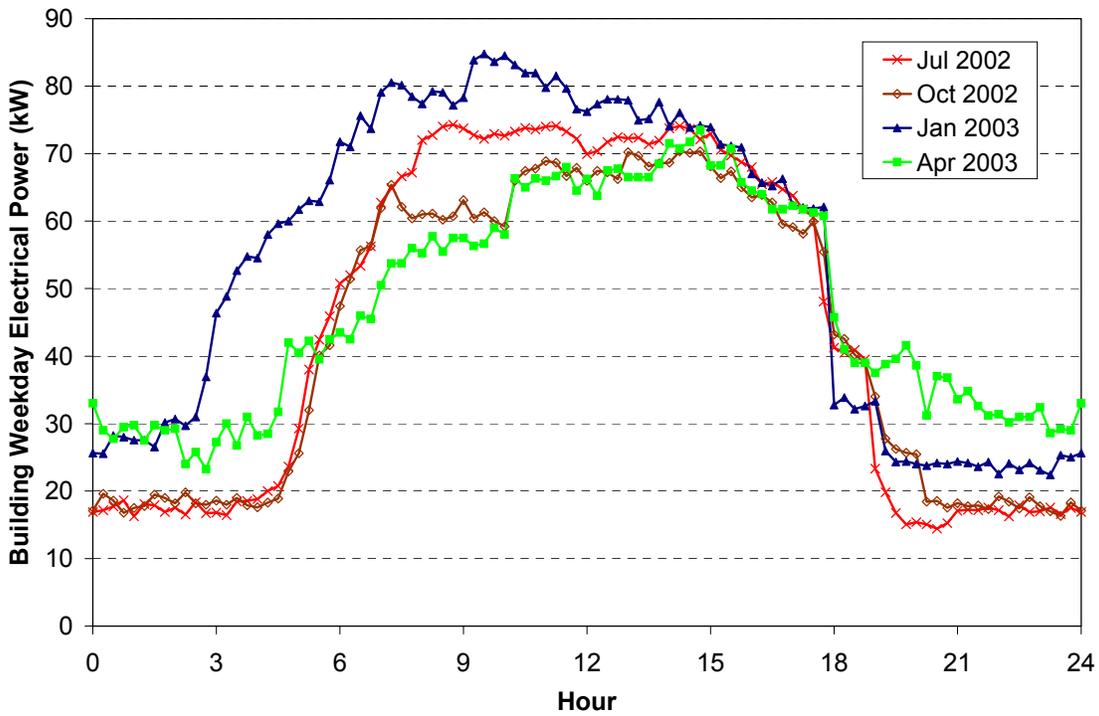
Figure 6-7 Average daily building load profile for weekdays (2002–2003)

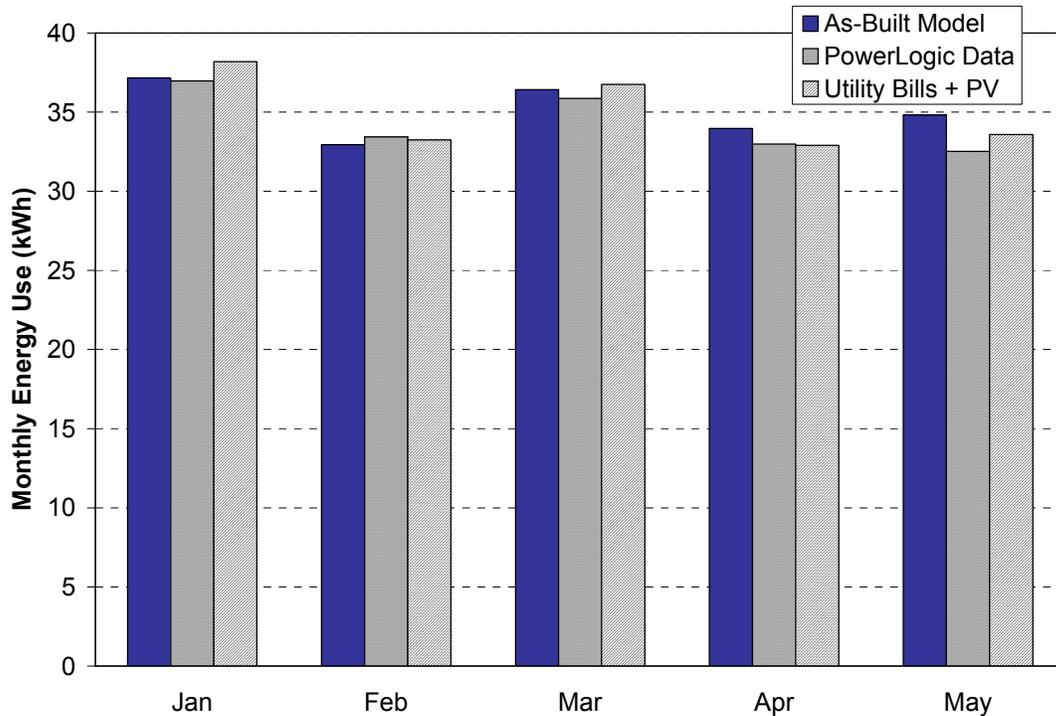
Figure 6-8 Energy use from the calibrated simulation model and measurements for five months in 2002.

The next step in the calibration process was to run the simulation and compare the results with the measured data. As stated earlier, the period from January to May 2002 was selected as the calibration period. The plug load and lighting profiles were adjusted to match the measured data from January to May 2002. Using these adjusted profiles, the As-Built Model was compared to the energy use measured by the PowerLogic system. The energy use from the calibrated model was compared to the measured energy use from the PowerLogic system and the utility bills in Figure 6-8 and Table 6-7.

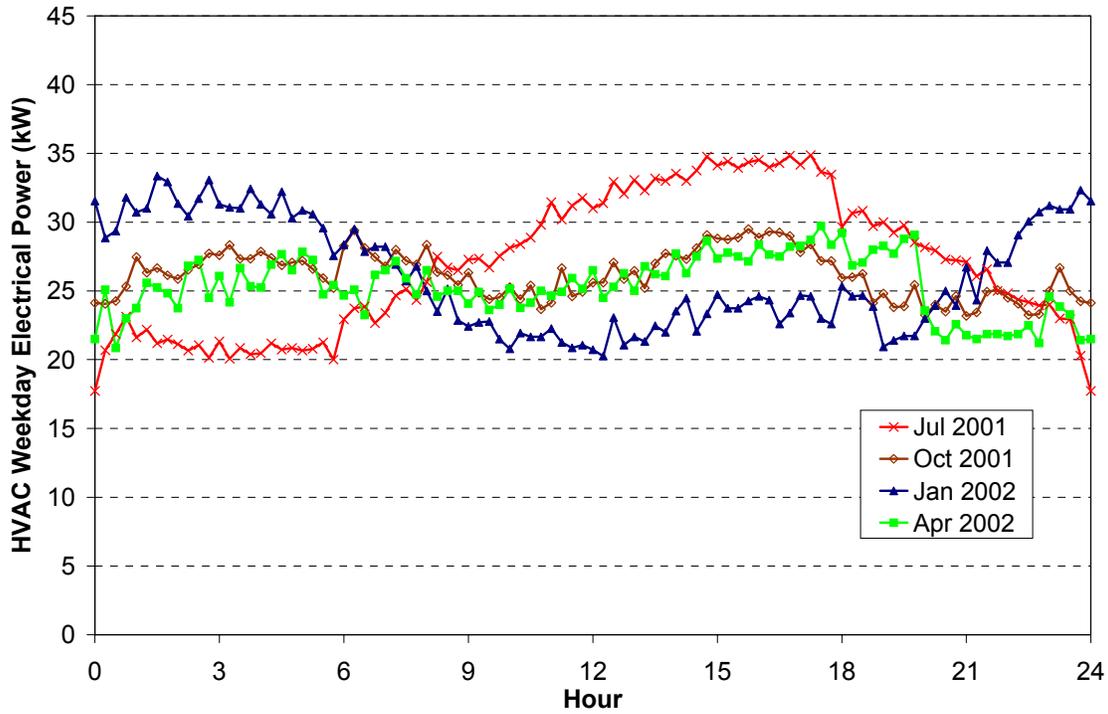
Figure 7-1 Average daily HVAC load profile for weekdays (2001–2002)

As shown in Section 6.2.2, the HVAC systems consume about 55% of the total energy; therefore, operational changes can have a large impact on the building energy performance. The average daily HVAC load profiles for July 2001 to April 2002 and July 2002 to April 2003 are shown in Figures 7-1 and 7-2. The differences in the load profiles from Figure 7-1 to Figure 7-2 are mainly caused by changes in the control strategies and somewhat by weather differences. Table B-1 presents a summary of changes to the control settings.

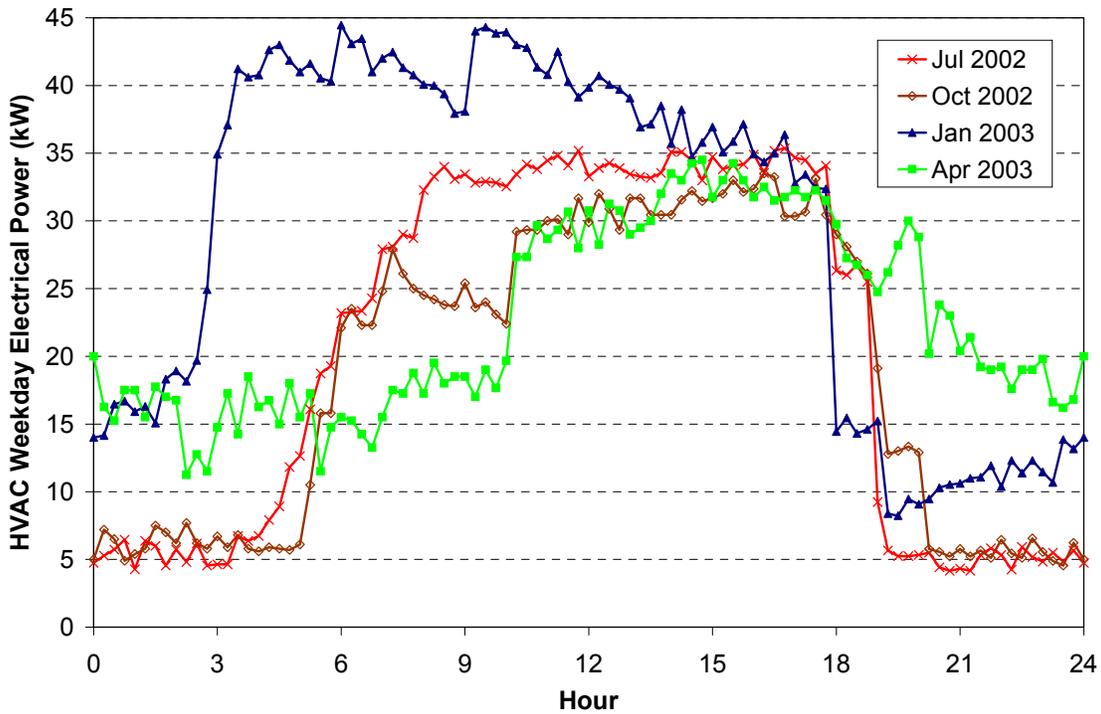
Figure 7-2 Average daily HVAC load profile for weekdays (2002–2003)

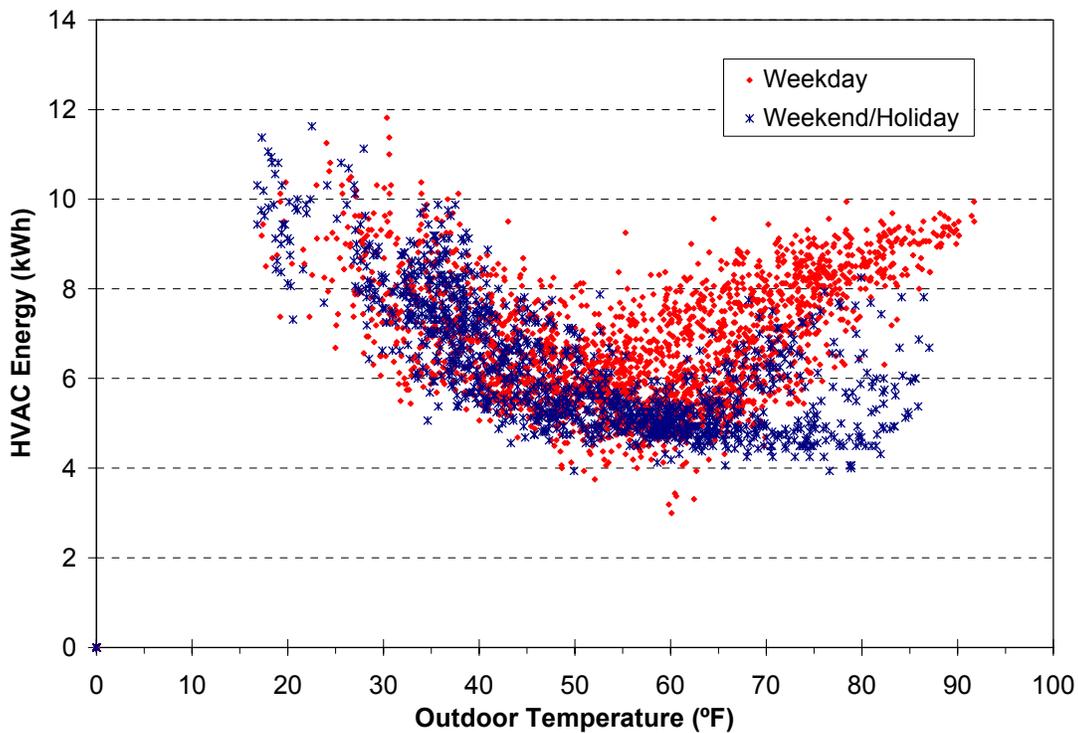
Figure 7-3 Hourly HVAC energy versus outdoor temperature (July–December 2001)

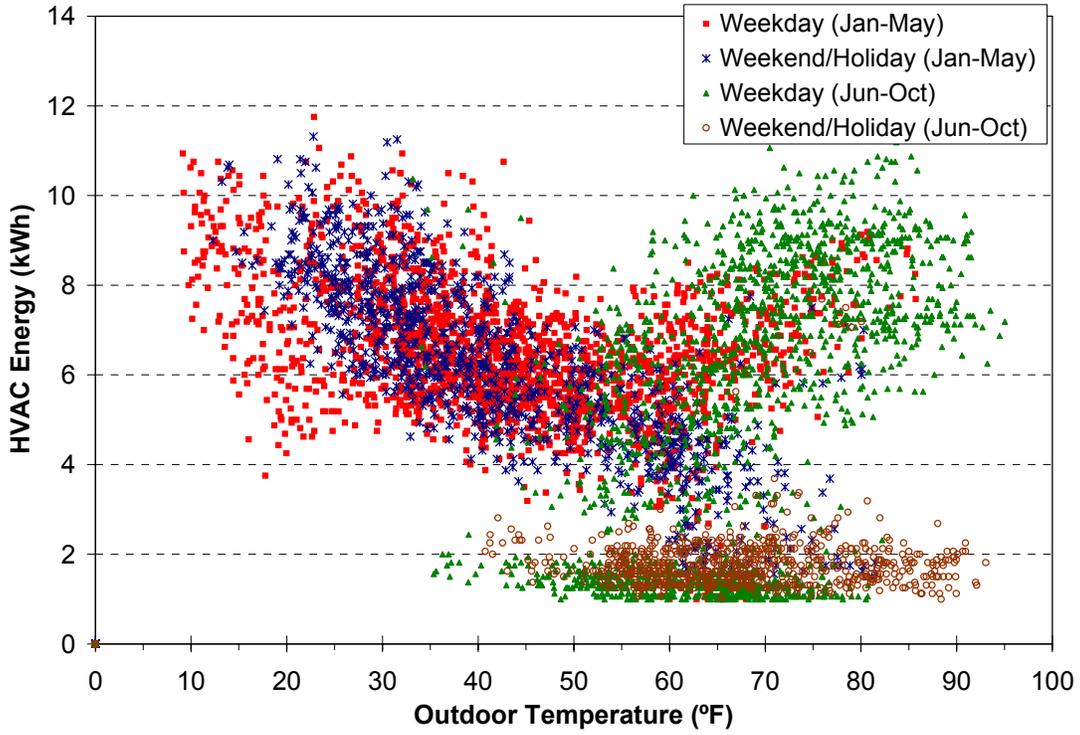
Figure 7-4 Hourly HVAC energy versus outdoor temperature (January–October 2002)

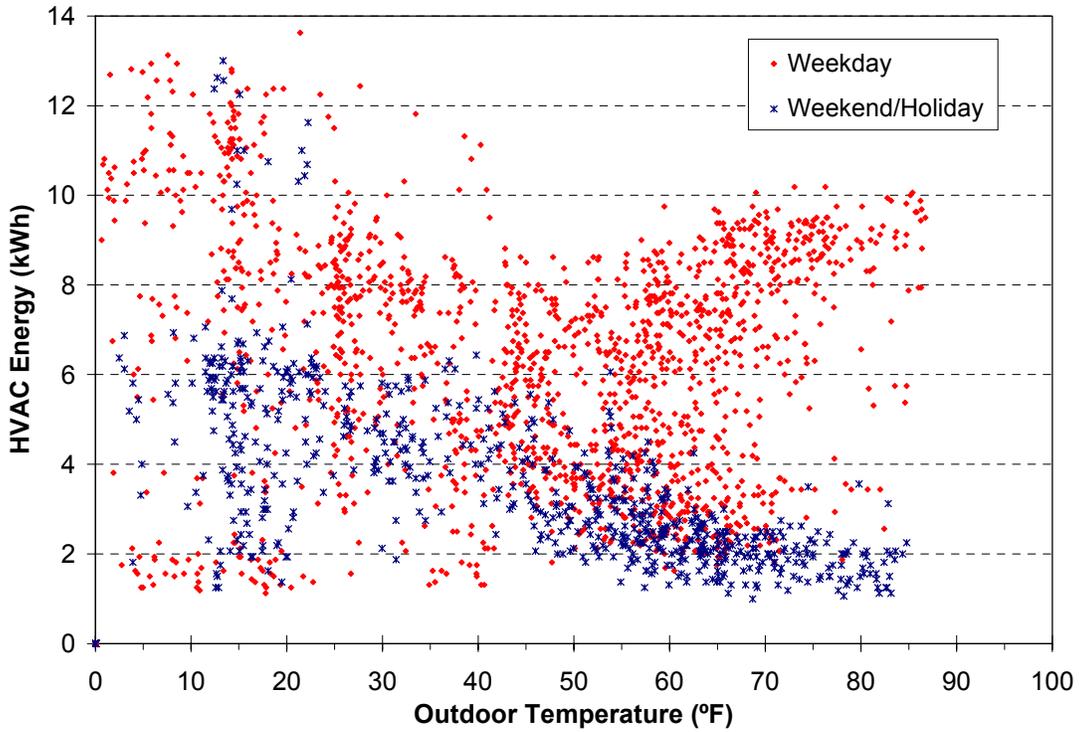
Figure 7-5 Hourly HVAC energy versus outdoor temperature (January–June 2003)

The data for 2003, shown in Figure 7-5, are more scattered than 2001 and 2002 for a number of reasons. This was the first winter with the west ERV off at night and weekends, and it was much colder than the previous winter. There are some weekday nighttime hours and weekend hours with cold temperatures that required no heating and some hours that required a small amount of heating. In addition, the thermostat settings were changed (probably more than once) during this period. At some point, the heat pump fans were set to run continuously and the temperature set points were set to constant values, or, in some cases, to higher heating set points at night. Finally, the time clock on the west ERV was off by three hours, causing the system to come on earlier in the morning.

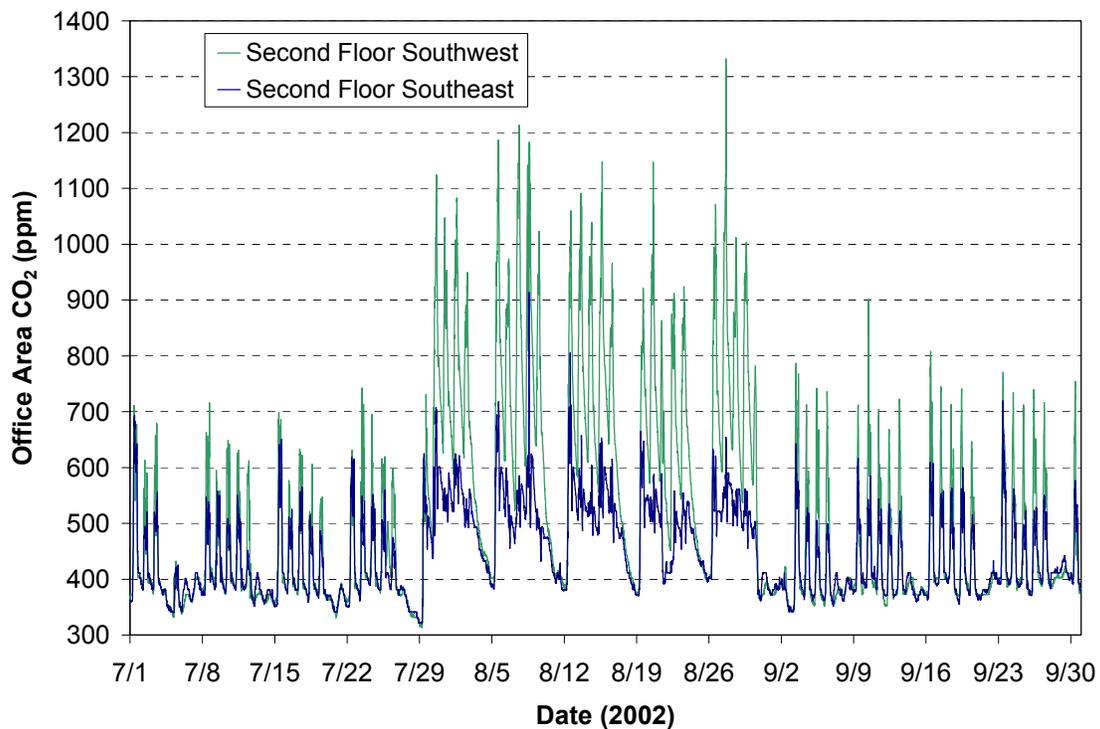
Figure 7-6 Office space CO₂ concentrations with the west ERV off during August

The ERVs represent one of the largest factors in the HVAC energy use. The ERV fans consume a considerable amount of energy to bring in large amounts of outside air, which must be conditioned. According to ASHRAE Standard 62-1999 (ASHRAE 1999), the minimum outside air for an office is 20 cfm/person (10 l/s·person). When both ERVs are running, there are 4,500 cfm (2,125 l/s) of outside air. The average daily peak occupancy is approximately 70 people. A conservative estimate of the design maximum is 100 occupants. At 100 occupants, the ERVs deliver 45 cfm/person (21 l/s·person), more than double the minimum required. An accidental test of the amount of outside air required occurred when the west ERV was inadvertently turned off on July 30 and left off until August 29, 2002. The measured CO₂ levels during the month before, during, and after the ERV was turned off are shown in Figure 7-6.
