Analysis of the Design and Energy Performance of the Pennsylvania Department of Environmental Protection Cambria Office Building

M. Deru and P. Torcellini
National Renewable Energy Laboratory

M. Sheffer and A. Lau
7group

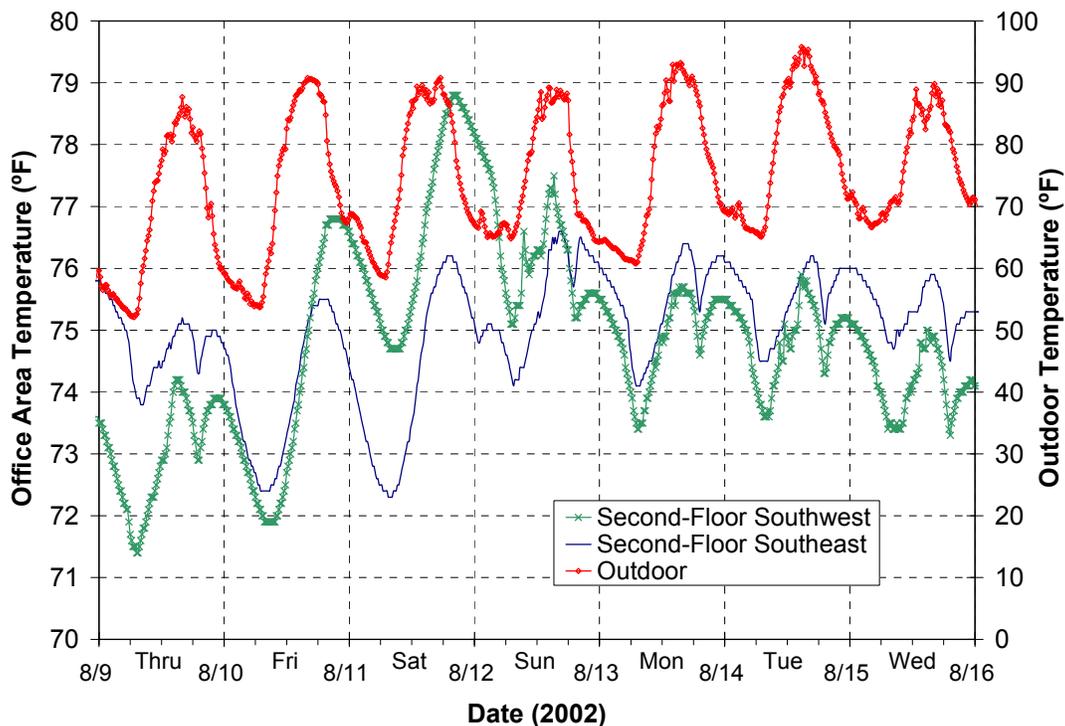
Figure 7-7 Office and outdoor temperatures for the summer of 2002

The space temperatures for the second-floor, southwest and southeast quadrants are shown in Figures 7-7 and 7-8 for summer and winter periods. Figure 7-7 shows the performance during the warmest day in 2002, and Figure 7-8 shows the space temperatures during one of the coldest periods in 2002. These temperature readings were taken from the permanent monitoring system. The data from this system were checked and compared with data from a hand-held sensor during the summer of 2002. The permanent system consistently logged temperatures that were 1°F–2°F (0.5°C–1°C) higher than the hand-held system. The temperatures shown were adjusted to more closely match the temperatures measured on the hand-held system.

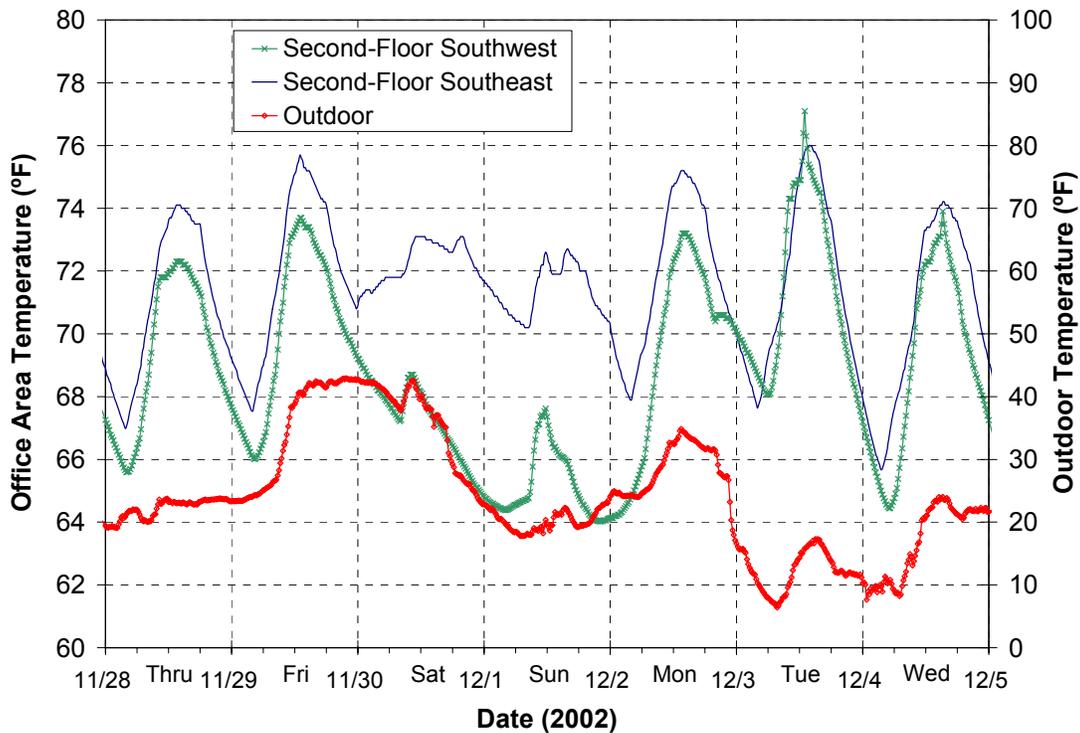
Figure 7-8 Office and outdoor temperatures for the winter of 2002

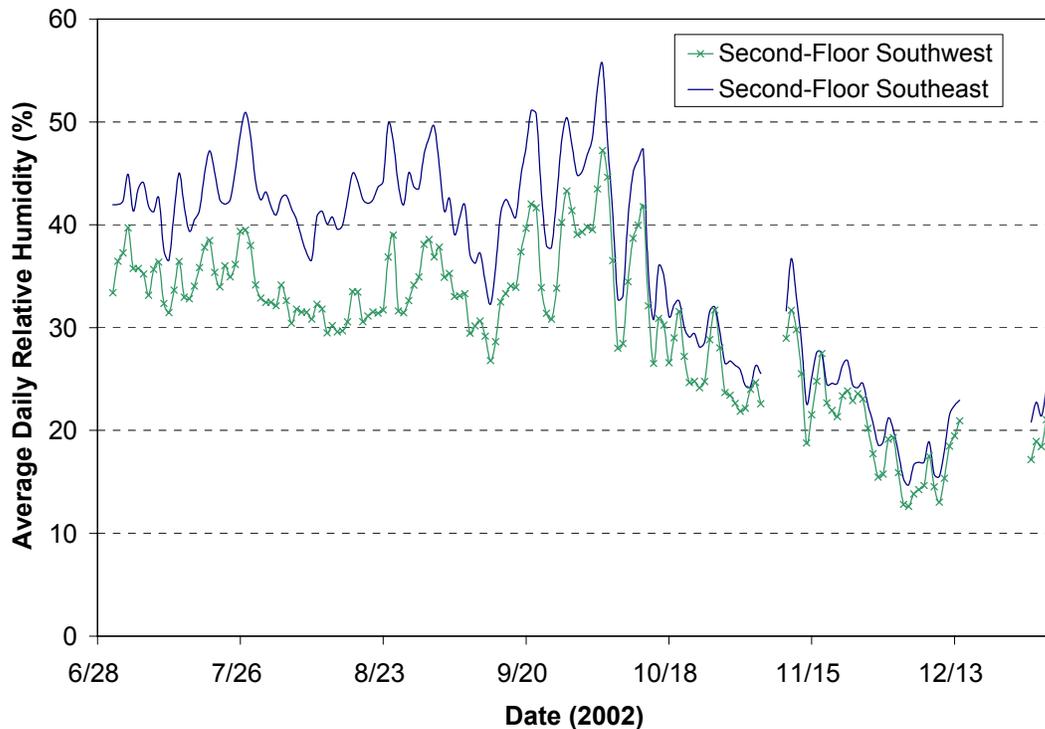
Figure 7-9 Average daily RH levels in the second-floor offices

Interior humidity also influences thermal comfort; however, the comfort range from ASHRAE Standard 55-2004 is quite broad. The upper limit is stated as a humidity ratio of 0.012, which is approximately 80% RH at 70°F (21°C) and 55% at 80°F (27°C). There is no lower limit, but experience has shown that people in humid climates expect a higher humidity level and may be dissatisfied below 20% RH. The average daily RH levels in the office spaces are shown in Figure 7-9 for July through December 2002. The summer RH levels for the southwest space are 30%–40%, which is low, but acceptable. The southeast summertime RH levels are consistently 40%–50%, which provides a comfortable environment. The RH levels from both sensors start dropping in October and reach levels below 20% in December. The cold winter air has a low moisture content, and when the air is warmed to the building temperature, it has a low RH. There have been some complaints in this building about the dry air in the winter. Reducing the amount of outside air introduced to the building in the winter would help keep the humidity levels higher.

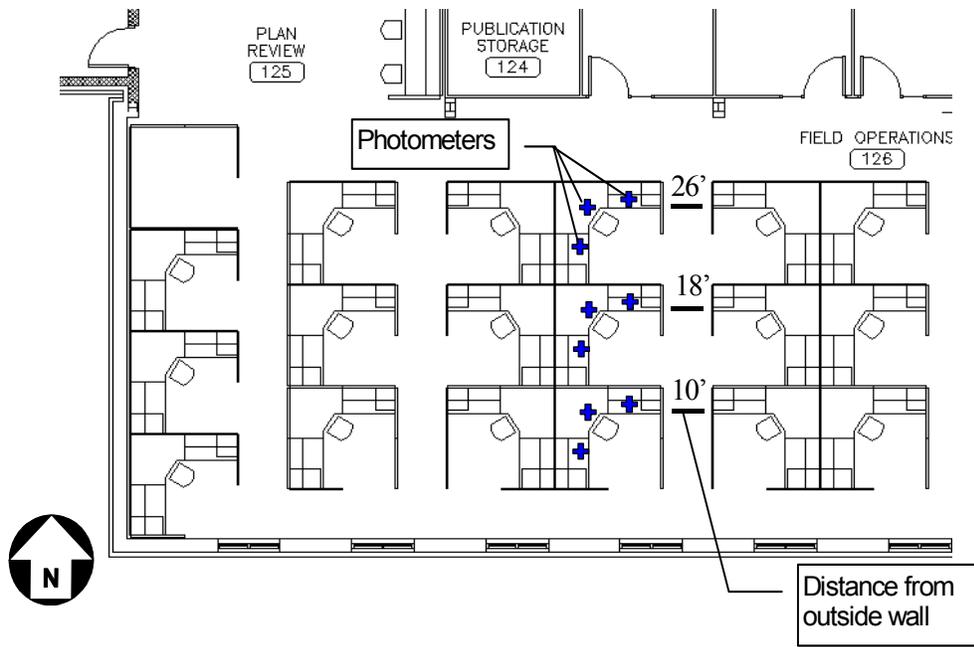
Figure 7-11 Photometer placement in the first-floor, southwest corner of the building

The indoor light levels were measured on the working surfaces in cubicles along a north-south cross section in the first-floor, southwest quadrant and the second-floor, southwest and northwest quadrants. On the first floor, three photometers were placed in each cubicle—one in front of the keyboard and one on the working surfaces on either side of the cubicle (see Figure 7-11). The three photometers in front of the keyboards were 10, 18, and 26 ft (3.0, 5.5, and 7.9 m) from the inside surface of the outside wall. On the second floor, two photometers were placed in each cubicle—one in front of the keyboard and one on the working surface to the left of the keyboard (see Figures 7-12 and 7-13). The photometers in front of the keyboards were again 10, 18, and 26 ft (3.0, 5.5, and 7.9 m) from the inside surface of the outside wall. Measurement of the illuminance from the electric lights only was taken between 9:00 p.m. and 10:00 p.m. on Friday, July 13. The recommended minimum illuminance level on a horizontal surface for open offices is 30 to 50 fc (300 to 500 lux), depending on the task (IESNA 2000). For general reading of handwriting with a pen or printed materials in 8–10 point font, the recommended minimum illuminance is 30 fc (300 lux). For reading lighter copies or smaller fonts, the recommended minimum illuminance is 50 fc (500 lux).

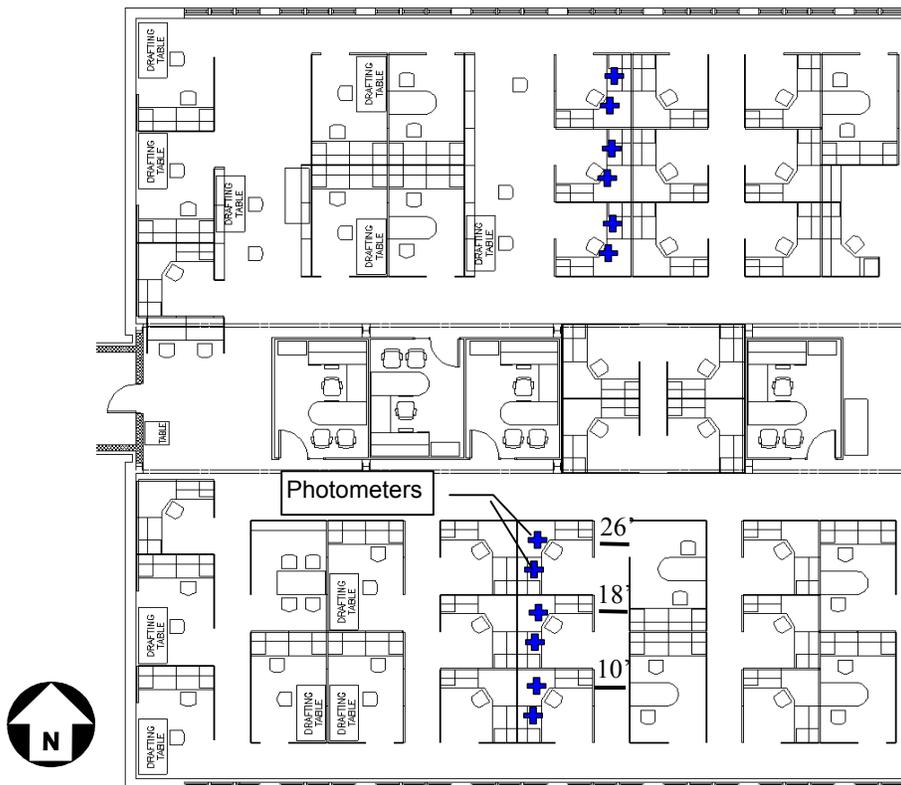
Figure 7-12 Photometer placement in the second-floor, west end of the building

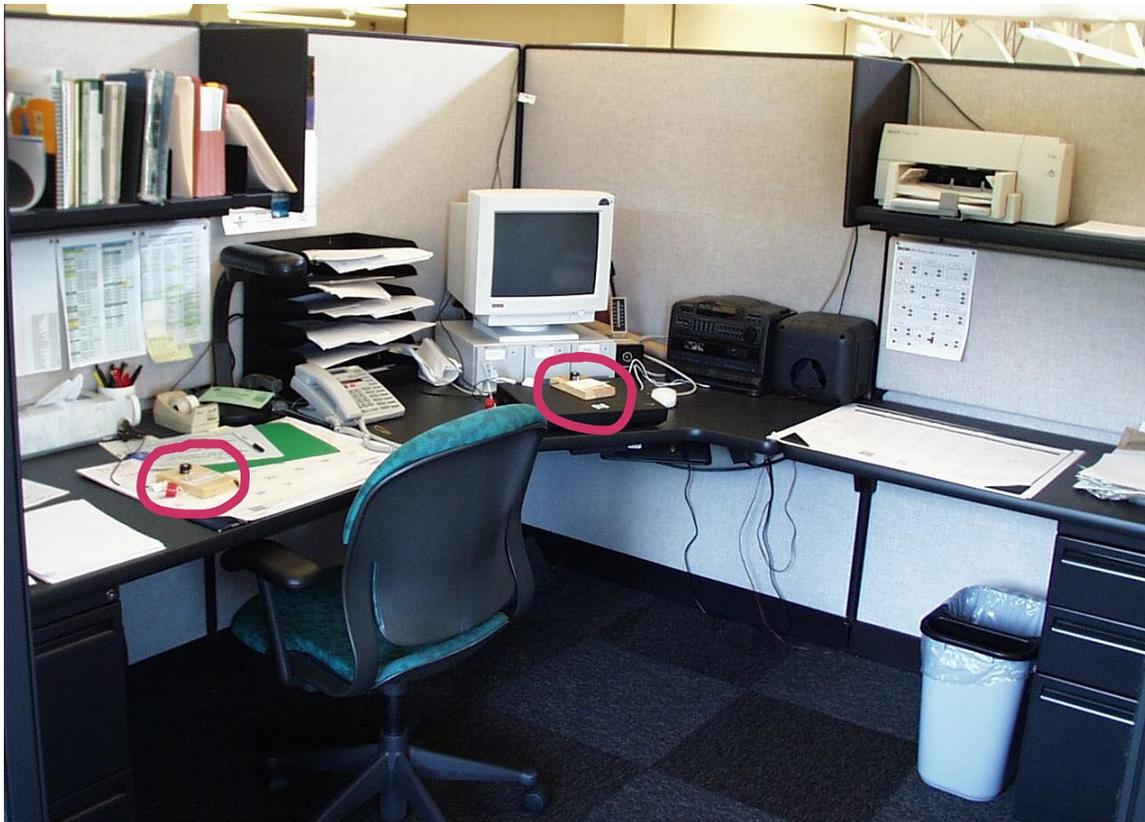
Figure 7-13 Placement of two photometers (shown circled) on the working plane of a cubicle

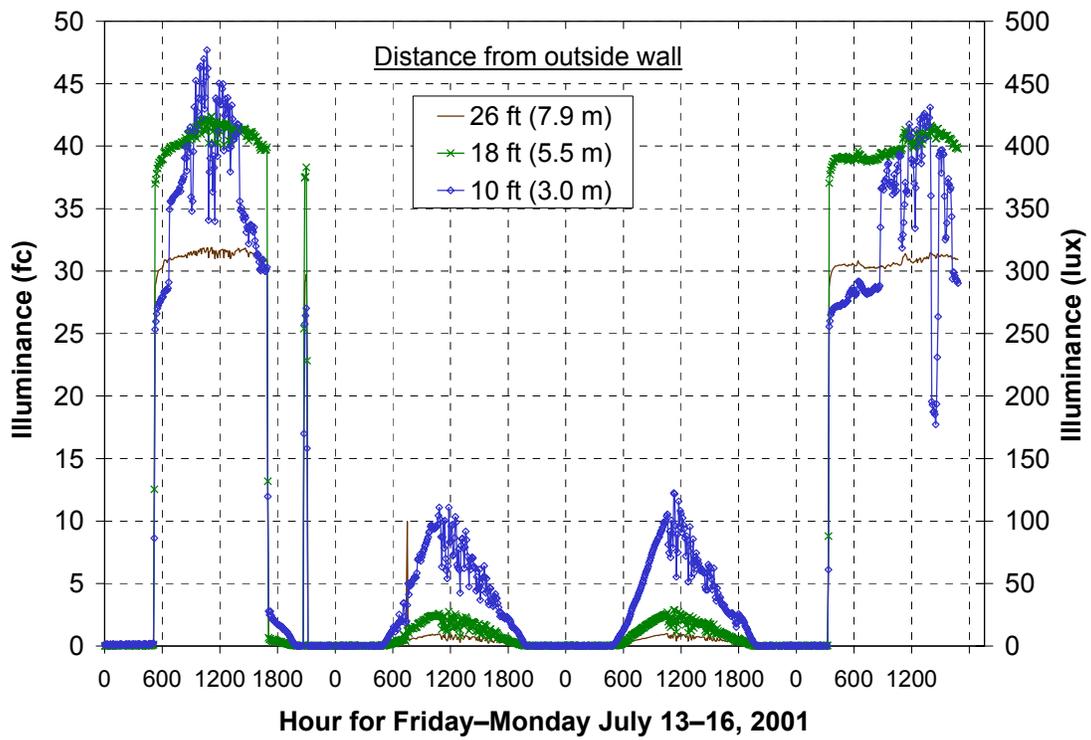
Figure 7-14 Illuminance measurements at workstations for the first-floor, southwest office area from July 13-16, 2001 (task lights used in cubicle 10 ft [3 m] from outside wall)

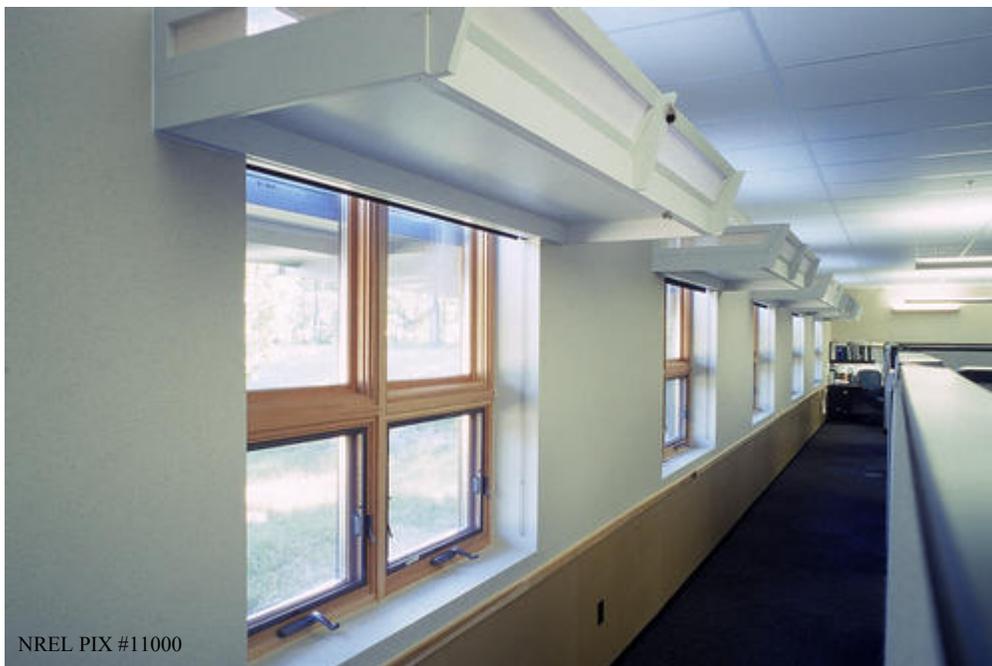
Figure 7-15 Lighting conditions on the first floor on June 7, 2001

Figure 7-15 shows the lighting conditions near midday on June 7, 2001, which had similar sky conditions to those during the illuminance measurements. The reflected light from the light shelves only penetrates approximately 3 ft (1 m) along the ceiling. The light shelves are not effective because of the small amount of glass area (the wide window frames block much of the light), low reflectance off the light shelves, and the high angle of the summer sun. There was no useful daylighting (i.e., dimming of electric lighting) in the first-floor office area during this testing period.

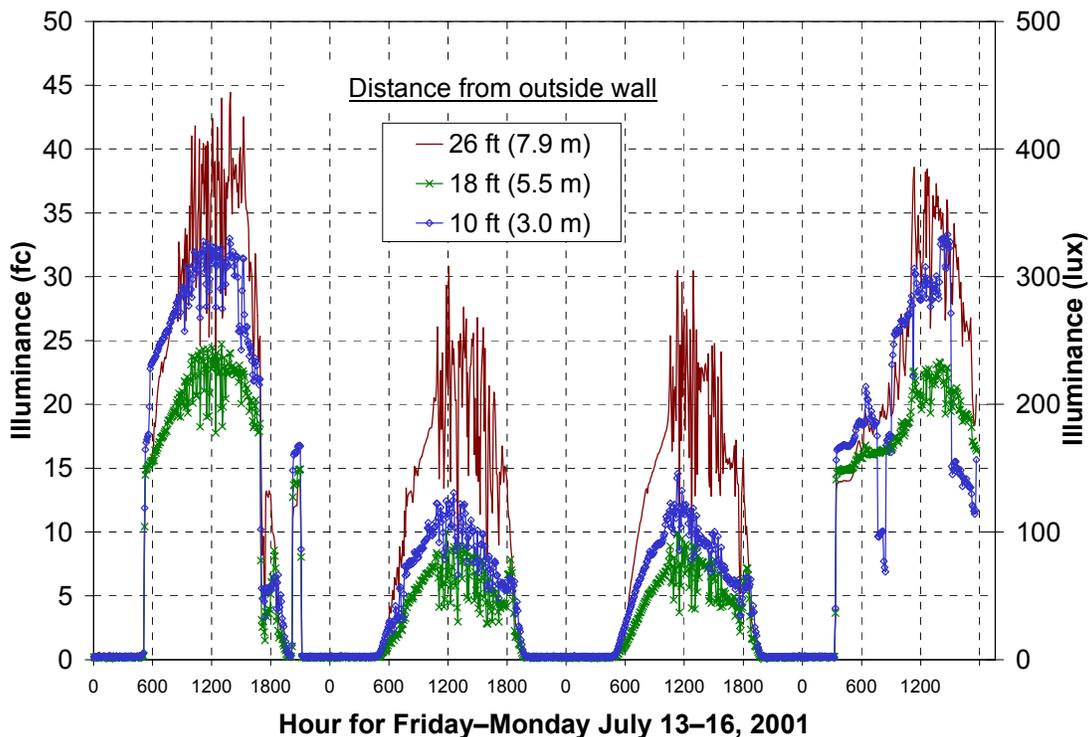
Figure 7-16 Illuminance measurements at workstations for the second-floor, southwest office area from July 13–16, 2001 (no task lighting)

Illuminance from the ambient electric lights was measured Friday evening between 9:00 p.m. and 10:00 p.m. Illuminance levels at the workstations with only the ambient electric lights were approximately 15 fc (150 lux). This is lower than the first floor because the indirect luminaires do not reflect well off the high ceiling with trusses. The combination of the ambient electric lights and daylighting provided 20–40 fc (200–400 lux) at midday. The natural light levels over the weekend were 10–25 fc (100–250 lux) on the working surfaces and 20–30 fc (200–300 lux) in the open circulation areas. The daylighting on the second floor is reduced because of the poor reflection off the high ceiling, blockage by the roof trusses, the dark floor, and the windows on the outside walls are too low to provide light beyond the first row of cubicles. In addition, the illuminance levels on the second floor would be improved with direct lighting luminaires.

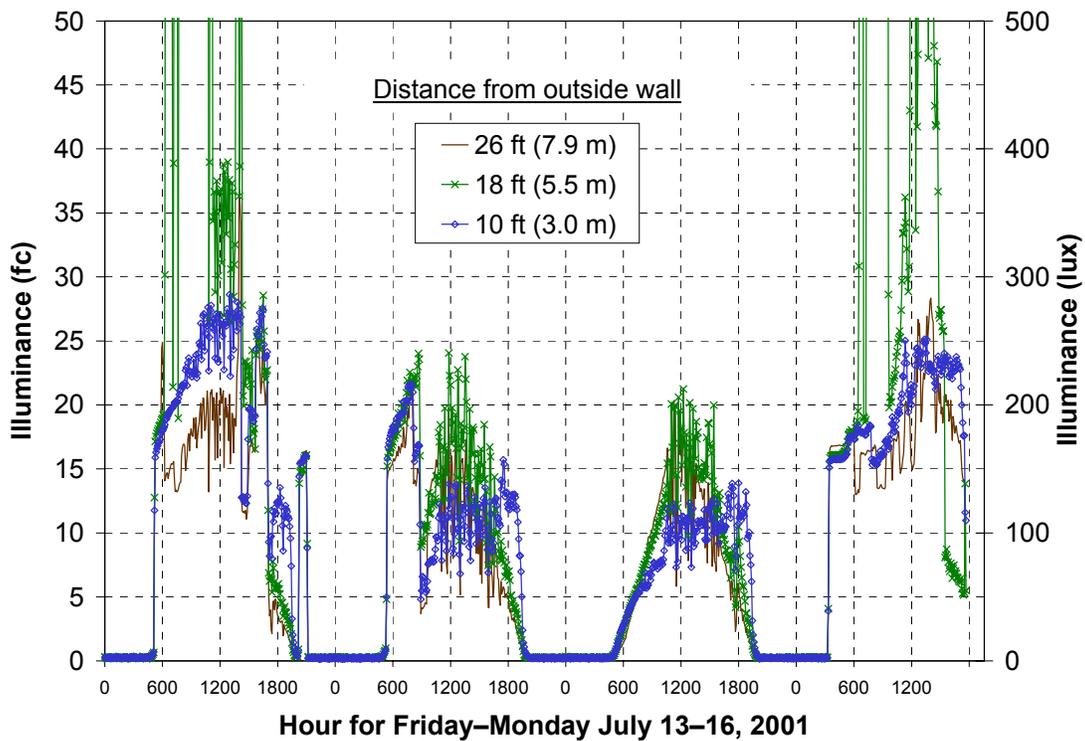
Figure 7-17 Daylighting measurements at workstations for the second-floor, northwest office area on July 13–16, 2001 (task lights used in cubicle 18 ft [5.5 m] from outside wall)

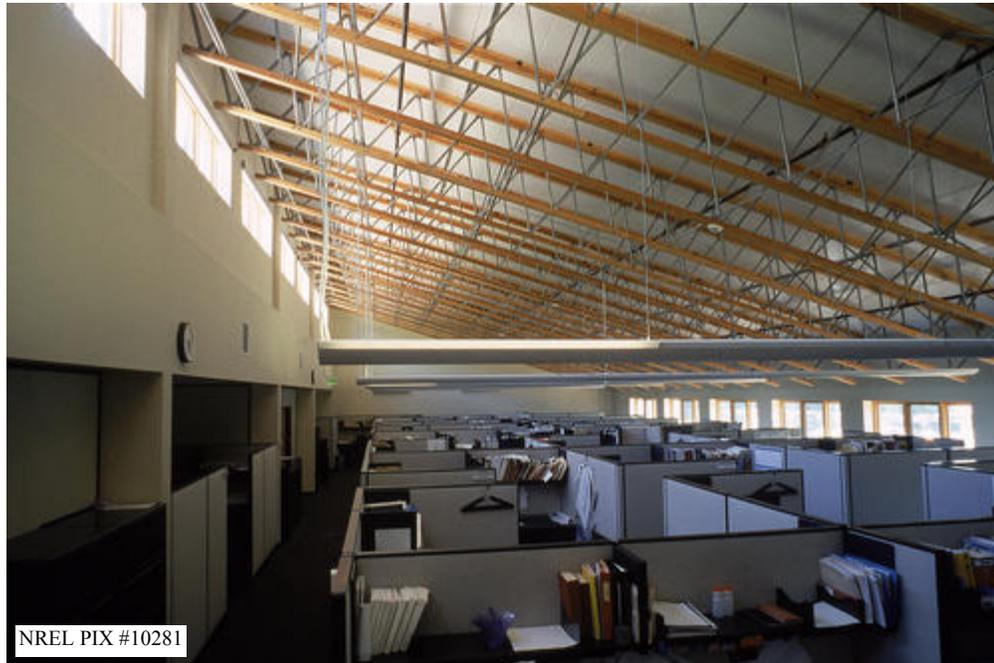
Figure 7-18 Lighting conditions in the second-floor, northwest office area on June 7, 2001, with the overhead electric lights on

Figure 7-18 shows the lighting conditions in the northwest office area near midday on June 7, 2001 with the ambient electric lights on. The light distribution is fairly even as expected from the illuminance measurements. The ceiling is bright near the clerestory windows and has a darker area in the middle. The south-facing clerestory windows can be the source of undesirable lighting conditions at times. At low sun angles, they can admit direct beam radiation, and they can be very bright at other times, causing contrast and glare problems. Automatic sunshades are installed on the interior of the windows to block the direct beam radiation. The sunshades are controlled by an exterior photosensor. The sunshades block an excessive amount of light and defeat the purpose of the clerestory windows. Other options for these windows are to diffuse the incoming light with frosted or patterned glass or a light-diffusing film on the glass or direct the beam radiation to the ceiling with a louver system. The drawback of these solutions is the view of the sky will be lost.

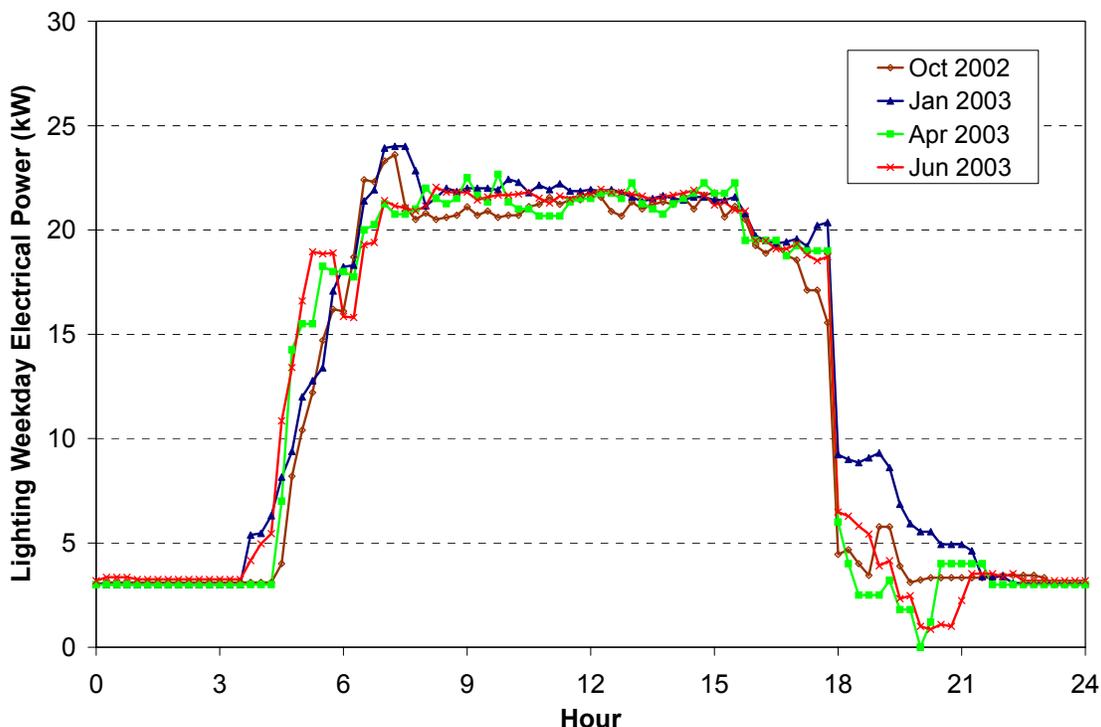
Figure 7-19 Daily interior lighting load profiles for weekdays

The interior lights are on from approximately 5:00 a.m. to 6:00 p.m. Most of the interior lights are controlled by timer circuits in the breaker boxes to turn on at 6:00 a.m. and turn off at 6:00 p.m. However, the cleaning crew comes in every morning around 5:00 a.m. and manually turns most of the lights on in the building. Between 2 kW and 4 kW of interior lights are manually controlled in enclosed offices and storage spaces. The slight drop in the power between 3:30 p.m. and 4:00 p.m. is when many of the occupants leave and some of the manually controlled lights are turned off. The variation in the early evening is due to the operation of the parking lot lights, which are used more in the winter and fall. The 3-kW nighttime load is from exterior lights on the building and exit signs in the building. The ambient lighting in the open office areas on the second floor is dimmable with the daylighting controls. Very little, if any, savings are realized by the daylighting controls. The weekend/holiday lighting load profiles are inconsistent from month to month. The weekend nighttime load profile is the same as the weekday load profile, but the weekend daytime load profile varies between 0 and 7 kW because of holidays that occur during the weekdays and occupants who occasionally work on weekends. The lighting controls have no provision for a holiday schedule; therefore, all the building lights turn on for holidays that fall on weekdays. An alternative option that has worked well in other buildings is a manual on switch with a timer controlled off for the normally unoccupied periods. The duration of the timer would be set by the person turning on the lights.

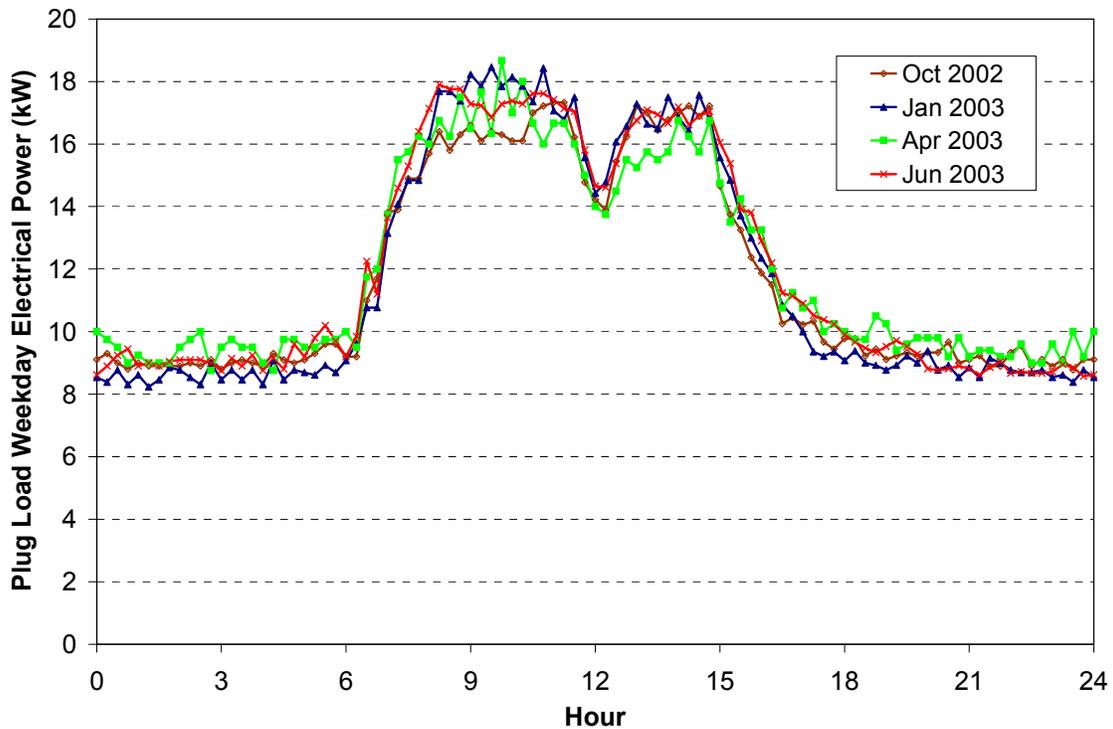
Figure 7-20 Daily plug load profiles for weekdays

The plug loads in the building consist mainly of computers, monitors, printers, task lights, and other office equipment. Daily load profiles for the plug loads are shown in Figure 7-20. The total load is very consistent and varies between 9 kW at night and on weekends to approximately 17 kW during the occupied hours.

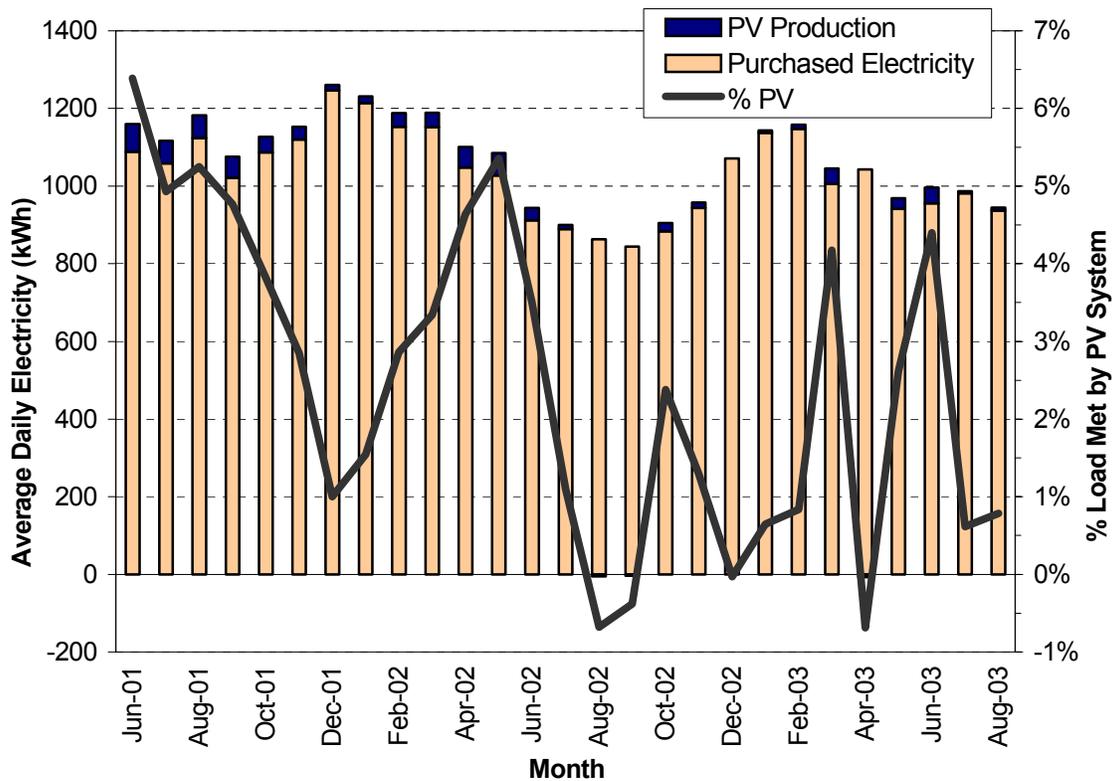
Figure 7-21 Average daily purchased energy and PV system performance for June 2001 to August 2003

The average daily purchased energy from the utility bills and the average daily energy from the large PV system are shown in Figure 7-21 for June 2001 to August 2003 and Figure 7-22 for January 2004 to December 2004. The main PV system was turned off in August 2003 due to inverter problems, and the inverter was replaced in late February 2004. The PV data for June 2001 through May 2002 are from the PV utility meter readings, and the remaining PV data are from the NREL installed monitoring system. The data from the PV utility meter represent the net PV energy production of the large PV system, that is, the PV energy produced minus the energy consumed by the isolation transformer when the PV system is down. The data from the NREL installed monitoring system are also the net energy and include the energy produced by the small PV system. The height of the columns is the total energy consumption of the building. The percent of the total building load met by the PV system is included as a line graph.

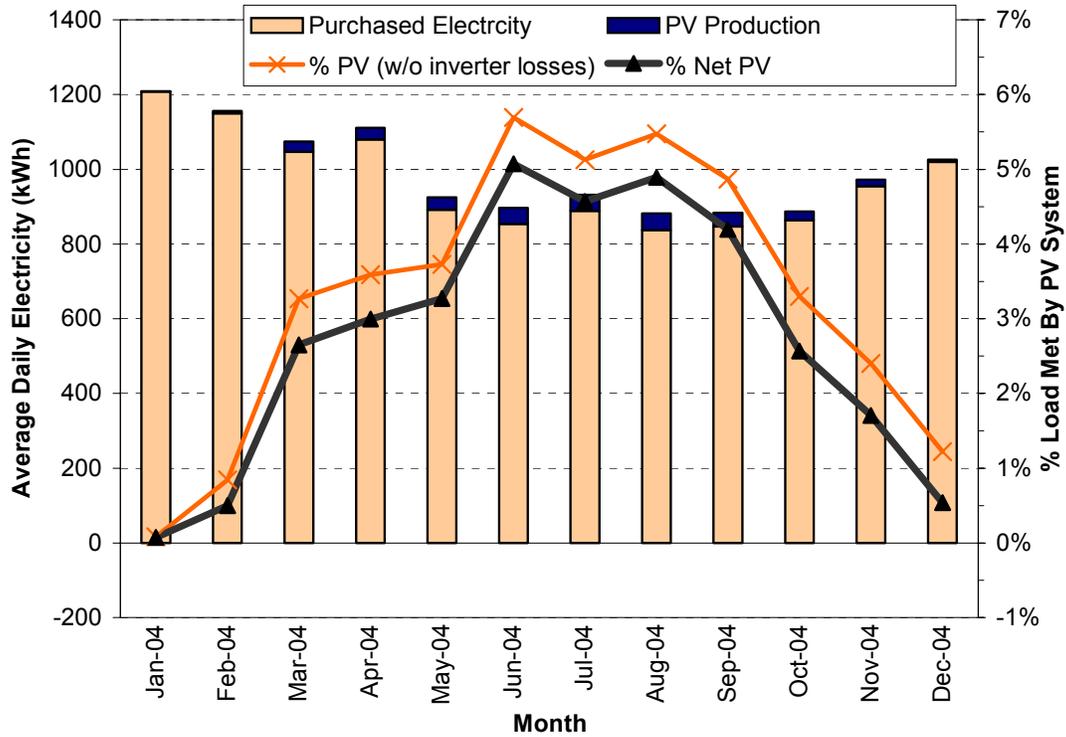
Figure 7-22 Average daily purchased energy and PV system performance for January 2004 to December 2004 (a new inverter was installed in late February)

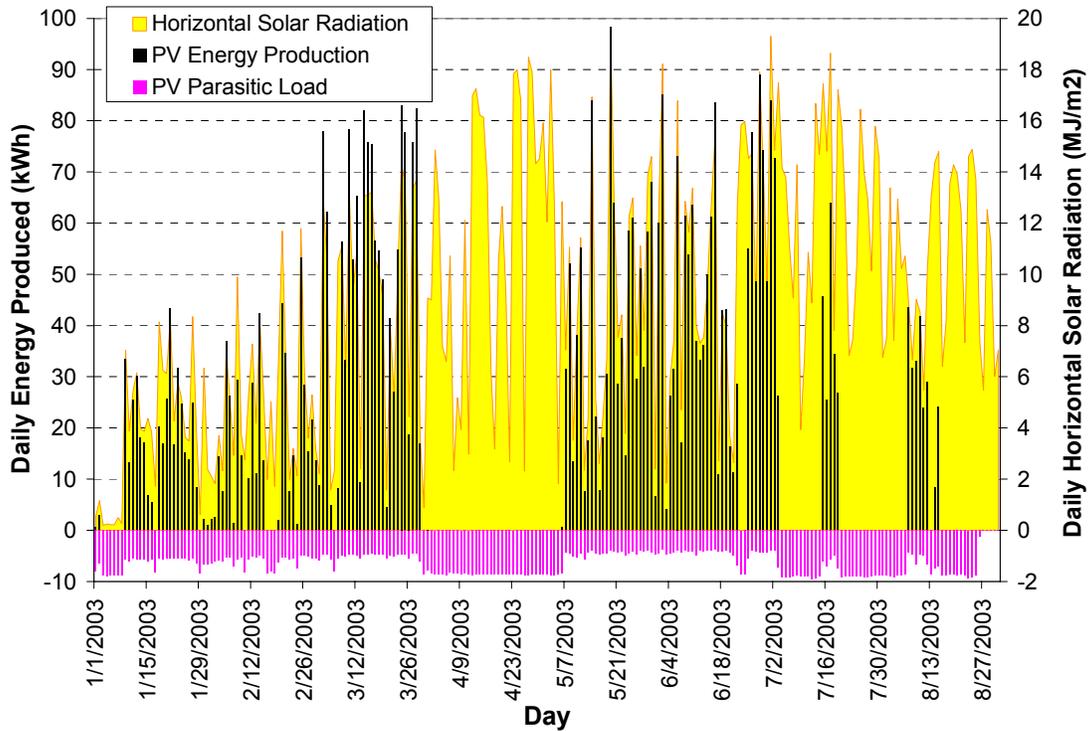
Figure 7-23 Daily PV system energy production, parasitic load, and horizontal solar radiation

Figure 7-23 shows the daily energy production and parasitic load for the main PV system for 2003. The daily global horizontal solar radiation is also shown as an area graph. The main PV system was shut down several times because of inverter faults and was finally disconnected from the grid on August 26, 2003. The causes of the faults were a high AC voltage and high temperature. The high temperature fault was the most severe because the system would have to be manually reset. The inverter was removed and sent to the manufacturer in December 2003 and replaced with a new unit in February 2004.

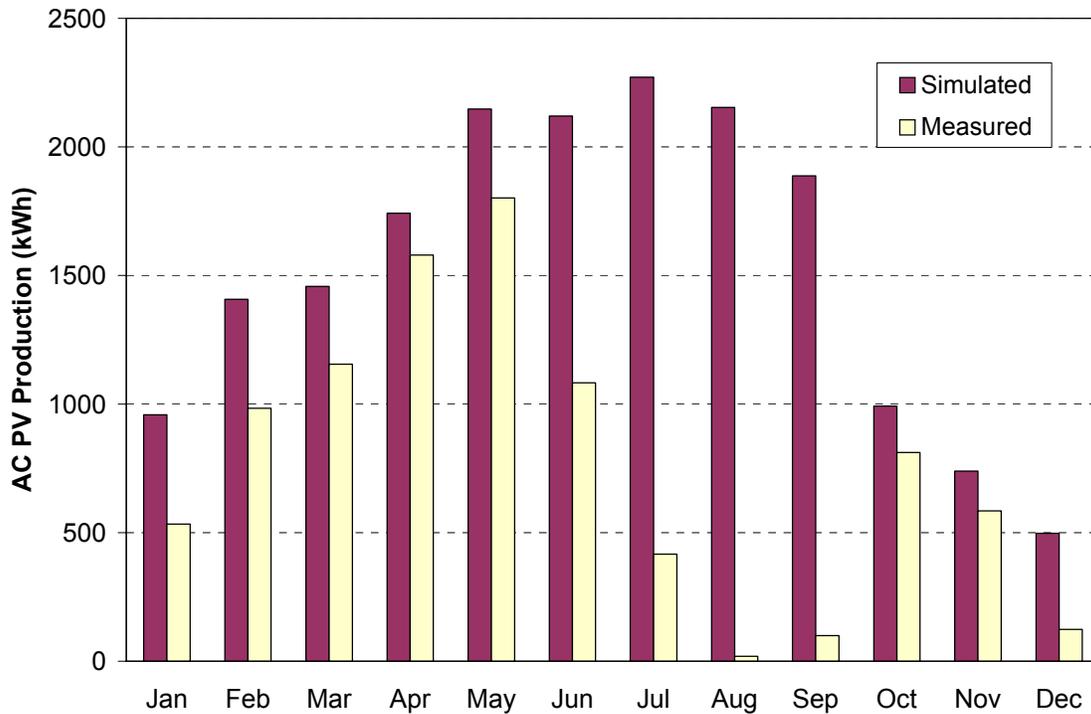
Figure 7-24 Simulated and measured PV performance for 2002

A simulation using PVSYS v3.2 (Mermoud 1996) was conducted to estimate the performance of the large PV system. The simulation was completed for 2002 using a weather file constructed from weather data measured on site. Figure 7-24 shows the net energy production from the simulation and the measured data.
