Operating Experience and Teardown Analysis for Engines Operated on Biodiesel Blends (B20)

ABSTRACT

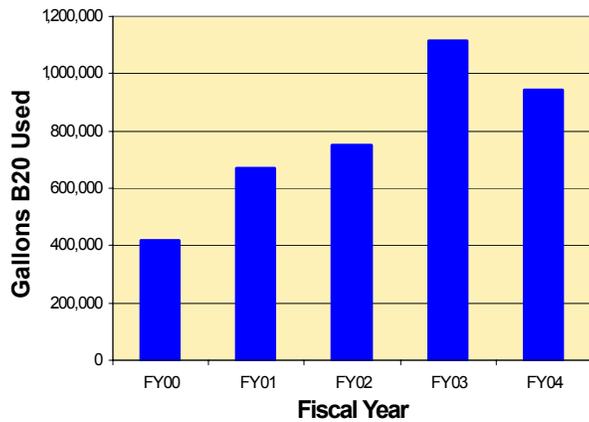
Figure 1. Fiscal Year 2000–2004 USPS B20 Consumption

The USPS is one of the first federal agencies to use B20. B20 use was initiated about 5 years ago in Manhattan, New York; Detroit, Michigan; St. Louis, Missouri; and Miami, Florida. In some locations, the fuel supply comes from a mobile refueler. The mobile refueler eliminates the need to own and maintain fuel tanks. Biodiesel and biodiesel blends have been known to promote microbial growth in fuel storage tanks under certain conditions. In 2004, 929 USPS cargo vans, truck tractors, spotter tractors, and step vans were using B20. B20 consumption during 2000–2004 is shown in Figure 1 [10]. B20 consumption declined in 2004 because of a fuel filter-plugging problem at the Miami location.

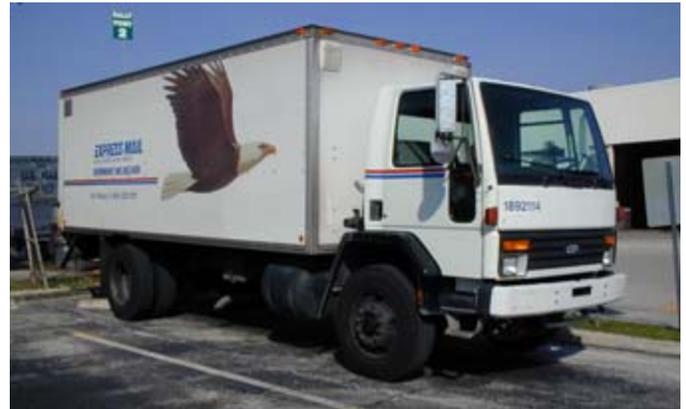
Figure 2. 1993 Ford 9-Ton Cargo Van

The Ford cargo van is used to transport large volumes of mail from mailers' plants and P&DCs to post offices and airmail facilities. The candidate Ford vans were near the end of their useful life. The Mack tractors were nearing a scheduled engine rebuild.

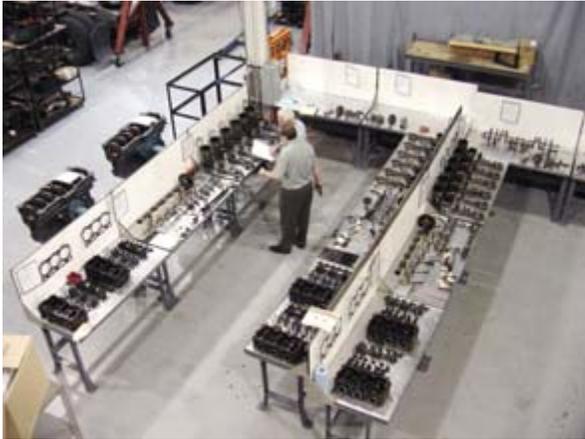
Figure 4. Teardown Inspection at Roush

Roush Industries performed engine removal, disassembly, inspection, evaluation, and rebuild (Figure 4). The Bosch fuel injection pumps were tested, disassembled, inspected, and rebuilt by a fuel systems facility (Superior Turbo & Injection, Detroit, Michigan), which was approved and recommended by Robert Bosch North America. Internal parts were compared for wear, breakage, or other damage as well as the accumulation of dirt, sludge, and carbon deposits in an effort to uncover effects attributable to the type of fuel used. The essential results of the evaluation are

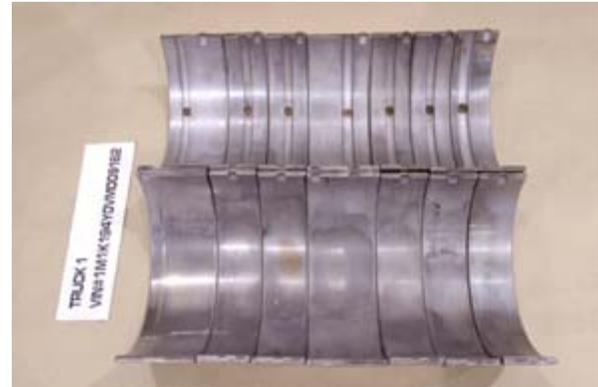
Figure 5. Mack No. 1 B20 Main Bearing Wear

In examining the cylinder block, crankcase, and lubrication system of the Mack tractors, no significant differences were found between the B20 and diesel engines. The main bearings exhibited wear that was normal for the accumulated mileage. The No.1 and 2 B20 engines showed bearing wear into the copper linings (Figure 5), and the No. 3 and 4 diesel engines showed typical “hen-tracking” and “orange peel” (Figure 6). The crankpin bearings also exhibited normal wear, with wear into the copper lining on the upper inserts, except for the No. 4 diesel engine, which had lower accumulated mileage.

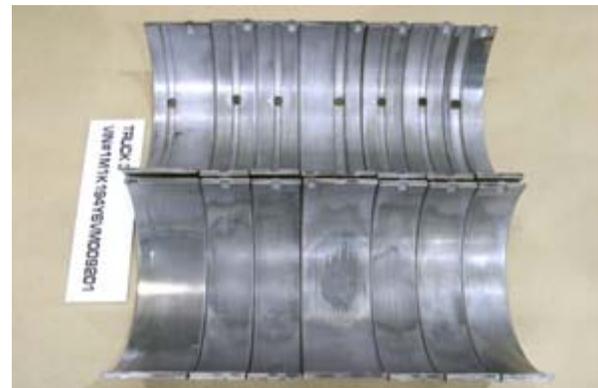
Figure 6. Mack No. 3 Diesel Main Bearing Wear

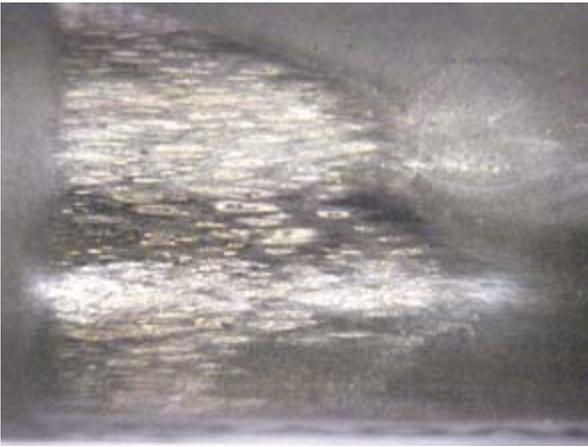
Figure 7. Mack No. 1 B20 Oil Pump Pressure Relief Valve Piston Wear

Minor differences were seen in the oil pump pressure relief valve pistons. The relief valve pistons in the No. 1 and 2 B20 engines showed scuffing and were not suitable for reuse (Figure 7). The No. 3 and 4 diesel relief valve pistons had only minor blemishes and could be reused (Figure 8). These minor differences may be attributable to differences in oil filters (B20 engines used reusable cartridges, diesel engines used a disposable spin-on type), but the observed wear was not unusual for the accumulated mileage.

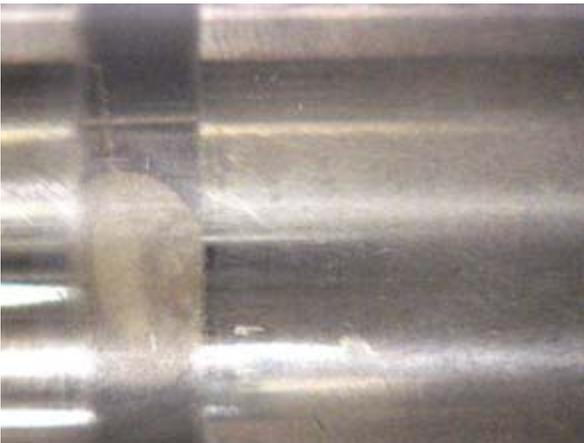
Figure 8. Mack No. 3 Diesel Oil Pump Pressure Relief Valve Piston Wear

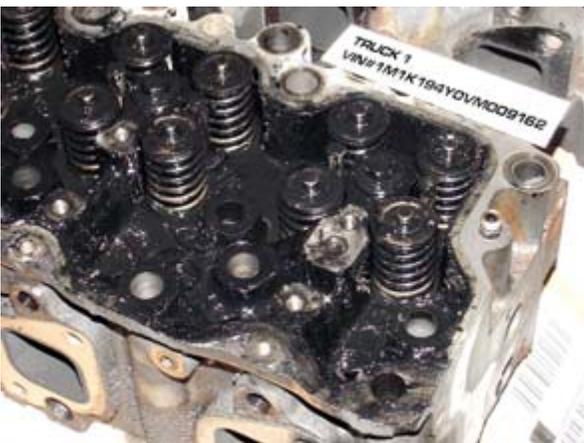
Upon inspection, no differences were seen in the pistons, intake, and exhaust valves. All components exhibited similar and expected amounts of carbon buildup on the combustion sides. However, the cylinder heads of the No. 1 and 2 B20 engines contained a heavy amount of sludge on the valve deck around the rocker assemblies (Figure 9).

Figure 9. Mack No. 1 B20 Valve Deck Sludge Accumulation

Thus, the current hypothesis for the formation of the valve deck sludge is exposure of the engine to one or more off-specification batches of biodiesel blend containing high levels of sodium. Sodium soaps have a high boiling point and would concentrate in the engine oil. Because of the polyunsaturated nature of many of

the fatty acid chains present in the biodiesel, soap (and possibly biodiesel) in the oil could undergo oxidative polymerization leading to deposits that clog oil drain passages. If this occurred in the valve deck area, engine oil would have a long residence time. This would lead to higher levels of decomposition and deposition of the detergent and anti-wear additives, consistent with the concentration of calcium, zinc, and phosphorus in the sludge. The FTIR carbonyl signature for biodiesel is not observed in the sludge either because the ester functionality decomposed in this relatively high-temperature environment or because the sample work-up procedures applied to obtain an FTIR spectrum removed the biodiesel-containing components.

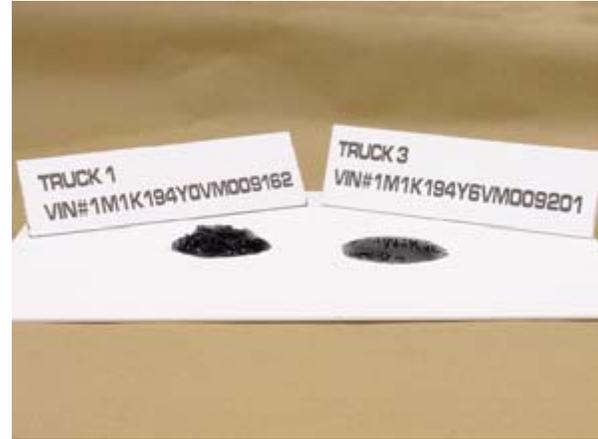
The valve deck sludge was thick and gel-like compared with the oily residue found in the diesel engine heads. Figure 10 illustrates the difference between the substances found. The B20 sludge formed a pile on the sample card, whereas the diesel just left a stain. Looking closer at the differences between the sludge found in the No. 1 B20 engine head and the No. 2 B20 engine head, No. 2 had less accumulation and lighter consistency sludge with none found on the rocker assemblies. Maintenance records showed that the No. 2 B20 engine's injectors were replaced right after B20 use stopped (November 2003). The rocker assemblies likely were cleaned as part of the injector replacement and effort made to clean the cylinder head at that time.

Figure 10. Cylinder Head Sludge Comparison (Mack No. 1 B20 vs. Mack No 3. Diesel)

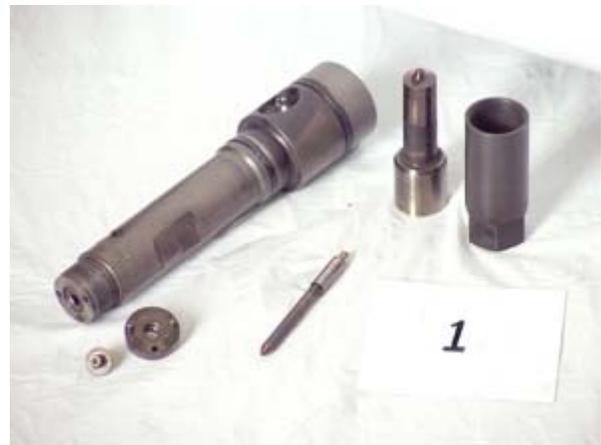
All the fuel injector nozzle assemblies were removed, bench tested for leak-down rates, and then disassembled. The injector nozzles from No. 1 B20 were not within specified leak-down limits and required replacement (Figure 11). The No. 3 and 4 injector nozzles tested at the low end of the limits but could be reused. The No. 2 B20 injectors tested well within limits, confirming maintenance records of recent injector replacement. In comparing fuel injector nozzle replacements from the beginning of the data period (August 2000) until the time teardown was completed,

Figure 11. Mack No. 1 B20 Worn Fuel Injector Nozzle Disassembled

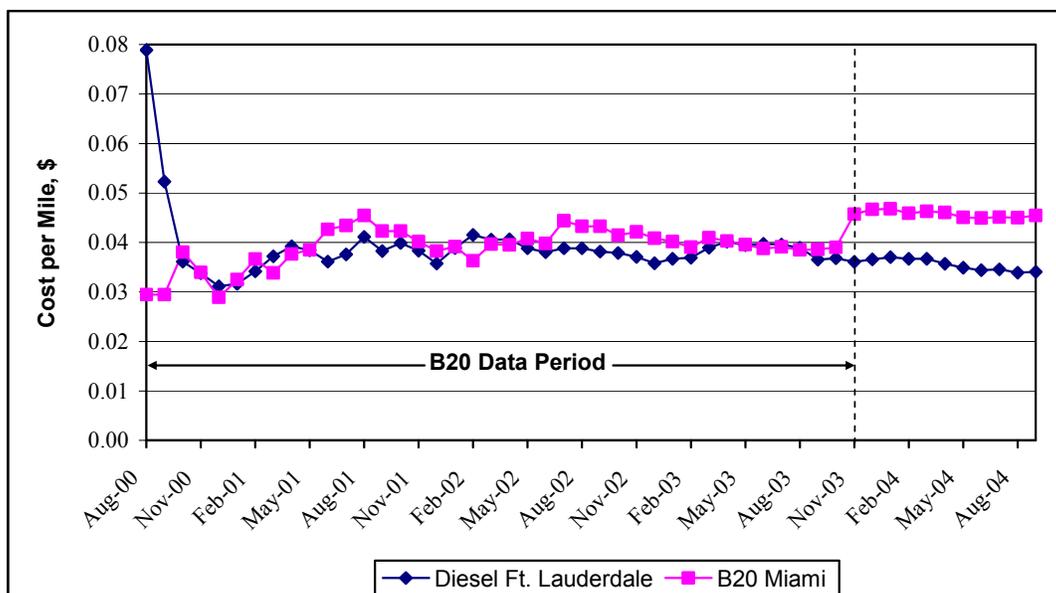
Figure 12 shows engine- and fuel-related maintenance costs per vehicle mile for the two study groups of Mack tractors. These data points are a cumulative running average of the engine and fuel system costs per mile of operation. B20 use ended in November 2003. For most of the B20 data period the two groups of vehicles had essentially identical maintenance costs. However, in November 2003, the No. 2 B20 tractor had the complete set of six injectors and fuel pump replaced because of operational problems. This single event caused the cumulative average cost of maintaining the two B20 Mack tractors to increase by \$0.01/mile or 28%. This is reflected in Figure 12 as a step change occurring in November 2003.

Figure 12. Cumulative Running Average Engine- and Fuel-Related Maintenance Costs per Mile for the Mack Tractors. Costs for the two groups of vehicles were the same for most of the study; however, an overall \$0.01/mile or 28% higher cost to maintain the B20 vehicles is attributed to a single event in Nov. 2003.

Prior to the November 2003 event, Mack No. 2 B20 had significant unscheduled or roadcall repairs for the fuel system. In August 2001, the fuel tank on No. 2 B20 was cleaned out to remove “sludge.” However, it should be noted that Mack No. 1 B20 did not have significant unscheduled or roadcall repairs for the fuel system or a “won’t start” condition. While the injector and fuel pump replacement for vehicle No. 2 may be attributed to fuel quality issues, because no similar problems were exhibited by vehicle No. 1, the results are not conclusive.

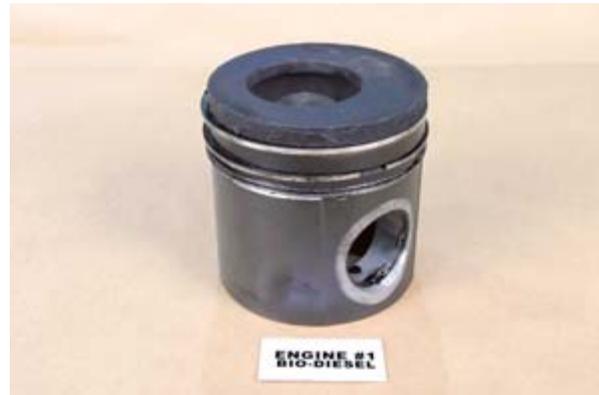
In examining the cylinder heads, combustion chambers, and fuel systems, no significant differences were noted in the teardown of the Fords. The cylinder head cavities of all four engines were clean with only a normal oily residue found in each. The pistons in all of the engines were in good condition with some carbon buildup in the bowl area and above the ring lands (Figure 13). The intake and exhaust valves were clean with light carbon deposits on the sealing surfaces and normal buildup on the valve heads.

Figure 13. Ford No. 1 B20 Piston Carbon Deposits

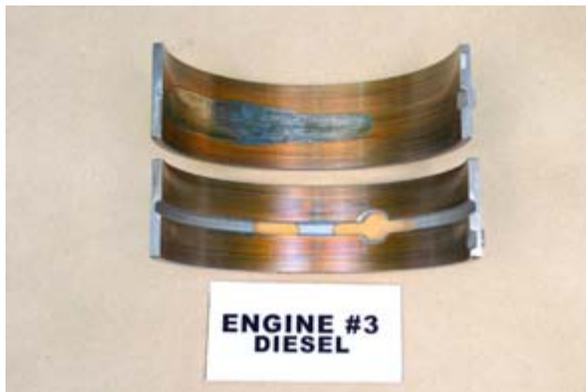
Bearings on the No. 3 diesel engine exhibited heavy to severe wear. Main and connecting rod bearings show wear into the copper linings with severe wear at the fourth main journal position, resulting in complete bearing failure (Figure 14).

Figure 14. Ford No. 3 Diesel Main Bearing Failure

The lower bearing insert is worn through the copper lining, scoring the crankshaft at the fourth journal position. Severe wear and damage exhibited in the No. 3 diesel engine indicates a lack of lubrication. Maintenance records show that this Ford van had problems that may have indicated or contributed to the lubrication problem; however, there is no conclusive evidence as to the cause of the lack of lubrication.

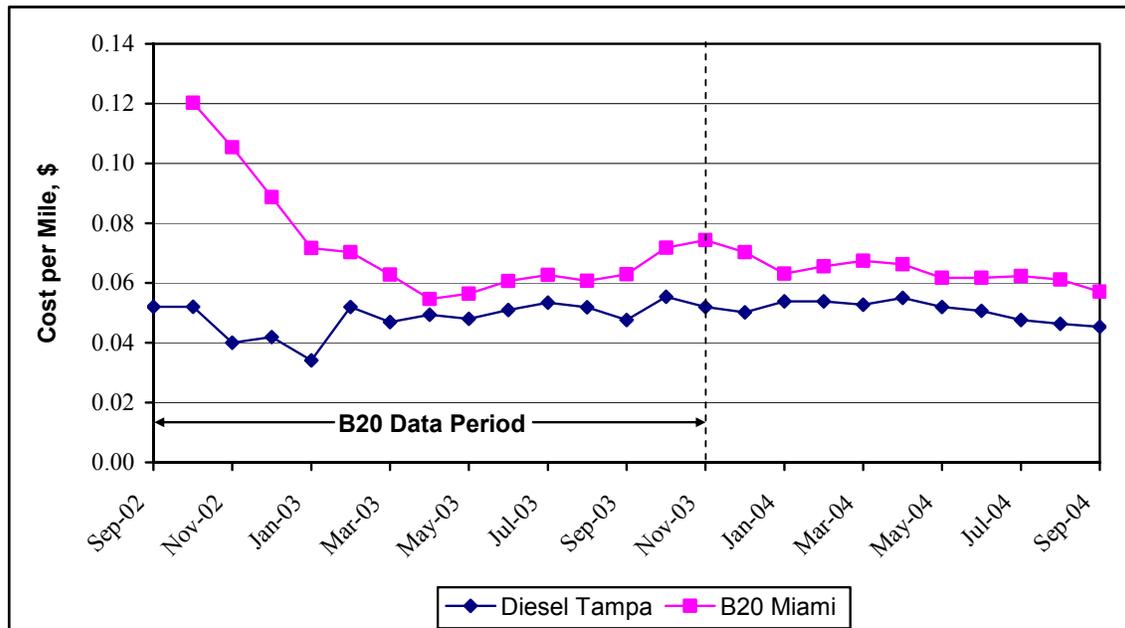
Figure 15 shows cumulative engine- and fuel-related maintenance costs for the two study groups of Ford vans. B20 use ended in November 2003. Generally, the B20 Ford vans at the Miami VMF had slightly higher (14% higher) maintenance costs for the engine- and fuel-related systems than the diesel-only Ford vans at the Tampa VMF. Both of the Ford van study groups had a significant number of maintenance actions for the accelerator pedal and throttle problems that caused significant cost. The Miami B20 vans had more costs associated with this problem, and this accounted for most of the cost difference between the two study groups. This problem does not appear to be related to the use of B20. With the additional accelerator costs removed from the Miami B20 vans, the engine and fuel system maintenance costs are nearly identical to those of the Tampa diesel vans.

Figure 15. Cumulative Running Average Engine- and Fuel-Related Maintenance Costs per Mile for the Ford Vans. Higher costs to maintain the B20 vehicles are probably not attributable to the fuel, as discussed in the text.
