Structural Testing of 9 m Carbon Fiber Wind Turbine Research Blades

Conference Paper
NREL/CP-500-40985
January 2007

Structural Testing of 9 m Carbon Fiber Wind Turbine Research Blades*

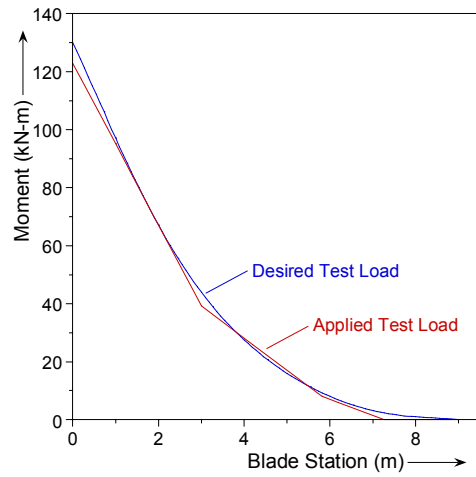
Figure 7: CX-100 test loading distribution.

The blades were loaded and unloaded in increasing 25% increments up to the 100% test load as shown schematically in Figure 6. At each load step, the load was held for approximately 60 s. The 100% test load was calculated by multiplying the design load distribution for each blade by 1.10 to account for test-to-test variability. The resulting distribution was then approximated with a piece-wise linear fit achieved by point loads applied at the three saddle locations. The desired and applied test moment distributions for the CX-100, TX-100 and BSDS blade tests are shown in Figure 7, Figure 8, and Figure 9

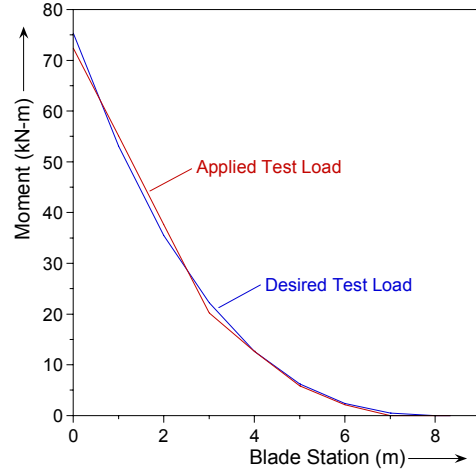
Figure 9: BSDS test loading distribution.

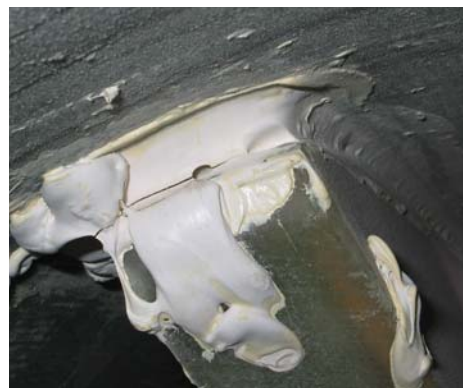
Figure 25: Crack at shear web termination on the LP surface of the BSDS blade.

During the BSDS test, the only high-energy events were located around 0.350 m, which is the station where the shear web terminates on the root end. A closer examination of this area after the test showed that a large crack had developed between the low-pressure skin and the shear web in the bonding joint. A photograph of the crack is shown in Figure 25.
