Wind Turbine Generator System Duration Test Report for the Mariah Windspire Wind Turbine

Technical Report
NREL/TP-500-47072
May 2010

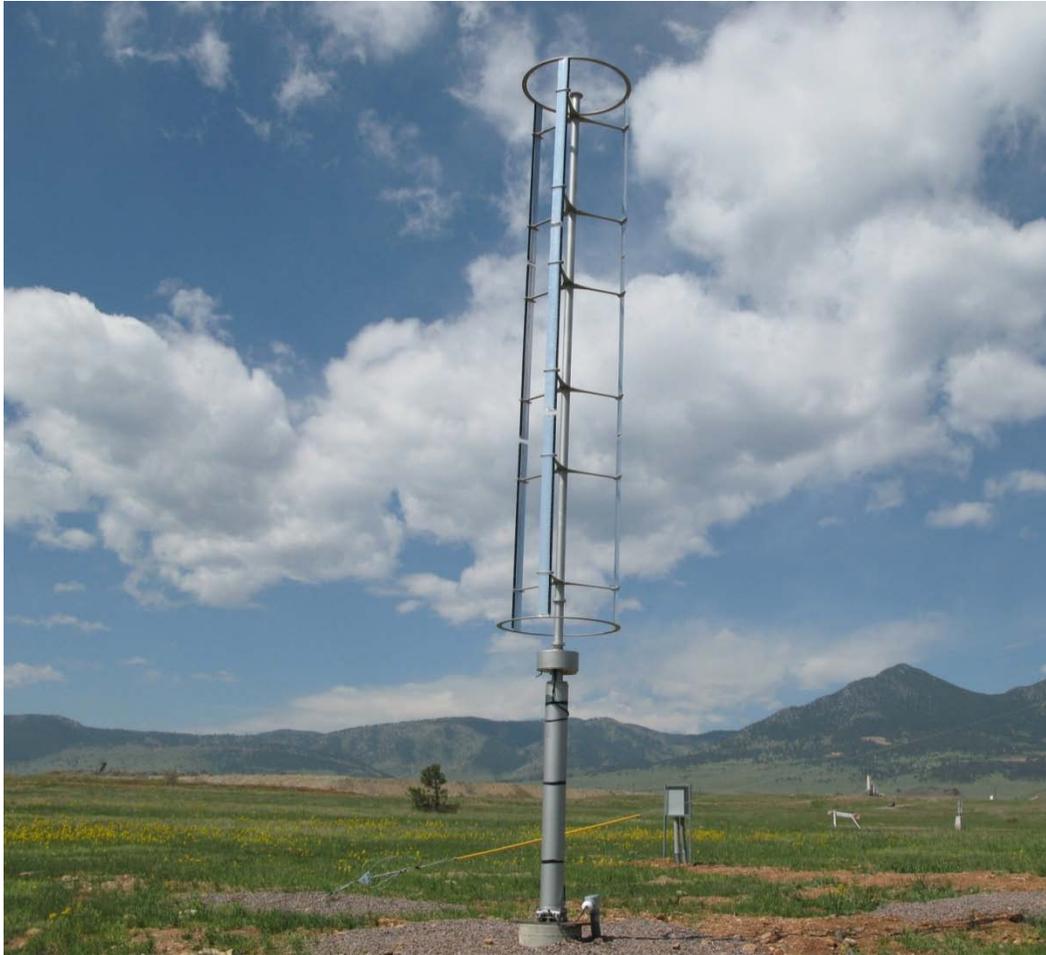
Figure 1. The Mariah Power Windspire wind turbine installed at the NWTC

The Windspire is a three-bladed vertical axis wind turbine rated at 1 kW output at 11 m/s. The Windspire supplies single-phase, 120 VAC power to the grid through a permanent magnet generator and inverter. The turbine's airfoils are aluminum. Table 1 lists basic turbine configuration and operational data.

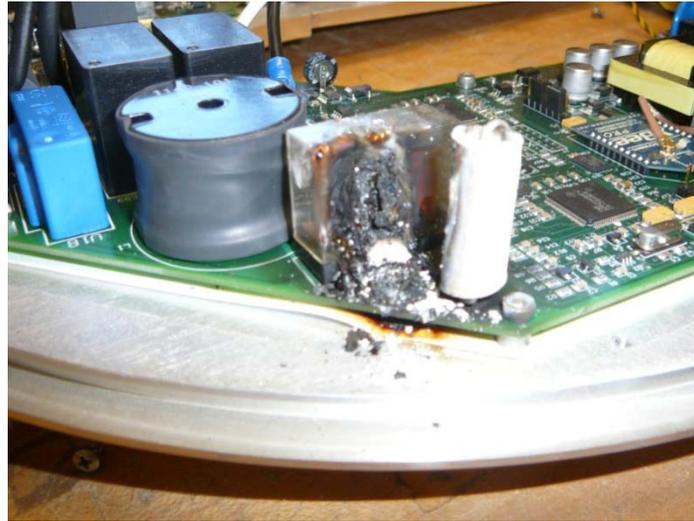
Figure 5. Damaged electrical components in the inverter

On September 13, 2008, the turbine experienced an inverter failure. This likely occurred because the parameters in the inverter were set to optimize power performance. This may have led to overheating of the electrical components and eventual failure, see Figure 5. The turbine was subsequently inoperable until October 7, 2008 when the inverter was replaced. The parameters in this inverter were set for normal power production. Since an inverter failure is considered a major failure by the Standard, the duration test was restarted on October 7, 2008.

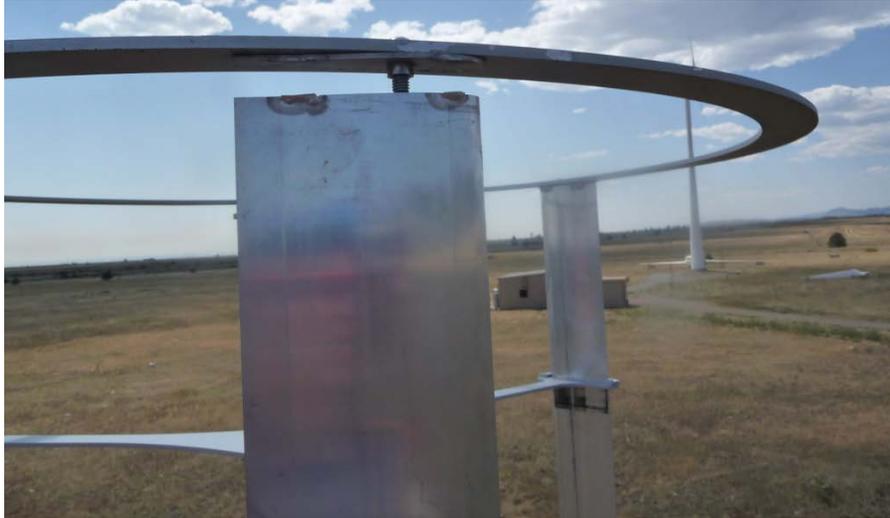
Figure 8. Separated weld between airfoil and cap

On July 20, 2008, NREL discovered cracks in some of the spot welds that held the airfoils to their end caps. On one airfoil, the cracks had completely separated the airfoil from the end cap, see Figure 8. On a different airfoil, there were cracks observed in the welding but separation had not taken place. It was also noted that the airfoils had moved in the struts that are meant to hold them in place. This is a possible cause for the broken welds, see Figure 9. Mariah Power replaced the airfoils and struts on August 7, 2008. The new airfoils were welded to the end caps with a continuous weld instead of spot welds. Additionally, the struts were redesigned to prevent slipping.

8/7/08	The manufacturer was on-site to replace the airfoils and struts. This is a change that will be required for all production machines. The tower base bolts were replaced with bolts with set screws to keep bolts from loosening. The weld was improved to a continuous weld.
8/18/08	The magnetic bearing was replaced. The initial magnetic bearing did not have a dust cover and was susceptible to iron dust getting into the magnetic air gap, which can stop operation of the turbine.
9/13/08	The inverter failure occurred because the set points of the inverter were set to optimize power performance. The increased performance caused the temperature to rise, and over time, caused the inverter to fail.
10/7/08	The inverter was replaced. The set points were set for normal production. The power performance test was stopped because the inverter failed. The test was not completed because the wind speed range requirement was not fulfilled/met. A new power performance test was started after the inverter was replaced.
