A New Method to Characterize Degradation of First Surface Aluminum Reflectors

Preprint

Conference Paper

NREL/CP-5500-49164

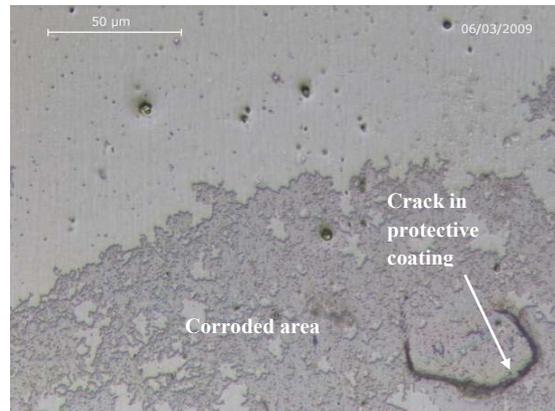
Fig. 7b. Filiform corrosion and crack viewed in the light microscope

Small corrosion spots were observed by visual or microscopic inspection on all samples exposed at every outdoor site. The corrosion starts at coating defects such as micro-cracks, coating break outs or pinholes (Fig. 7a and 7b).
