Strategy Guideline: Quality Management in Existing Homes

Cantilever Floor Example

J. Taggart, J. Sikora, J. Wiehagen, and
A. Wood
NAHB Research Center

December 2011

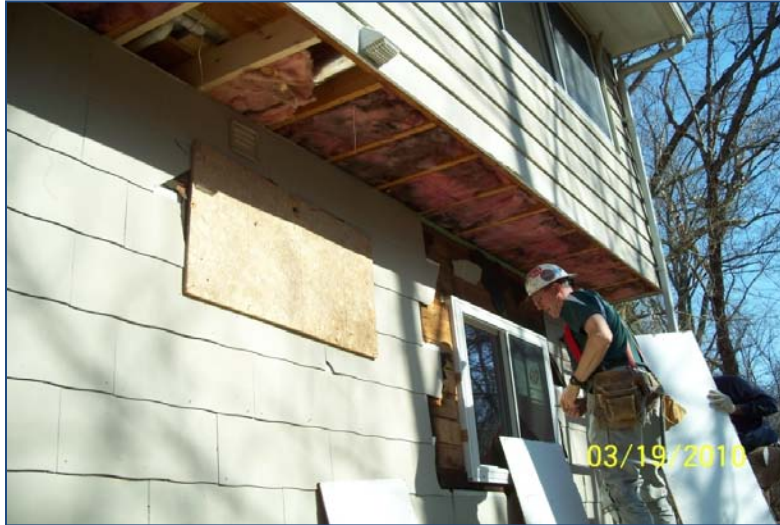
Figure 3. Typical cantilevered floor area depicting issues leading to performance problems

The cantilevered floor area was insulated with fiberglass batts and covered on the underside with soffit material that is perforated and permeable—therefore, not airtight. In addition, the existing design lacks an external air barrier (e.g., sheathing) and permits the relatively free flow of air into the cantilevered space and ultimately directly into the house. There is a direct path for air to infiltrate the home through the vented soffit over the interior wall as shown in Figure 3. The air leakage path through the cantilevered floor area is clearly evident by the dirty spots seen throughout the insulation in Figure 3. The air leakage through a typical cantilevered floor also leads to uneven room temperatures, increased energy bills, and potential condensation issues that can lead to deterioration within the cantilevered space.

Holes cut in the subfloor to accommodate plumbing drains also permit the flow of air between the cantilevered area and the interior, increasing air infiltration to the interior and creating cold floors that can lead to condensation as shown in Figure 3. In addition, an exhaust vent runs through the space nearly adjacent to the exterior and, therefore, is barely insulated. During cold weather, the warm moist air running through this exhaust vent condenses in the vent duct, causing deterioration of the vent duct and, possibly, wetting of the insulation and water leakage through the soffit material. Further, if mechanical systems are run through the exposed floor systems, there is potential for excessive energy loss, condensation, and/or pipe freezing.

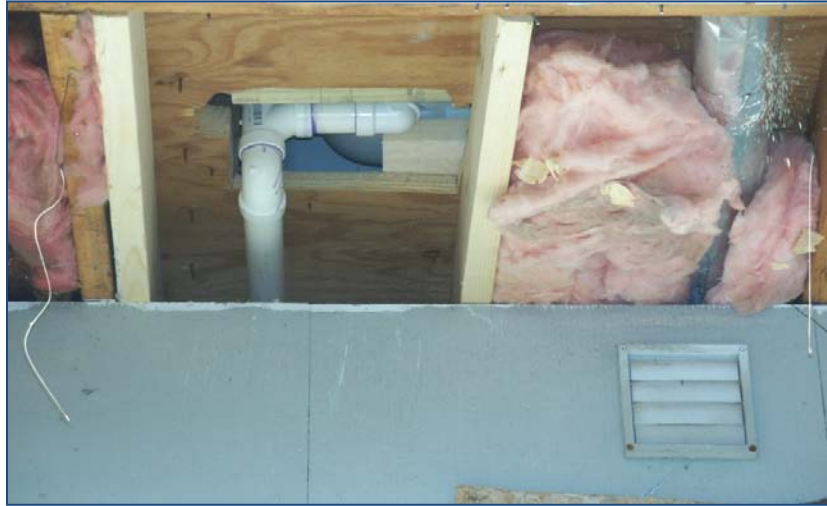
Figure 4. Existing conditions of cantilever floor area per visual inspection

The results of the visual inspection are shown Figure 4. There is batt insulation installed, however, it is not installed in every cavity of the cantilever floor. In addition, the insulation is dirty indicating that there is significant air flow through the insulation. There is not currently an air barrier or blocking installed and there is minimal air sealing of penetrations and duct sealing measures currently installed.

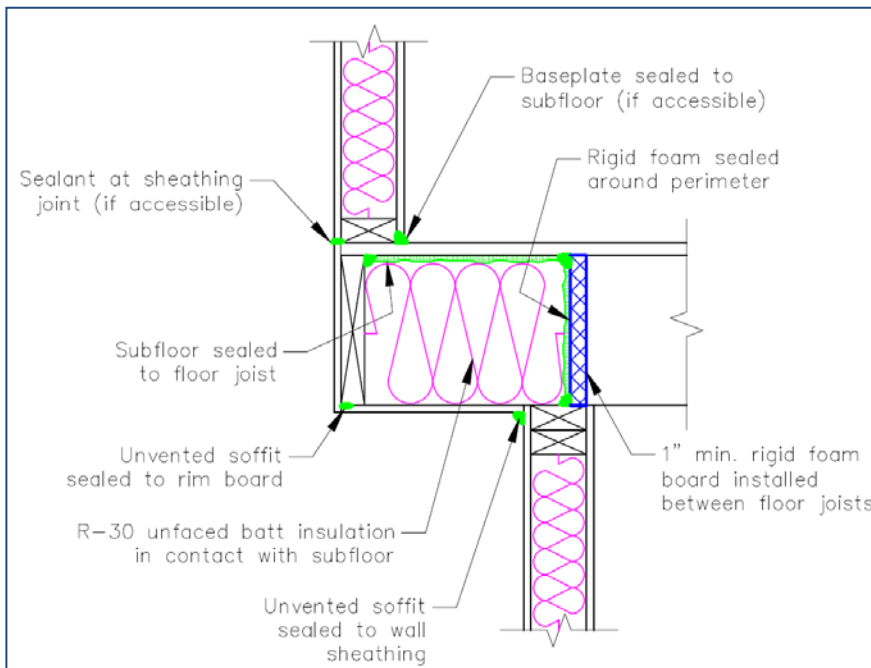
Figure 7. Cantilevered floor blocking, air sealing, and insulation detail

As part of developing the scope of work, it is important to have available and include the construction detail. In this example, the detail for the cantilever floor upgrade is shown in Figure 7. This is also referenced in the Scopes of Work text outlined by trade following the figure.

It is also important to outline the approved materials for the project. For a QA approach to energy remodeling of a cantilevered floor, the material specifications as depicted in Figure 7 and Figure 8 include:

- a. Unvented soffit: Exterior painted plywood sheathing
- b. Blocking:
 - i. 1" thick nonstructural sheathing board (R-6.5) between floor joists
 - ii. *Alternate acceptable products are 1" XPS or polyisocyanurate rigid foam sheathing*
- c. Air Sealing:
 - i. Normal expansion polyurethane spray foam insulating sealant
 - ii. Construction adhesive or caulk
- d. Insulation: R-30 un-faced insulation in joist cavities

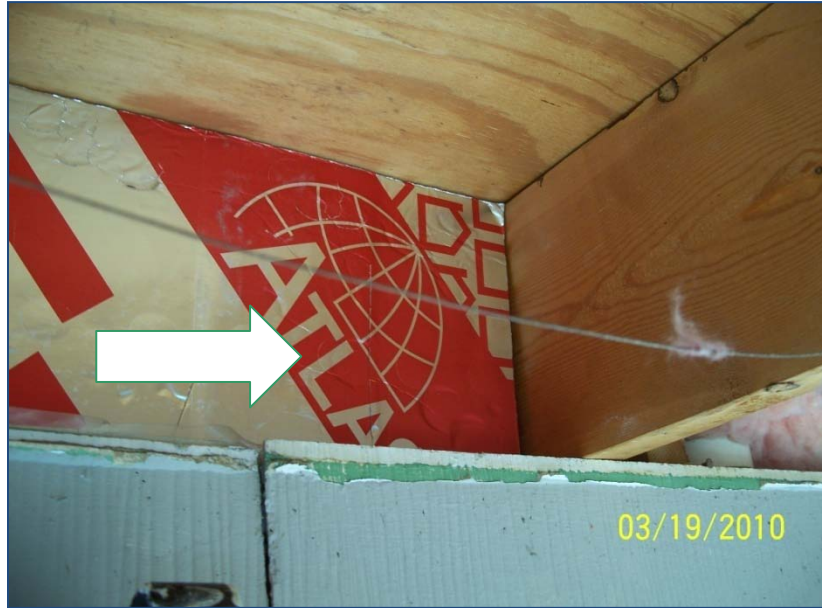
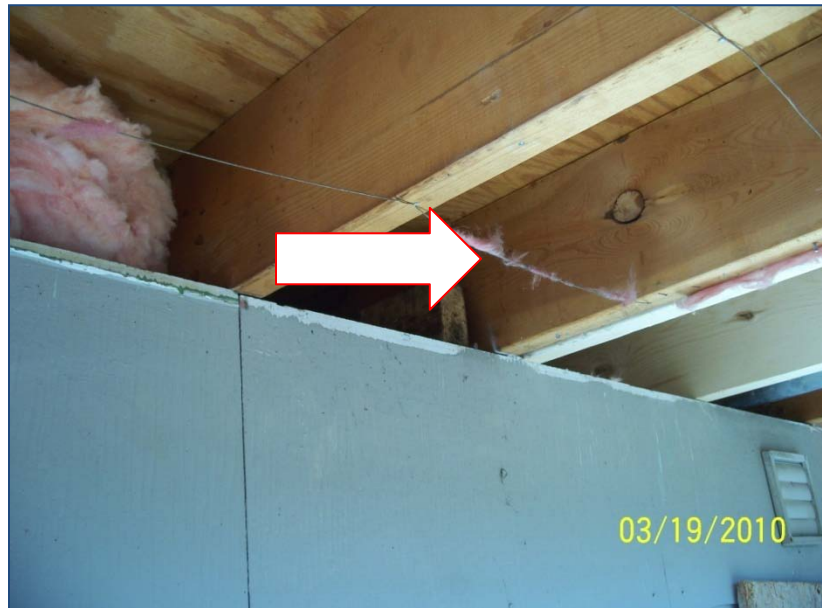
Figure 9. Cantilevered floor blocking training sheet

Instalar blocking en los pisos cuando sobresalen espacios no condicionados

Right / Bueno

Wrong / Malo

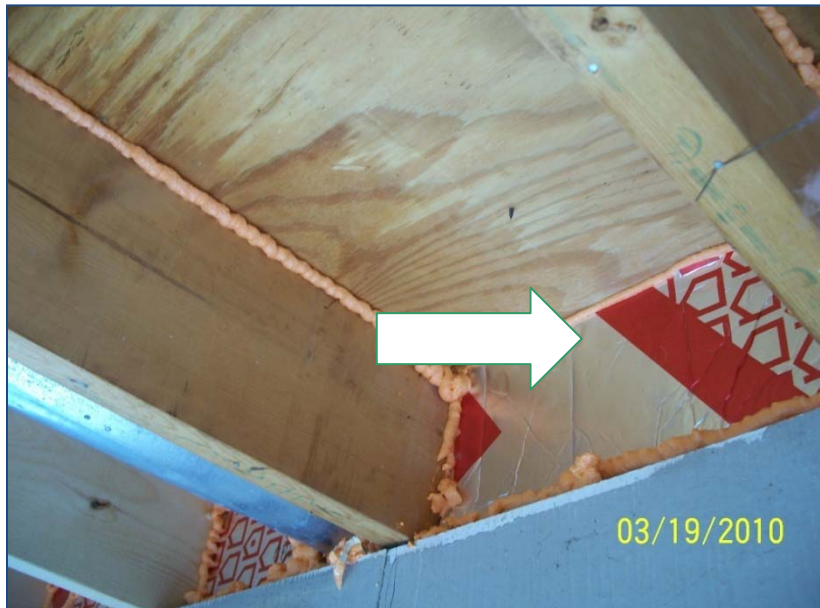
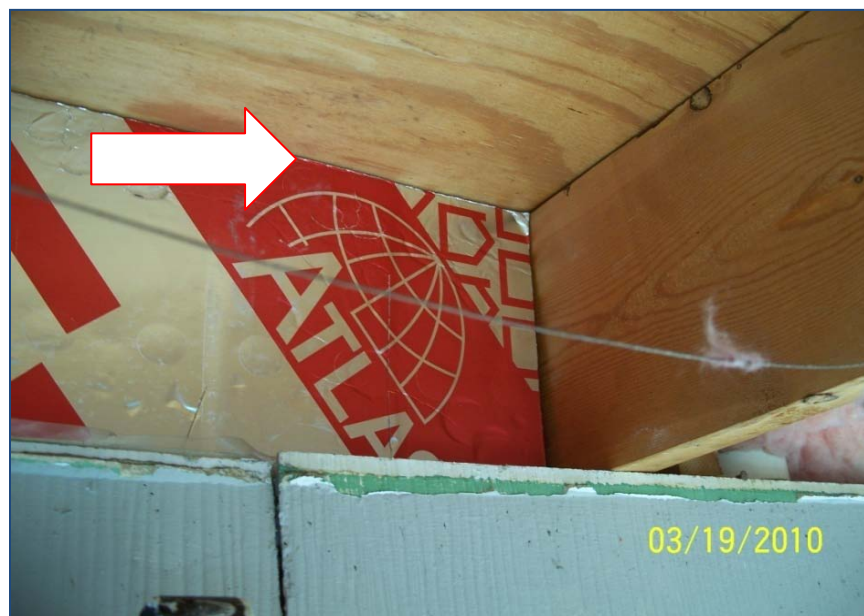
Figure 10. Cantilevered floor air sealing training sheet

Training Sheet: Sealing cantilevered floors after blocking

Keep all blocking joints smaller than ¼" and foam seal all cracks

Right / Bueno

Wrong / Malo
