Airtightness Results of Roof-Only Air Sealing Strategies on 1 ½-Story Homes in Cold Climates

C. Ojczyk, T. Murry, and G. Mosiman
NorthernSTAR

July 2014

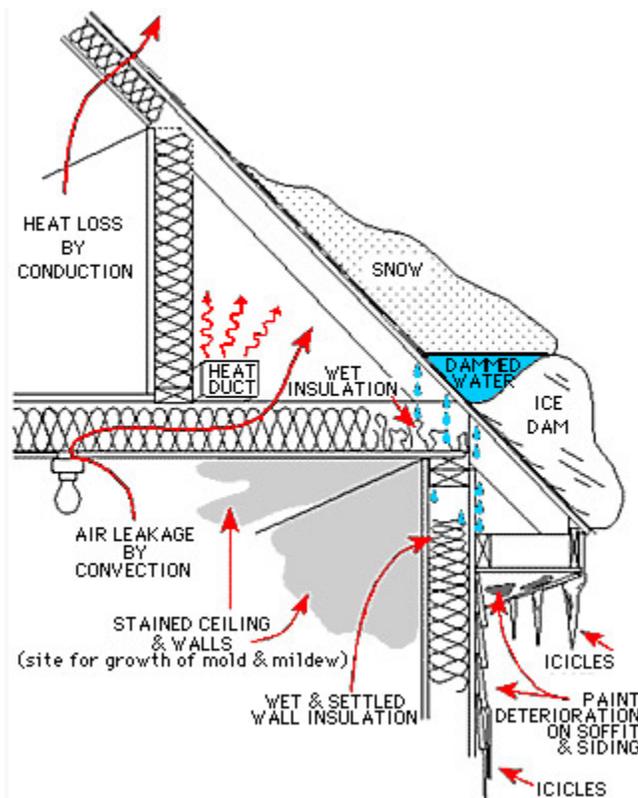
Figure 1. Ice dam formation

One of the obstacles many older homes in cold and very cold climates face during winter months is the development of ice dams caused by energy loss from the building envelope. As shown in Figure 1 (UM 2010), ice dams are particularly a problem in 1 ½-story homes due to heat loss through the building envelope. This is important since many older homes, especially those with 1 ½-story construction, experience ice dams and resulting structural and/or interior damage and increased heating energy use. Many approaches to ice dam mitigation have been tried in the past including: (1) interior-applied improvements to insulation and air sealing, (2) roof raking, and (3) heat tapes.

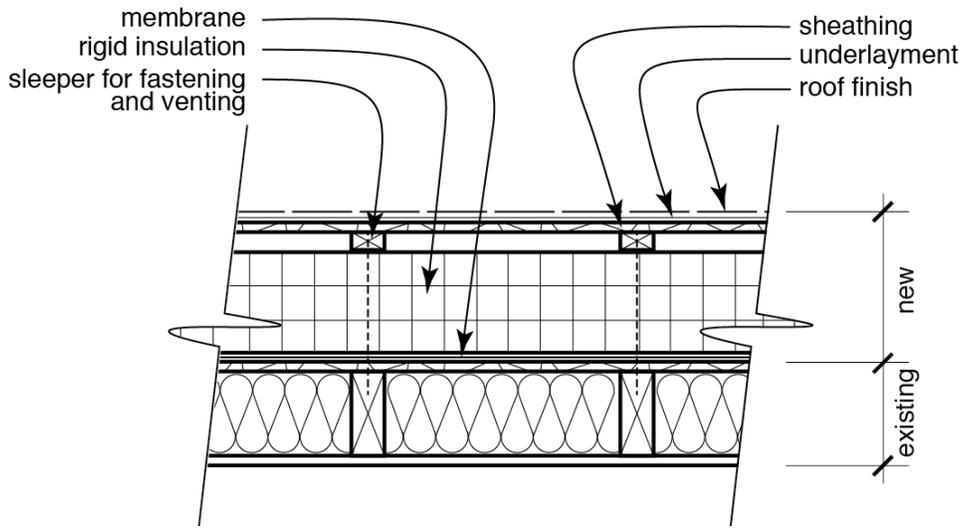
Figure 2. Details for ETMMS roof overcoat approach

The figure demonstrates the air/vapor membrane layer between the existing roof decking and the rigid insulation. Ventilation is designed into the system using sleepers attached through the insulation. Roof sheathing and underlayment are similar to standard roofing practices.

Figure 2 represents the basic details for the roof-only ETMMS approach:

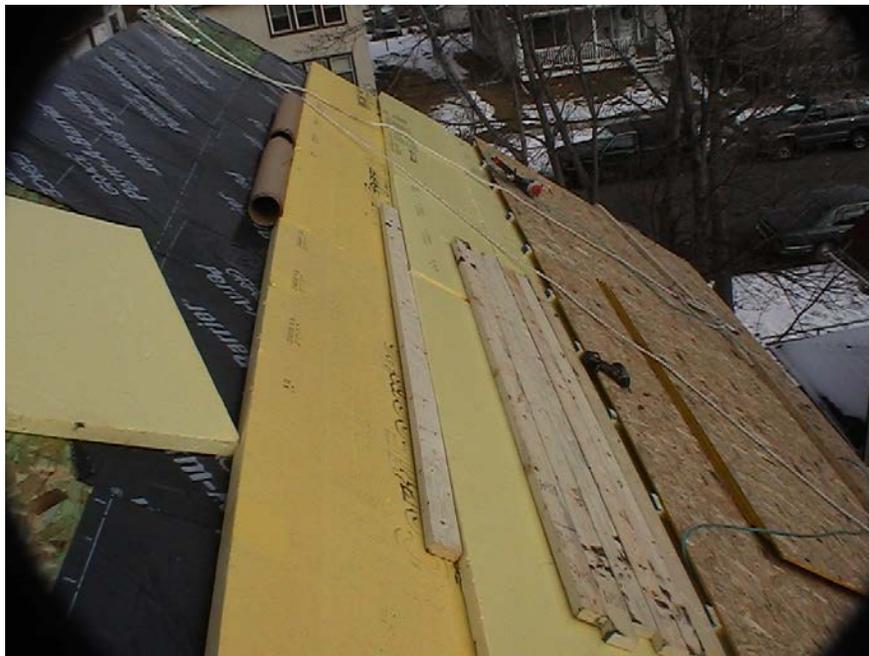
Figure 3. Details for ETMMS exterior overcoat retrofit on 1 1/2-story home

In the ETMMS process for the upper level of a 1 ½-story house, proper insulation and air sealing would be applied to everything from the upper (attic) floor and higher. That includes roof planes, gable end walls, dormer faces, and side walls. Applying ETMMS to the roof-only of existing homes may require deviation from the optimal process due to existing features that cannot be altered such as brick cladding on gable ends. Air sealing and insulation for these areas would need to be done from the inside when accessible.

Figure 3 demonstrates the layering of the materials in the ETMMS approach:

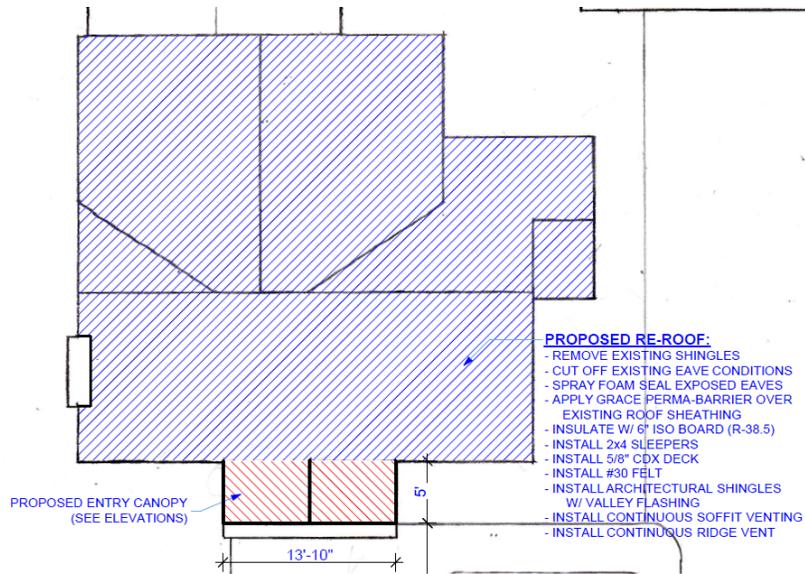
Figure 4. Roof overview of Cocoon St. Louis Park House pre-retrofit with proposed details of portico in red

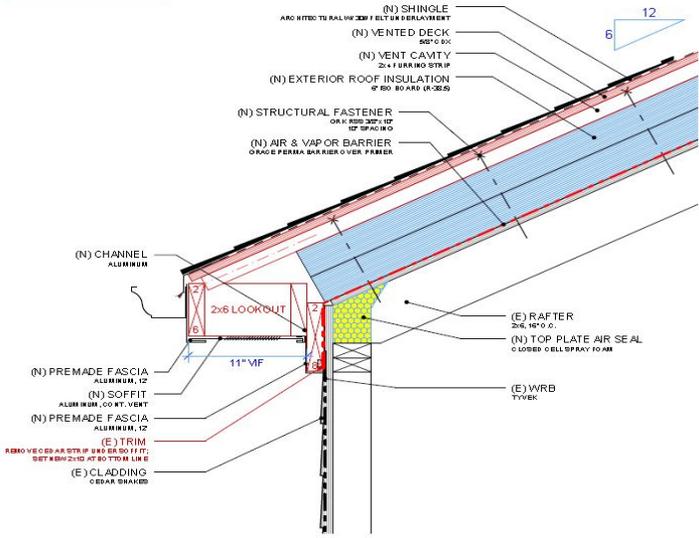
BLANDIN ROOF
6:12 EAVE DETAIL
 SCALE: 1/2" = 1'-0"
 DATE OF ISSUE: 7/1/2012

Figure 6. Proposed eave details for Cocoon St. Louis Park house
 (Courtesy of Cocoon)

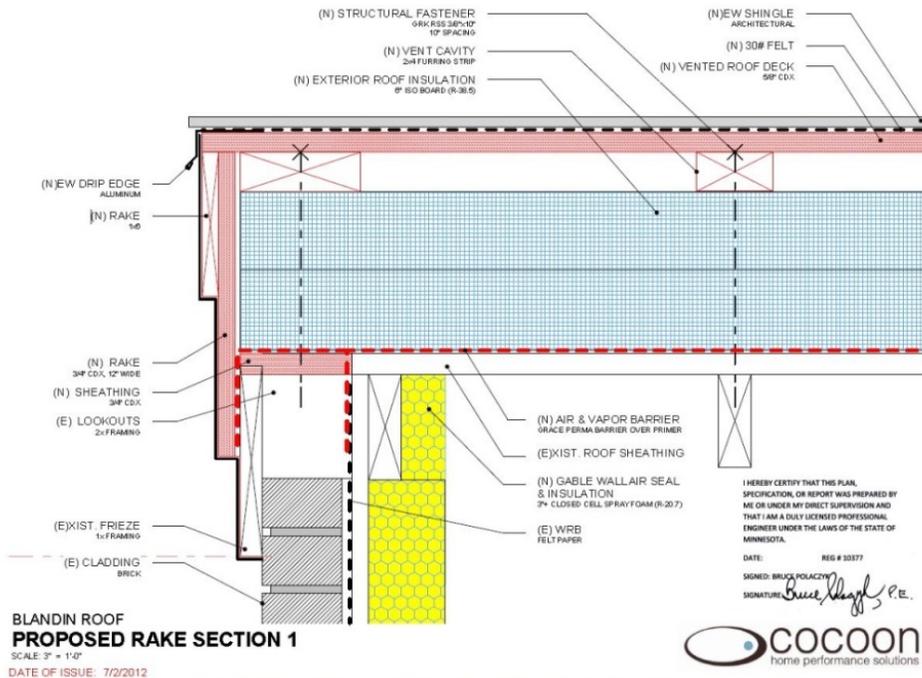
BLANDIN ROOF
PROPOSED RAKE SECTION 1
 SCALE: 3/8" = 1'-0"
 DATE OF ISSUE: 7/2/2012

Figure 7. Proposed rake details for Cocoon St. Louis Park house
 (Courtesy of Cocoon)

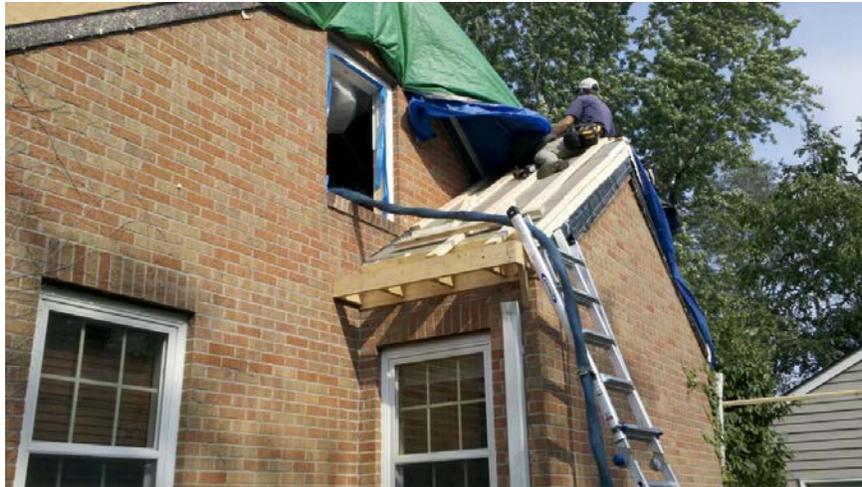
Figure 8. Details of bump-out after the application of rubber membrane, rigid insulation, furring strips for ventilation, and rebuild of soffit assembly for Cocoon St. Louis Park house

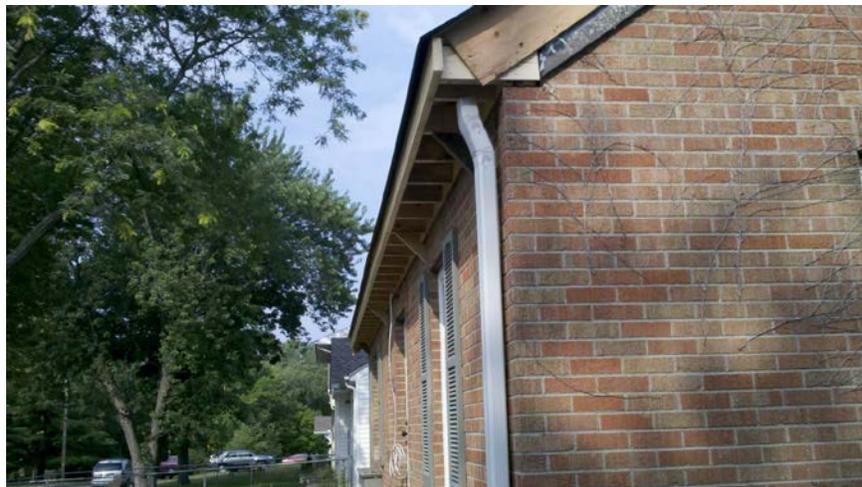
Figure 9. Details of soffit assembly rebuild after the application of rubber membrane, rigid insulation, furring strips for ventilation, rake board, and new roof deck

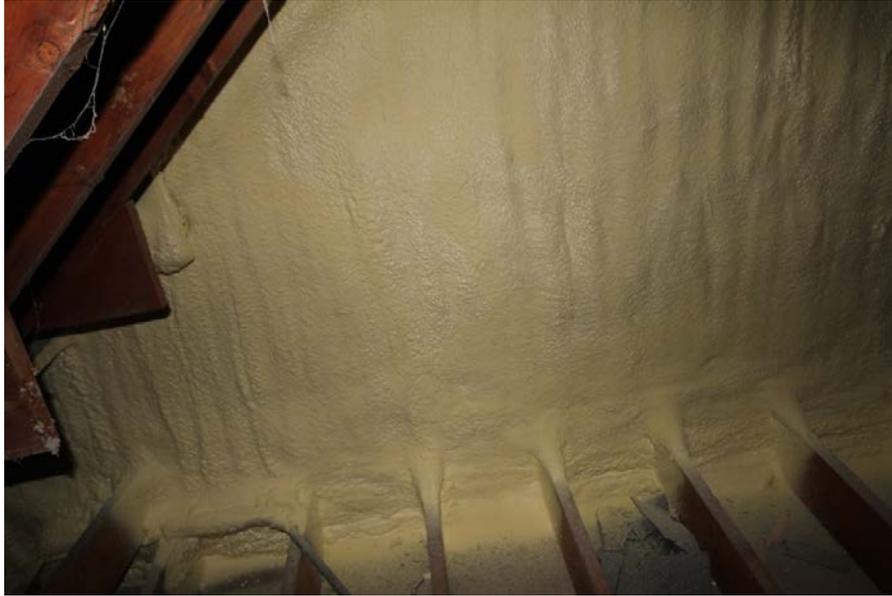
Figure 10. Details of air sealing brick-clad gable wall from the interior using closed cell spray polyurethane foam in Cocoon St. Louis Park house
(Courtesy of Cocoon)

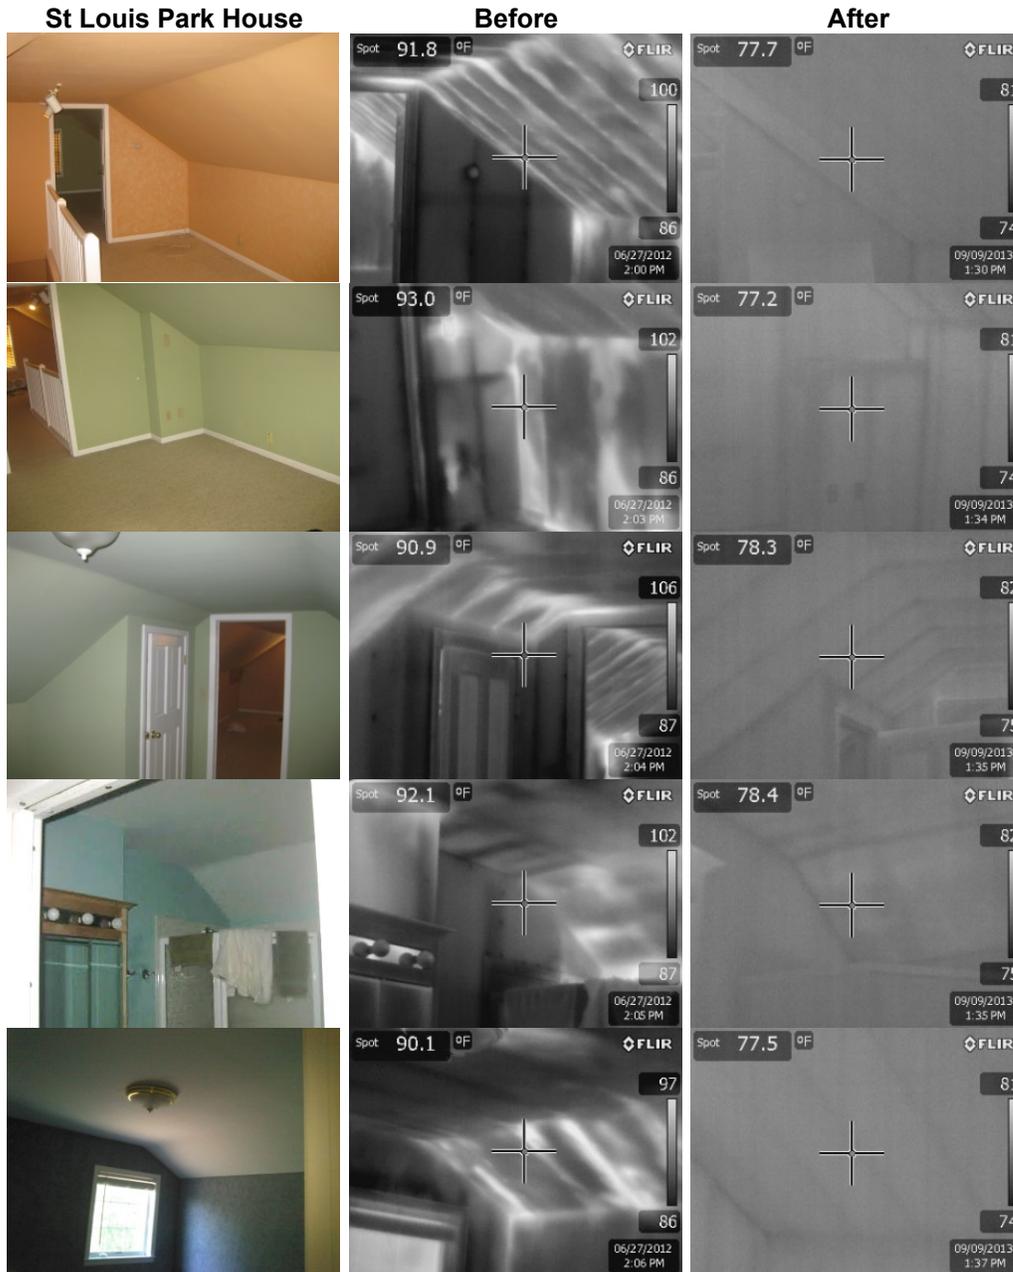
Figure 12 below represents the infrared thermal images taken by Cocoon before and after the roof overcoat. Cocoon uses thermal imaging to verify their work for customers and to support their warranty. The crosshairs in the images are part of the camera function that pinpoints the location of the first image when taking a follow-up image. The reduction in air leakage and thermal bridging is seen by the lack of bright and dark elements in the after photos.

Figure 12. Before and after infrared images for Cocoon St. Louis Park house
(Courtesy of Cocoon)

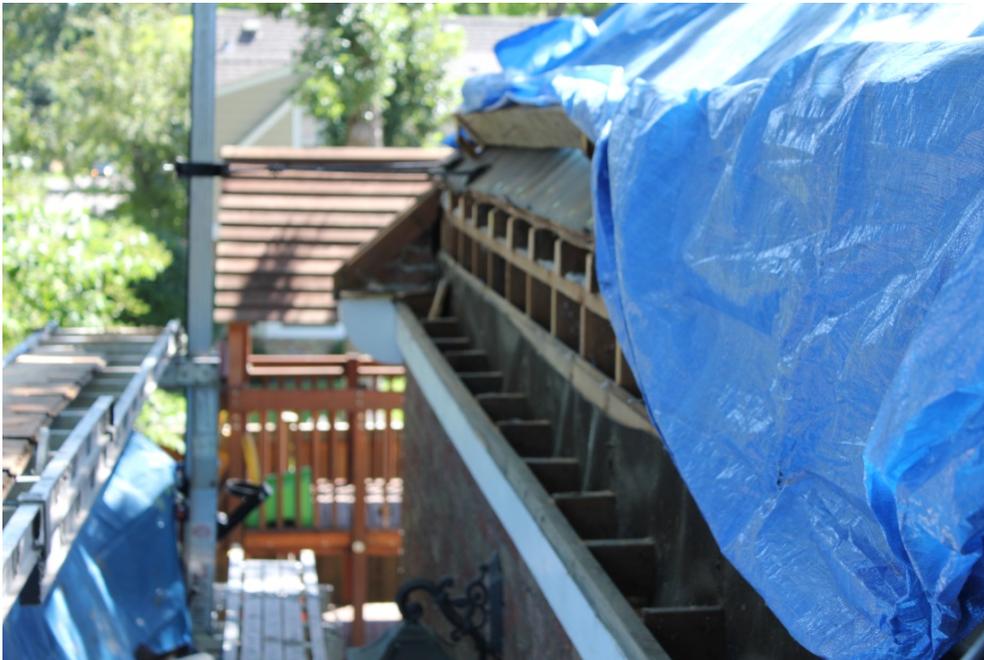
Figure 15. Creating a connection between the brick wall and roof by removing the original soffit and wrapping the membrane over the top of the wall
(Courtesy of Cocoon)

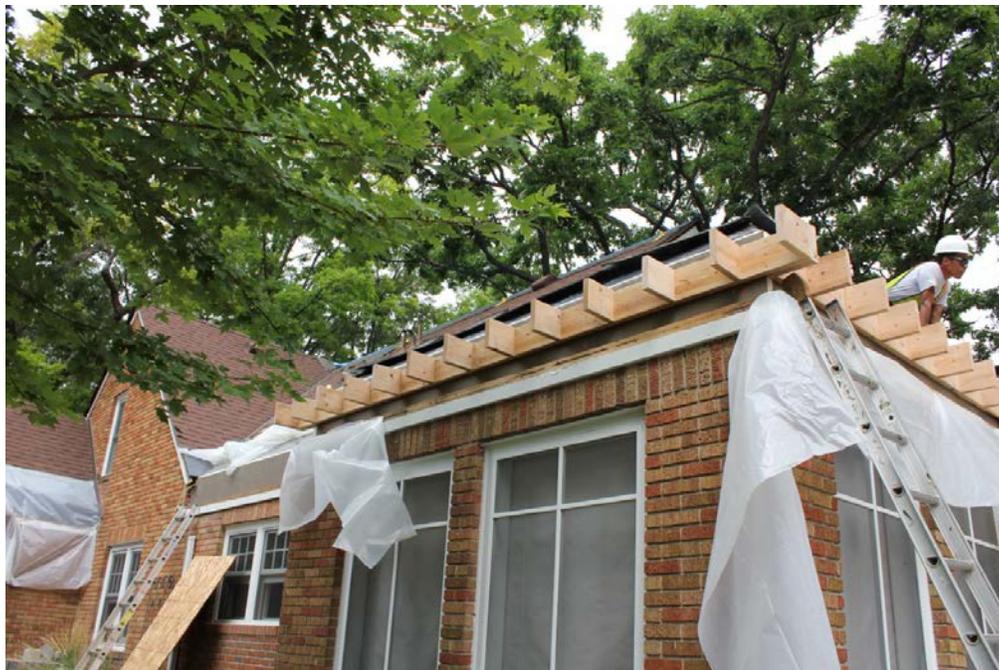
Figure 16. Building a structure for the new soffit
(Courtesy of Cocoon)

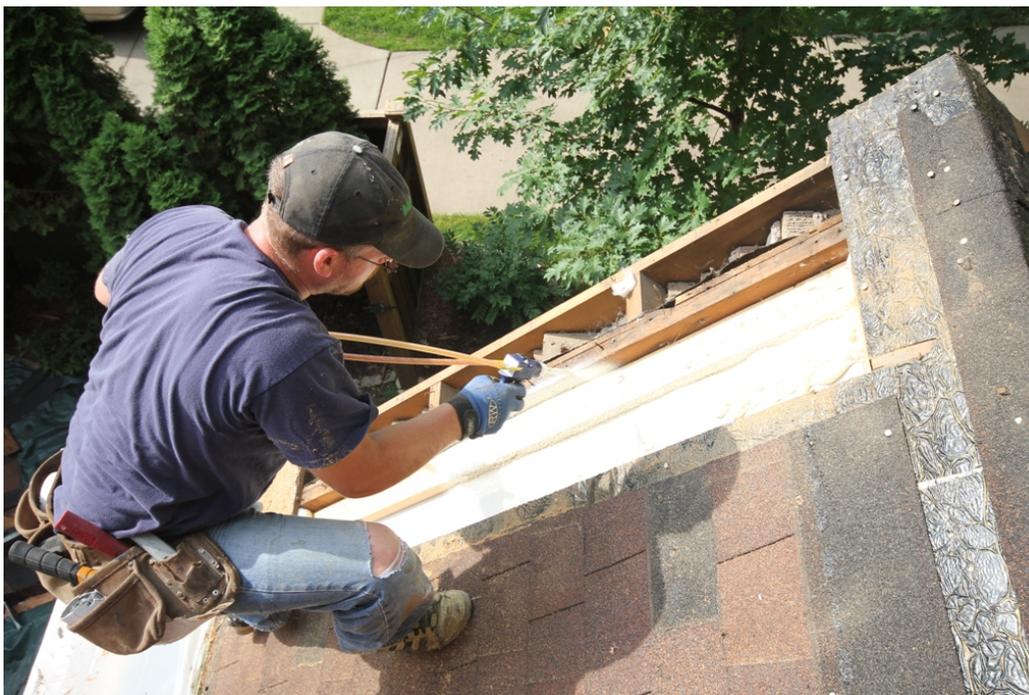
Figure 17. Air sealing the gable wall/roof connection using closed cell spray polyurethane foam
(Courtesy of Cocoon)

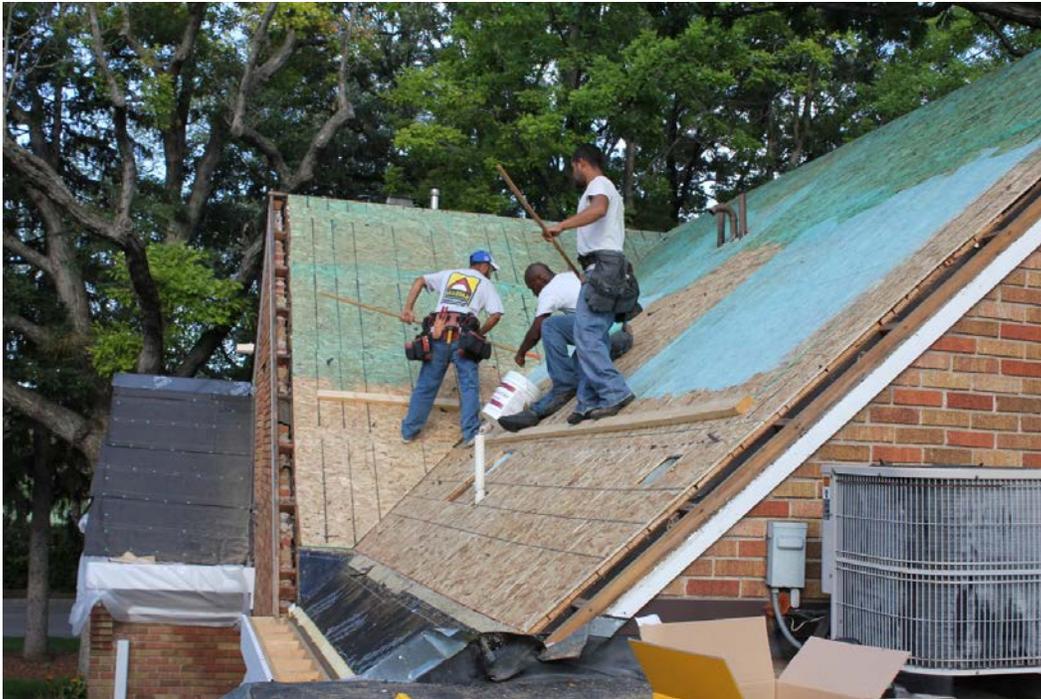
Figure 18. Applying primer before installing the membrane
(Courtesy of Cocoon)

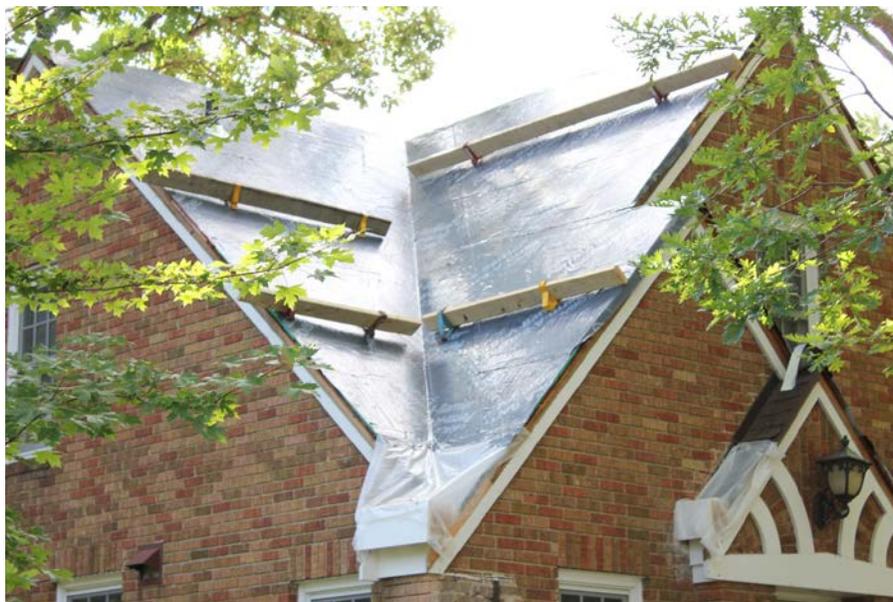
Figure 19. Membrane applied over original sheathing
(Courtesy of Cocoon)

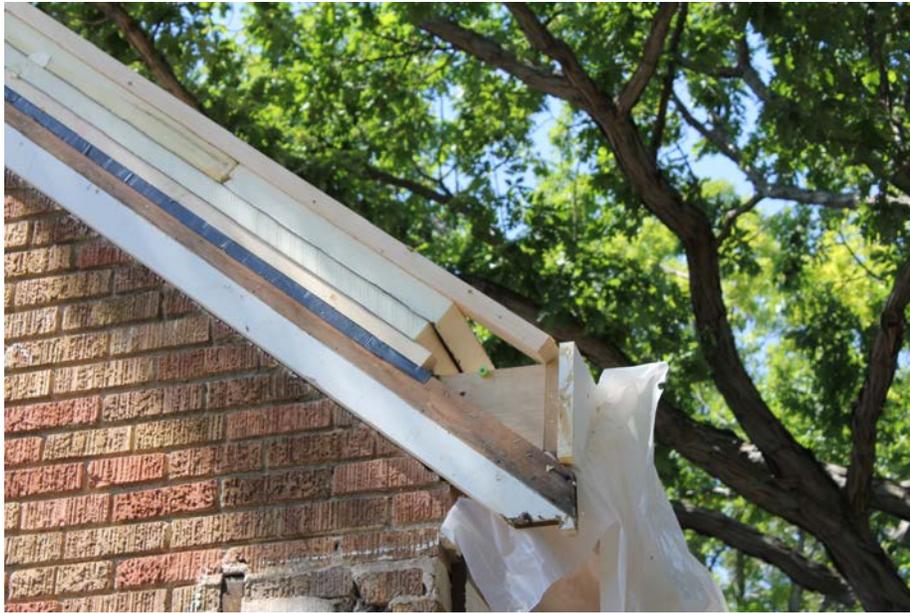
Figure 20. 5-in. of rigid insulation sealed at the seams, each layer with seams offset
(Courtesy of Cocoon)

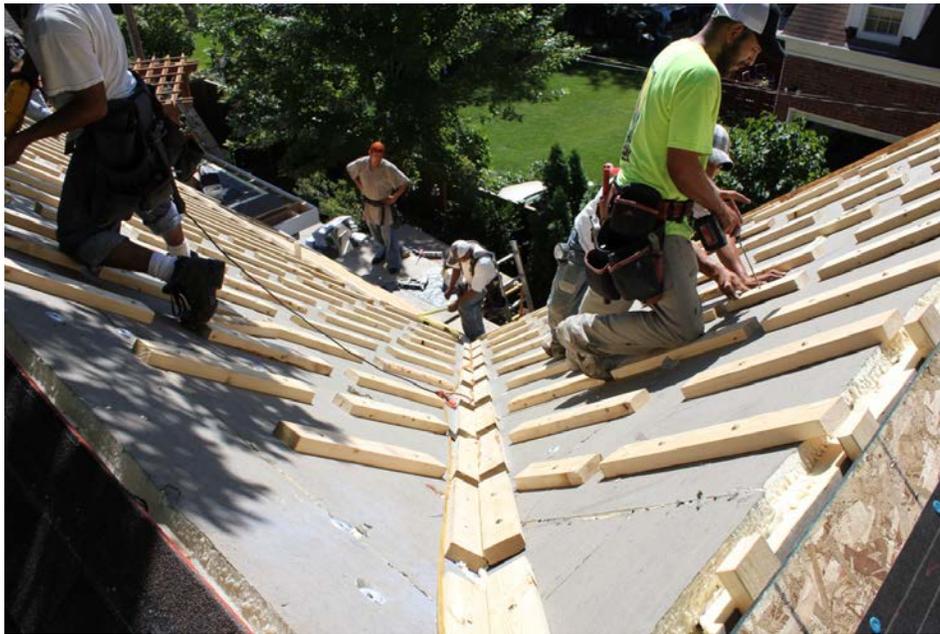
Figure 21. Furring strips configured to allow for side motion ventilation at the valleys
(Courtesy of Cocoon)

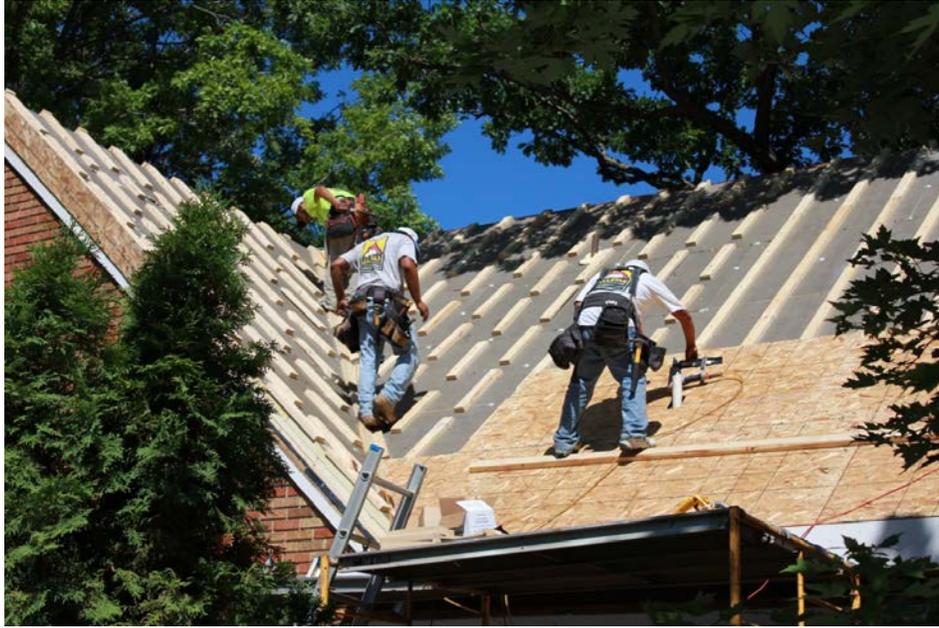
Figure 22. Installing outer layer of sheathing to support asphalt shingles
(Courtesy of Cocoon)

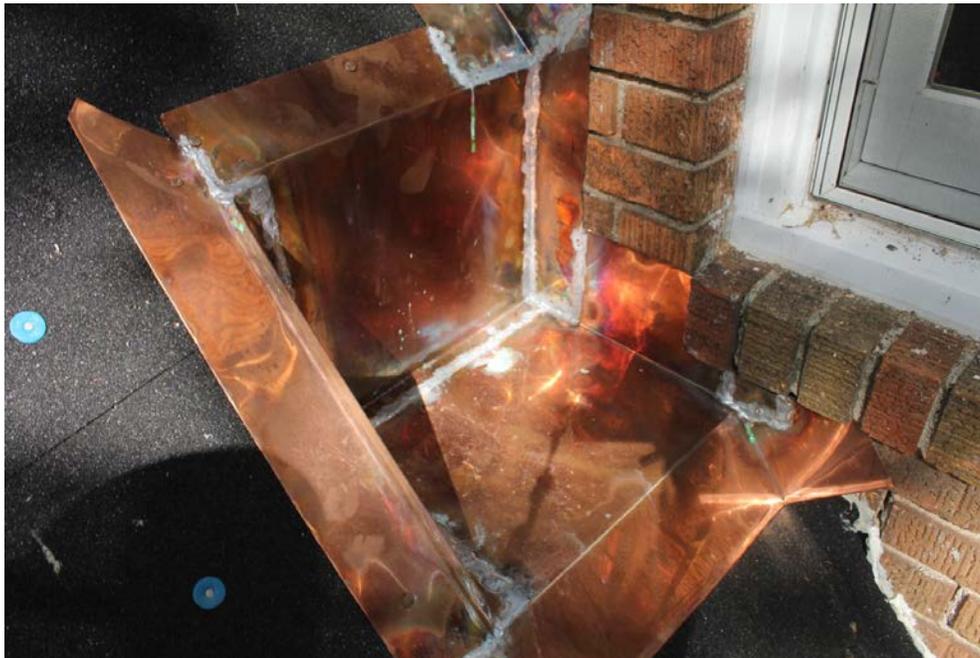
Figure 23. Creating a copper “birds mouth” to accommodate thickness of overcoat layers without impeding window
(Courtesy of Cocoon)

Special details needed to be created for several windows located close to the roofline to accommodate the extra height of the insulation and sheathing. A “birds mouth” made of copper (see Figure 21) was used to frame the window corner. Careful attention to flashing details was important to prevent water leakage.

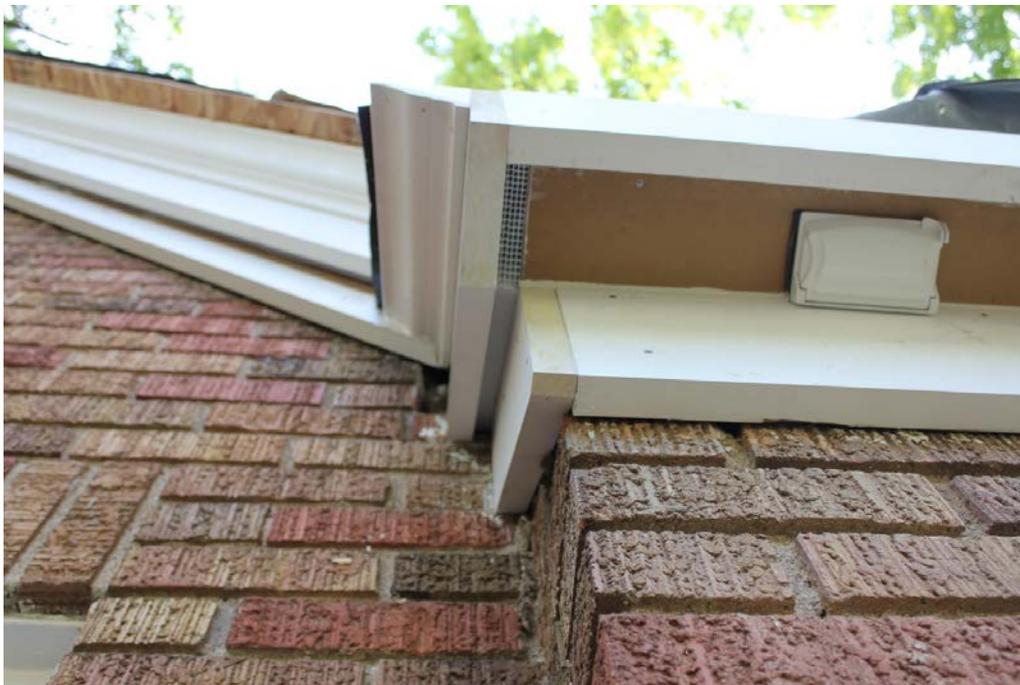
Figure 24. Mesh ventilation with insect barrier

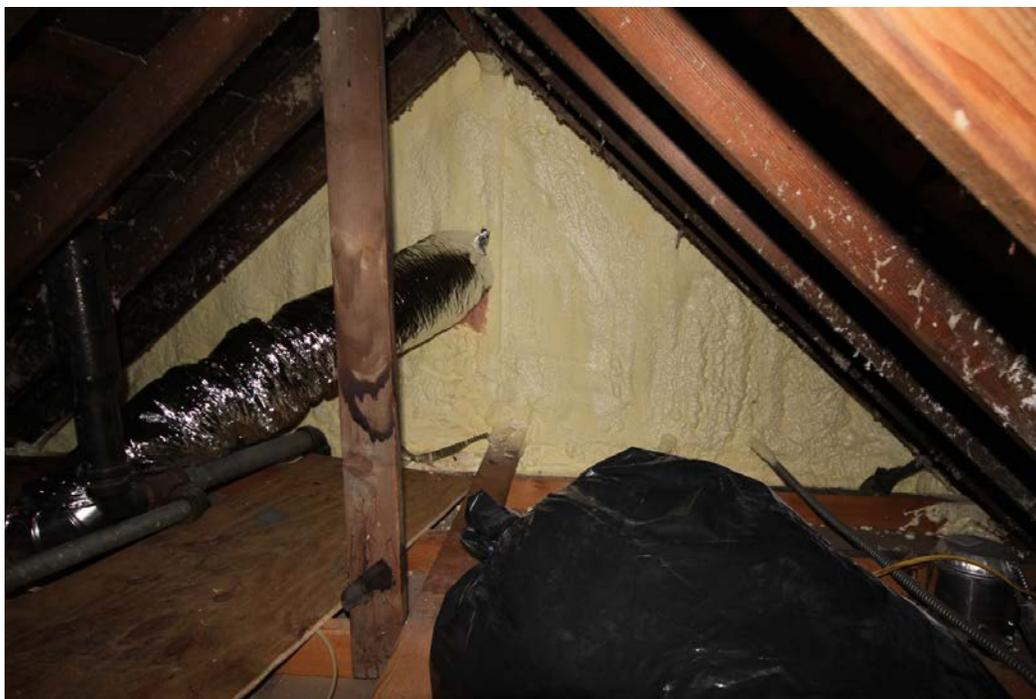
Figure 25. Gable ends above 1/2 story ceiling sprayed with closed cell spray foam

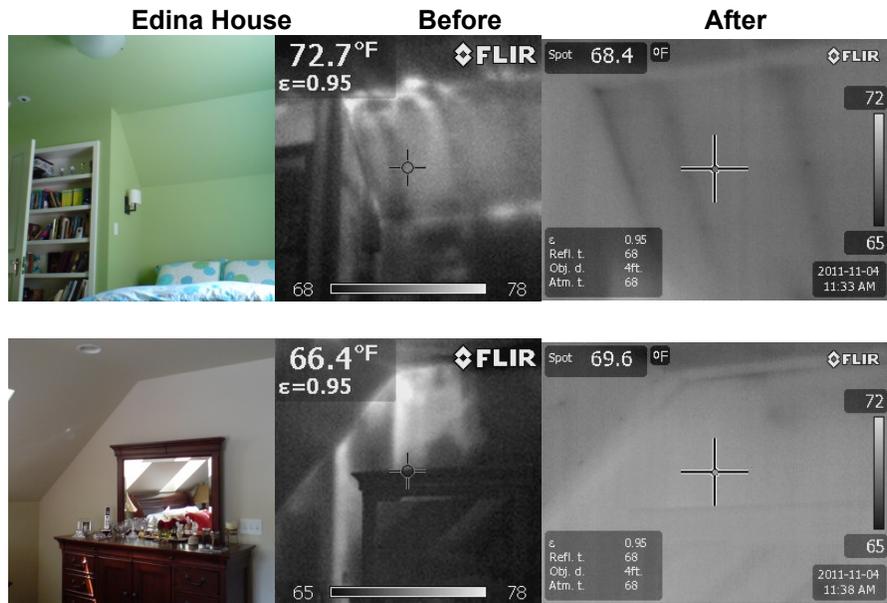
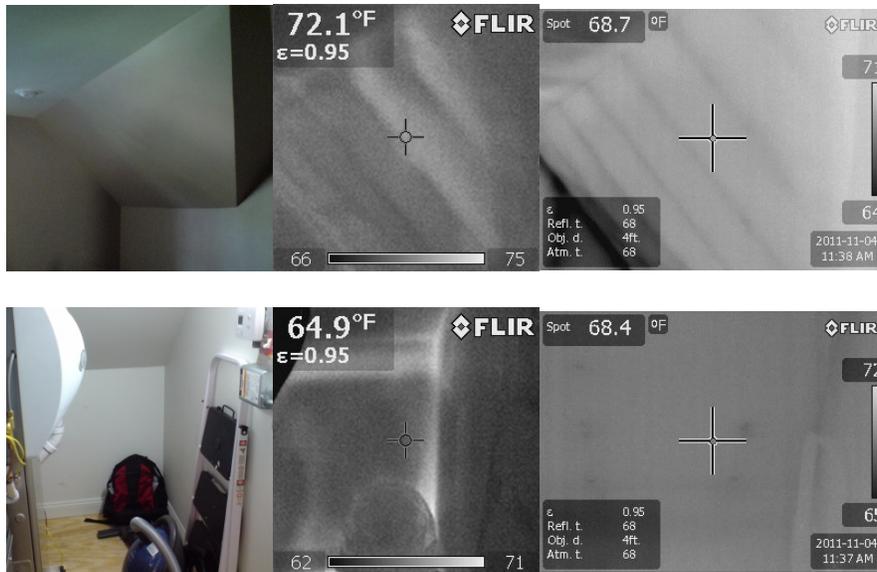
Figure 27 below represents the infrared thermal images taken by Cocoon before and after the roof overcoat. The reduction in air leakage and thermal bridging is seen by the lack of bright and dark elements in the after photos.

Figure 27. After view of Cocoon Edina house post-retrofit
(Courtesy of Cocoon)

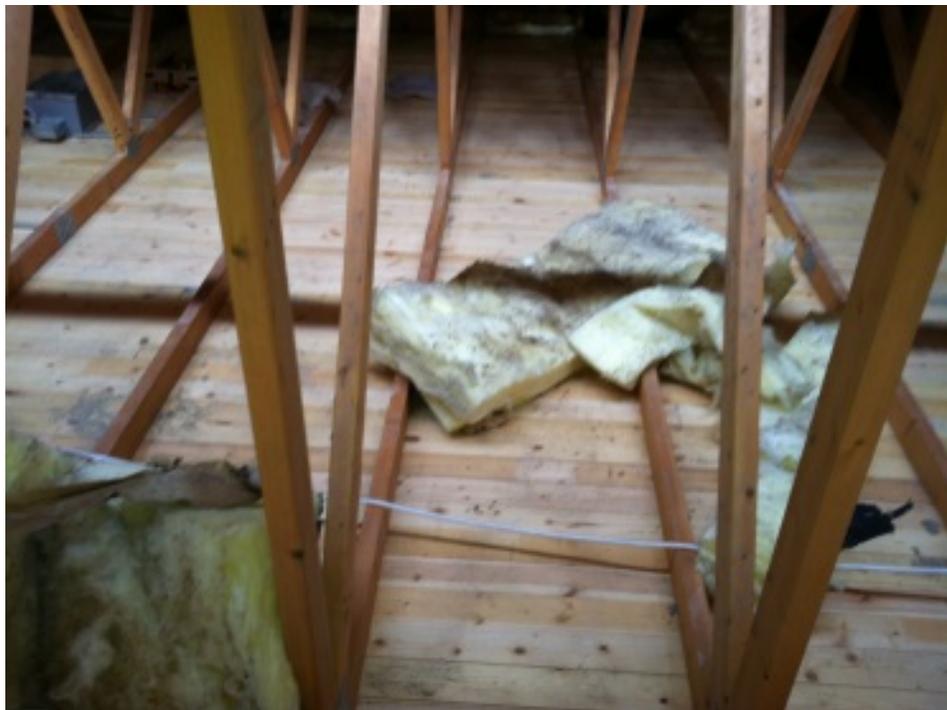
Figure 30. Nor-Son house attic floor post-vacuum
(Courtesy of Nor-Son)

- Remove all insulation on the attic floor using specialized vacuum equipment that removes fine pieces and dust (see Figure 28).
- Install closed cell spray polyurethane foam over the clean attic floor to provide an air sealing layer and insulation. The foam also provides a vapor barrier for this home with its tongue and groove ceiling (see Figure 29).
- Place on top of the foam a layer of cellulose insulation to enhance the R-value (see Figure 30).

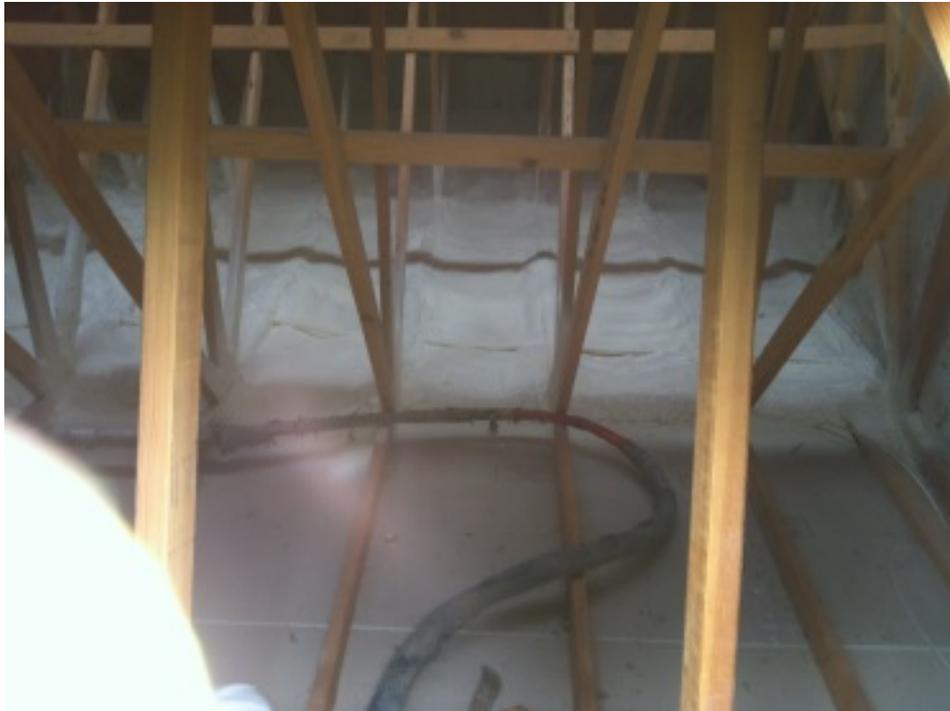
Figure 31. Nor-Son house attic floor spray-foam stage
(Courtesy of Nor-Son)

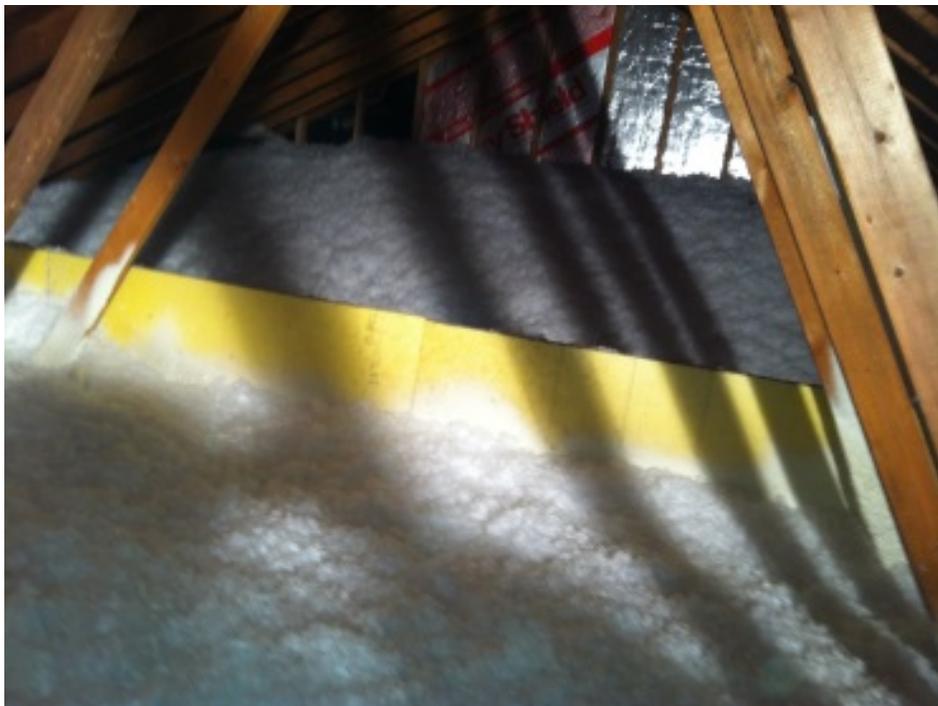
Figure 32. Nor-Son house attic floor post-insulation
(Courtesy of Nor-Son)

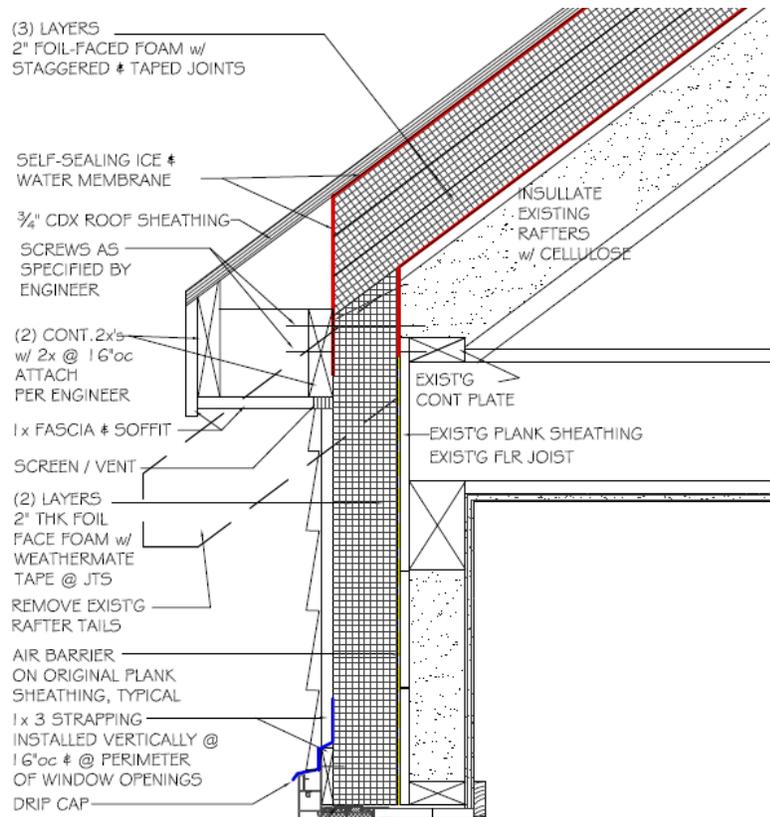
Figure 33. Details of roof/wall intersection for Byggmeister Belmont whole-house DER

Some details for each project are provided in Figures 33 through 36 to show the similarities of the membrane and insulation to roof-only ETMMS and some of the details needed to address a whole-house application. Figure 36 demonstrates the impact of unique architectural features that prevent a complete ETMMS process on an existing home. In this retrofit, the homeowners did not want to remove and replace the slate roof. Insulation and air sealing for the roof planes occurred from inside the attic while ETMMS was applied to the walls. This dual approach required extensive details for aligning air and thermal layers, also seen in Figure 36.

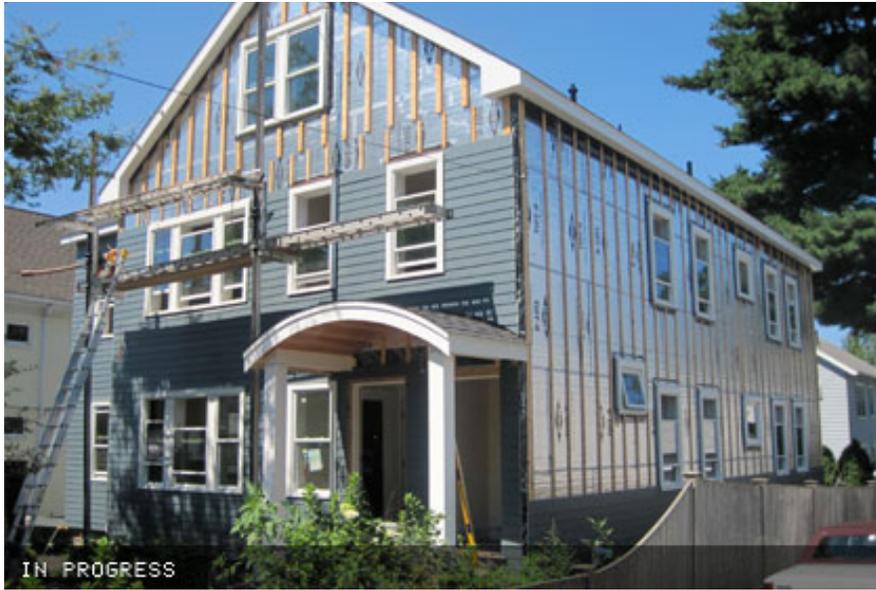
Figure 34. Details of external insulation and furring strips for ventilation used by Byggmeister for Belmont DER

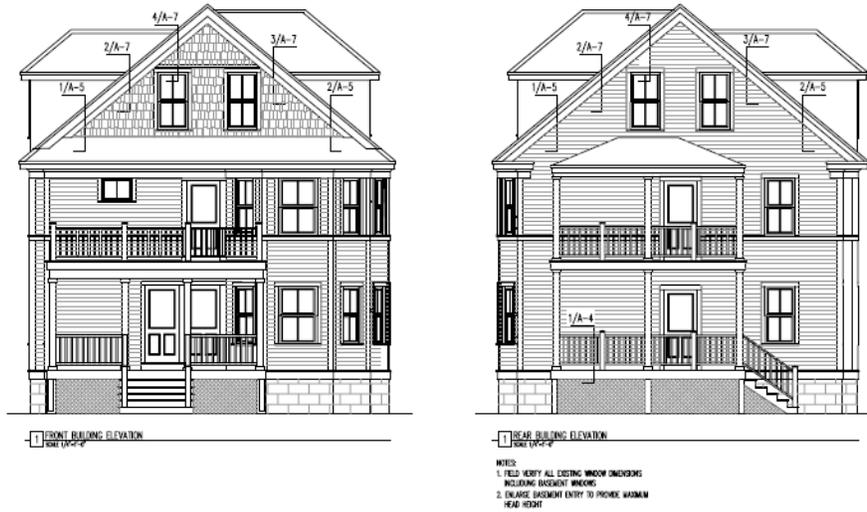
Figure 35. Line drawings for Byggmeister Jamaica Plain house

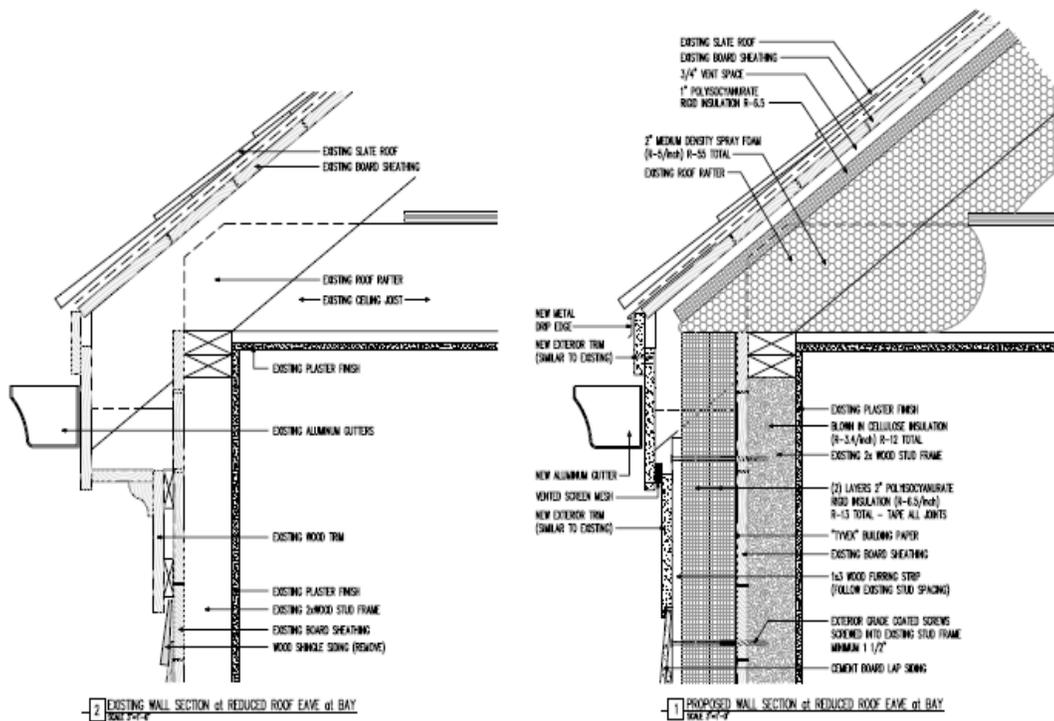
Figure 36. Details for roof/wall connections for Byggmeister Jamaica Plain house
(Courtesy of Byggmeister, Inc.)

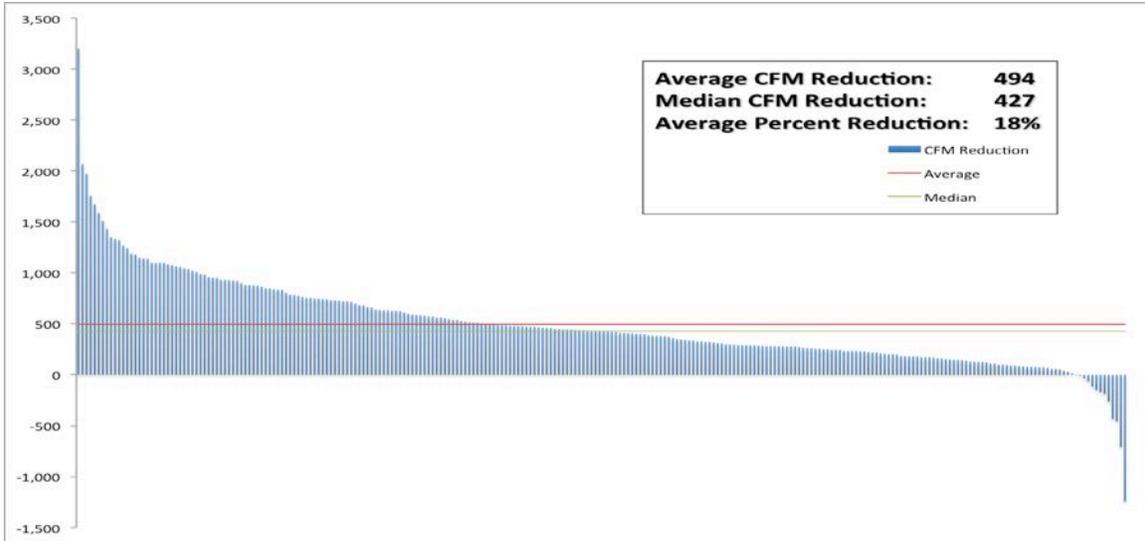
Figure 37 is a visual overview of the CFM50 reduction results from all 250 homes combined. While the data are of minimal value because the variables are so great from project to project, the data show the extent of variation in airtightness reduction achieved through an interior approach. Several of the projects also produced highly unusual negative reductions in airtightness. The data do not indicate why or how the homes were leakier after the retrofit than before.

Figure 37. Overview of all program data from three partner groups

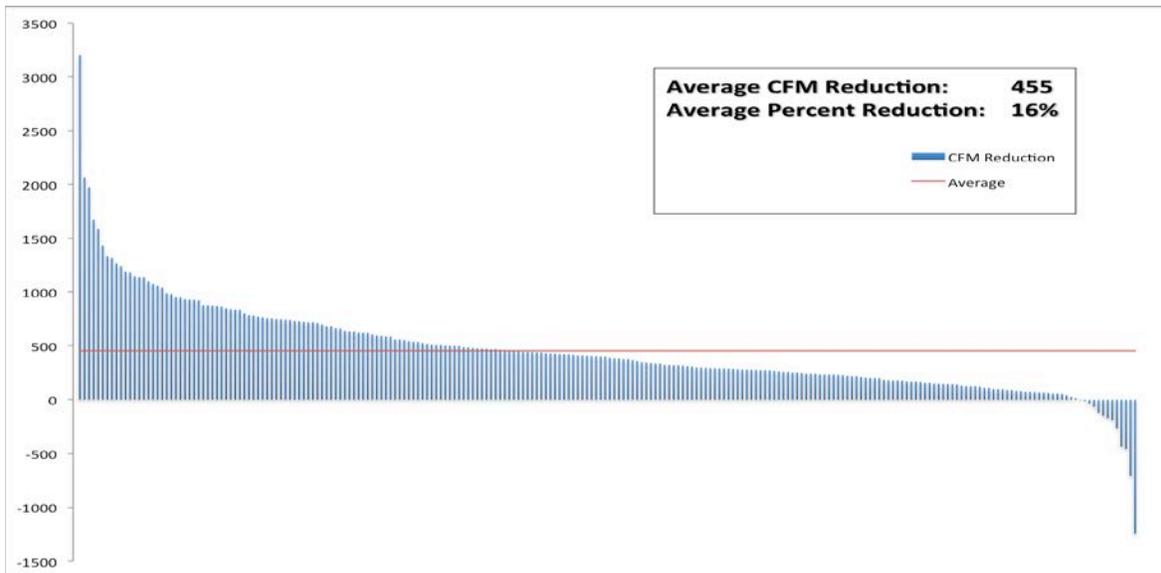
Figure 38 represents CFM50 reduction from the 224 data points provided by CEE’s home energy program in the Minneapolis, Minnesota region. Several of the projects produced highly unusual negative reductions in airtightness. The data do not indicate why or how the negative numbers were achieved. When the negative numbers were included in computation, the average CFM reduction was 455 CFM, representing an average 16% reduction in air leakage between pre- and post-retrofits.

Figure 38. Overview of all CFM reduction data provided by CEE for 1 ½-story roof-only retrofits

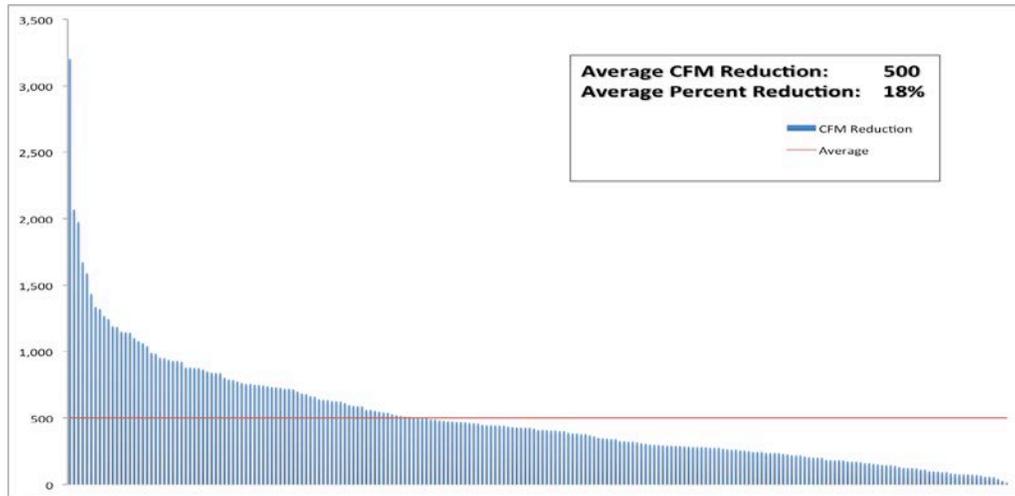
The team was not given an explanation as to why there were negative CFM reductions. Since it is generally impossible to achieve negative results after air sealing, Figure 39 represents the

results of removing the negative numbers to inform performance without the outliers include. The average CFM reduction and percent reduction improved as expected.

Figure 39. Overview of CFM reduction data provided by CEE for 1 ½-story roof-only retrofits with negative data points removed

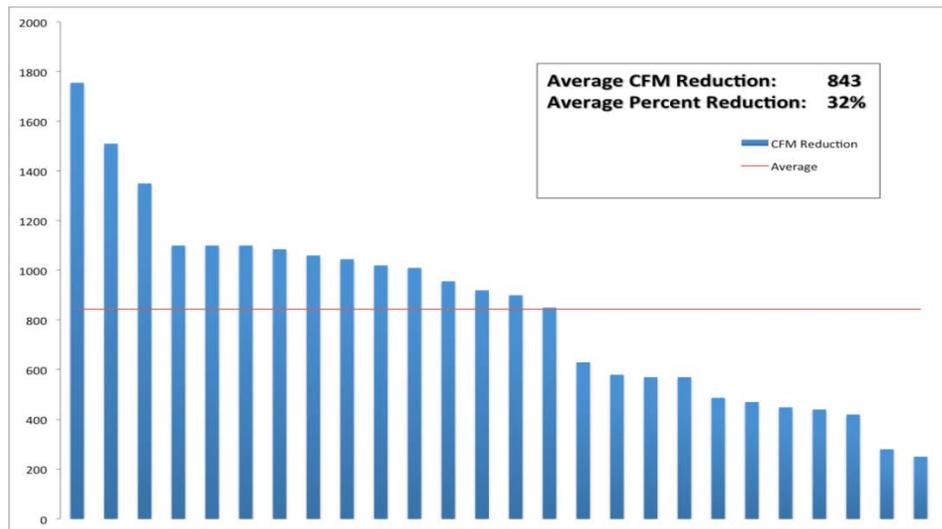
Figure 40 below summarizes airtightness data provided by SRC and NEC from a total of 26, 1 ½-story roof-only weatherization projects. After comparing the CEE home energy program results with the weatherization houses it was noticed that weatherization homes had significantly more CFM reduction. This seems to indicate that there are multiple levels of quality control in the general market.

Figure 40. Overview of CFM reduction data provided by SRC and NEC for 1 ½-story roof-only weatherization retrofits
