Passive Leak Detection Using Commercial Hydrogen Colorimetric Indicator

Kevin Hartmann, William Buttner,
Robert Burgess, and Carl Rivkin

Technical Report
NREL/TP-5400-66570
September 2016

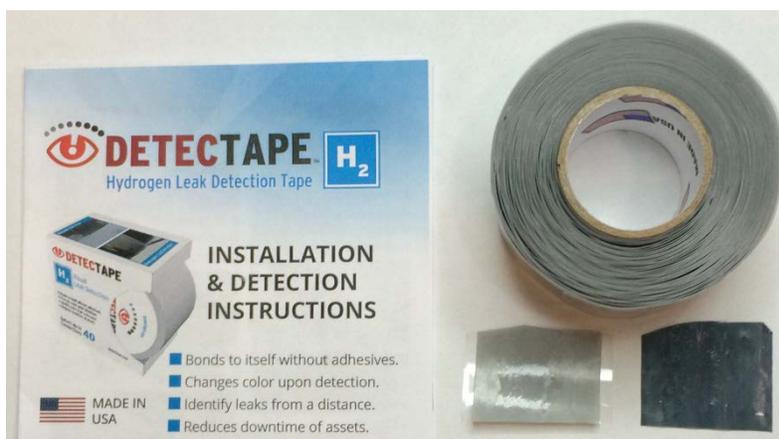
Figure 1. The commercial version of DetecTape. When exposed to hydrogen, the indicator transforms from a pale gray color to black. The color change is not reversible.

Element One, Inc. (www.elem1.com), a small business in Boulder, Colorado, has been developing hydrogen detection technology based upon a highly selective colorimetric indicator (U.S. Patent 6,895,805) [8]. In its native state, the indicator pigment is a pale gray color, but becomes black upon exposure to hydrogen. The colorimetric change can be readily observed by the naked eye without the need for supplemental electronics or other hardware. Recently, the colorimetric indicator was integrated into a pliable, self-adhesive tape that can readily wrap around pneumatic fittings to serve as a hydrogen leak detector (Patent pending) [9]. A prototype version of the Element One indicator tape was tested in an NREL hydrogen system and successfully identified the unexpected presence of a small leak. A summary document for this case study is presented in Appendix A. The tape was subsequently configured into 15-foot rolls as a product prototype that has just recently been commercialized and marketed under the trade name DetecTape.¹ Figure 1 shows the commercial version of DetecTape along with an indicator sample in its native state and one that had been exposed to hydrogen. DetecTape is a self-fusing, silicone-based tape impregnated with a proprietary hydrogen-sensitive indicator. A length of the tape can be cut from the roll and stretched by a factor of two or three times around a fitting. Due to the self-adhesive property of the tape, this provides a tight seal around the fitting. The seal is not hermetic and is not intended to prevent the release of a leaking gas. However, a portion of the hydrogen leaking from a wrapped fitting will pass through the tape and react with the active indicator impregnated in the tape, thereby inducing blackening.

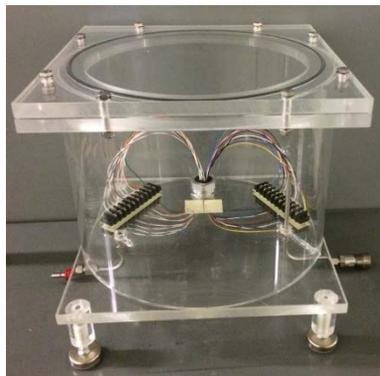
Figure 2. Hydrogen Exposure Chamber.
(The electrical feedthroughs were not needed for DetecTape.)

Following the prescribed hydrogen exposure, the indicators were removed from the test chamber and visually inspected to verify their sensitivity to hydrogen. A color change was readily observed when active indicators were subjected to this exposure sequence. Digital photographs were also taken of the indicator to record the impact of hydrogen exposure. Typically, the color change could be observed within 45 minutes following initiation of the hydrogen exposure by visual inspection through the transparent walls of the exposure chamber.

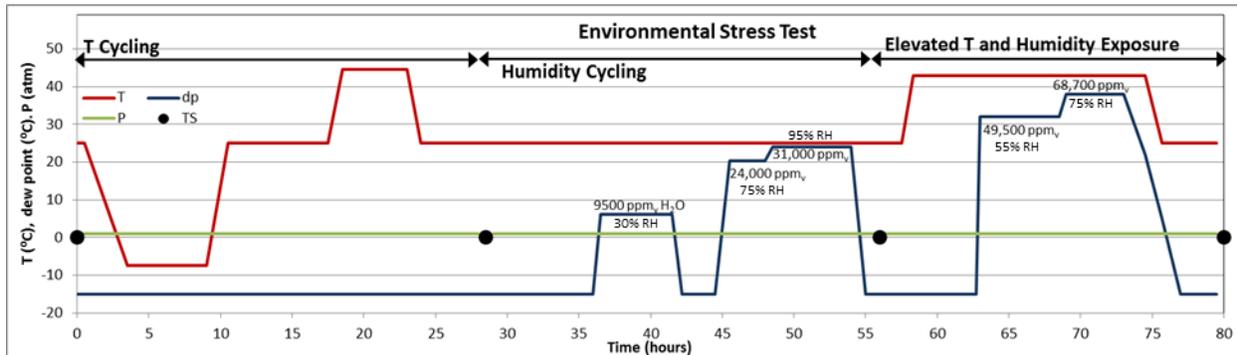
Figure 3. Illustration of the environmental stress test performed on DetecTape using environmental control features available in the NREL Sensor Test Apparatus [4].

Functionality testing was performed on new indicators and on indicators that were subjected to various pretreatments. Pretreatments included subjecting the indicator to the Environmental Stress Test protocol illustrated in Figure 3 and summarized in Table 1. The Environmental Stress Test was performed to elucidate the impact of short-term temperature and humidity fluctuations on the stability of the indicators. This testing consisted of three segments: temperature cycling, humidity cycling, and elevated temperature and humidity exposure. Indicator test samples (TS) were removed following each sequence and checked for activity. Humidity is plotted as the dew point (dp) with the corresponding parts per million volume (ppm_v) water vapor (H₂O), and

relative humidity (RH) labeled in the plot. Dew point and ppmv H₂O were calculated from the measured relative humidity (RH) and temperature (T) using an on-line conversion tool [12].

Multiple indicator samples were installed in the NREL Sensor Test Apparatus [4], which served as an Environmental Test Chamber. As a control, two indicators were not subjected to the temperature or humidity cycling prescribed by the Environmental Stress Test (Samples 2 and 3) before being subjected to the functionality test. The remaining indicator samples were placed inside the Environmental Test Chamber and subjected to the temperature cycling test, which exposed the indicators to temperatures ranging from approximately -7°C to $+45^{\circ}\text{C}$ at a pressure of 1 atm and a dry RH corresponding to a dew point less than -15°C . Following the temperature cycling test, two indicators (Samples 3 and 4) were removed from the Environmental Test Chamber and transferred to the Hydrogen Exposure Chamber and subjected to the functionality test described above. The indicators remaining in the Environmental Test Chamber were then subjected to the humidity cycling test, which ranged from $<1\%$ RH ($dp < -15^{\circ}\text{C}$) up to approximately 95% RH ($dp = 24.1^{\circ}\text{C}$) at a temperature of 25°C and a pressure of 1 atm. Following the humidity cycling test, two indicators (Samples 6 and 7) were removed from the Environmental Test Chamber and transferred to the Hydrogen Exposure Chamber and subjected to the functionality test. The indicators remaining in the Environmental Test Chamber were then subjected to an elevated T and RH exposure test performed at a temperature of 40°C and humidity up to 75% ($dp = 38^{\circ}\text{C}$) and a pressure of 1 atm. Following the elevated temperature and humidity exposure test, the remaining indicators (Samples 8 and 9) were removed from the Environmental Test Chamber, transferred to the Hydrogen Exposure Chamber, and subjected to the functionality test described above. Table 1 summarizes the indicator pretreatments. Photographs of the indicators following respective sequences of the environmental stress test and the functionality test are shown in Figure 4, which clearly show that the functionality of the indicator was not impacted by short-term exposures to the temperature and humidity extremes prescribed by the Environmental Stress Test.

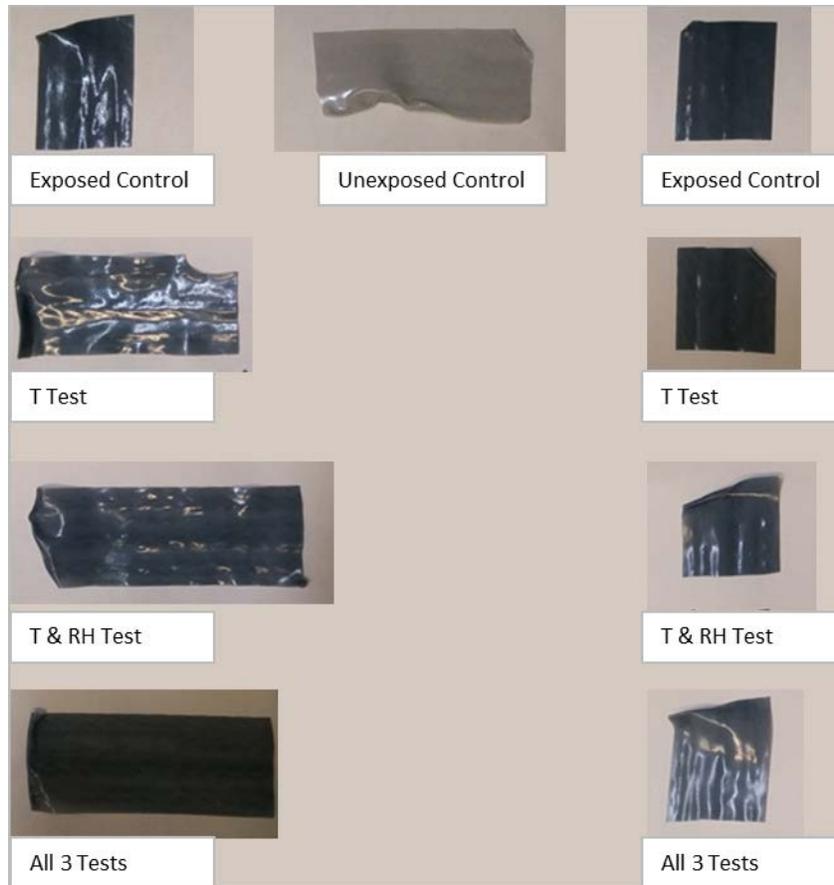
Figure 4. Images of DetectTape samples that had been exposed to hydrogen following the indicated portion of the Environmental Stress Test. For comparison, an unexposed indicator sample (center top row) is shown. The samples on the right and left are duplicate samples.

Sample Number	Pretreatment	Hydrogen Exposure	Functionality
Sample 1	Ambient only ^a	None	n.a.
Sample 2 Sample 3	Ambient only	Standard ^b	Active
Sample 4 Sample 5	Ambient, temperature cycling	Standard	Active
Sample 6 Sample 7	Ambient, temperature cycling, and humidity cycling	Standard	Active
Sample 8 Sample 9	Ambient, temperature cycling, humidity cycling, and elevated temperature and humidity cycling	Standard	Active

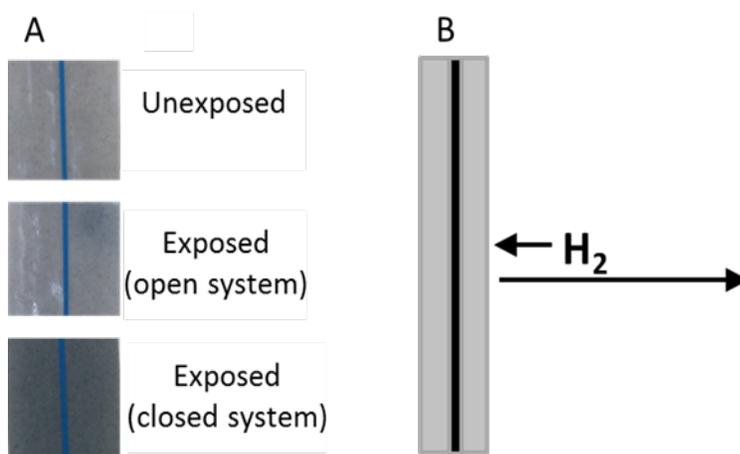
Figure 5. A: Comparison of unexposed and exposed DetecTape under different deployment conditions. B: Illustration of the layered silicone structure of DetecTape and its interaction with hydrogen. The hydrogen will diffuse away from the surface of the tape in an open system.

DetecTape will readily respond to hydrogen leaking through pneumatic components and when stored in a closed chamber with a uniformly mixed hydrogen atmosphere (e.g., such as those used in the functionality test). However, it was found that DetecTape is not an efficient detector for hydrogen released into the open air. This can be rationalized by the need for hydrogen to partition from the surrounding air into the layered silicone structure in order to access the active indicator chemical. In an open system, the proclivity of hydrogen to diffuse into the open atmosphere would prevent significant adsorption into the solid substrate. Even when the flow from a hydrogen gas cylinder was directed onto the surface of DetecTape in the open air, no color change was observed. While it is likely that eventually a color change would take place with such direct exposure to hydrogen, the partition into the silicone membrane is a slow process in open air, and the most likely fate of the hydrogen would be to simply diffuse away. This is illustrated in Figure 5. No color change was observed after 10 vol% H₂ in nitrogen was flowed directly onto the DetecTape surface for 10 minutes in an open system (Figure 5A, middle photograph). Conversely, DetecTape will undergo a color change in a closed system that was continuously purged with 10 vol% H₂ in nitrogen for 10 minutes (Figure 5A, bottom photograph). Although not fully developed, the color change was clearly visible. The rationale for this behavior is illustrated in Figure 5B. In an open environment, hydrogen will tend to diffuse away from the tape rather than be adsorbed. In a closed environment, the hydrogen will be uniformly mixed, thus minimizing the driving force for dispersion, and as a result will more readily partition into the silicone substrate to react with the indicator. When used over a leaking fitting, released hydrogen will necessarily diffuse directly into and through the permeable silicone tape. Thus, DetecTape will work well as a leak detector when applied over pneumatic components, but not as an area monitor for unintended hydrogen releases. DetecTape will not readily react to background levels of hydrogen in open air. Verification of its potential as a passive leak detector was demonstrated in the NREL field deployment study, described in the next section.

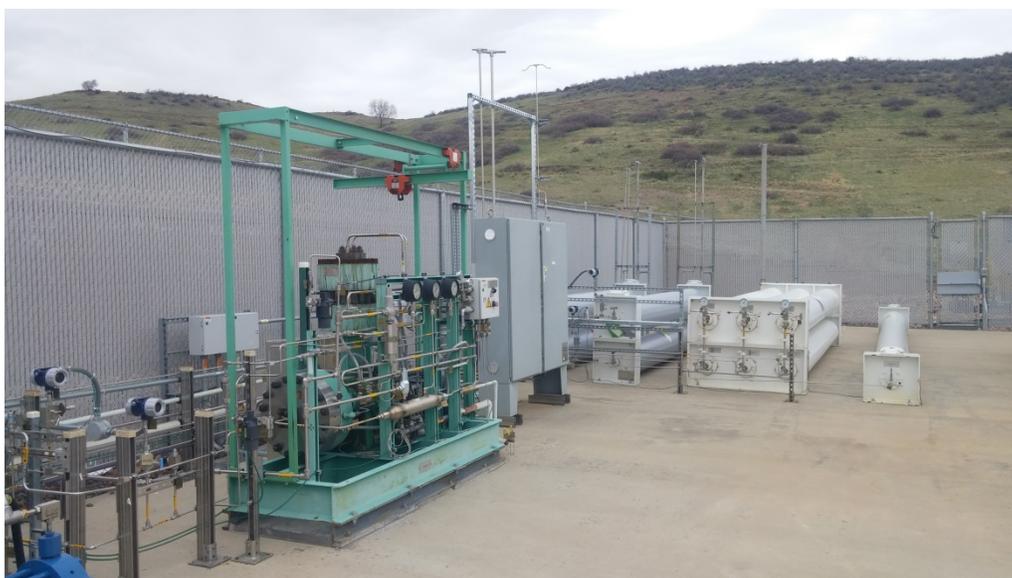
Figure 6. Support systems for the NREL hydrogen dispenser, including (from left to right) the compressor, the gas management panel, and the hydrogen storage tanks. DetecTape was deployed on pneumatic components for each system.

The NREL onsite hydrogen storage facility consists of three separate hydrogen cylinder storage banks pressurized to 200 bar, 400 bar, and 875 bar. During a cascade fill, hydrogen is drawn from separate storage tanks to better match the pressure of the vehicle tank; this is done to minimize the cost and complexity of pressurization during the fill and is controlled through the Gas Management Panel. The storage tanks and support pneumatic system, shown in Figure 6, are outside and thus exposed to prevailing weather conditions, including rain, snow, and sun, along with the daily and long-term temperature fluctuations.

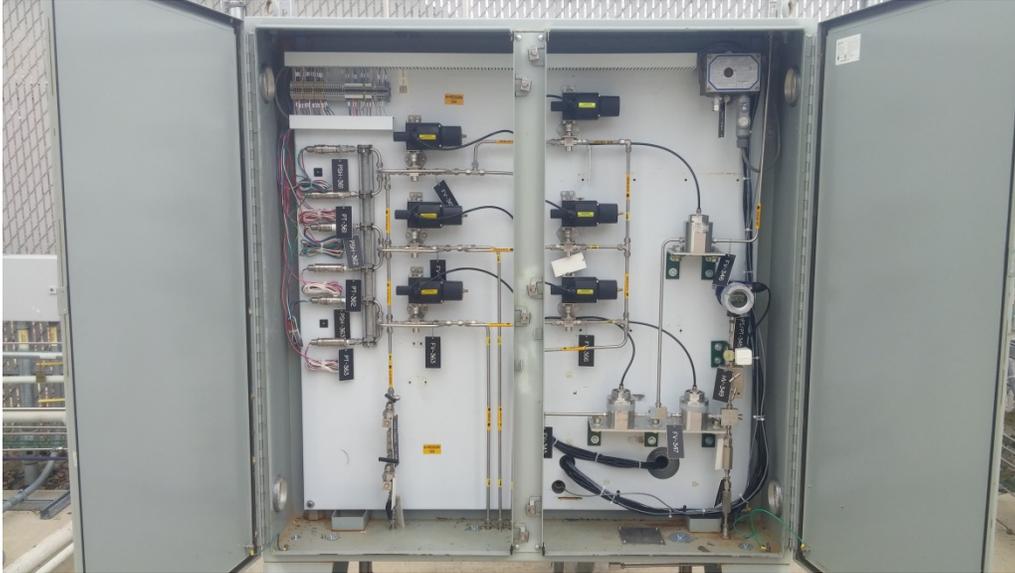
Figure 7. An internal view of the Gas Management Panel. DetecTape was deployed on numerous fittings within the Gas Management Panel.

The Gas Management Panel is the interface between the hydrogen storage tanks and the compressor. During a fill, hydrogen is drawn from the appropriate storage tank as controlled by the Gas Management Panel and Dispenser. The Gas Management Panel, shown in more detail in Figure 7, is enclosed within a gray metal cabinet. Access is through two doors, which open to

expose the Gas Management Panel pneumatic system. The cabinet is fully enclosed, thereby protecting tubing and valves from direct exposure to sun, rain, and snow. The cabinet, however, is not thermally regulated, and thus is subjected to daily and seasonal temperature fluctuations.

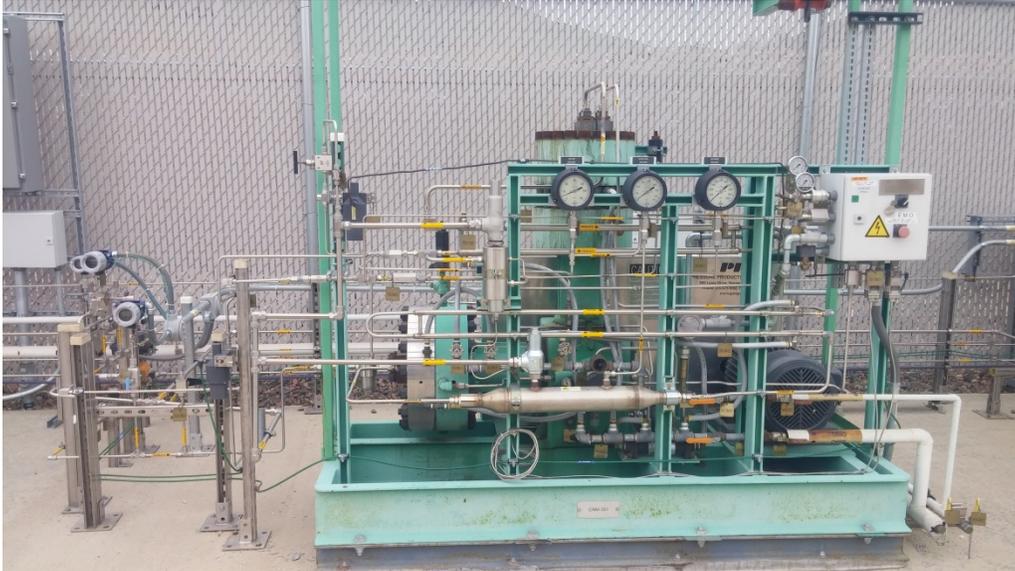
Figure 8. Hydrogen fuel station compressor

The compressor for the NREL hydrogen fueling station is shown in Figure 8. Components in the compressor cycle between high and low temperatures and pressures. Vibrations are also present when the compressor is running. Vibrations, pressure, and temperature fluctuations can stress the integrity of pneumatic fittings and thus can be prone to induce leaks. Furthermore, as an outdoor system, the compressor is in direct contact with environmental conditions such as rain, snow, and sun, as well as daily and seasonal temperature fluctuations.

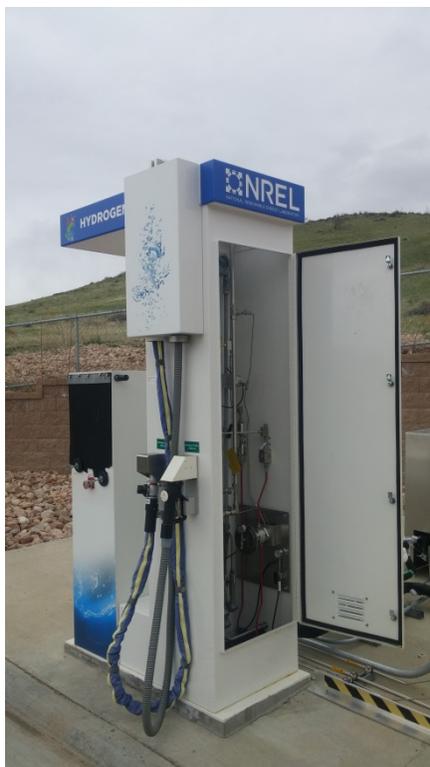
Figure 9. Fuel station dispenser. The internal pneumatic system is partially visible through the open panel.

The dispenser is shown in Figure 9. It consists of a roofless cabinet with two external fueling hoses and internal plumbing. The dispenser is the interface that delivers hydrogen from the storage tank, through the compressor, and into the vehicle. The dispenser transfers gas that is pressurized up to 875 bar and cooled to temperatures as low as -40°C . The tubing and components in the dispenser cabinet would be exposed to precipitation and the sun, as well as daily and seasonal temperature fluctuations.

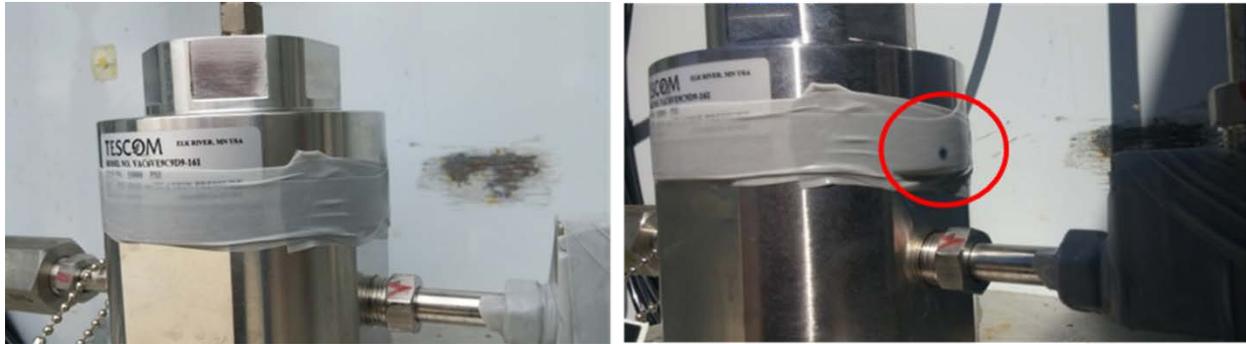
Figure 10. Indication 1: DetecTape indicator mounted on a valve (ID# 2015-07-08-008) showing before (left photo) and after (right photo) an indication.

Indication #1: ID# 2015-07-08-008 – This indication formed as a small, well-defined dot on DetecTape applied over the weep hole of a cone and thread fitting on a valve mounted in the Gas Management Panel. The valve was rebuilt and reinstalled into the Gas Management Panel. A replacement indicator (ID# 2015-11-13-043) was applied to this valve. Figure 10 shows DetecTape mounted on the valve before and after the indication. A function of the weep hole is to allow controlled venting of hydrogen that is released during normal operation of the component, thus this indication represents a normal phenomenon e.g., not a leak.

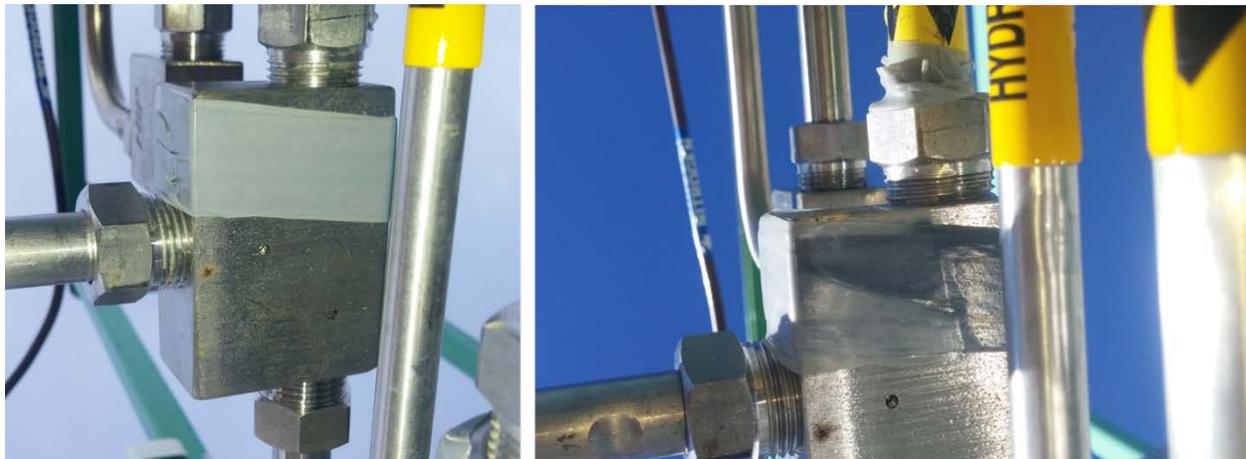
Figure 11. Indication 2: DetecTape mounted on a cone and thread fitting (ID# 2015-10-16-039) before (left photo) and after (right photo) indication.

Indication #2: ID# 2015-10-16-039 – This was a large and splotchy indication that formed over the weep hole of a cone and thread fitting mounted on the compressor. Figure 11 shows the DetecTape mounted on the valve before and after the indication. This indication was considered out-of-normal, and the leak was verified with a sniffer. The fitting was remounted on the pneumatic line, and a replacement indicator (ID# 2015-11-16-047) was applied to this fitting. The replacement indicator showed some coloration and is described below (Indication # 7), but this second indication was somewhat ambiguous and not clearly indicative of an out-of-normal hydrogen release.

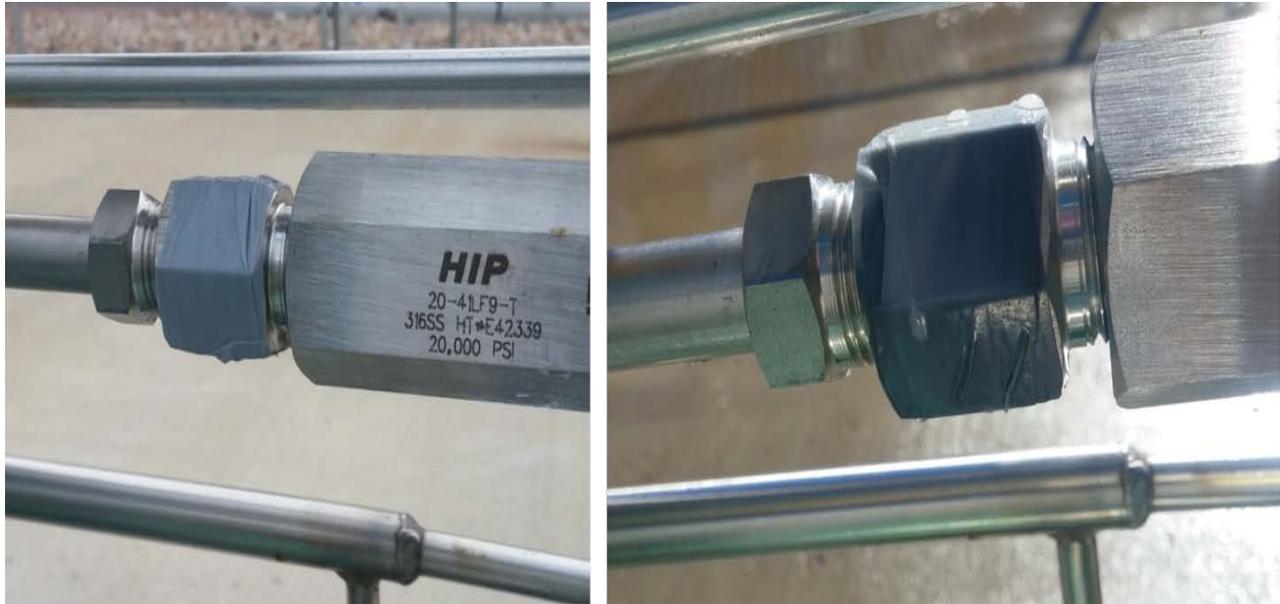
Figure 12. Indication 3: DetecTape mounted over the weep hole of a check valve with a cone and thread fitting on the compressor at the NREL hydrogen dispenser (ID# 2015-10-16-040), showing before (left photo) and after (right photo) the indication.

Indication #3: ID# 2015-10-16-040 – This indication formed over the weep hole of a check valve with a cone and thread fitting mounted on the compressor. This fitting and indication are shown in Figure 12. This indication was considered out-of-normal and was verified with a sniffer. The fitting was re-torqued, and a replacement indicator (ID# 2015-11-16-048) was applied to this fitting. The replacement indicator showed some coloration and is described below (Indication # 8), but this second indication was somewhat ambiguous and not clearly indicative of an out-of-normal hydrogen release.

A total of nine indications were observed. Of these, Indications 1, 4, 5, and 9 were considered normal.² These were seen from weep holes of cone and thread fittings (e.g., Figure 12). Most of the valve indications were due to very small releases of hydrogen seen as black dots on the indicator tape mounted over the weep holes. The hydrogen releases through the weep hole were miniscule and normal for this valve and did not pose a risk. In one case, however, the DetecTape clearly identified a hydrogen release on a valve that was out-of-normal (Indication #6). For this valve, the indication was much larger than those observed for a low-level release deemed acceptable (normal) for a cone and thread fitting weep hole. Overall, there were three clear “out-of-normal” indications (2, 3, and 6). There were two additional indications (Indications 7 and 8) that are probably associated with normal hydrogen releases that are being monitored to verify this assertion.

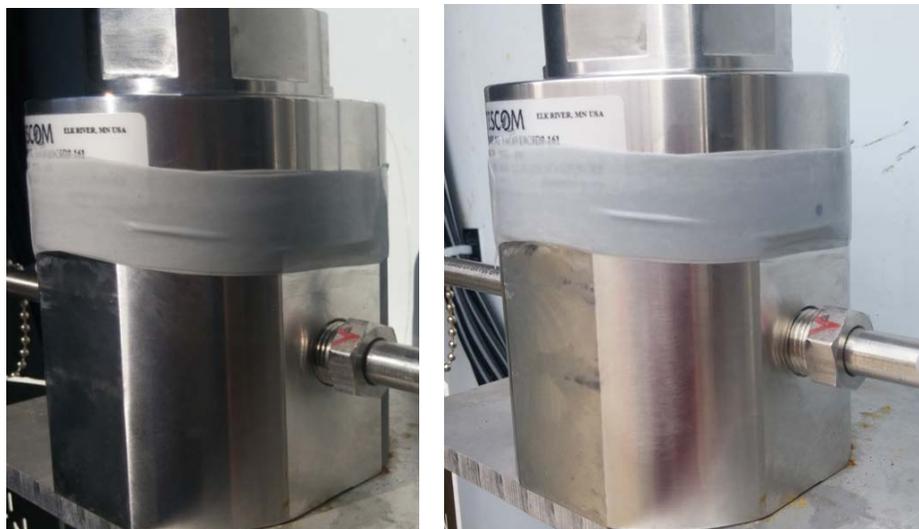
Figure 13. Indication 4: Indication formed over a weep hole of a cone and thread fitting (ID# 2015-11-13-043). This was ultimately determined to be a normal occurrence.

Indication #4: ID# 2015-11-13-043 – This indicator replaced indicator ID# 2015-07-08-008 (Indication #1). Although the two indications observed on this valve were ultimately considered to be normal, the valve was rebuilt following the first indication but prior to the application of the replacement indicator. The second indication formed again as a small confined dot over the weep hole of a cone and thread fitting on a valve located in the Gas Management Panel, as shown in Figure 13.

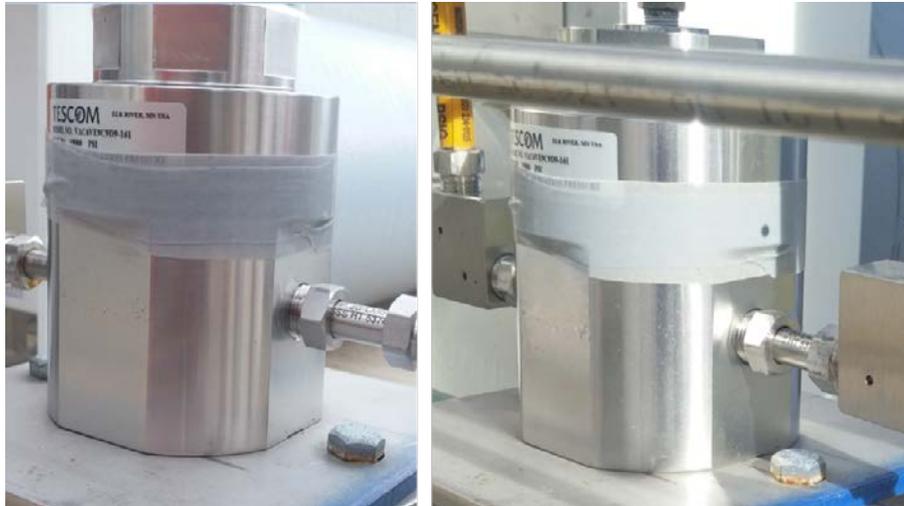
Figure 14. Indication 5: Before (left photo) and after (right photo) the indication (ID# 2015-11-16-045). This was considered to be a normal event.

Indication #5: ID# 2015-11-16-045 – This indication was formed as a small confined dot over the weep hole of a cone and thread fitting on a valve installed near the fuel storage tanks. This indication was considered to be normal. In this case, the indicator was left in place, and the valve was not rebuilt or re-torqued. This indication is shown in Figure 14.

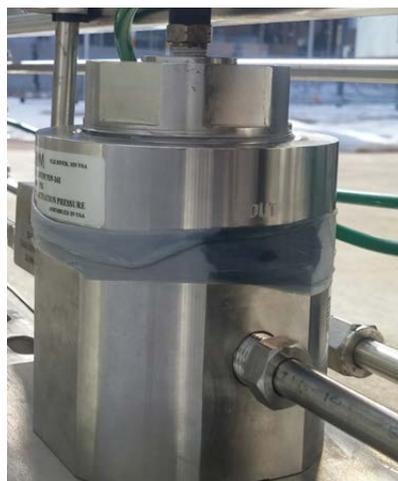
Figure 15. Indication 6: Indication formed on a valve (ID# 2015-11-16-046). This was an out-of-normal occurrence caused by a valve failure, resulting in maintenance of the valve.

Indication #6: ID# 2015-11-16-046 – This was a large and splotchy indication over the weep hole of a cone and thread fitting on a valve near the fuel storage tanks. Compared to normal indications on other fittings observed in this study, this indication was much larger, spreading out over the DetecTape. This indication clearly represented an out-of-normal hydrogen release that required the valve to be rebuilt. This indication is shown in Figure 15. Following valve maintenance, indicator ID# 2015-12-04-051 was applied to this fitting. No further out-of-normal indications were observed for this specific fitting.

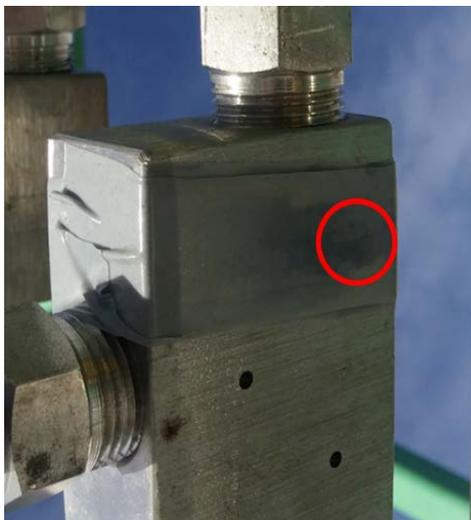
Figure 16. Indication 7: Slight coloration of the indicator (ID# 2015-11-16-047). This was the second indication observed on this fitting (Indication 2, corresponding to ID# 2015-10-16-039 shown in Figure 11). This was viewed as an ambiguous indication requiring continued monitoring to differentiate between normal and out-of-normal hydrogen releases.

Indication #7: ID# 2015-11-16-047 – This indicator replaced ID# 2015-10-16-039 (Indication #2). This indication was observed over the weep hole of a cone and thread fitting mounted on the compressor (Figure 16). Unlike the normal releases associated with other cone and thread fittings (e.g., Indication #5, Figure 14), it could not be unequivocally determined that this indication arose from a normal release or from a small but out-of-normal event. Because the color change was not as obvious as indications associated with out-of-normal releases (e.g., Indication #3, Figure 12), this indicator will continue to be monitored to determine if it transforms into an unambiguous indication and then it will be ascertained whether it is a normal or out-of-normal indication.

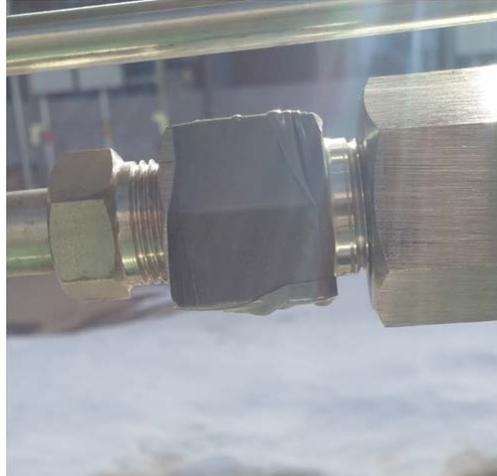
Figure 17. Indication 8: Slight coloration of the indicator (ID# 2015-11-16-048). This was the second indication observed on this fitting (Indication 3, corresponding to ID# 2015-10-16-040, shown in Figure 12). This is an ambiguous indication requiring further monitoring to verify if it is a normal or out-of-normal hydrogen release.

Indication #8: ID# 2015-11-16-048 – This indicator replaced ID# 2015-10-16-040 (Indication #3). The possible indication was seen as the initiation of a slight darkening of the pigment over the weep hole of a check valve with a cone and thread fitting mounted in the compressor (Figure 17). Although more pronounced than the indication associated with the weep hole on other cone and thread fittings (e.g., Indication # 5, Figure 14), the color change was not as obvious as other out-of-normal indications. This indicator will continue to be monitored to determine if it transforms into an unambiguous indication and then it will be ascertained whether it is a normal or out-of-normal indication.

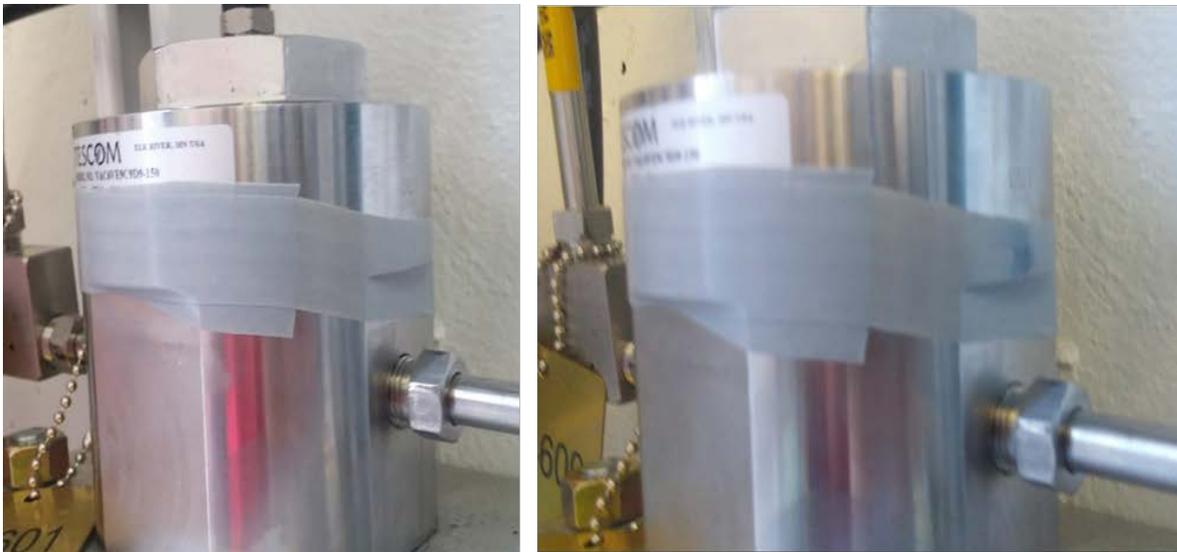
Figure 18. Indication 9: DetecTape mounted on a valve installed on a hydrogen system in the ESIF High Pressure Test Bay, showing before (left) and after (right) a normal indication (ID# 2015-11-16-050).

Indication #9: ID# 2015-11-16-050 –This indication was formed as a small confined dot on the weep hole of a cone and thread fitting on a valve in the high pressure test bay (PRD testing). This indication is considered to be normal; therefore, the indicator was left in place, and the valve was not rebuilt or re-torqued. This indication is shown in Figure 18.

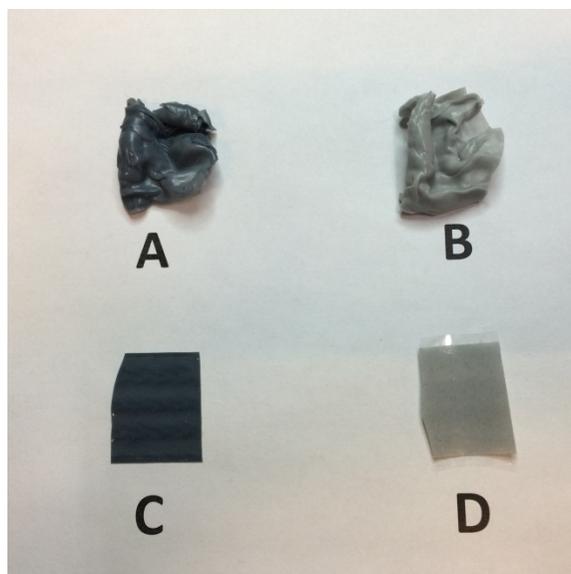
Figure 19: DetecTape samples deployed on the Gas Management Panel of the NREL Hydrogen Dispenser (A and B) compared to fresh samples (C and D). The deployment was from July 2015 until April 1, 2016. Samples A and C were exposed to 5.7 vol% H₂ in nitrogen under laboratory conditions, while Samples B and D are shown prior to laboratory hydrogen exposures. Sample A corresponds to deployment number 2015-07-08-013, and B corresponds to deployment number 2015-07-08-004.

The first indicator was deployed within this project on July 8, 2015, and additional samples were deployed over the duration of the project. The initial deployments remained in place until April 2016, when some of the initially deployed indicators were removed to verify functionality; this was done by subjecting the decommissioned samples to the Functionality Test. In outdoor deployments, the indicators were subjected to variable weather conditions, including dry, hot, sunny weather; extreme cold; rain; and snow. Table 2 identifies several indicators that were decommissioned (removed from deployment) to allow for laboratory testing. For each decommissioned indicator, a new indicator was applied over the fitting and assigned a new identification number, which are also listed in Table 2. The decommissioned indicators were all still active, as verified by the Functionality Test. Figure 19 shows a comparison of a decommissioned sample exposed to hydrogen (ID# 2015-07-08-013) to an unexposed sample (ID# 2015-07-08-004). Both samples were subjected to deployments of comparable duration and environmental conditions. The color change of a fresh sample is included in Figure 19. Thus, extended deployment and exposure to environmental extremes associated with the outdoor environment had no apparent adverse impact on functionality.

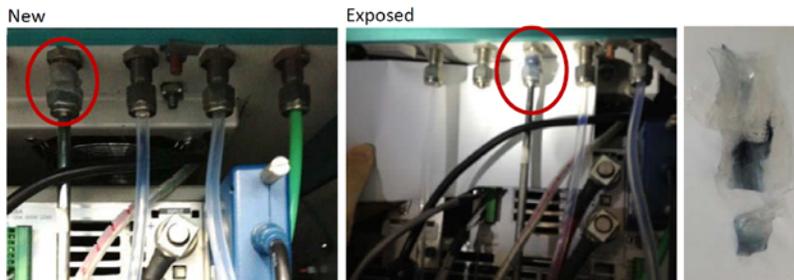
Figure 2: The Element One H₂ indicator deployed in a hydrogen test fixture. Left: Freshly deployed. Center: After approximately 1 week (note dark color). Right: Indicator removed, clearly showing discoloration.

Under an MOU with Element One, the NREL sensor laboratory deployed samples of the prototype tape with the irreversible form of indicator at multiple locations within an operational H₂ test fixture. A discoloration of the indicator was observed, but at only one deployment location, shown in Figure 2. It is to be noted that the leak was small and did not pose a safety hazard (there is an operational hydrogen sensor for safety monitoring within the system). Although previously undetected, subsequent inspection with a sensitive electronic H₂ leak detector confirmed the existence of the leak. The fitting was replaced and the system remains operational.
