Extended Pulse-Powered Humidity-Freeze Cycling for Testing Module-Level Power Electronics

NREL/SNL/BNL PV Reliability Workshops – Lakewood, CO February 28 – March 2, 2017
Peter Hacke, Miguel Rodriguez, Michael Kempe, and Ingrid Repins

NREL/PR-5J00-68846

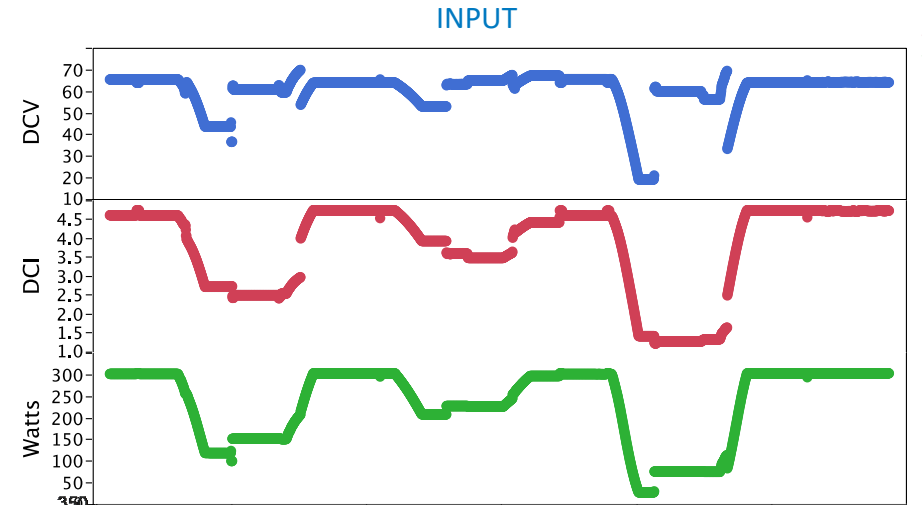
No significant difference between stressed and control samples in P_{max} tracking capability and efficiency

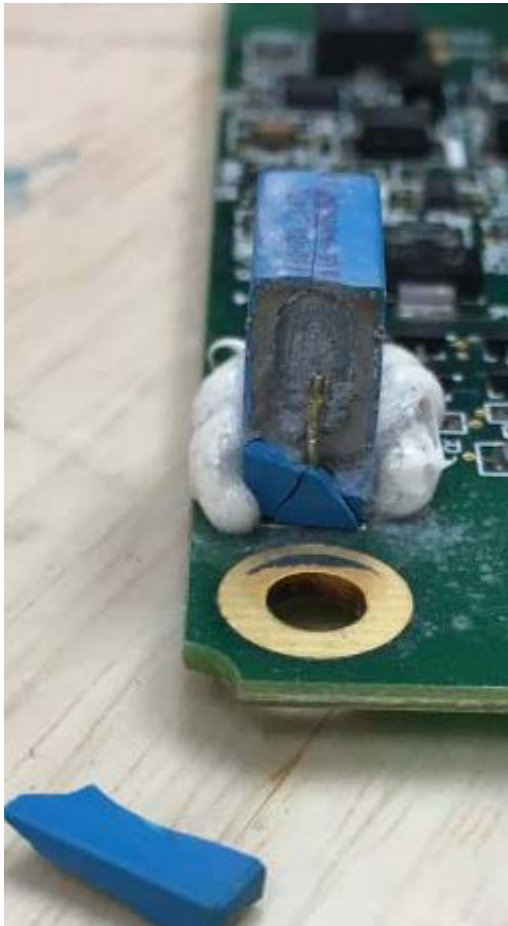
- Polypropylene film capacitor (MKP)
- EMI suppression
- Capacitor failed in an open circuit
- Appears on the input side, normally functions to suppress interference generated by the device from getting into the wiring
- Cracked open, powder falling out

- EMI suppression capacitor (polypropylene film type) failed by “popcorning” due to vapor outgassing in the pulse powered humidity-freeze cycles.
- No shorts or shunts could be detected despite mildly corroded metallization visible in the failed capacitor.
- Humidity-freeze cycling is optimized to break into moisture barriers. However, further studies will be done on additional MLPE devices to optimize the stress testing for condensation to precipitate any weakness to short circuiting and other humidity/bias failure modes.
