# Uptower Investigation of Main and High-Speed-Shaft Bearing Reliability

Jonathan Keller, Yi Guo, and Latha Sethuraman

*National Renewable Energy Laboratory*

**Technical Report**  
NREL/TP-5000-71529  
May 2019

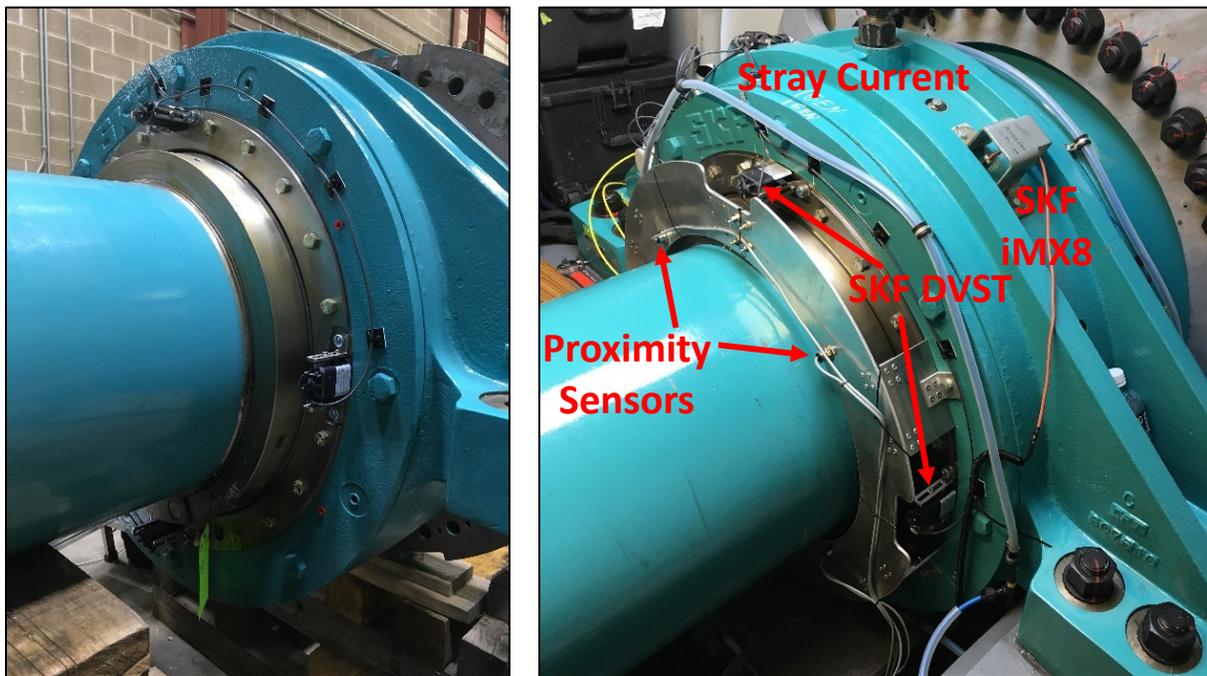
**Figure 1. SKF SRB-Wind main bearing (left) and instrumentation (right).** Photos by Jonathan Keller and Jerry Hur, NREL 49379 and 49959

The main bearing is a new SRB-Wind bearing model BS2-8115/C2H produced by SKF. Although similar to a standard 240/600 double-row series SKF Explorer SRB, its design was updated to optimize internal geometry, use a new cage, provide better sealing and improve lubrication [15]. It is housed in a SKF model HC-Z 7051 BF housing and was first filled with SKF Winter Grade LGWM2 grease in September 2017. The main bearing and associated instrumentation are shown in Figure 1.

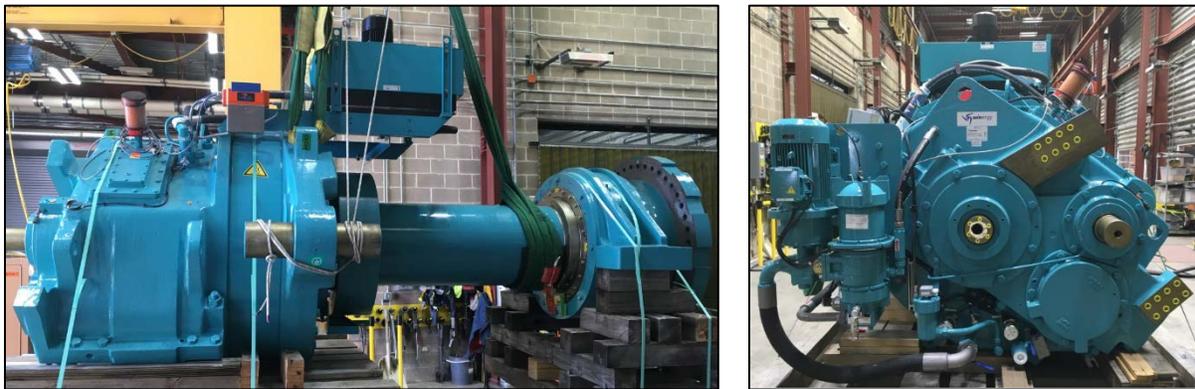
**Figure 2. Winergy PEAB 4410.4 gearbox side (left) and rear (right) view.** Photos by Jonathan Keller, NREL 49044 and 49045

The gearbox is a Winergy model PEAB 4410.4 produced by the Flender Corporation. It has a nominal power rating of 1,660 kilowatts (kW). With a gearbox ratio of 78.292, it increases a main rotor speed of 18.39 revolutions per minute (rpm) to an output shaft speed of 1,440 rpm. The gearbox is composed of a single planetary stage followed by two parallel stages with helical gearing. The test gearbox and main shaft, shown while in storage in Figure 2, were contributed by Flender to the project under CRADA CRD-17-694.

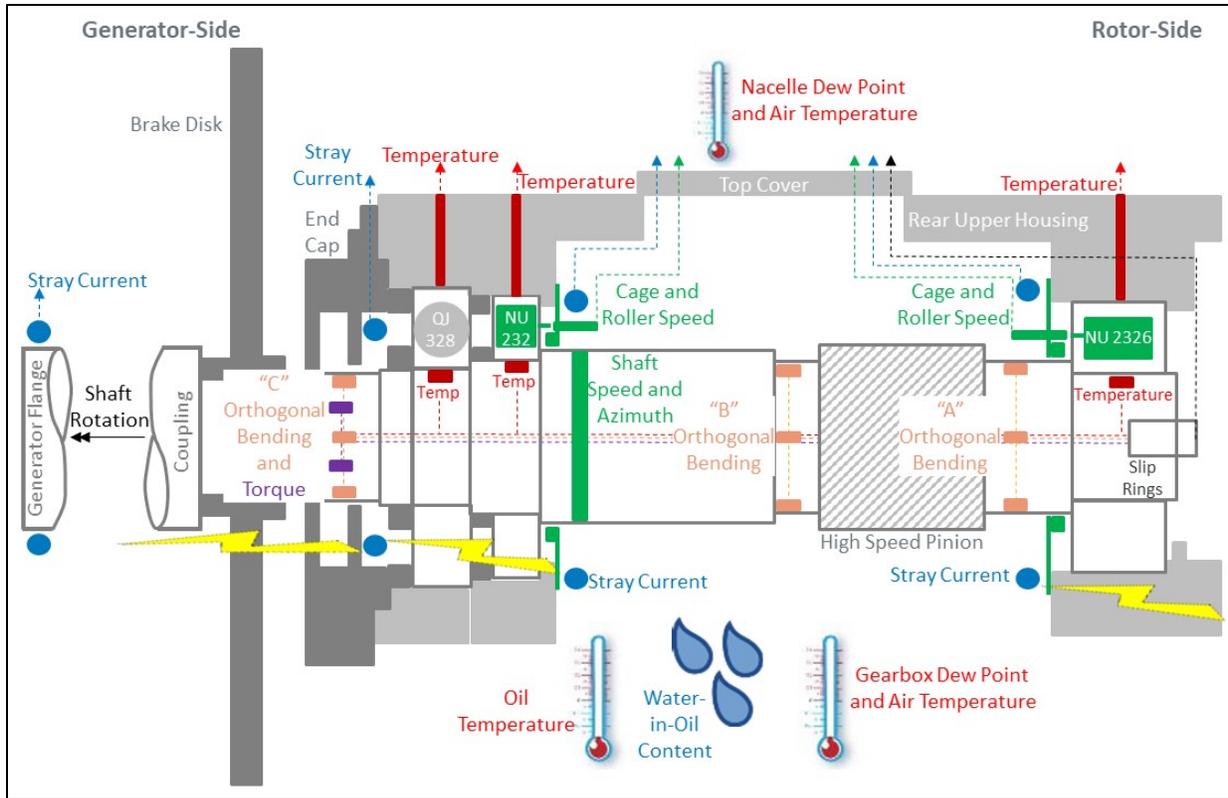
**Figure 3. High-speed-shaft instrumentation schematic**

The primary gearbox instrumentation is focused on the high-speed shaft (HSS) and support bearings [18] as shown in Figure 3. The shaft speed is measured with an encoder, and torque and bending moments are measured with strain gauges. The NU 2326 ECML/L4BC3 and NU 232 ECML/L4BC3 cylindrical roller bearings (CRBs) on the RS (or position “A”) and GS inboard (GS-in or position “B”) of the pinion, respectively, each have a magnetized roller and patented instrumentation developed by SKF. The bearings and these devices measure rolling element speed [19] and were contributed to the project by SKF GmbH under CRADA CRD-16-608. Commercial proximity switches detect the passing of a single metal pin in the cages each cage revolution, thus determining the average cage speeds over the revolution and indicating the precise circumferential position of the magnetized roller. Additional instrumentation measures the tribological environment of the RS and GS-in bearings and the outboard GS (GS-out or position “C”) bearing, including the bearing inner and outer ring temperatures, Amsoil PTN 320 lubricant temperature and water content, air temperature and humidity within the gearbox cavity with respect to the wind turbine nacelle, and any stray electrical current across the bearings.

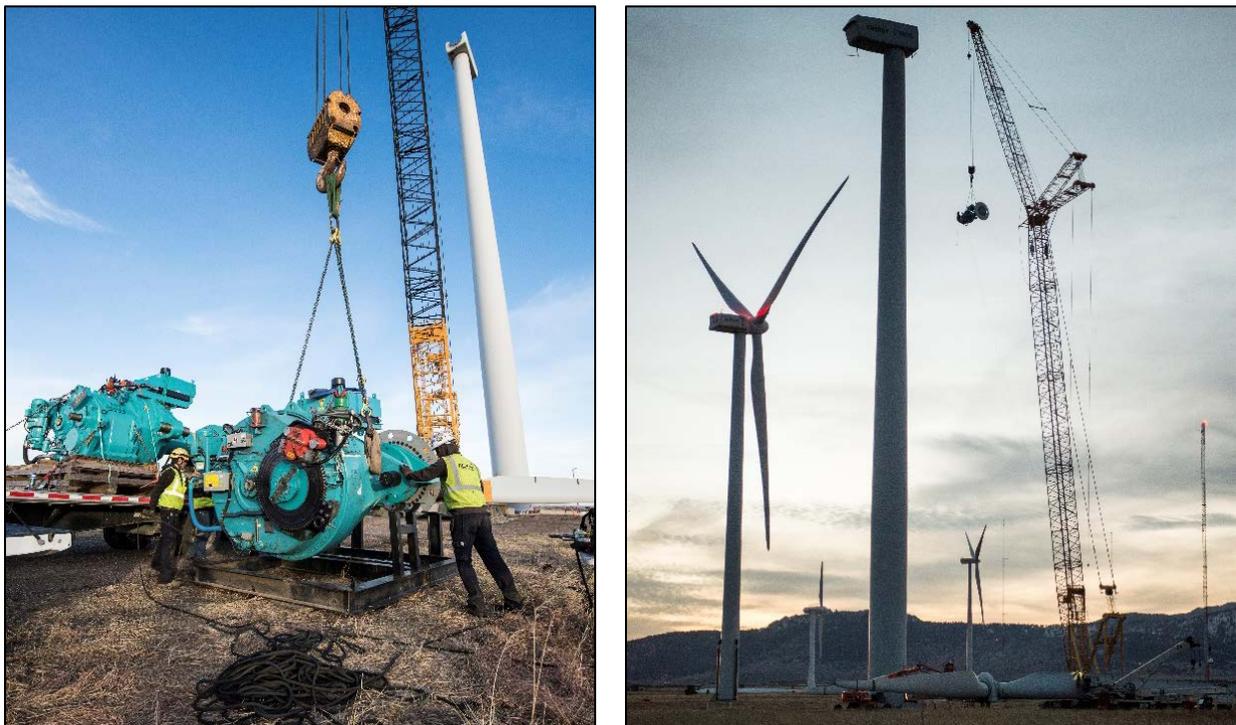
**Figure 4. Gearbox swap (left) and installation in turbine (right).** Photos by Dennis Schroeder, NREL 49409 and 49413

After production acceptance testing of the gearbox and instrumentation checkout at the Flender facility in September 2017 [12,18], the gearbox, main bearing, and main shaft were mated together. The assembled drivetrain was delivered to the NWTC on October 18. The exposed instrumentation on the main bearing and gearbox lubrication system were installed after delivery. The existing GE Transportation Services 7GA87E2 gearbox and main bearing were then removed and the new drivetrain was installed on December 16, 2017, as shown in Figure 4. This original drivetrain had produced approximately 6 million kilowatt-hours of energy in 14.17 thousand hours of grid operation time. After an additional maintenance procedure to replace the generator coupling and brake disk assembly, the turbine and new drivetrain were recommissioned on January 5, 2018.

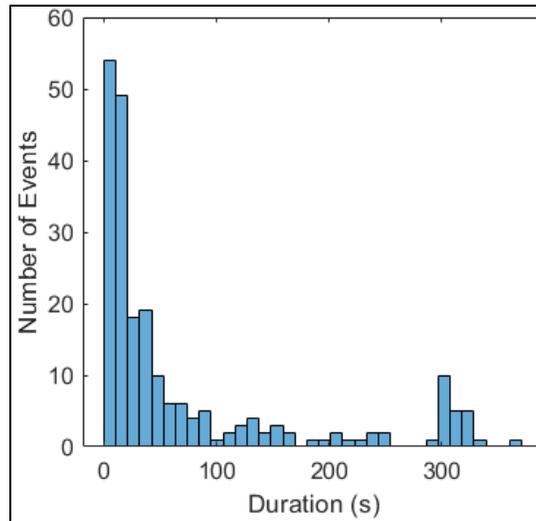
**Figure 5. Normal power production data acquisition durations**

For these recorded normal power production cases, the duration of each data acquisition varies as shown in Figure 5. Note that because of the focus on the drivetrain and the need for data collection at rates up to 5 kilohertz, the data acquisitions described in this report are mostly short in duration. They are not for the typical duration of 10 minutes; except for a few that lasted up to 5 minutes, the majority of the data acquisitions are less than 25 seconds (s) in length.

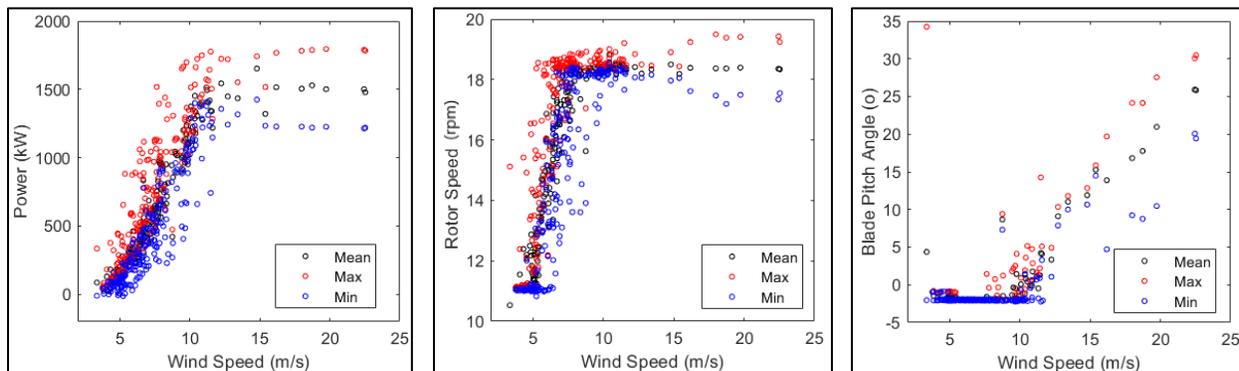
**Figure 6. Power (left), rotor speed (middle), and blade pitch angle (right) in normal power production**

The statistics for the turbine active power, rotor speed, and blade pitch angle for all the normal power production cases captured are shown in Figure 6. As listed in Table 2, most of the data were measured within a wind speed range from cut-in to the rated wind speed of 14 m/s [23], with a few events at wind speeds just below cut-out. Measured power ranged from near zero to as high as 1,800 kW. In the rated wind speed region, the rotor speed ranged from 17 to 19.4 rpm, although the average value is the rated rotor speed of 18.39 rpm.

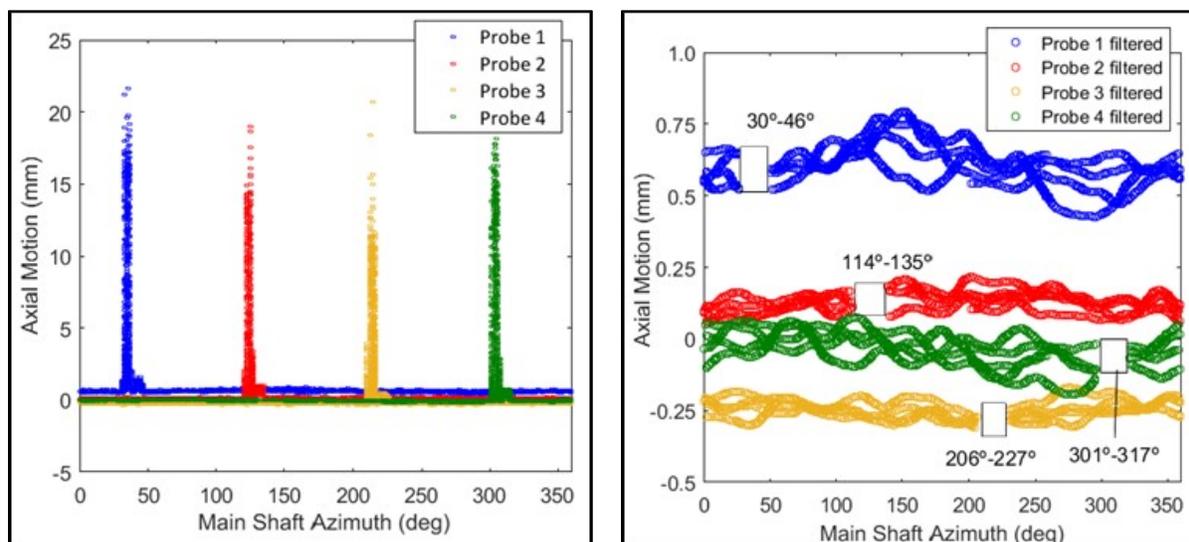
**Figure 7. Main bearing proximity probe raw (left) and filtered (right) measurements in a normal power production case**

Example main bearing proximity probe measurements are shown in Figure 7 (filename “DRC15\_fast\_2018\_04\_02\_16\_42\_18.h5”). Each measurement is shown with respect to the time-synchronized main shaft azimuth over multiple revolutions of the shaft. Normal measurement values are less than 1 millimeter (mm). Each measurement does show an excursion from these nominal values to 20 mm. This excursion is a result of a slot in the locknut, visible in Figure 1, and is not meaningful in and of itself. Because the probes are 90° apart, this excursion occurs at approximately 35°, 125°, 215°, and 305° azimuth values for probes 1, 2, 3, and 4, respectively. To make the proximity probe measurements more useful, the excursions can be selectively filtered out by using a window around these azimuths up to 30° in width. The resulting filtered signals are also shown in Figure 7.

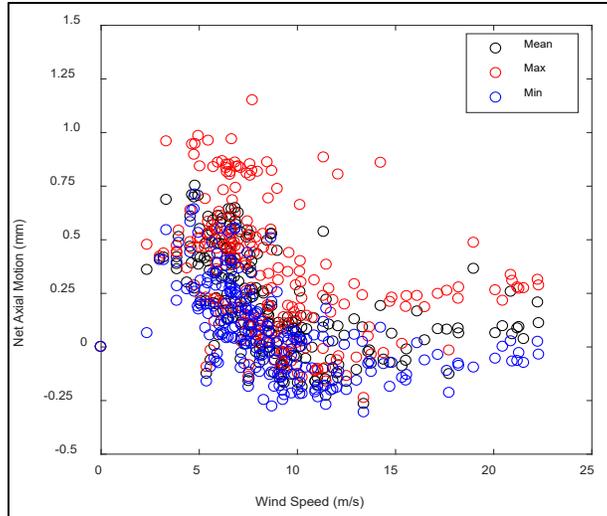
**Figure 8. Main shaft net axial motion in normal power production**

The filtered time-history data from each probe were further smoothed by applying a 0.1 s (500 point) moving average to remove short-term fluctuations. The net axial motion of the main bearing is then the instantaneous average of the smoothed time histories of each probe, excluding the periods where the filter has been applied to any probe. The descriptive statistics for the maximum, minimum, and mean of main bearing net axial motion across the range of normal power cases is shown in Figure 8. The net axial motion generally follows the same shape as the thrust curve for the turbine, with the maximum axial displacement occurring at the rated wind speed. Overall, the main bearing moves downwind (i.e., the distance decreases as the bearing moves closer to the probe) over 1 mm from its central resting position at very low wind speeds or in idling conditions to its position at the rated wind speed. The correlation between the range of motion and the turbulence intensity for each wind speed is being investigated.

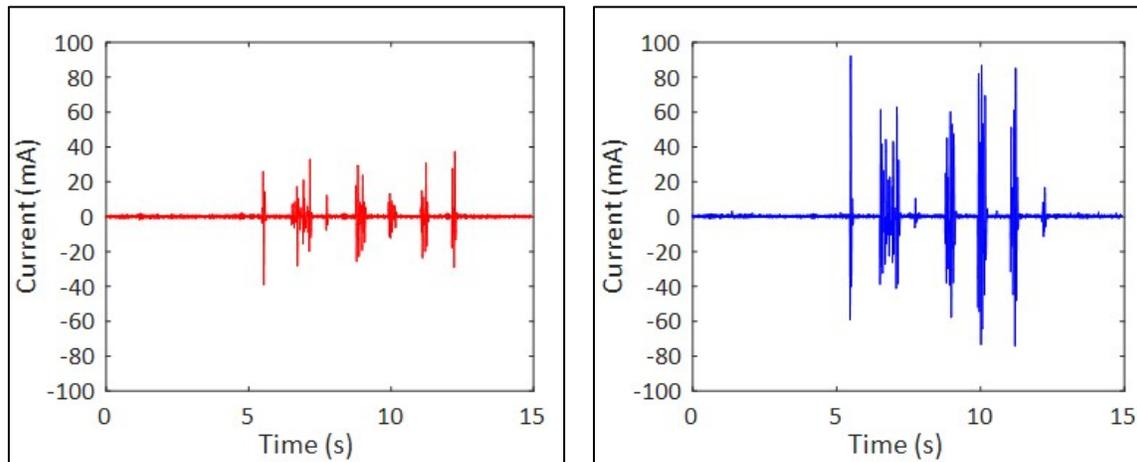
**Figure 9. Main bearing generator-side (left) and rotor-side (right) electrical current in a normal power production case**

Example time histories of stray electrical currents measured on both sides of the main bearing are shown in Figure 9 (filename “DRC15\_fast\_2018\_04\_02\_16\_42\_18.h5”). In general, these measurements exhibited noncontinuous, near-symmetric time-varying oscillations of current on the order of tens to hundreds of milliamper (mA).

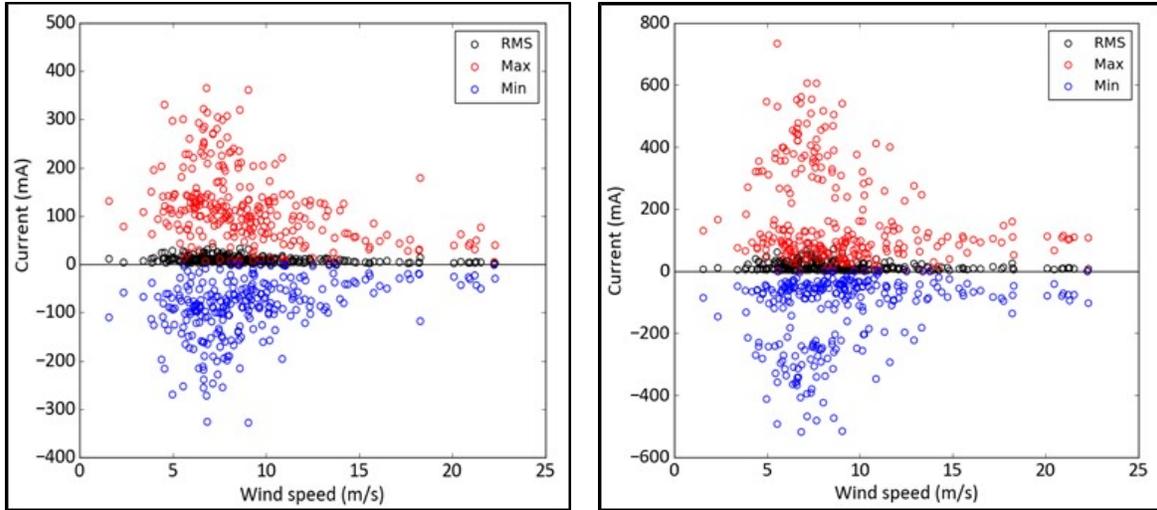
Figure 10. Main bearing generator-side (left) and rotor-side (right) stray electrical current in normal power production

The descriptive statistics for the maximum, minimum, and root-mean-square (RMS) level of main bearing electrical current across the range of normal power cases is shown in Figure 10. The correlation between these measurements and blade pitch motor activity [17] or other parameters is being investigated; however, the largest currents up to almost 800 mA were observed on the RS Rogowski coil in the variable speed operating region for the turbine from 3 to 14 m/s. The measurements on the GS coil are similar, but lower in magnitude. The RMS current is on the order of 10 mA because of the noncontinuous nature of the measurement as seen in Figure 9.

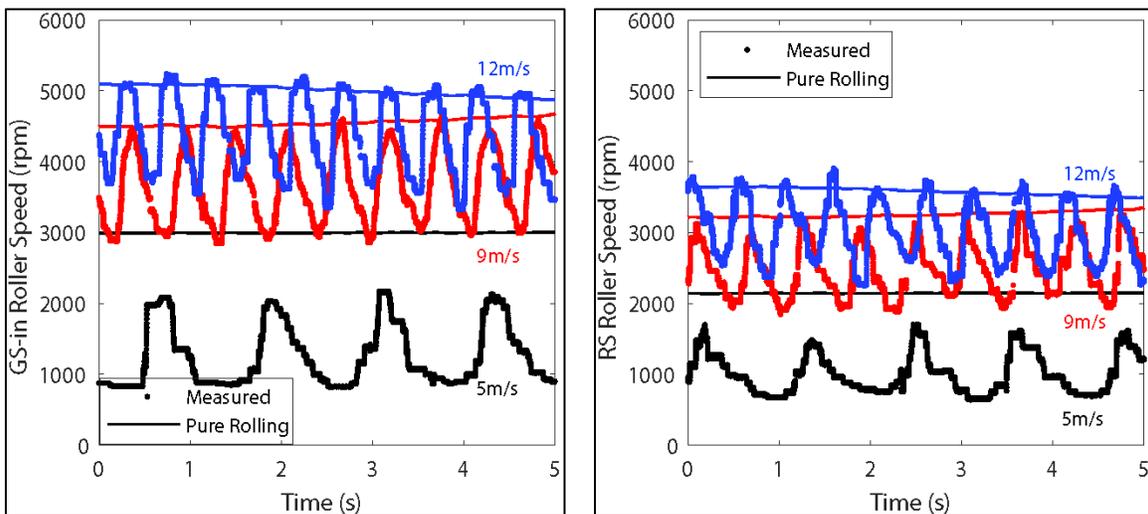
Figure 11. High-speed-shaft generator-side-in (left) and rotor-side (right) bearing roller speed in normal power production cases

Example 5-second time histories of the rotational speed of the rollers in the CRBs supporting the HSS are shown in Figure 11. Three different wind speed cases, 5 m/s, 9 m/s, and 12 m/s, are shown (filenames “DRC15\_fast\_2018\_04\_06\_17\_56\_34.h5”, “DRC15\_fast\_2018\_04\_10\_19\_20\_45.h5”, and “DRC15\_fast\_Normal\_power\_1500KW2018\_03\_04\_21\_55\_27.h5”). As expected, the measured roller speeds increase as the wind speed, drivetrain speed, and torque increase. In each case, the roller speeds exhibit roughly a sinusoidal behavior, in which the maximum roller speed is reached when the roller is in the bearing load zone. In this situation, it achieves a pure rolling condition as evidenced by the measured speed reaching the theoretical speed for the pure rolling condition. The maximum roller speed for the 12 m/s and 9 m/s cases reach the speed for pure rolling, while for 5 m/s it only reaches two-thirds of that value. As the rollers leave the load zone, they decelerate and the minimum roller speed typically occurs just prior to them re-entering the bearing load zone.

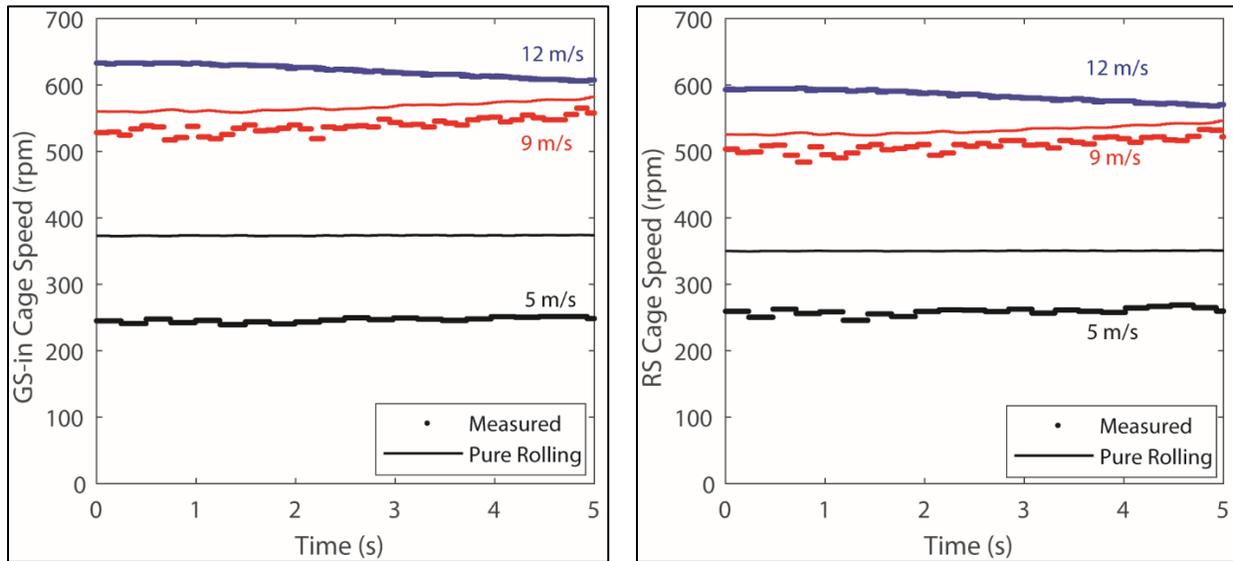
**Figure 12. High-speed-shaft generator-side-in (left) and rotor-side (right) bearing cage speed in normal power production cases**

Example time histories of both CRB cage speeds are shown in Figure 12 for the same conditions. In each case, the measured cage speed is nearly constant, as the measured HSS speed that determines the cage speed in pure rolling conditions is also nearly constant. The measured cage speed at 12 m/s wind speed is almost exactly equal to the theoretical speed, whereas the measured cage speed at 9 m/s is slightly less than the speed for pure rolling conditions. In contrast, the measured cage speed at 5 m/s wind speed is about two-thirds of the speed for pure rolling conditions. Like the roller speed results in Figure 11, this indicates that significant sliding of the rollers is occurring even within the bearing load zone.

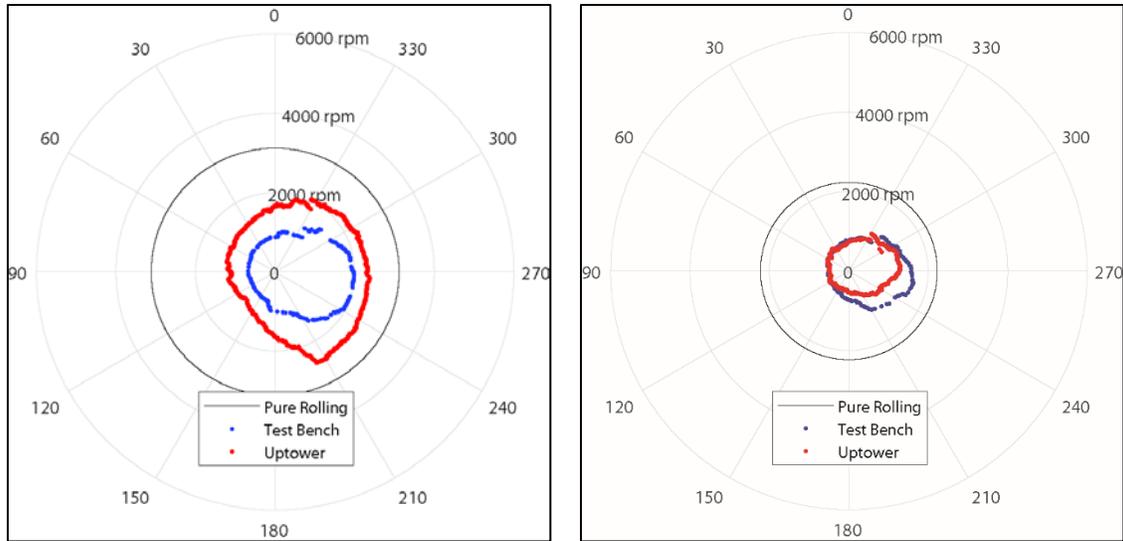
**Figure 13. High-speed-shaft generator-side-in (left) and rotor-side (right) bearing roller speeds at 900 rpm and 257 kW**

The bearing roller speeds can also be examined as they proceed around the circumference of the bearing with the cage as shown in Figure 13 to Figure 15. The orientation of the figure is viewed from the generator looking upwind toward the rotor with the rollers and cage rotating around the circumference in the counterclockwise direction. The applied forces to the bearing consist of a combination of the weight of the shaft, pointing downward, and the gear mesh force, pointing to the right for this gearbox [18]. For medium and higher load cases, the center of the bearing load zone points to the right at an azimuth of  $270^\circ$ , whereas for the lowest load cases gravity makes a greater contribution than the gear mesh force and the load zone points downward and to the right. The measured speeds from the uptower tests can be compared to the theoretical values for pure rolling conditions and the measurements acquired during previous production acceptance testing [18], which was conducted in steady-state conditions at three different drivetrain speeds and power settings. At the lowest 900 rpm and 257 kW setting shown in Figure 13, the measured roller speeds are much slower than the theoretical values, suggesting that every roller is sliding, even when the rollers are in the middle of the load zone.

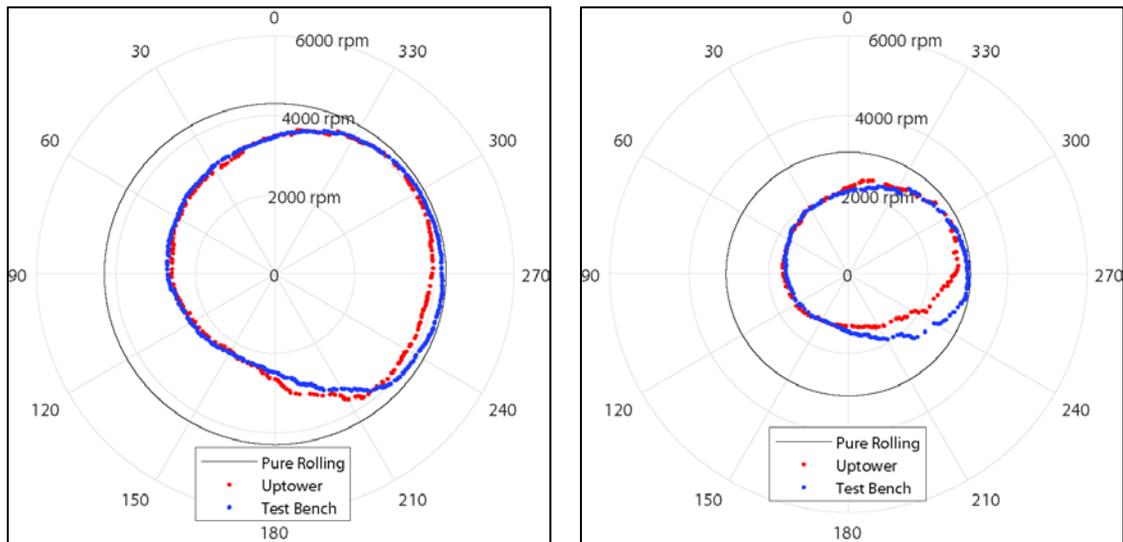
**Figure 14. High-speed-shaft generator-side-in (left) and rotor-side (right) bearing roller speeds at 1,220 rpm and 600 kW**

At the mid 1,220 rpm and 600 kW condition shown in Figure 14, the measured roller speeds briefly approach the theoretical values at the center of the load zone; however, aside from this point, the speeds are slower and indicate sliding in the rest of the load zone. There is also good correlation between the production acceptance and uptower test results, especially for the RS bearing.

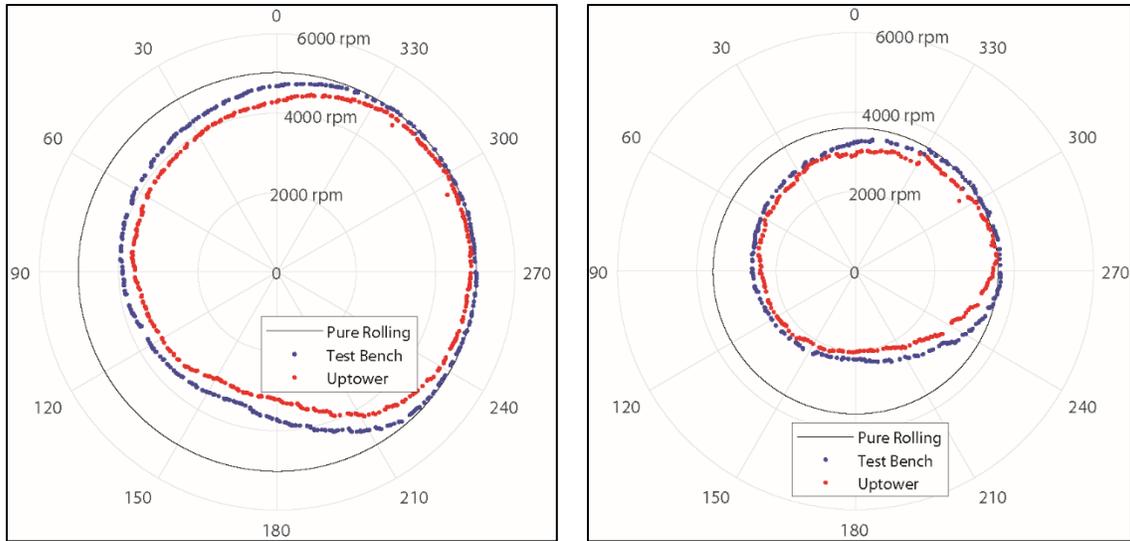
**Figure 15. High-speed-shaft generator-side-in (left) and rotor-side (right) bearing roller speeds at rated speed and power**

At the rated speed and power condition shown in Figure 15, the rollers are in pure rolling conditions for the almost the entire width of the load zone, which extends from approximately 195° to 345°. As the rollers leave the load zone near 345°, they slowly decelerate until they reach the re-entry to the load zone near 195°. The roller acceleration at the entrance to the load zone is very evident. The correlation between the test bench results and the uptower measurements is also very good for both bearings.

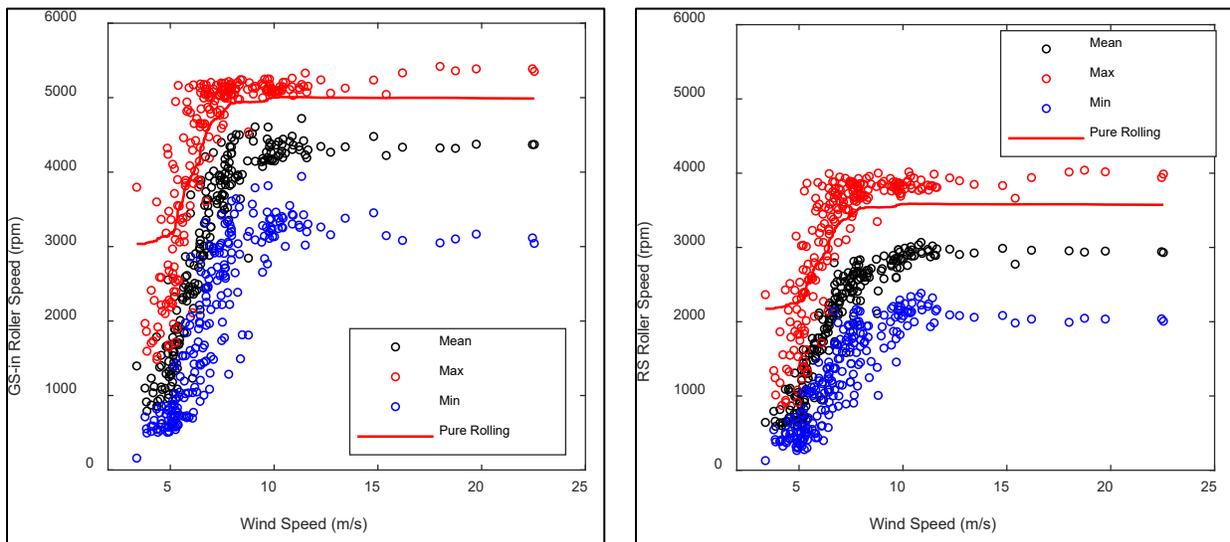
**Figure 16. High-speed-shaft generator-side-in (left) and rotor-side (right) bearing roller speed in normal power production**

The maximum, mean, and minimum values of the roller and cage speeds for the GS-in and RS bearings across all the normal power cases are shown in Figure 16 and Figure 17, respectively. As shown in Figure 16, the maximum measured roller speed values do achieve pure rolling conditions relatively quickly, except for the very slowest wind speed conditions of less than 5 m/s. Because the measured rotor speed frequently exceeds the rated rotor speed, as shown in Figure 6, the maximum measured roller speed also exceeds the value assumed for rated conditions. The minimum roller speed is typically three-fifths (60%) of the pure rolling condition at more than 8 m/s wind speed; however, it decreases to approximately one-third (33%) at the slowest wind speeds.

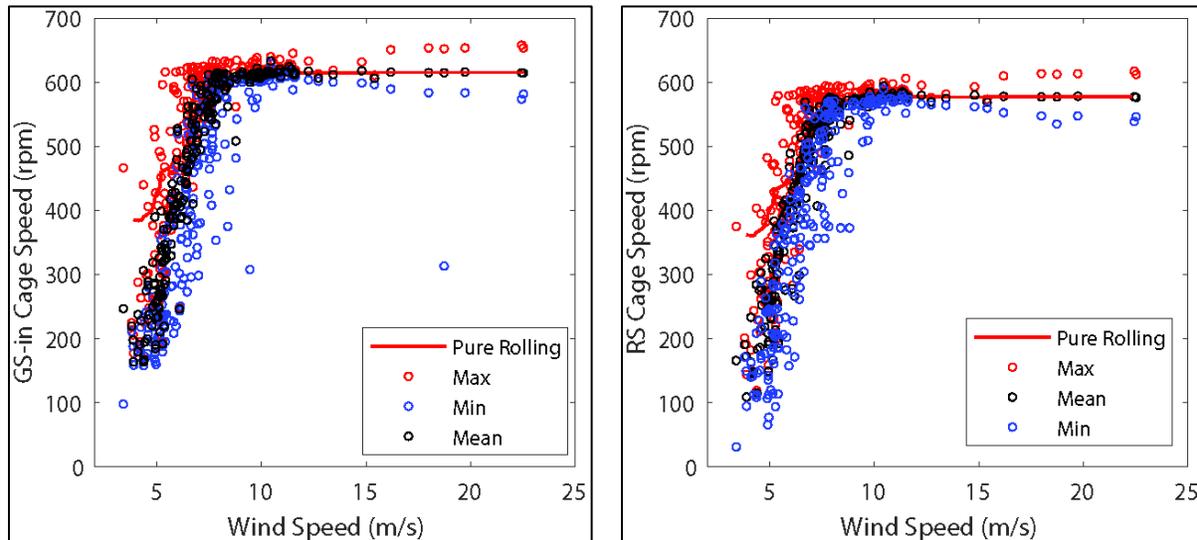
**Figure 17. High-speed-shaft generator-side-in (left) and rotor-side (right) bearing cage speed in normal power production**

As shown in Figure 17, the measured cage speed typically matches the speed for pure rolling conditions when the wind speed is more than 8 m/s. However, at less than this wind speed, the cage speed decreases and the amount of sliding in the roller set increases.

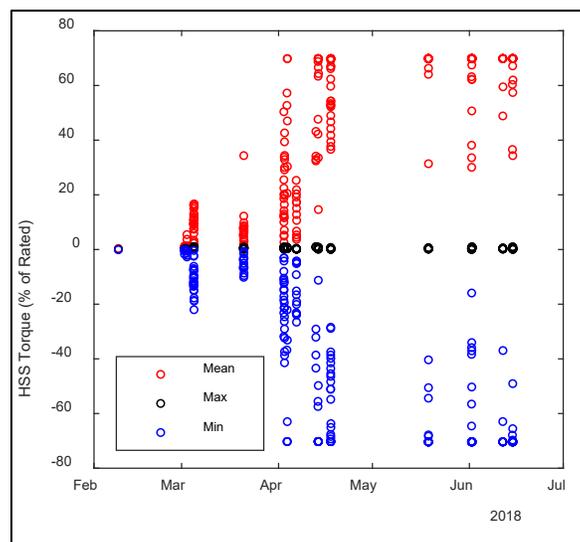
**Figure 18. Unfiltered high-speed-shaft torque in normal power production**

The HSS torque and bending moments are presented in this section, calculated from calibration measurements acquired from bench testing [18]. The processed statistics for the HSS torque from the normal power production cases are shown in Figure 18. Unfortunately, the torque and bending moments became increasingly dominated by noise, likely because of degradation of the slip ring or associated wiring during the test period. By the beginning of March, interpretation of a single value or a time history of these signals is no longer possible as the maximum values are many times the rated values. After April, the maximum values have become saturated by noise.

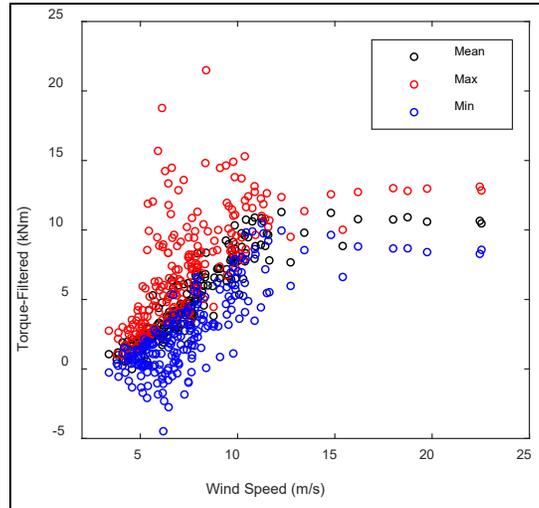
**Figure 19. Filtered high-speed-shaft torque in normal power production**

Various physical troubleshooting steps have to date been unsuccessful in removing the signal noise. However, various signal filters have been applied to yield some reasonable HSS torque and bending moment results. Figure 19 shows the same torque statistics after a 1-Hz low-pass filter and moving mean was applied. The filtered torque increases with wind speed from cut-in to 12 m/s at which point it reaches its rated value of slightly more than 10 kilonewton-meter (kNm).

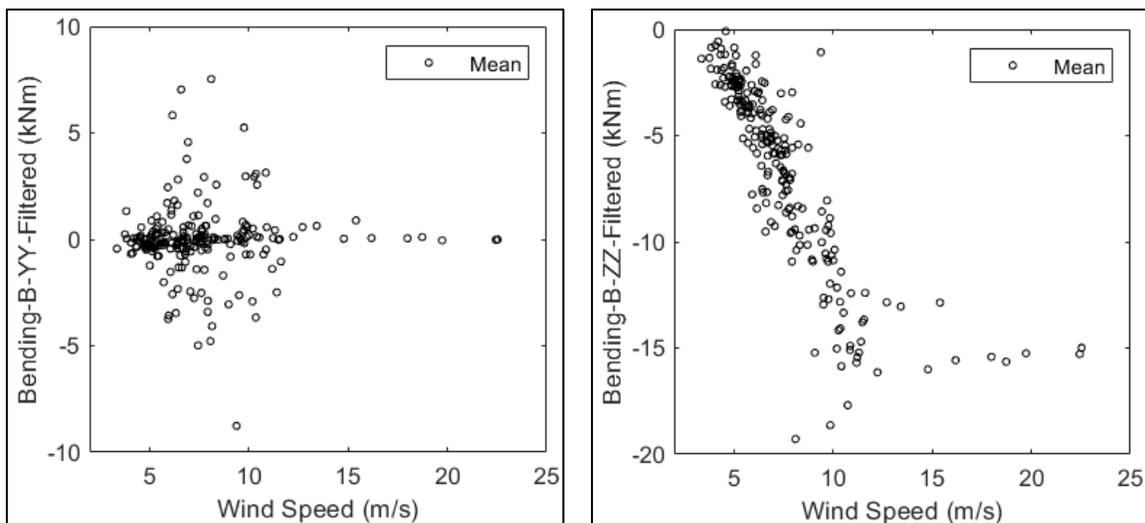
**Figure 20. Filtered high-speed-shaft Y (left) and Z (right) bending moment at B in normal power production**

Applying the same low-pass filter to the bending moments yields the statistics shown in Figure 20 and Figure 21 for two other locations on the HSS, in the fixed coordinate system. Similar to the bearing designations of A through C, the terminology A, B, and C has been used to indicate the location of the bending moments from the RS to the GS. The A and B strain gauges are just upwind and downwind of the HS pinion, while the C strain gauges are just downwind of the GS-out bearing. As shown in Figure 20 for the B strain gauges, the torque and the resulting tangential component of the gear mesh force result in a clear negative moment about the vertical (Z) direction and very little moment about the lateral (Y) direction.

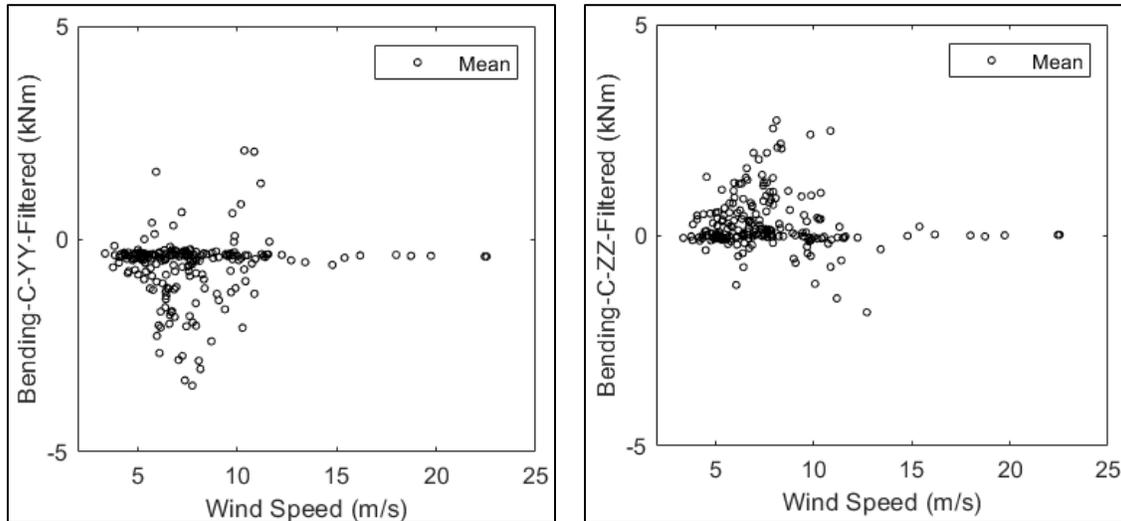
Figure 21. Filtered high-speed-shaft Y (left) and Z (right) bending moment at C in normal power production

As shown in Figure 21, the bending moments at C are far fewer than the bending moments at B. Because the C strain gauges are downwind of the GS-out bearing, they are not influenced by the gear mesh force. Instead, they only experience moments induced from motion of the gearbox and the generator coupling stiffness.

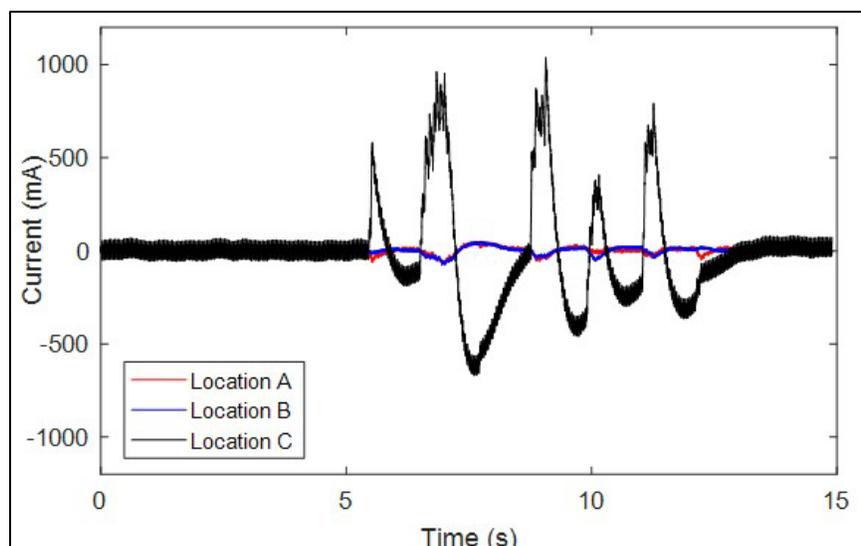
Figure 22. Gearbox and generator stray electrical current in a normal power production case

Example time histories of stray electrical currents measured in the gearbox are shown in Figure 22 (filename “DRC15\_fast\_2018\_04\_02\_16\_42\_18.h5”). In general, these measurements exhibit a different behavior than the main bearing electrical currents shown in Figure 9. For the electrical current measurements, location A is just upwind of the pinion, location B is just upwind of the GS-in bearing, and location C is just downwind of the GS-out bearing. The current measured at location C is up to 1,000 mA (1 A). Electrical currents at locations A and B are much lower.

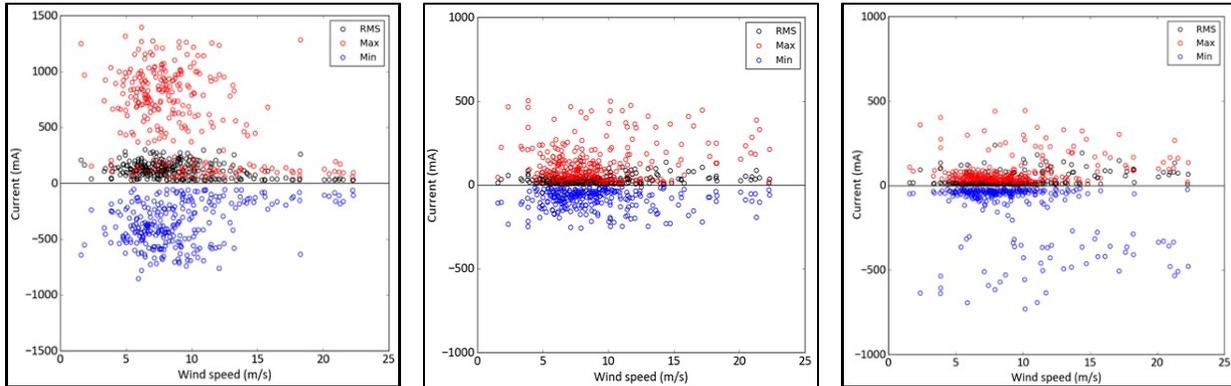
**Figure 23. High-speed-shaft generator-side-out (left), generator-side-in (middle), and rotor-side (right) stray electrical current in normal power production**

The descriptive statistics for the maximum, minimum, and RMS level of gearbox electrical current at each location across the range of normal power cases is shown in Figure 23. The correlation between these measurements' other parameters is being investigated; however, the largest currents up to 1.5 A were observed in the variable speed operating region for the turbine from 3 to 12 m/s.

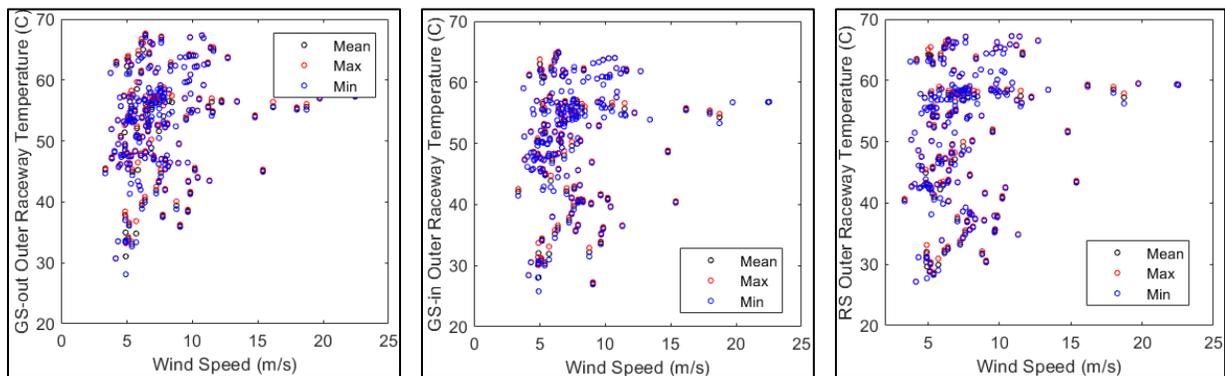
**Figure 24. High-speed-shaft generator-side-out (left), generator-side-in (middle), and rotor-side (bottom) bearing outer raceway temperature in normal power production**

The gearbox bearing and air temperature measurements are presented in this section. Like the load measurements, the HSS CRB inner ring measurements became increasingly dominated by noise after January because they are transmitted by the same slip ring. However, the outer ring measurements shown in Figure 24 are acquired by contact probes and provide useable results for the entire test period. Like the speed and loading behavior of the bearings, the temperatures follow the same behavior as the power curve. The maximum temperature of the outer ring for each bearing is less than 70°C. The lowest bearing temperatures are approximately 25°C, occurring just after cold starts in the early portions of the test in January through March.

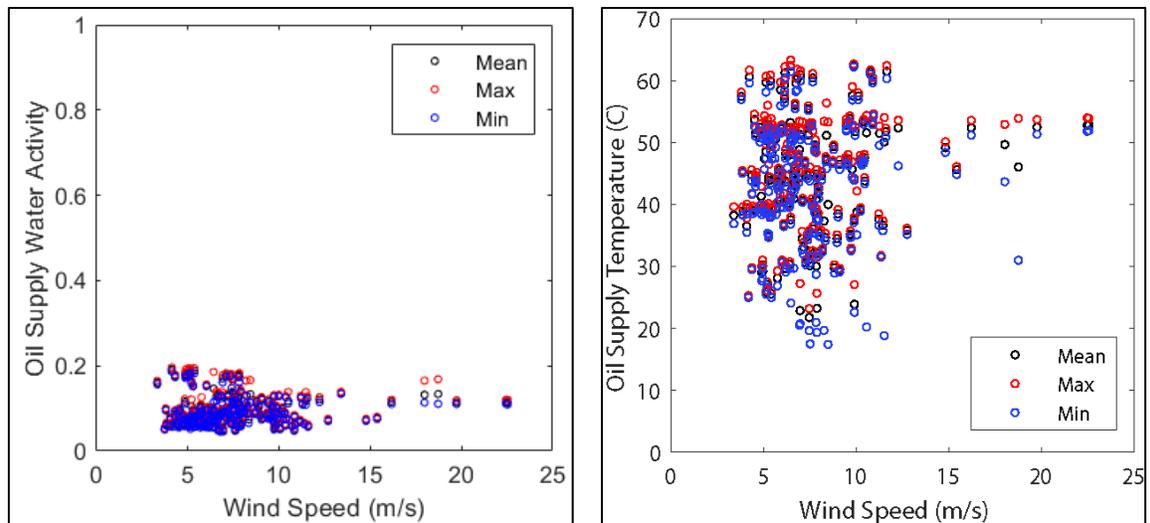
**Figure 25. Gearbox oil water activity (left) and temperature (right) in normal power production**

The gearbox water activity, a measure of the amount of water in the gearbox oil supply, is shown in Figure 25. The measured water activity was less than 0.2 for the entire test period, indicating that the oil has little dissolved water content. Oil temperatures ranged from quite cold conditions as low as 15°C after startups in the winter months to as high as 65°C.

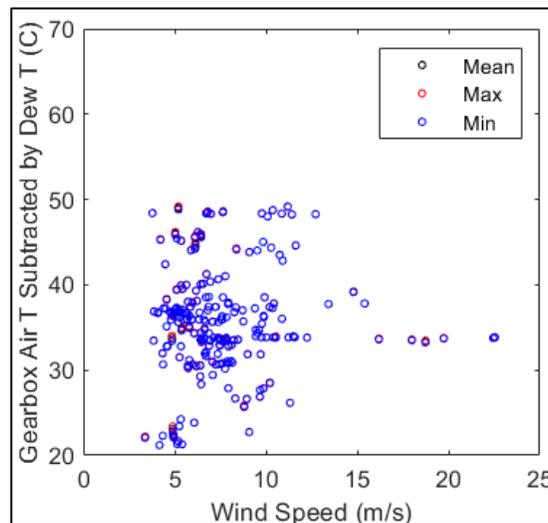
**Figure 26. Gearbox air and dew point temperature difference during normal power production**

Finally, the difference between the gearbox air and dew point temperatures is summarized in Figure 26. The air temperature is anywhere from 20°C to 50°C above the dew point, indicating that at least while in normal power production conditions there is no water vapor that would be condensing within the gearbox itself.

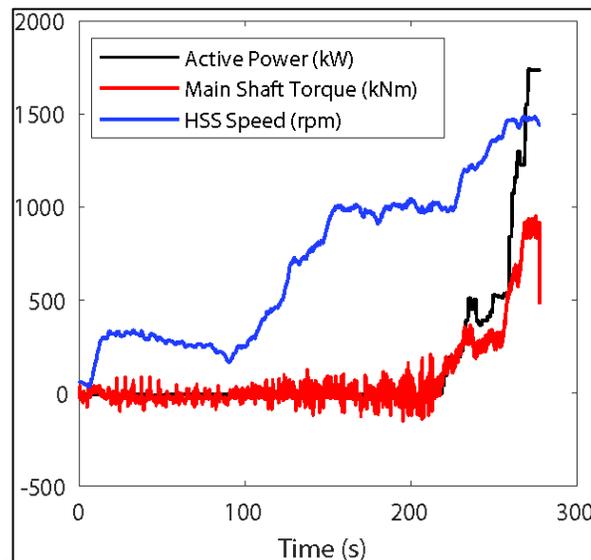
**Figure 27. Main shaft torque and speed during a normal startup**

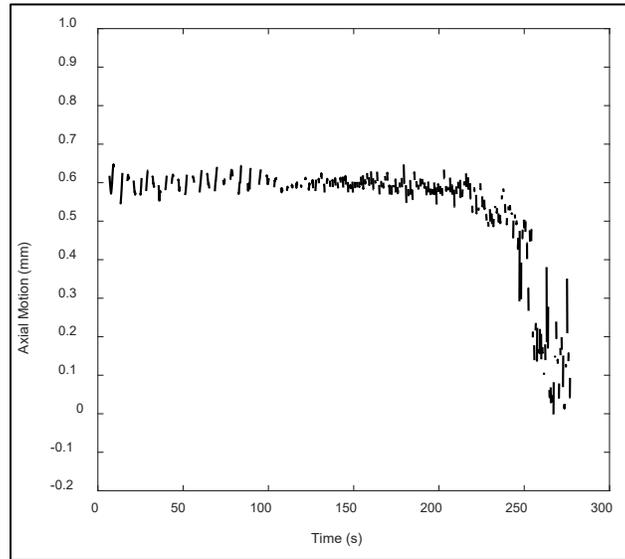
**Figure 28. Main bearing axial motion during a normal start-up**

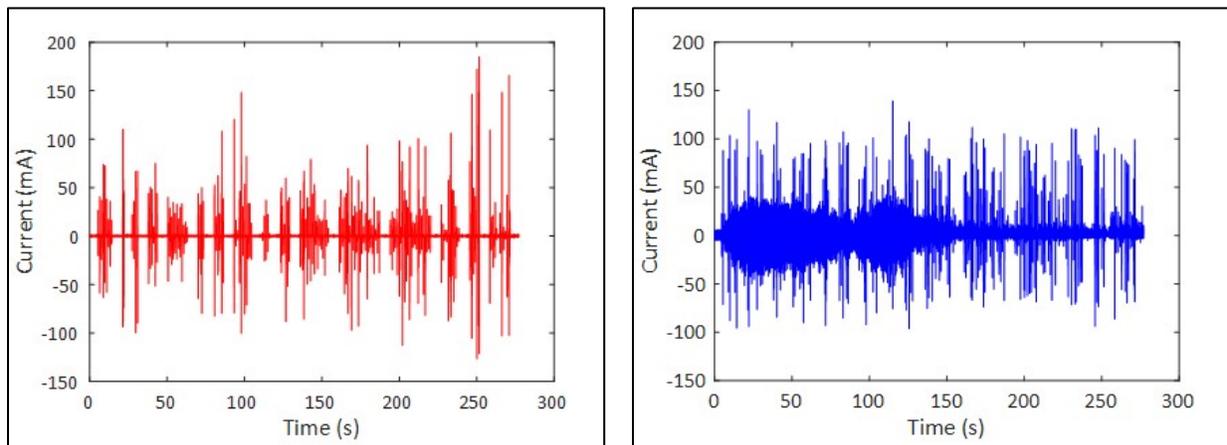
**Figure 29. Main bearing generator-side (left) and rotor-side (right) stray electrical current during a normal start-up**

The electrical current measurements through the main bearing during this start-up event are shown in Figure 29. Currents of up to 200 mA were observed throughout the event, regardless of the engagement of the generator, which occurs at approximately 200 s as shown in Figure 27.

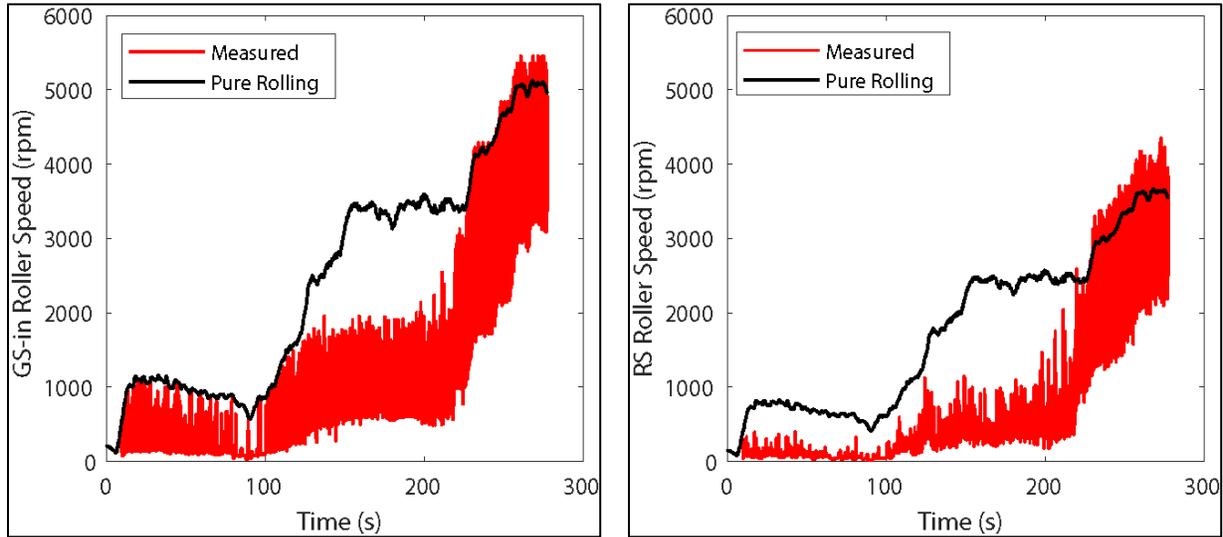
**Figure 30. High-speed-shaft generator-side-in (left) and rotor-side (right) bearing roller speed during a normal start-up**

Figure 30 and Figure 31 show the HSS bearing roller and cage speeds, respectively. In each figure, the measured values are compared to the theoretical value for the pure rolling condition in the bearing. Pure rolling conditions are only achieved when the bearings are loaded by the drivetrain torque. Without appreciable load, the rollers have a combination of rolling and sliding with the bearing races. In extreme low-load conditions, the rollers cease to rotate and simply slide against the races. Prior to the engagement of the generator, the roller and cage speeds for both bearings are well below their theoretical values for pure rolling conditions. For a portion of

the rotation, the minimum measured roller speed is close to pure sliding conditions (that is, a roller speed of zero). After engagement of the generator, the maximum measured roller speed and cage speed for each bearing quickly reach the theoretical value for pure rolling conditions in the bearing load zone. The same behavior can be seen in the measured cage speeds during the event. In comparing the two bearings, the GS-in bearing demonstrates lower sliding than the RS bearing.
