# Uptower Investigation of Main and High-Speed-Shaft Bearing Reliability

Jonathan Keller, Yi Guo, and Latha Sethuraman

*National Renewable Energy Laboratory*

**Technical Report**  
NREL/TP-5000-71529  
May 2019

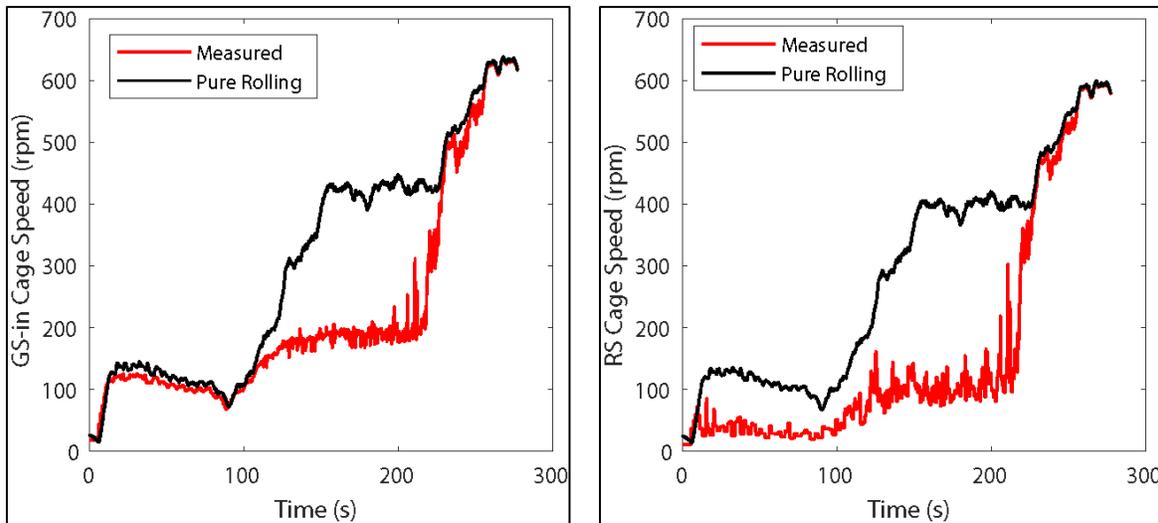
**Figure 31. High-speed-shaft generator-side-in (left) and rotor-side (right) bearing cage speed during a normal start-up**

Figure 30 and Figure 31 show the HSS bearing roller and cage speeds, respectively. In each figure, the measured values are compared to the theoretical value for the pure rolling condition in the bearing. Pure rolling conditions are only achieved when the bearings are loaded by the drivetrain torque. Without appreciable load, the rollers have a combination of rolling and sliding with the bearing races. In extreme low-load conditions, the rollers cease to rotate and simply slide against the races. Prior to the engagement of the generator, the roller and cage speeds for both bearings are well below their theoretical values for pure rolling conditions. For a portion of

the rotation, the minimum measured roller speed is close to pure sliding conditions (that is, a roller speed of zero). After engagement of the generator, the maximum measured roller speed and cage speed for each bearing quickly reach the theoretical value for pure rolling conditions in the bearing load zone. The same behavior can be seen in the measured cage speeds during the event. In comparing the two bearings, the GS-in bearing demonstrates lower sliding than the RS bearing.

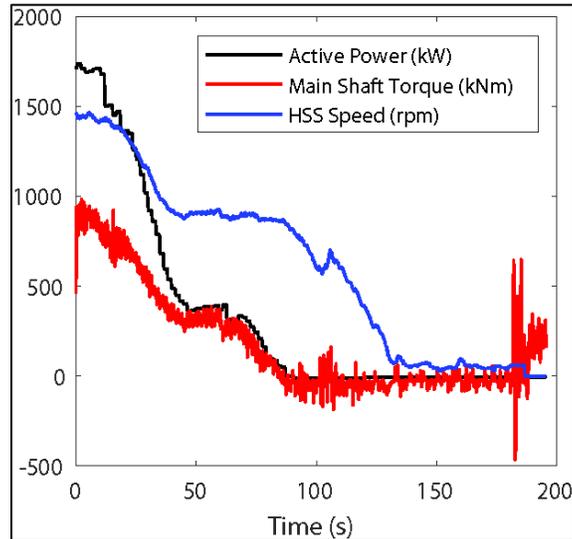
**Figure 32. High-speed-shaft torque and speed during a normal shutdown**

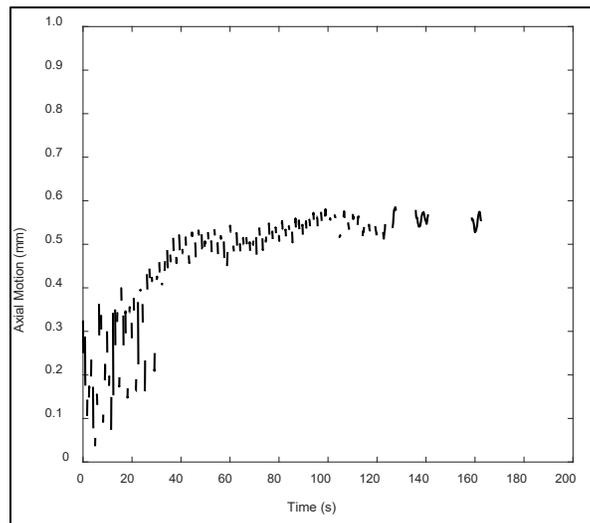
**Figure 33. Main bearing axial motion during a normal shutdown**

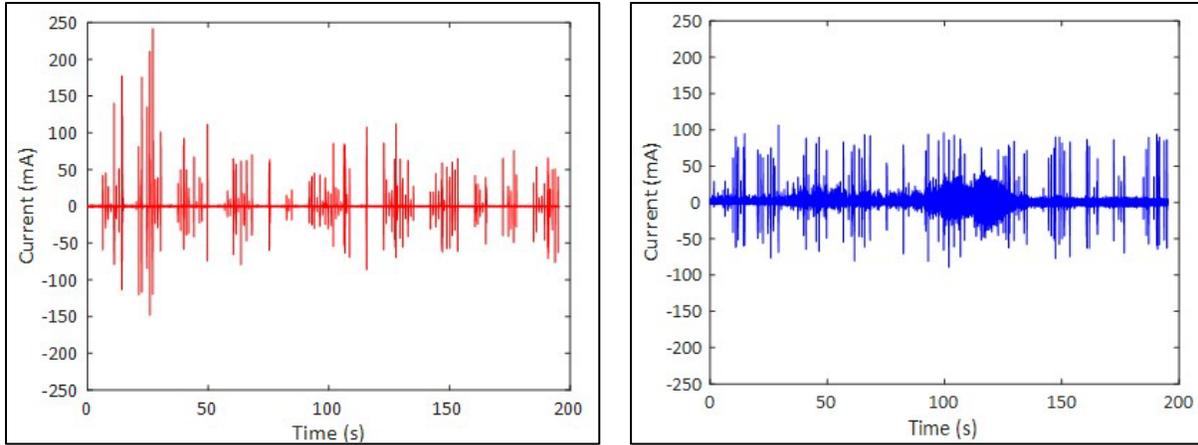
**Figure 34. Main bearing generation-side (left) and rotor-side (right) stray electrical current during a normal shutdown**

The electrical current measurements through the main bearing during this shutdown event are shown in Figure 34. Like the startup, currents of up to 200 mA were observed throughout the event, regardless of the engagement of the generator. They continue even after the rotor has come to a complete stop.

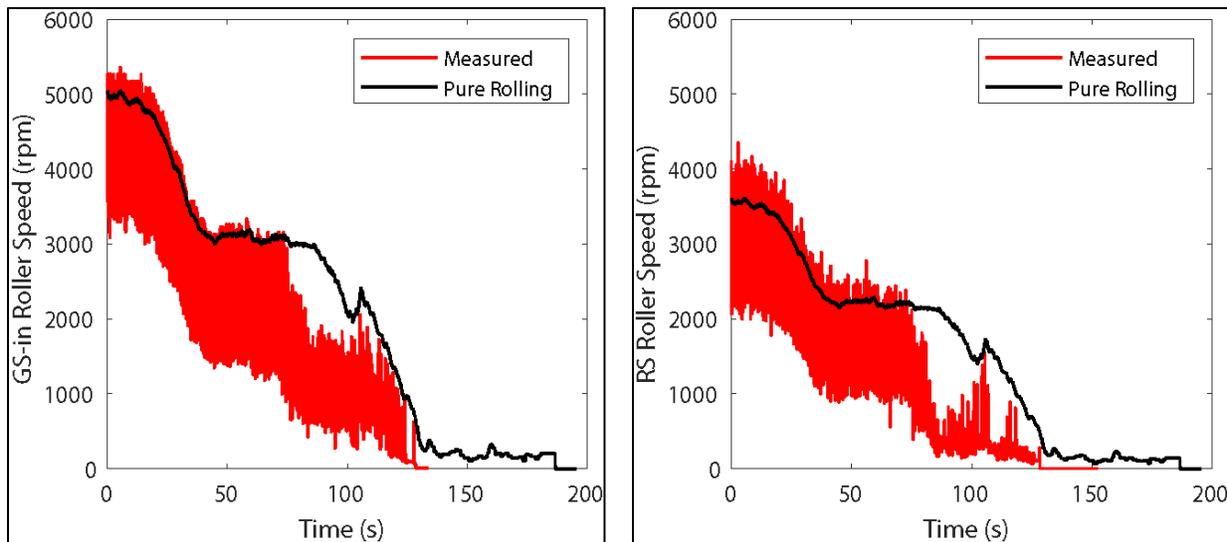
**Figure 35. High-speed-shaft generator-side-in (left) and rotor-side (right) bearing roller speed during a normal shutdown**

Figure 35 and Figure 36 show the HSS bearing roller and cage speeds during the shutdown, respectively. Prior to the disengagement of the generator, the maximum measured roller and cage speeds for both bearings reach their theoretical values, indicating conditions of pure rolling in the bearing load zone. After disengagement of the generator, the measured roller speeds decrease with the minimum reaching almost pure sliding conditions. Like the start-up event, the GS-in bearing demonstrates less sliding than the RS bearing in terms of both the measured roller speed and the measured cage speed.

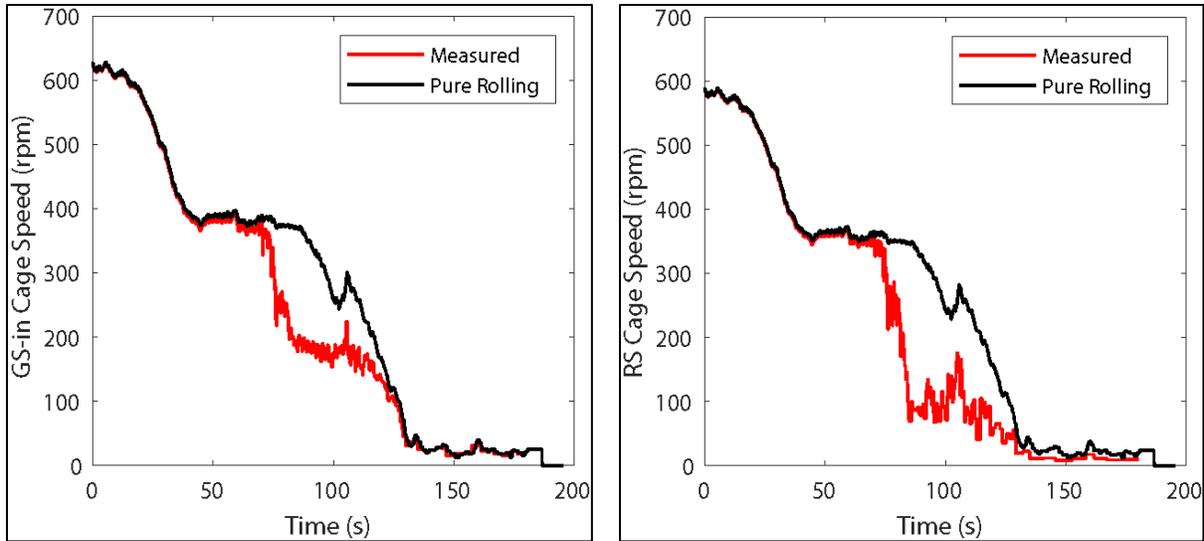
**Figure 36. High-speed-shaft generator side-in (left) and rotor-side (right) bearing cage speed during a normal shutdown**

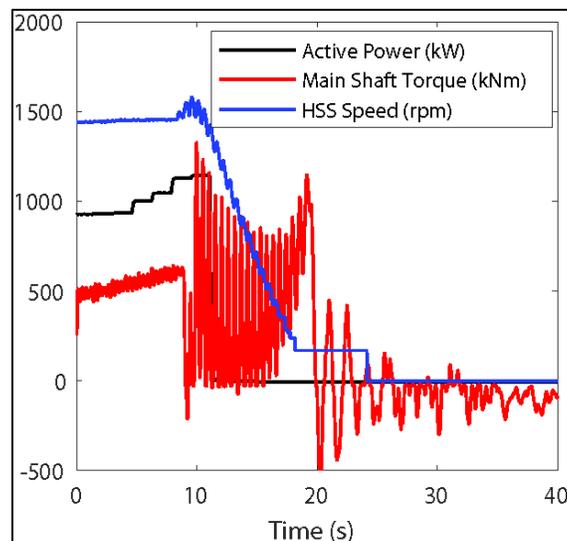
**Figure 37. Main shaft torque and speed during an emergency stop**

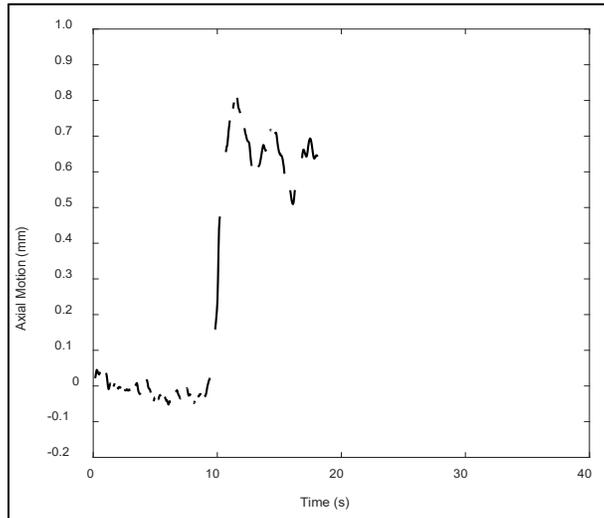
**Figure 38. Main bearing axial motion during an emergency stop**

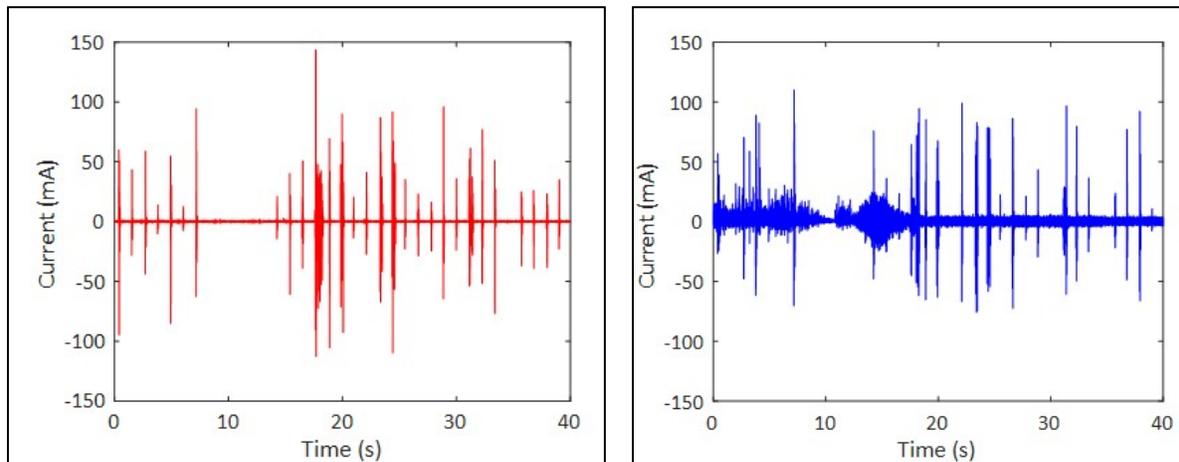
**Figure 39. Main bearing generator-side (left) and rotor-side (right) stray electrical current during an emergency stop**

The stray electrical currents measured across the main bearing are shown in Figure 39. Like other events, electrical currents of up to 150 mA were observed regardless of generator engagement or even rotation of the rotor.

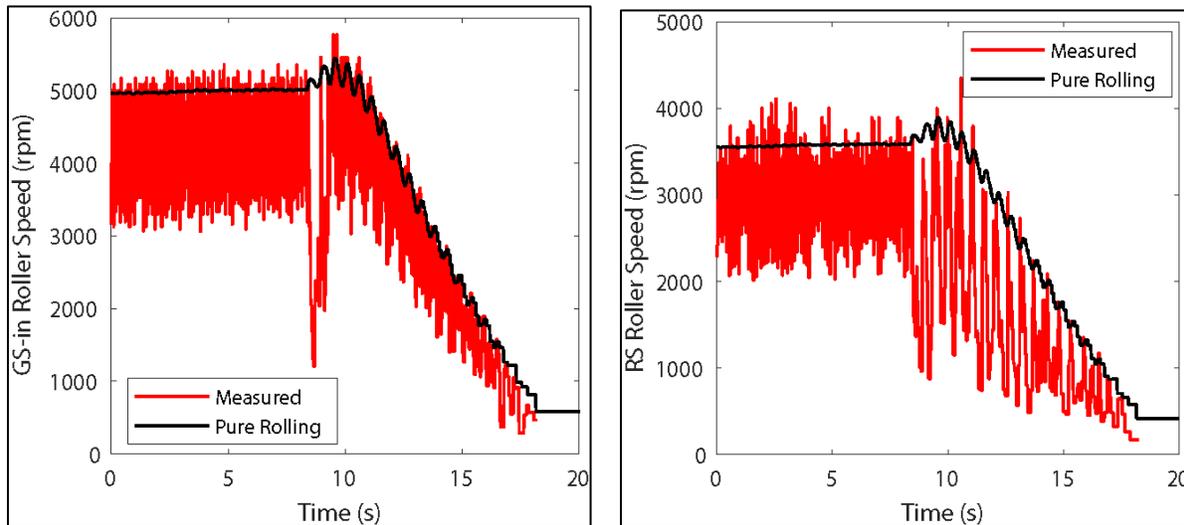
**Figure 40. High-speed-shaft generator-side-in (left) and rotor-side (right) bearing roller speed during an emergency stop**

Figure 40 and Figure 41 show the HSS bearing roller and cage speeds, respectively. Prior to the engagement of the brake, the maximum measured roller speed and the cage speed for each bearing is equivalent to the theoretical value for pure rolling conditions. When the brake is engaged, the roller and cage speeds drop dramatically. During the deceleration period, the two

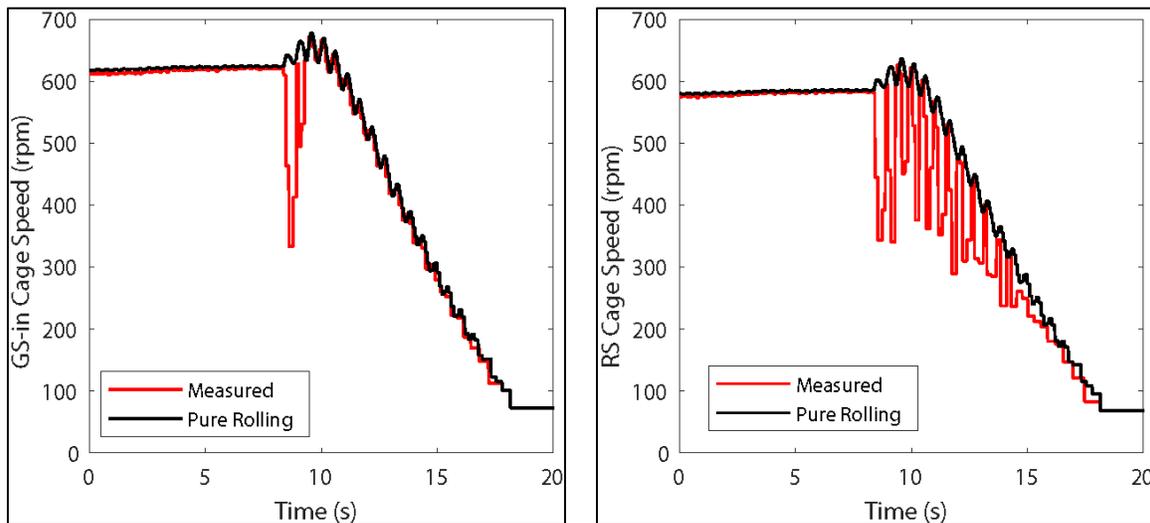
**Figure 41. High-speed-shaft generator-side-in (left) and rotor-side (right) bearing cage speed during an emergency stop**

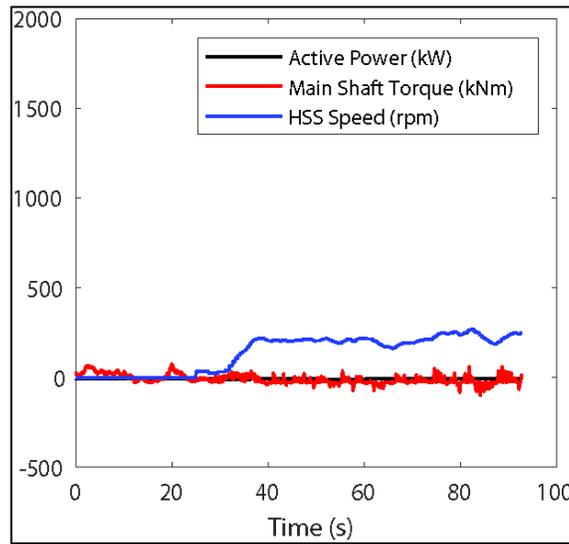
**Figure 42. Main shaft torque and speed during idling**

An example period that includes both parked and idling conditions is examined in Figure 42 (filename “DRC15\_fast\_slow\_roll2018\_03\_04\_22\_52\_49.h5”). The rotor turns very slowly at about 2.5 rpm, resulting in a HSS speed of approximately 200 rpm. No power is being generated, and the drivetrain torque is very low as expected.

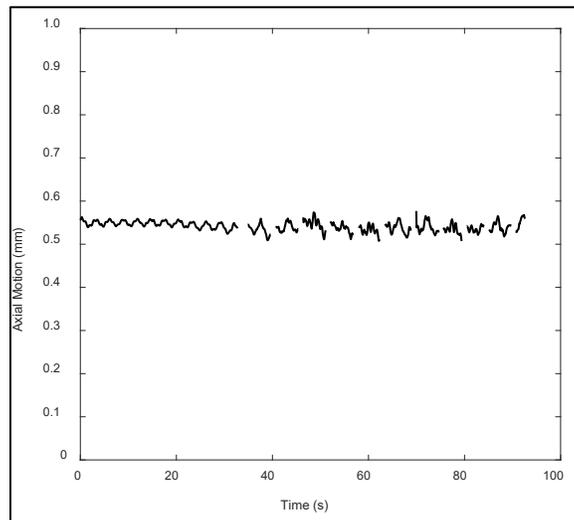
**Figure 43. Main bearing axial motion during idling**

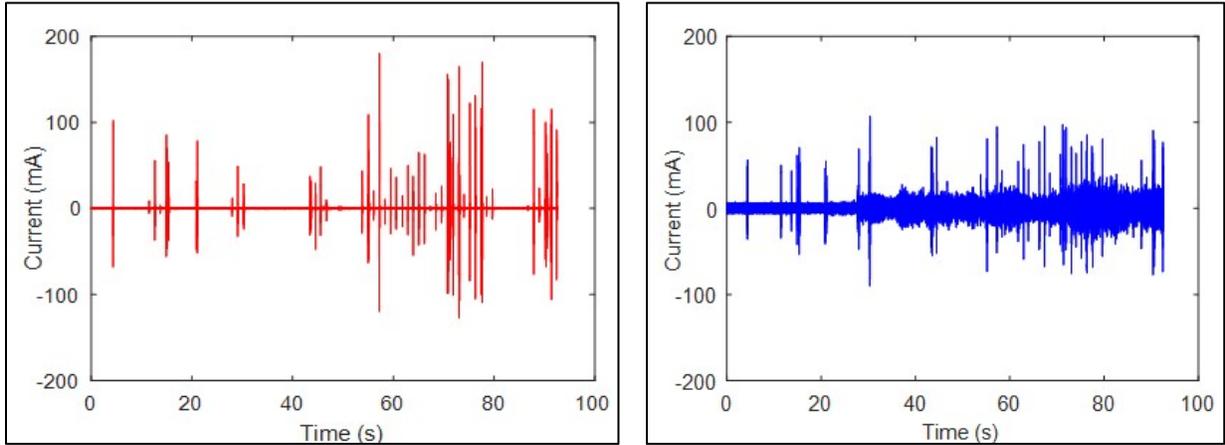
**Figure 44. Main bearing generator-side (left) and rotor-side (right) stray electrical current during idling**

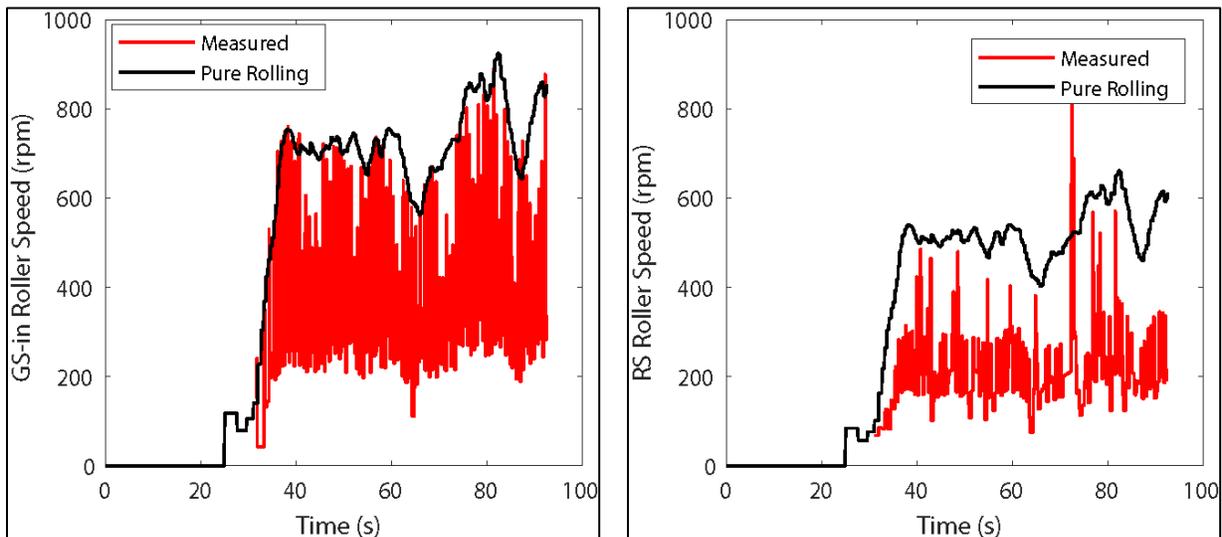
**Figure 45. High-speed-shaft generator-side-in (left) and rotor-side (right) bearing roller speed during idling**

The HSS roller and cage speeds during this idling condition are presented in Figure 45 and Figure 46. With the only torque transmitted as a result of rotor and generator inertia and drag friction throughout the drivetrain, it is not surprising that the rollers and cages are experiencing sliding conditions. Like the other events previously described, this is especially true for the RS bearing. The GS-in bearing is actually close to pure rolling conditions, which is clearly evident from the cage speed measurement shown in Figure 46. However, the overall shaft, cage, and roller speeds are quite slow, and the loads are very low in this condition.

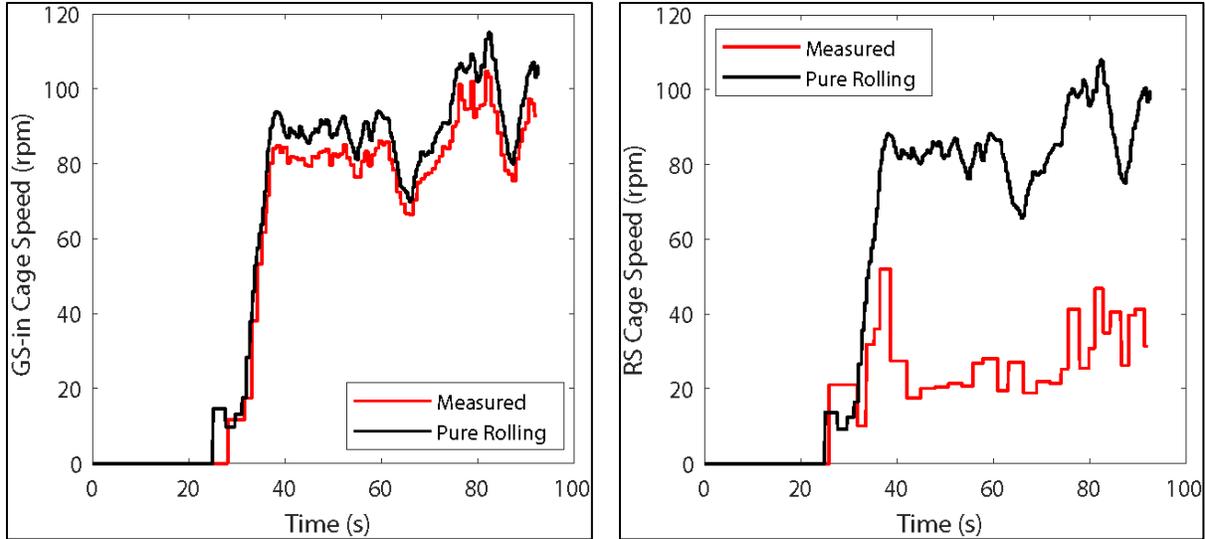
**Figure 46. High-speed-shaft generator-side-in (left) and rotor-side (right) bearing roller speed during idling**

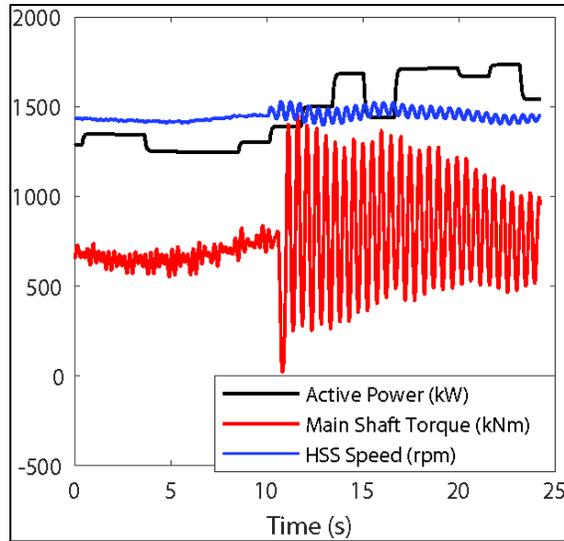
**Figure 47. High-speed-shaft torque and speed during a low-voltage ride-through**

An example LVRT event for a 50% voltage drop is shown in Figure 47 (filename “DRC15\_fast\_50LVRT300ms2018\_03\_05\_21\_45\_59.h5”). The event occurs just after 10 s in the figures below at slightly less than the rated power and torque conditions. Unlike the underfrequency events, the drivetrain torque is significantly affected by the LVRT. The torque initially drops as expected, but quite quickly the voltage returns to nominal and the torque oscillates to nearly double the initial value. This behavior is similar to previous dynamometer results [24]. The torque continues to oscillate for many cycles at the natural frequency of the system. The drivetrain speed is largely unaffected by the LVRT, although the effect of the drivetrain torque oscillations are reflected in slight speed oscillations.

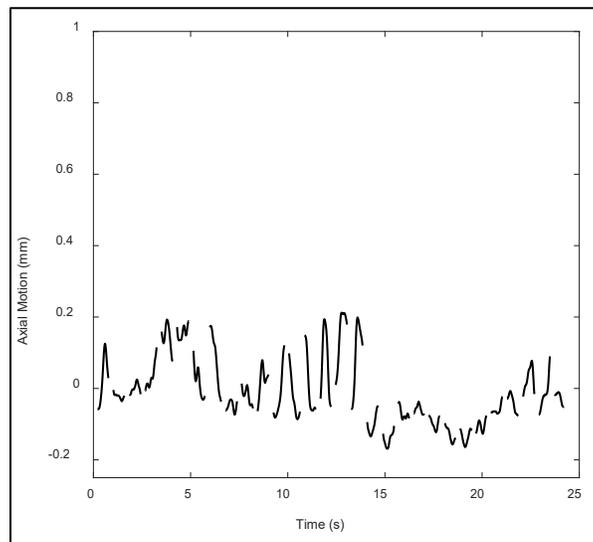
**Figure 48. Main bearing axial motion during a low-voltage ride-through**

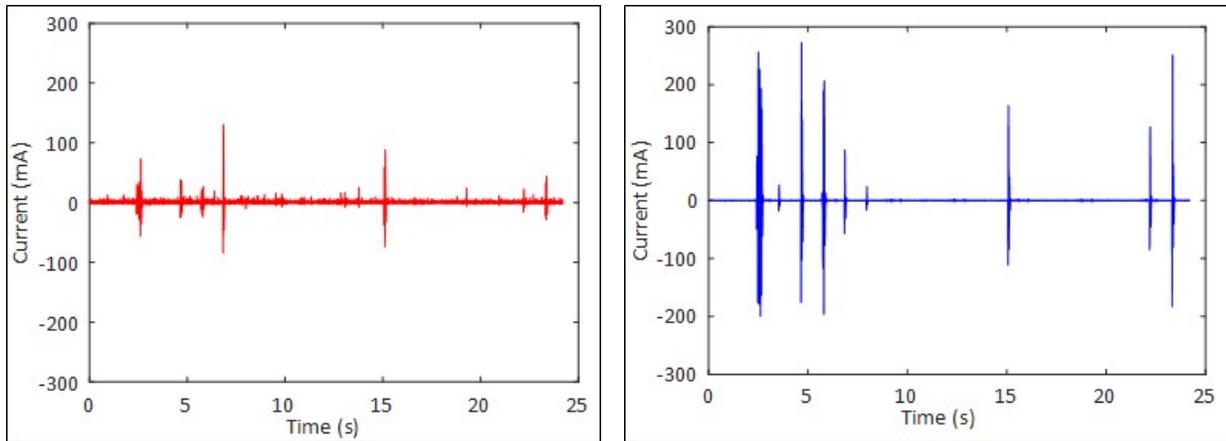
**Figure 49. Main bearing generator-side (left) and rotor-side (right) stray electrical current during a low-voltage ride-through**

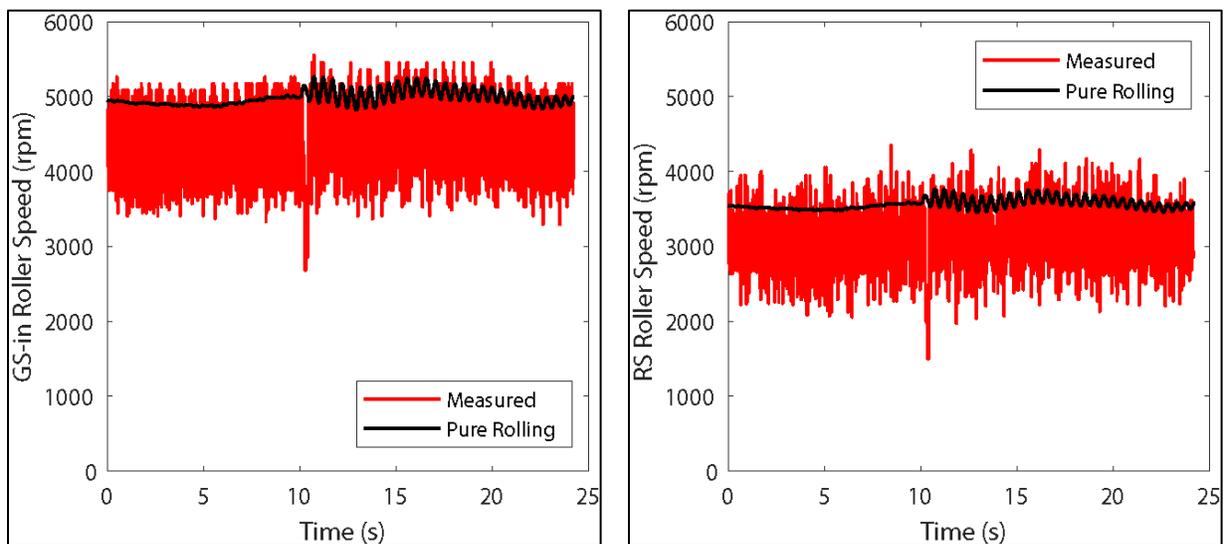
**Figure 50. High-speed-shaft generator-side-in (left) and rotor-side (right) bearing roller speed during a low-voltage ride-through**

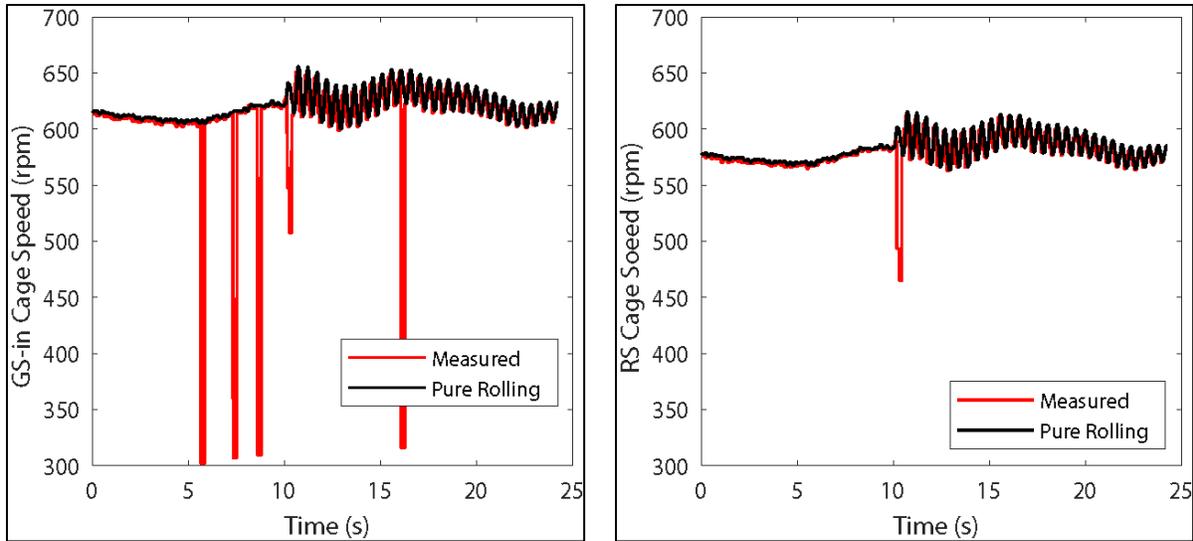
**Figure 51. High-speed-shaft generator-side-in (left) and rotor-side (right) bearing roller speed during a low-voltage ride-through**
