***In-situ* Microscopy Characterization of Cu(In,Ga)Se₂ Potential-Induced Degradation**

Preprint

Chuanxiao Xiao, Chun-Sheng Jiang, Steven P. Harvey, Lorelle Mansfield, Christopher P. Muzzillo, Dana Sulas, Jun Liu, Steve Johnston, and Mowafak Al-Jassim

Conference Paper
NREL/CP-5K00-73121
June 2019

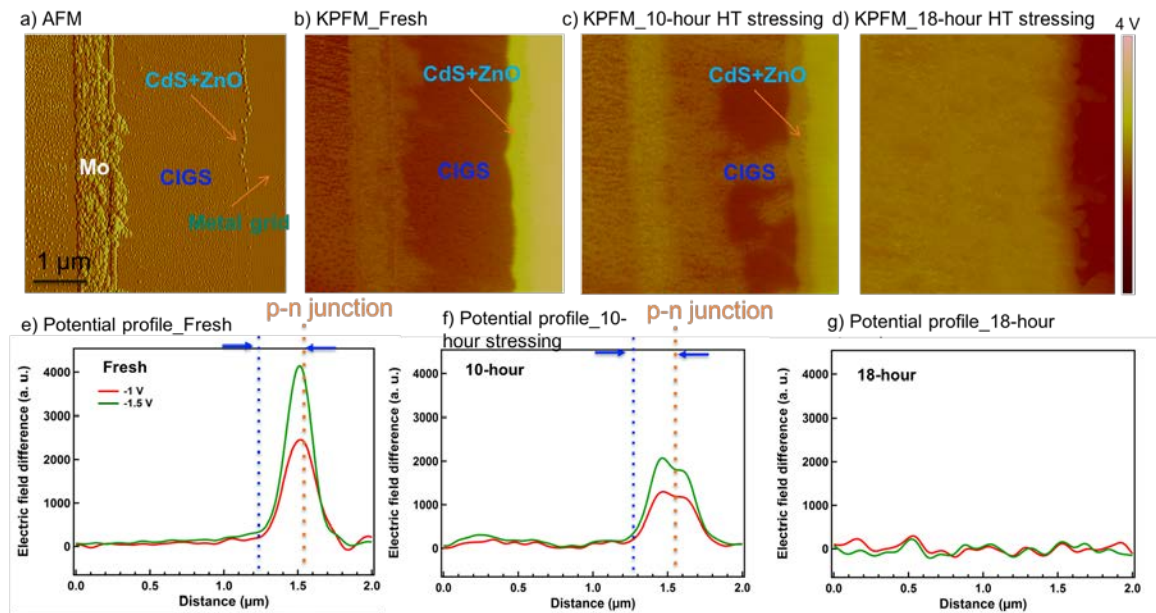
Fig. 3. KPFM results of HT-stressed CIGS cell.

Similarly, we monitored the potential evolution along HT stressing at 85°C . The AFM amplitude error image in Fig. 3a distinguished different layers of the device. The KPFM image at the fresh stage taken at -1.5 V in Fig. 3b is similar to Fig. 2b. After 10 hours stressing, we mapped the potential image (Fig. 3c) at the same location. After 18 hours stressing, no significant potential change was observed around the CIGS/CdS interface, with results shown in Fig. 3d. The potential profiles are shown in Figs. 3e–g. The electric-field difference curve in Fig. 3e is measured at HT, and it is similar to the fresh cell results at RT. After 10 hours of HT stressing at -1500 V, the electric-field peak intensity dropped about half and the depletion width is similar. This suggests that a large amount of Na may quickly diffuse to the CIGS/CdS junction area and increase the leakage current. After 18 hours, the junction collapsed to a flat line. There is no electric field detectable around the p-n junction region, which indicates that the sample has a very weak equivalent shunt resistance and behaves as a resistor rather than a diode.

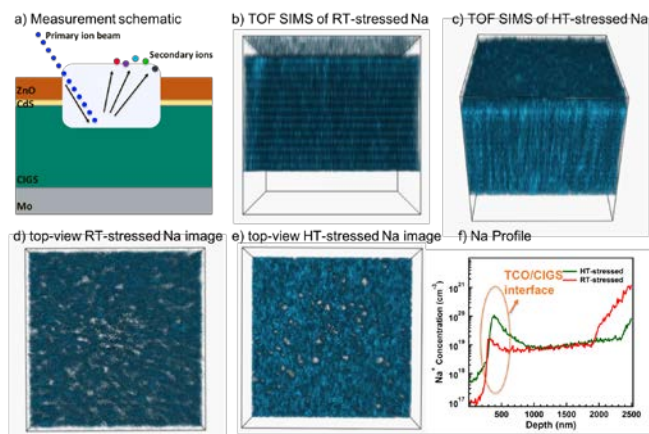
To address the Na issue in detail, we performed TOF-SIMS measurements on the two stressed CIGS devices characterized by KPFM and dark I-V measurements; results are shown in Fig. 5. The samples were both rinsed with deionized water to remove surface sodium and the possibility of sputtering drive-in artifacts in TOF-SIMS analysis.

The 3-dimensional data show similar trends: both RT- and HT-stressed samples have Na accumulation at the transparent conductive oxide (TCO) and CdS layers and the CIGS near the CdS/CIGS interface (Figs. 5b, c). More Na is found on the Mo/glass region, indicating that Na^+ ions drifted from the soda-lime glass. We observed different points of evolution of the Na profiles, most likely due to the temperature differences between the stressed samples. Figures 5d and 5e show the Na distribution in the upper CIGS layer. The RT-stressed sample seems to show Na mostly at grain boundaries in the CIGS and more uniformly incorporated at the TCO/CdS/CIGS region. The HT sample shows similar behavior, but a more laterally uniform Na distribution near the TCO/CdS/CIGS region. This is due to the different kinetics for the two experiments; the RT stressing lasts for more than one month, and if the high voltage were kept for a much longer time, then the Na should eventually shunt the device. These data suggest a PID degradation mechanism where the Na quickly diffuses through the CIGS grain boundaries and piles up at the TCO/CdS/CIGS region, at which point it also starts to diffuse into the CIGS grain interiors. Figure 5f shows a quantified Na profile over the

depth of the whole CIGS device. The Na concentration reaches 10^{20} cm^{-3} for the HT-stressed sample, and the CIGS upper layer has a concentration at 10^{19} cm^{-3} . This large amount of Na can effectively damage the p-n junction and cause a complete shunt for the device. For the RT-stressed sample, the Na peak is at a low 10^{19} cm^{-3} level, which can significantly alter the doping in both CIGS and CdS layers. The high contamination of Na in CdS makes it less n-doped, which causes the depletion to be wider, as observed in the KPFM potential profiles.

Fig. 5. TOF-SIMS results of RT- and HT-stressed samples.
