# Power Electronics Materials and Bonded Interfaces – Reliability and Lifetime

*Keystone Project 1*

PI: Paul Paret  
National Renewable Energy Laboratory  
June 11, 2019

DOE Vehicle Technologies Program  
2019 Annual Merit Review and Peer Evaluation Meeting

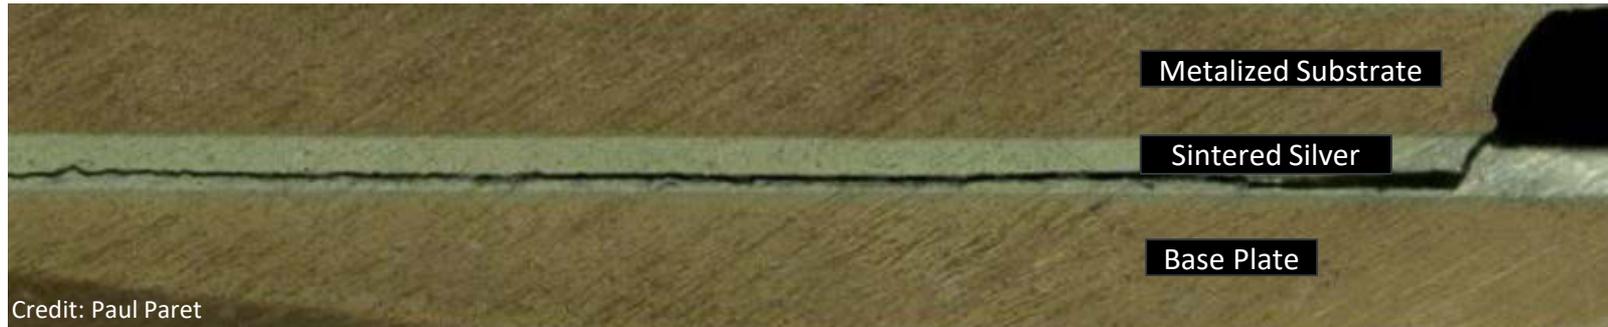
Crack Propagation in Pressure-Assisted (30- 40 MPa) Sintered Silver

- Sintered silver synthesized using high pressure (30–40 MPa) exhibits excellent reliability; survived for more than 2,000 cycles (-40°C to 150°C).
- Low-pressure sintering eases the manufacturing process and offers better protection to semiconductor devices and ceramic substrates.

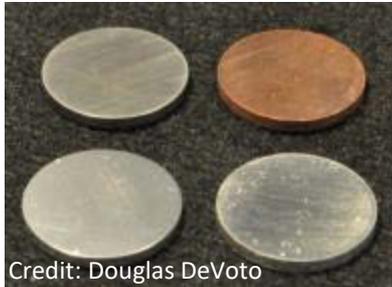
Copper – Invar Coupons

Top View

Φ 25.4 mm

- Subject CTE-mismatched samples bonded with the material of interest to thermal cycling from -40°C to 200°C.
- Obtain C-SAM images of the bond material at periodic cycling intervals.
- Estimate crack growth rate from C-SAM images through image analysis.

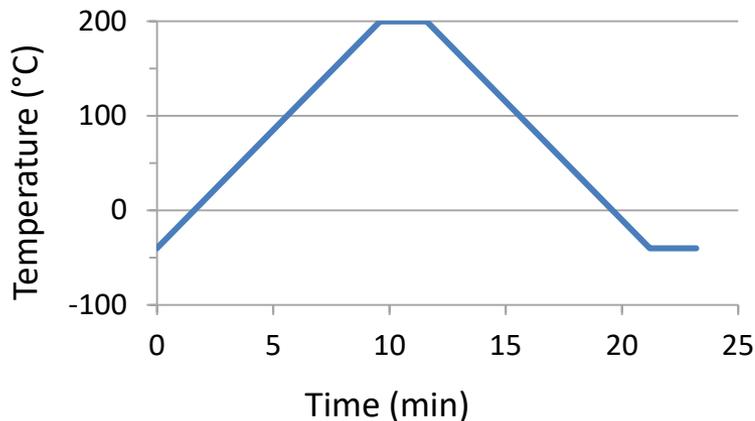
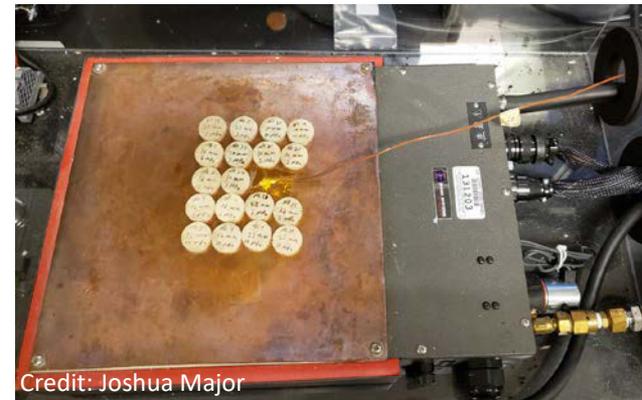
Thermal platform for thermal cycling

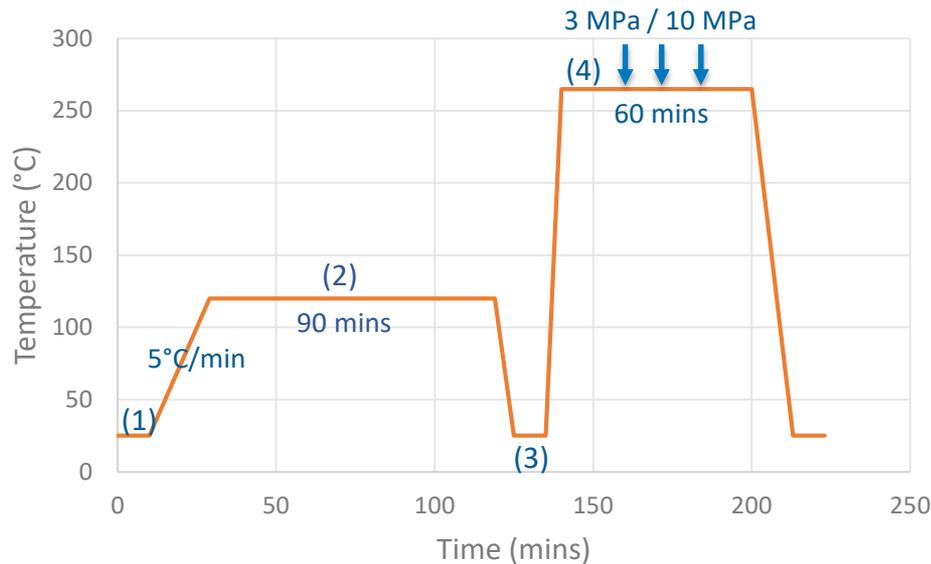
Low pressure-assisted sintering profile

- Paste was applied to each of the coupons, which were then joined together before sintering.
- Final bond line thickness averaged between 115  $\mu\text{m}$  and 137  $\mu\text{m}$ .

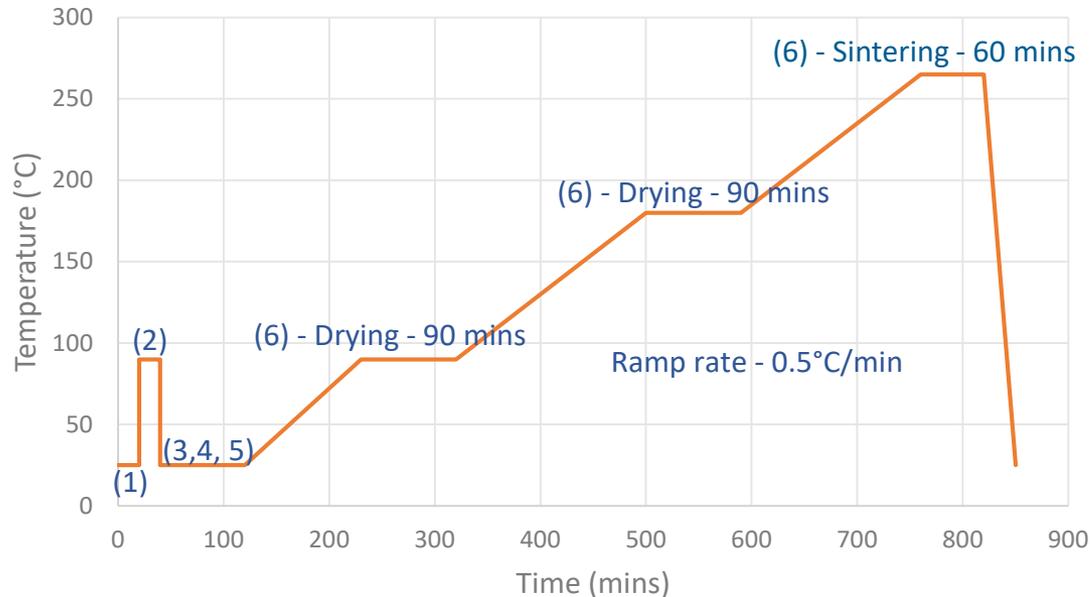
- Evaporation of solvents under the drying process tend to leave voids and cracks in the bond.
- No sintering pressure was applied.
- Final bond line thickness averaged around 100  $\mu\text{m}$ .

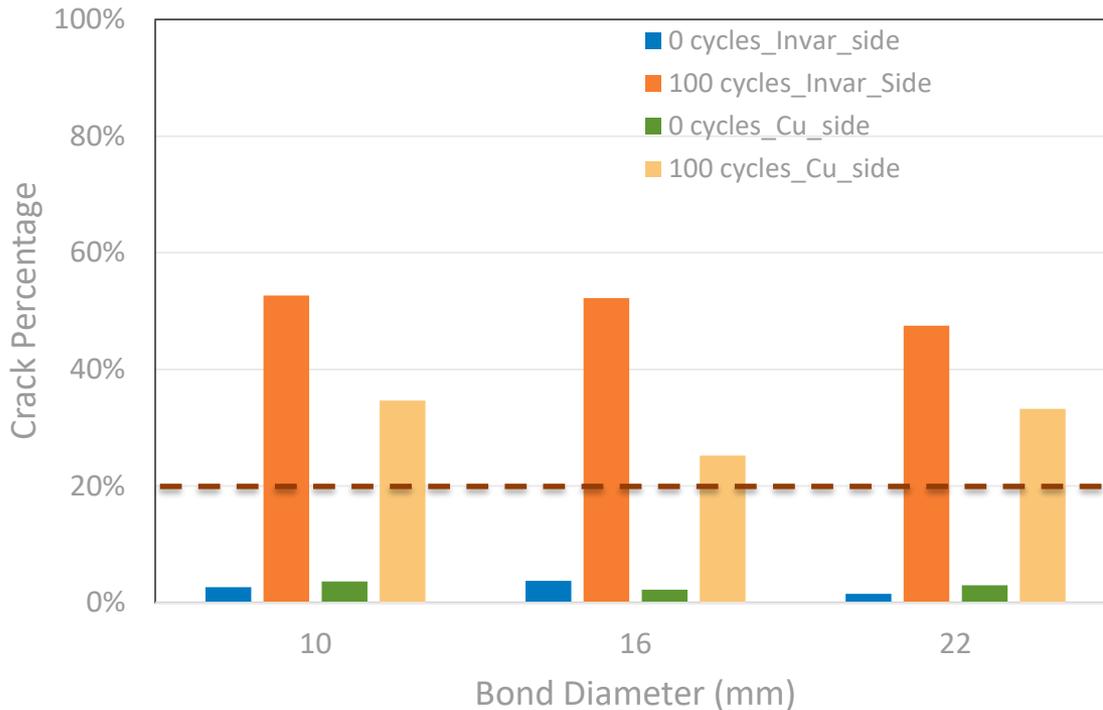
- Four samples were cycled for each diameter case.
- Failure (> 20% crack growth) may have occurred within 50 cycles.
- Crack growth rate was higher on the Invar side.

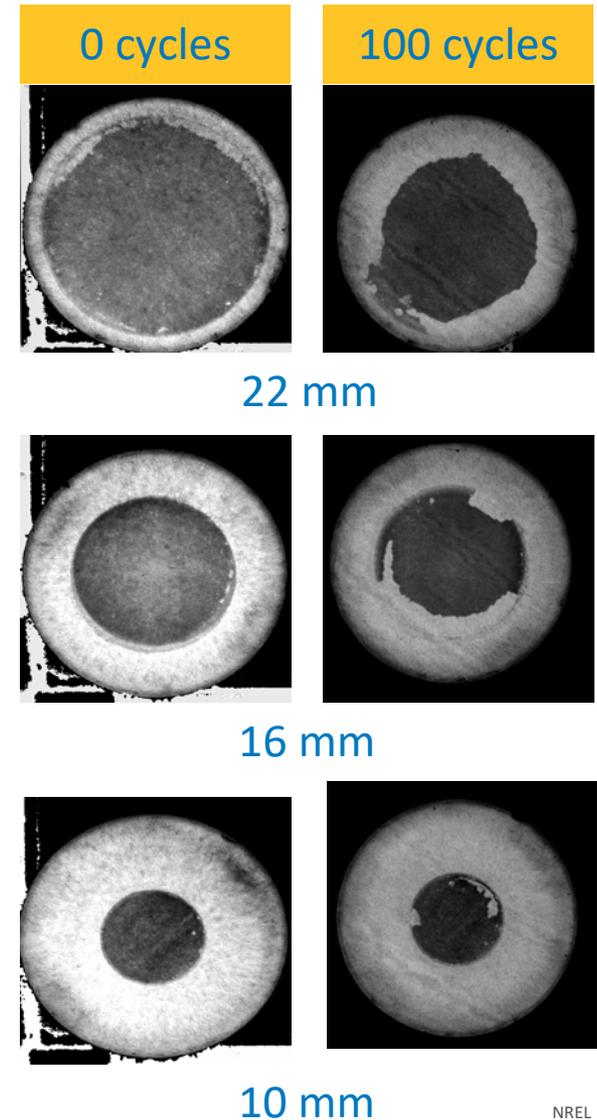
C-SAM images of sintered silver from Cu side

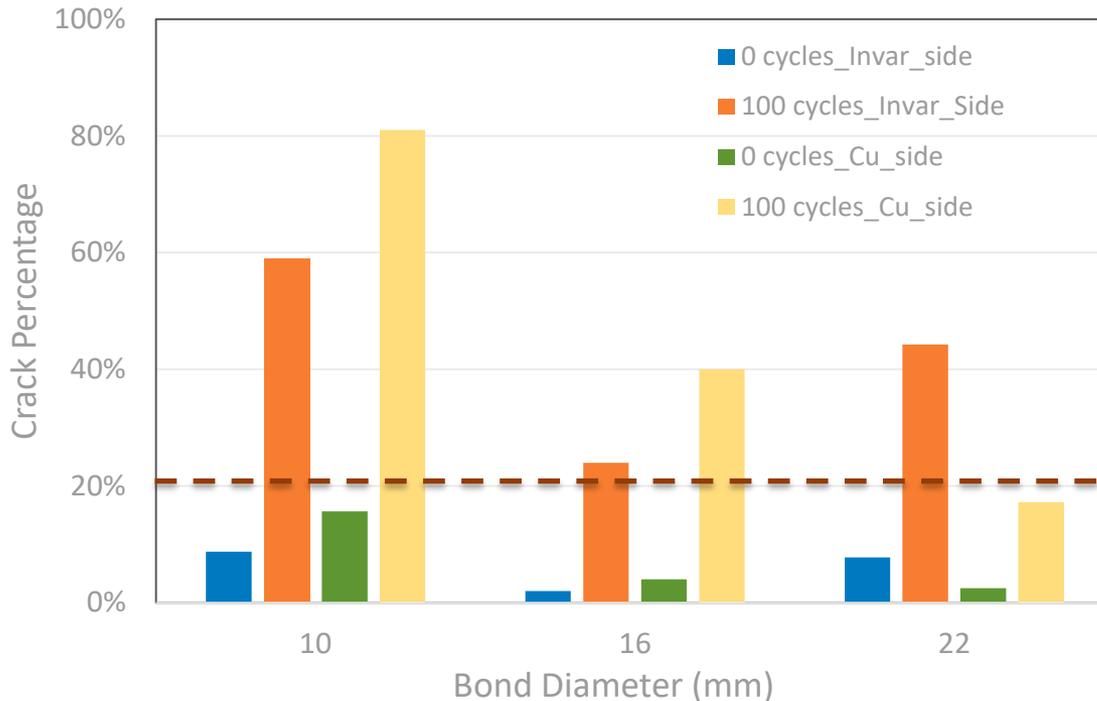
- Samples that had more than 20% initial crack (at 0 cycles) are not included in the graph.
- Failure occurred within 50 cycles.
- Crack growth rate was dictated by the initial crack percentage.

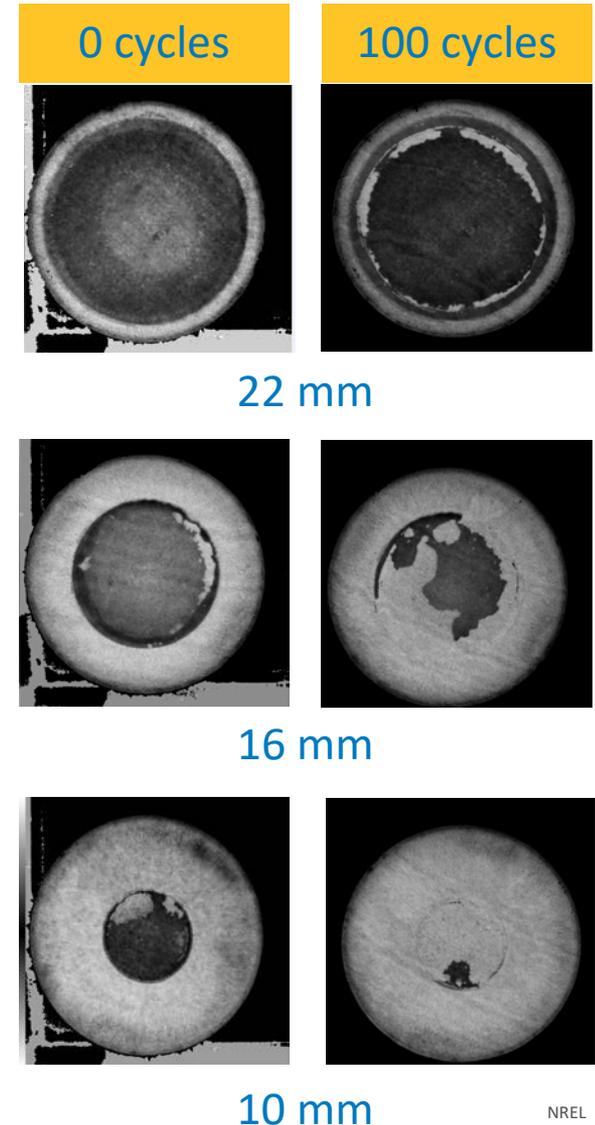
C-SAM images of sintered silver from Cu side

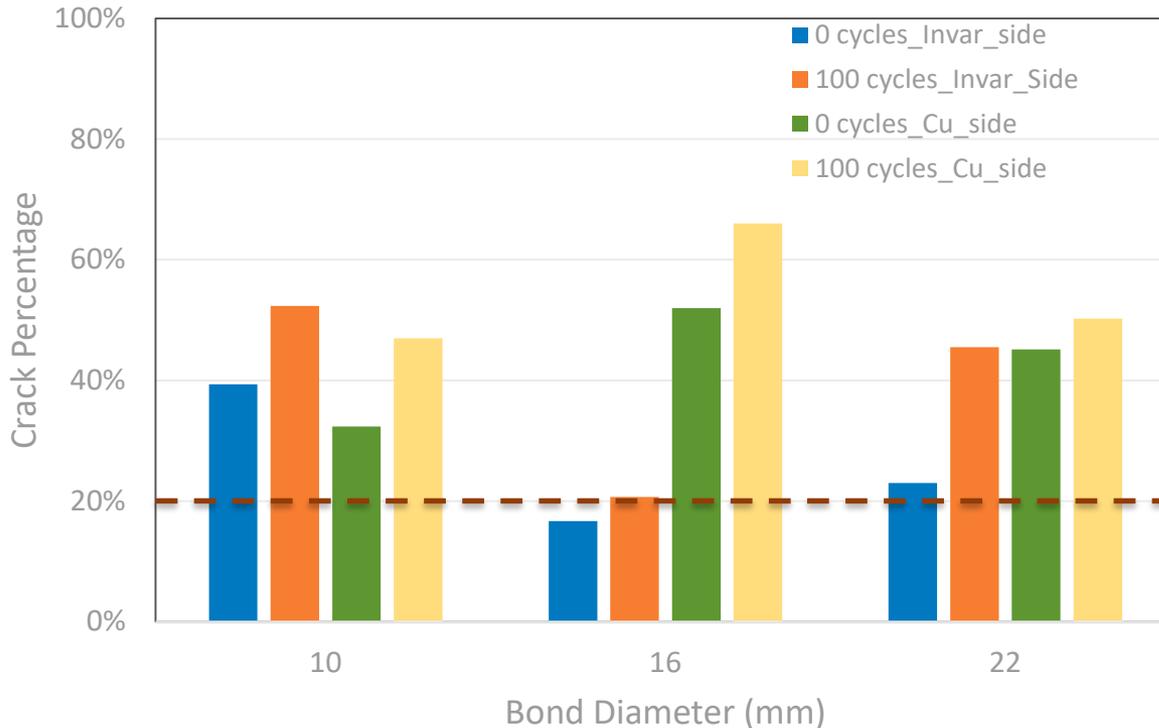
- Initial crack in most of the samples was more than 20% of the total bond area.
- Lack of sintering pressure led to poor densification of the micron-sized silver flakes and nano-silver particles.
- The lower crack growth rate may be due to the existing cracks providing stress relief under thermal cycling.

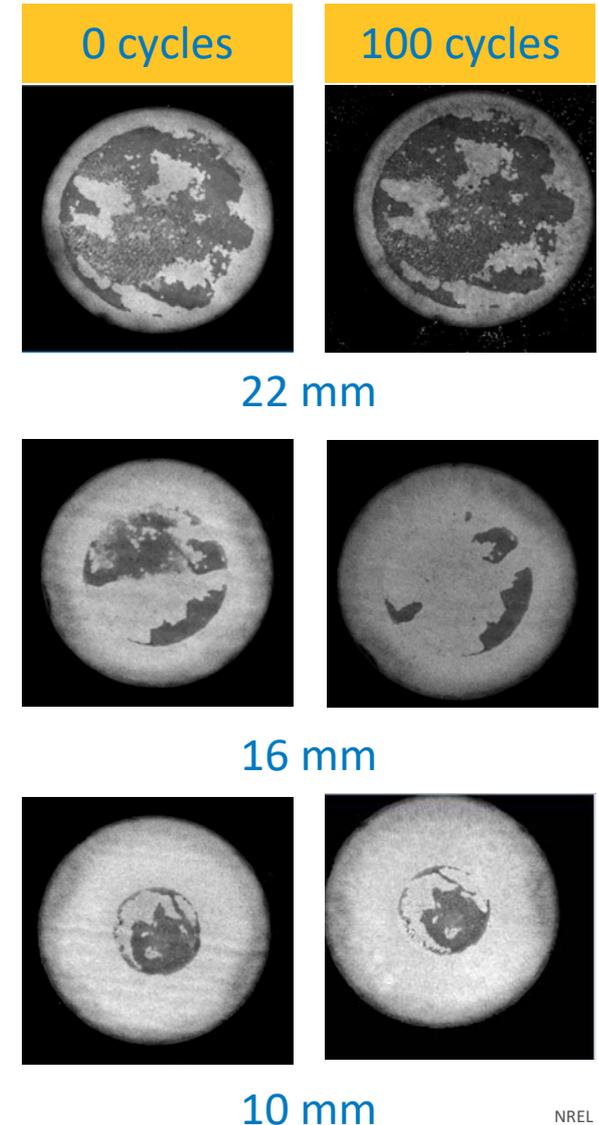
C-SAM images of sintered silver from Cu side

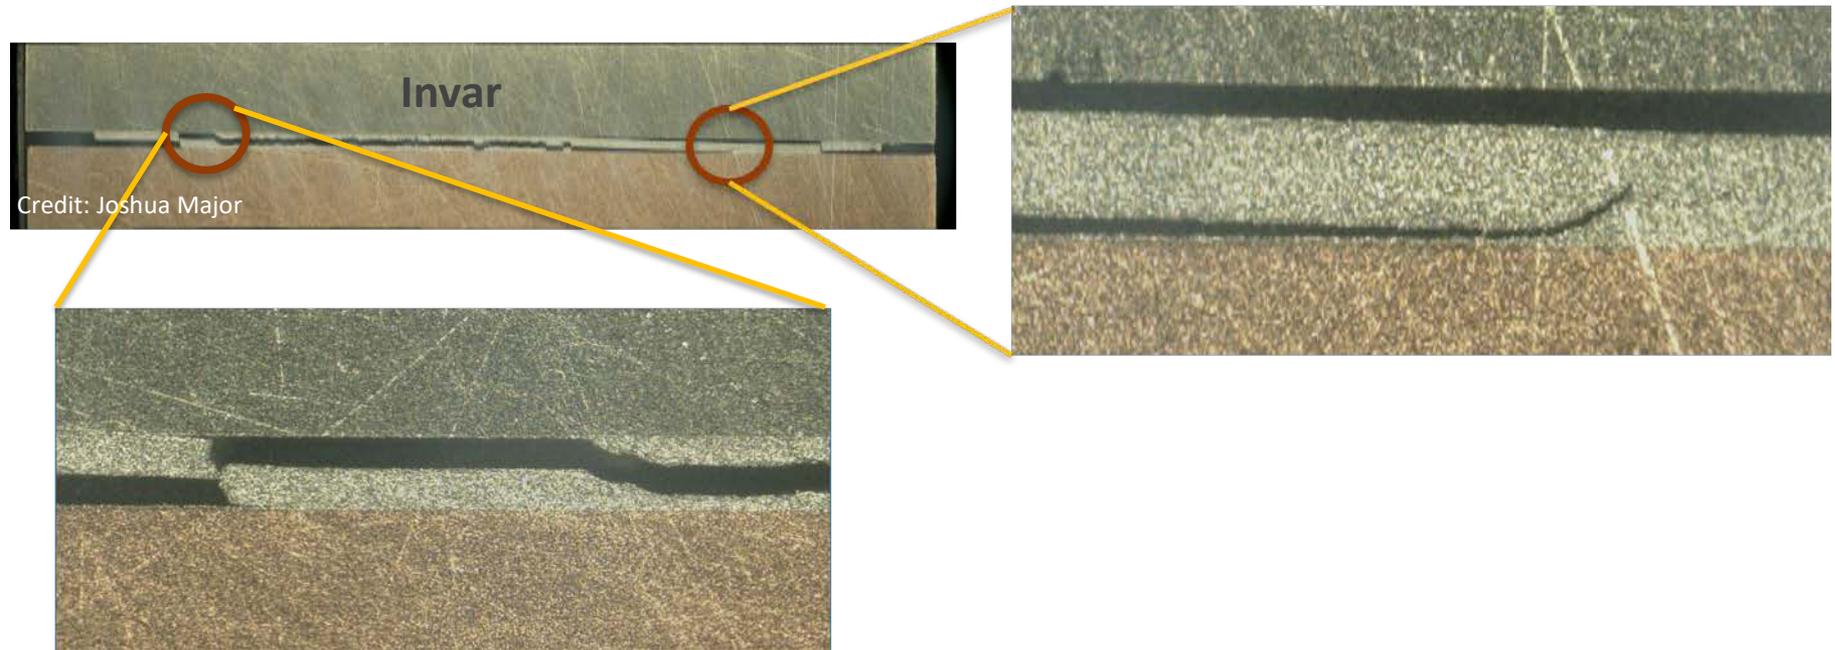
Cross-sectional Microscopic Images of Crack Propagation in Sintered Silver

- Mode of crack propagation was found to be a combination of cohesive and adhesive failure mechanisms.
- Presence of different crack modes possibly indicates the strong impact of both global (Cu and Invar) and local (silver and Invar) CTE mismatch .
- Multiple cracks observed explain the difference in C-SAM images/crack percentage calculations from Cu and Invar side.
