Development of Combined and Sequential Accelerated Stress Testing for Derisking Photovoltaic Modules

Peter Hacke
DuraMAT Monthly Webinar
May 13, 2019

NREL/PR-5K00-73984

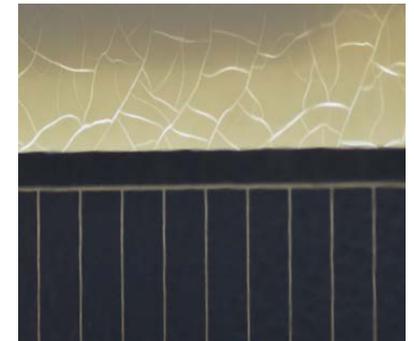
Sequences of UV + heat,
intermittent water spray to
replicate backsheet field
failures

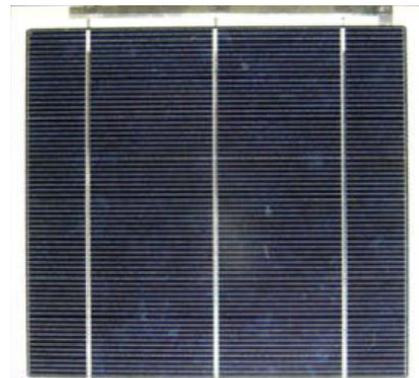
65°C + UV :180 W/m² 900 h

75°C without UV light, 1000 h

UV light + high temperature
leads to delamination

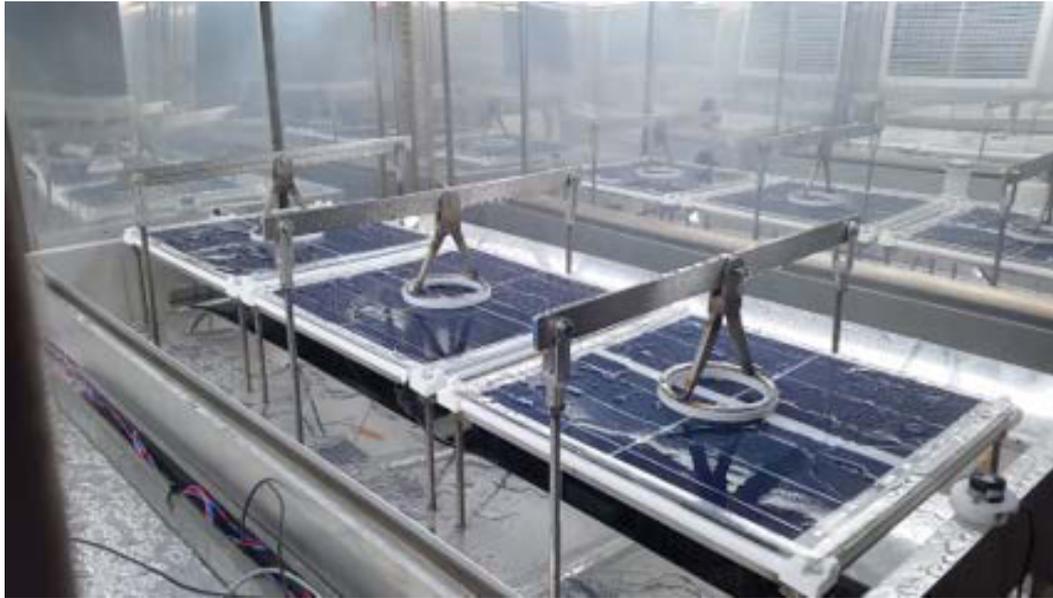
Combining stress factors

- Heat
- Light
- Humidity
 - Condensing
 - Non-condensing
- Mechanical pressure
- System voltage
- Reverse bias (*in progress*)

Mini-module platform

In-situ Metrology

- RH, T_{module} , I - V , EL

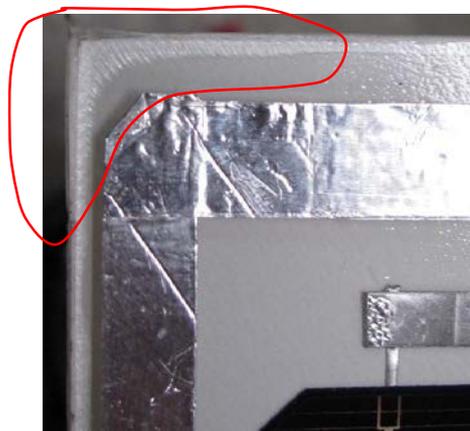
Delamination of
PA backsheet
edge seen at
week 8 of C-AST

If you have a free-standing coupon, or too small a sample, you might not have the critical dimensions to see the shrinkage and cracking: Sample representation critical
