WhiteWind: White Etching Crack (WEC) Bearing Failures in Wind Turbines

Cooperative Research and Development Final Report

CRADA Number: CRD-18-00758

Technical Report
NREL/TP-5000-81232
October 2021

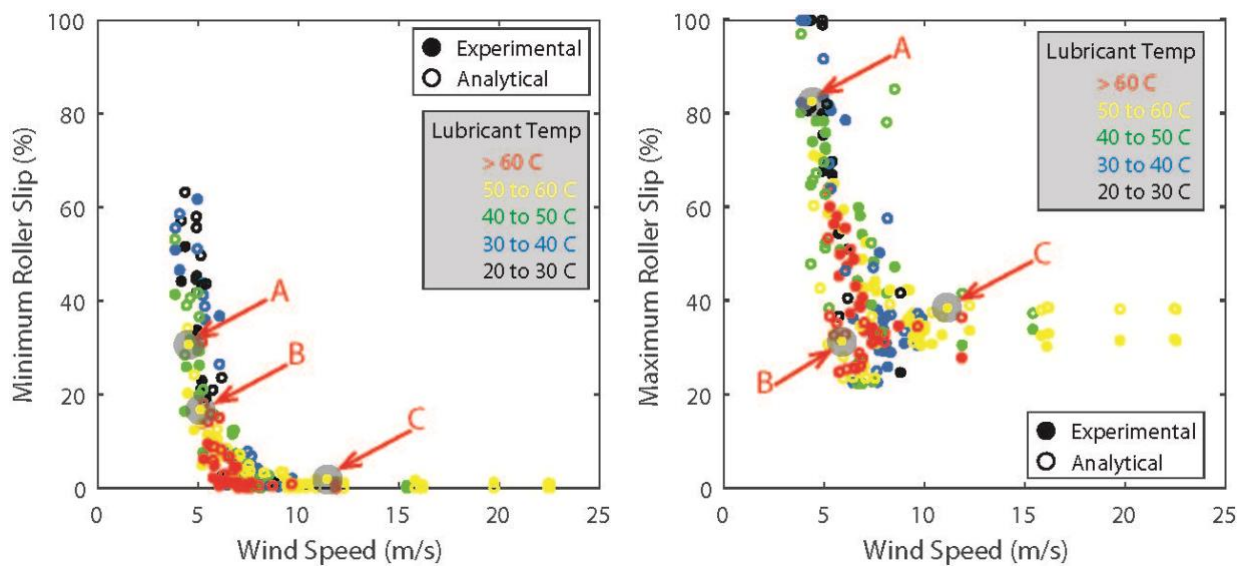
Figure 3. Minimum (left) and maximum (right) roller slip during normal power production [5]

The predicted cage and roller slip compared to the measured results with reasonable accuracy across a wide range of near steady-state operating conditions and transient events as shown in Figure 3. At its best, the analytical model predictions match experimental cage and roller slip measurements within 10% for lubricant temperatures above 40° C and wind speeds over 10 meters-per-second (m/s). The validated roller slip model was used to evaluate the cumulative frictional energy damage criteria as a potential driving factor for WECs [6].

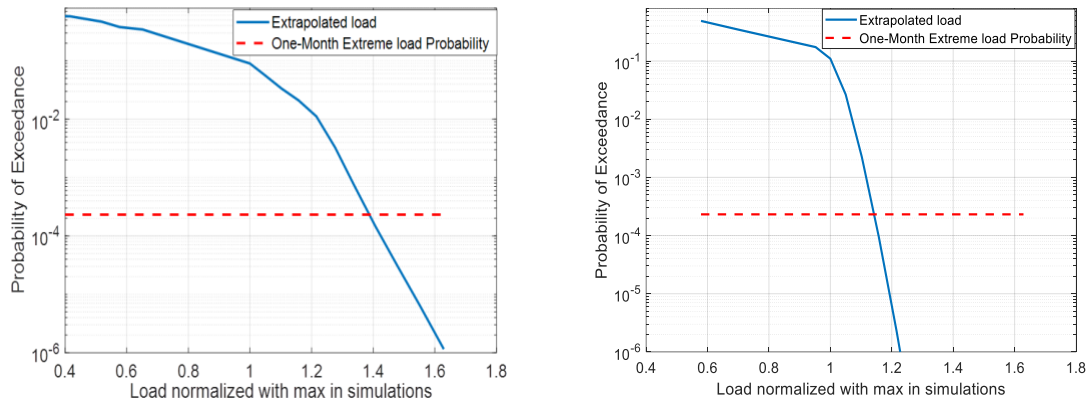
Figure 5. Probability of exceedance of the maximum roller contact load over the roller slip cases in the loaded zone for a month maximum for the Vestas V52 (left) and GE 1.5 (right) [7]

For the studied wind turbines, a Rayleigh distribution of the Class II wind speed defined in IEC 61400-1 was assumed and a Gumbel distribution with a quadratic exponent was used to fit the probability of exceedance of the peak contact load at each mean wind speed. Figure 5 shows the probability of exceedance of the maximum contact load at the time of slip during normal

power production for the Vestas V52 and GE 1.5SLE turbines. A 1-month return period of the maximum contact was chosen as the limiting load criteria for the WEC-inducing slip, as an example. The V52 requires about a 40% higher load than observed in simulations for this WEC criteria to hold, whereas the GE 1.5SLE requires an 18% higher load than observed in the data set for this WEC criteria to hold [7,8]. The damage criteria of the predicted 1-month extreme contact load can be continuously tracked using real-time measurements with updated simulations to determine if it exceeds a threshold load value, which is indicative of WEC onset. This provides a viable quantitative methodology to assess operating conditions as to whether they may induce WECs in the bearing.
