Energy Efficiency Assessment for a Microgrid in the Community of Castañer, Puerto Rico

Technical Report
NREL/TP-5500-81877
February 2022

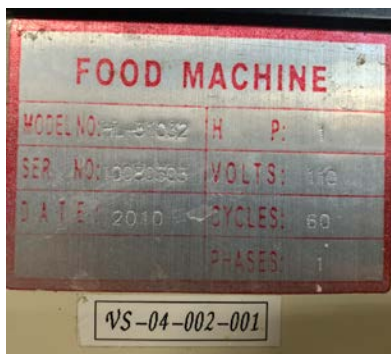
- *Power:* Look on the energy use sticker (see photo below) for the power number, labeled as HP
 - *Current:* Look on the energy use sticker (see photo below) for the current number, labeled in amps

Power	1HP
Current	6.7 A

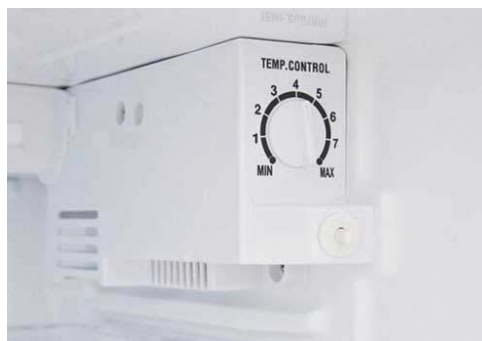
- Refrigeration equipment:
 - Setpoints—see below settings (freezer temperature settings at 4 of range 1–7 as below)
 - Setpoint schedule: Ask occupant if they change the settings over time of day

Freezer: Temperature settings at 4 of range 1–7
