WIND TURBINE DRIVETRAIN RELIABILITY

Interfacial Mechanics & Materials Group
Applied Materials Division
Argonne National Laboratory

National Renewable Energy Laboratory

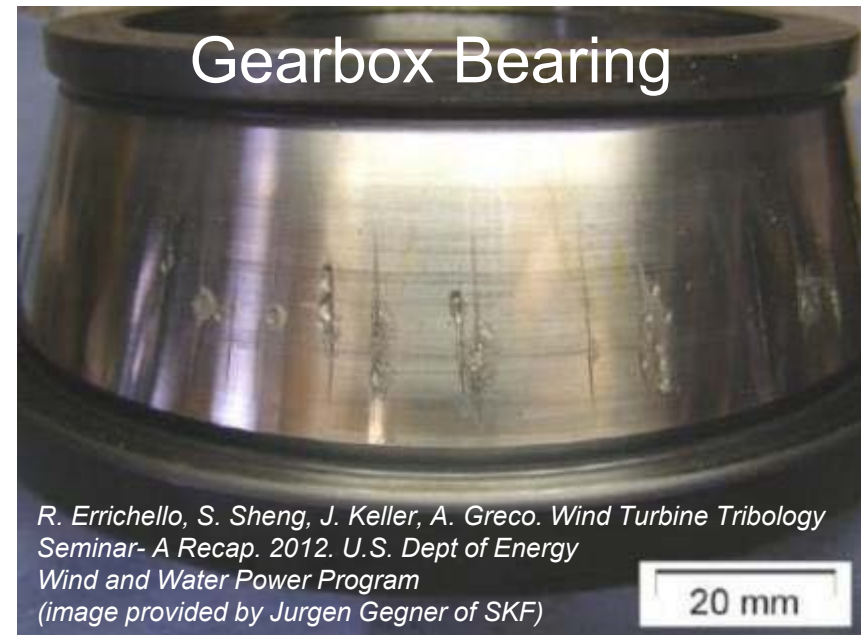
R. Errichello, S. Sheng, J. Keller, A. Greco. Wind Turbine Tribology Seminar- A Recap. 2012. U.S. Dept of Energy Wind and Water Power Program (image provided by Jurgen Gegner of SKF)

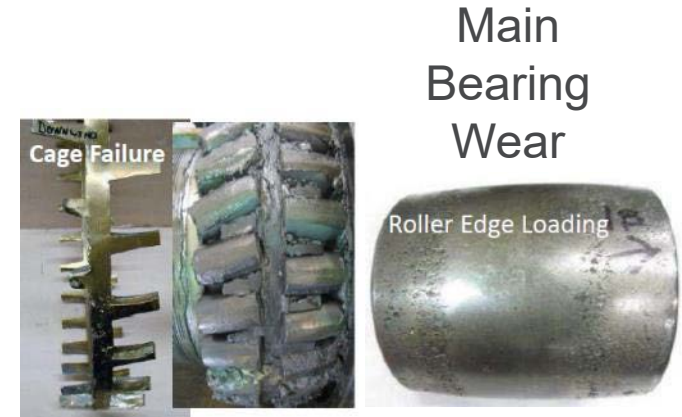
- White-etching crack/axial crack (gearbox bearing, main bearing)
- Main bearing wear (micropitting)
- Pitch bearing fretting wear
- Journal/plain bearing wear
- Advanced lubricant technology

D. Brake. WTG SRB Main Bearing Failures. Presented at the 2013 UVIG Wind Turbine/Plant Operations & Maintenance Users Group Meeting.

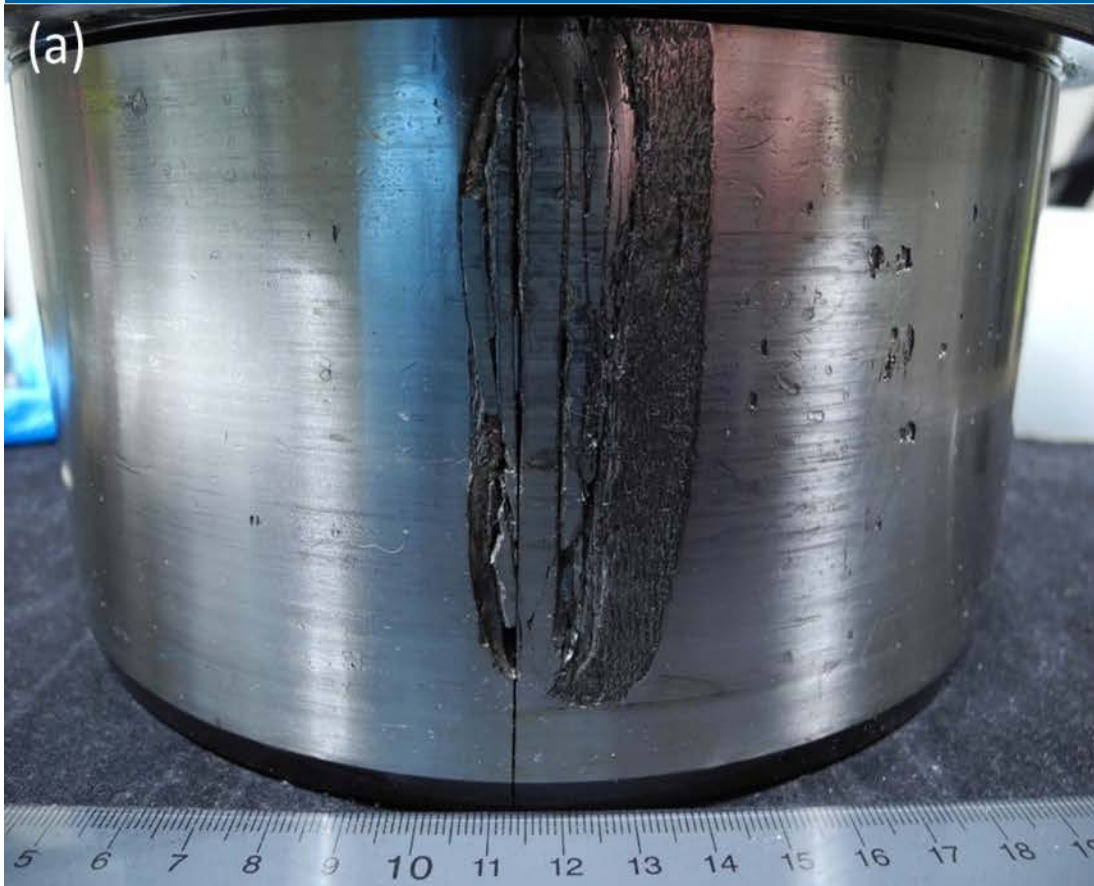
AXIAL CRACKS / WHITE-ETCHING CRACKS

White-etching cracks (WECs) cause premature bearing failure through spalls or cracks and are characterized by **irregular microstructural alteration** in the subsurface material.

- Failure at 1%–10% of rolling contact fatigue L_{10} design life
- Exact cause is unknown

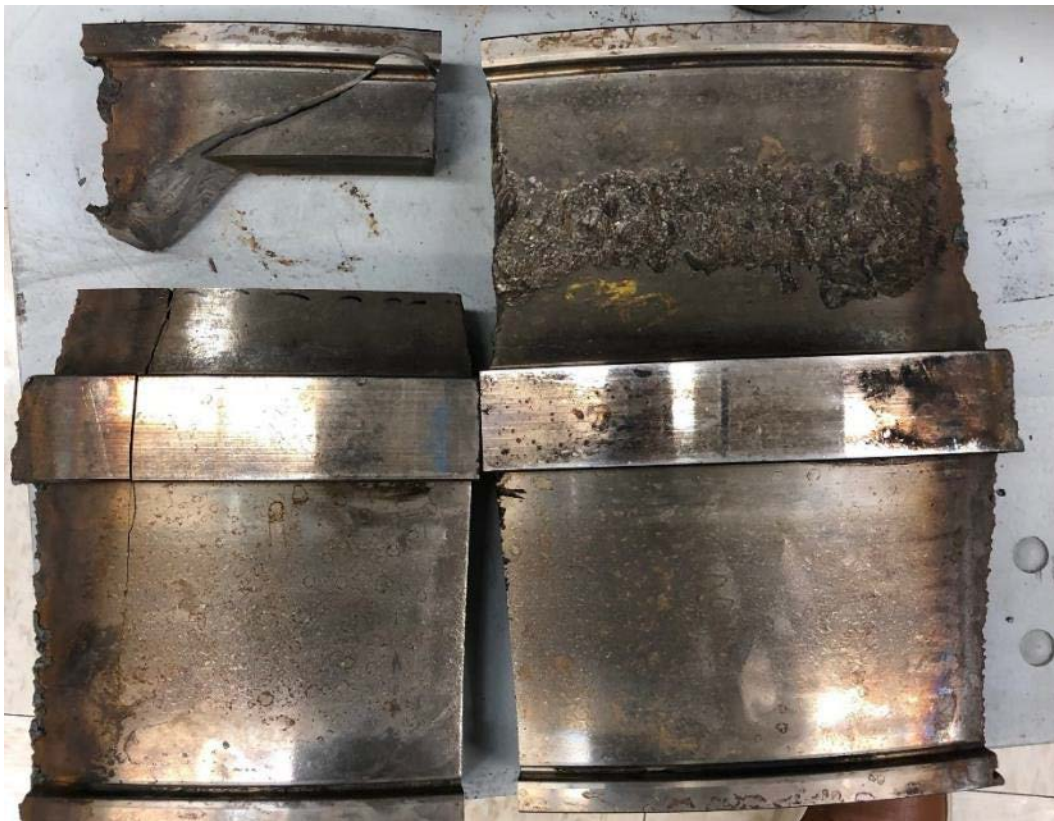
MAIN BEARING WEC FAILURES

- White Etching Cracks (WECs) observed in subsurface analysis of main bearings, with similar characteristics to WECs observed in high-speed shaft gearbox bearings.
- Evidence of WECs initiating at inclusion in the steel, indicating that steel cleanliness could be a factor
- Electrical current was also measured up-tower across main bearing contact for this example bearing

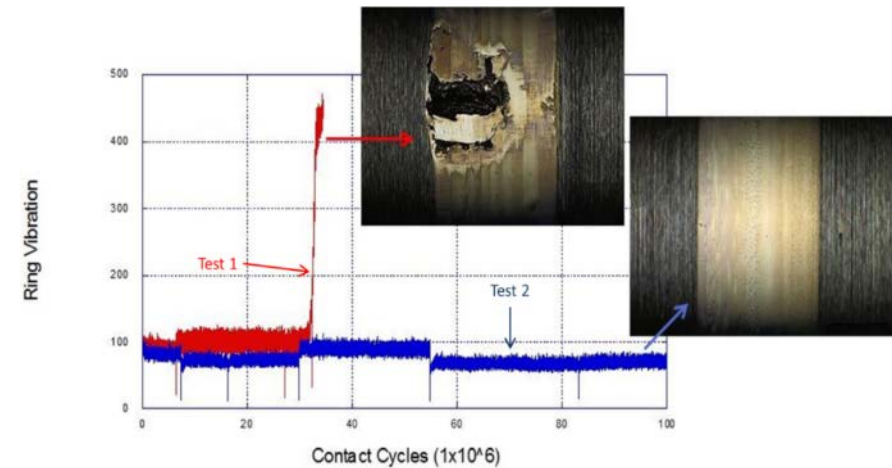
Bench-Top Rig

- Enables the study of WEC drivers independently (*load, slip, lubricant chemistry, stray electrical currents, etc.*)
- Accelerated, low-cost method for testing mitigation technologies (*lubricants, coatings, advanced materials*)

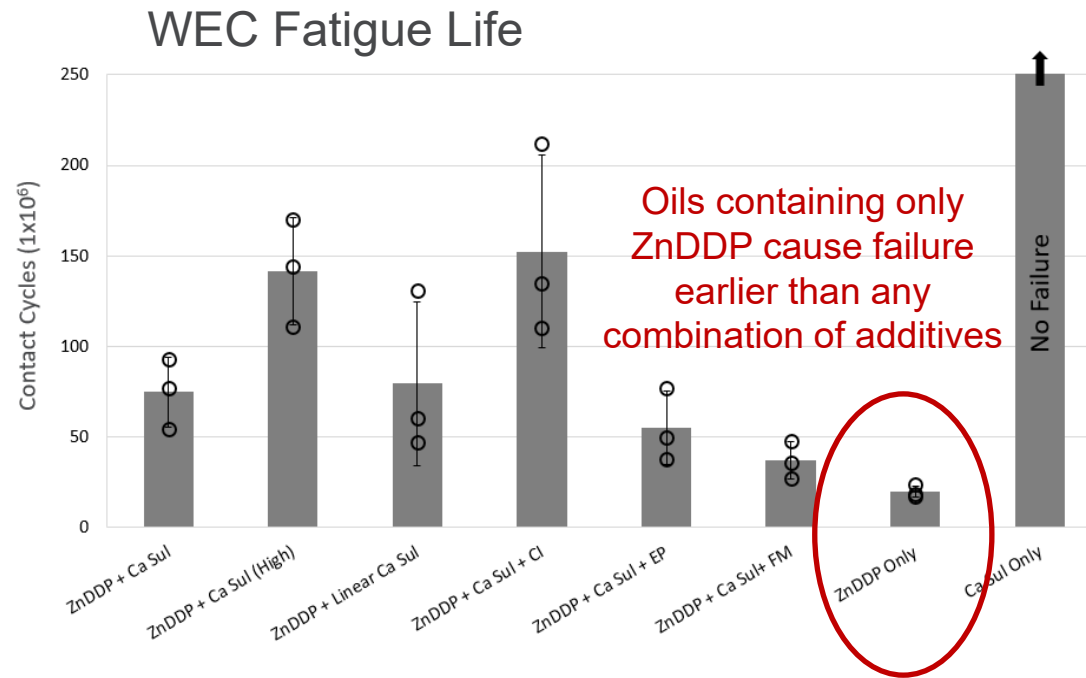
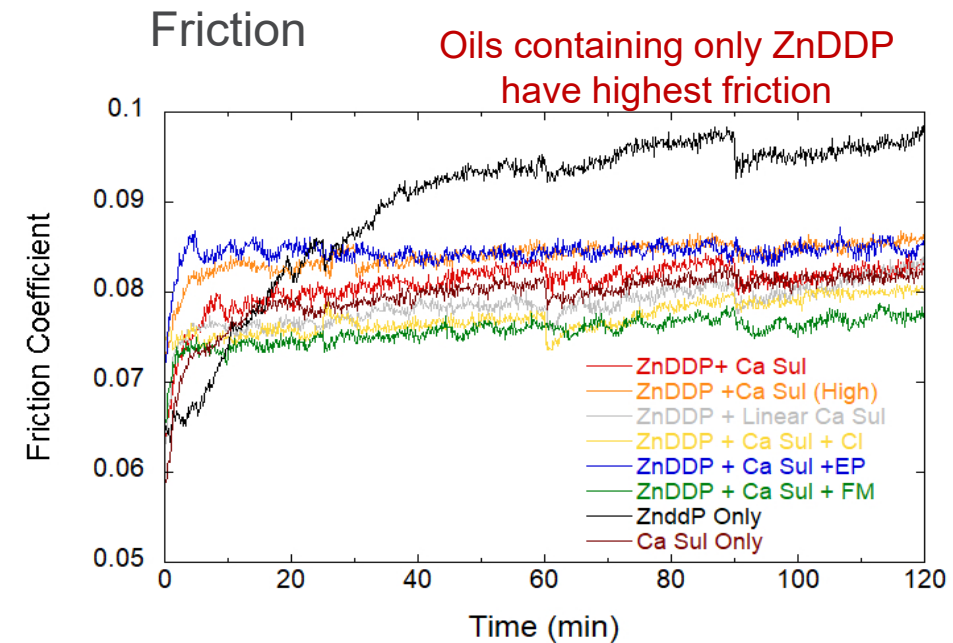
- Reverse-engineered the “bad reference oil”
- Identified that a common anti-wear additive, zinc dialkyldithiophosphate (ZnDDP), accelerated WEC failures
- Oils containing only ZnDDP also have the highest friction, resulting in higher frictional heating

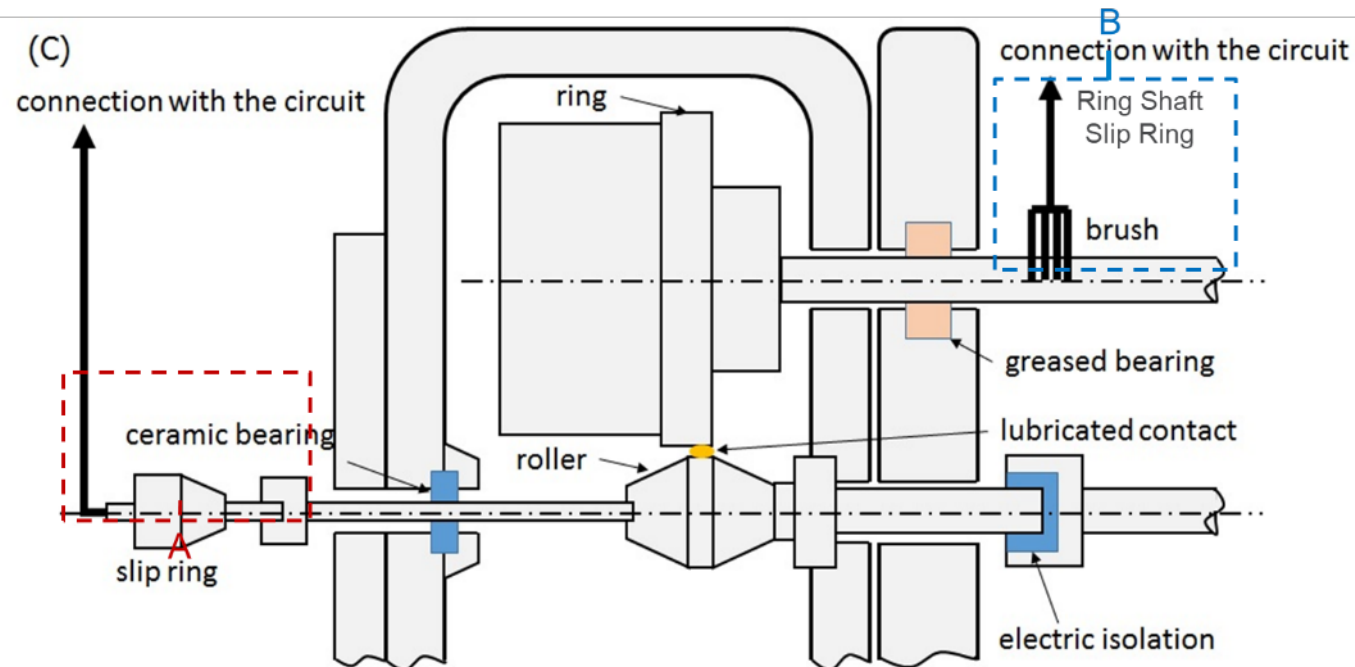
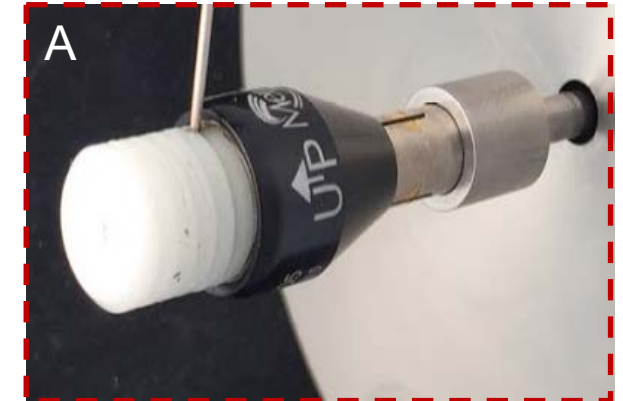
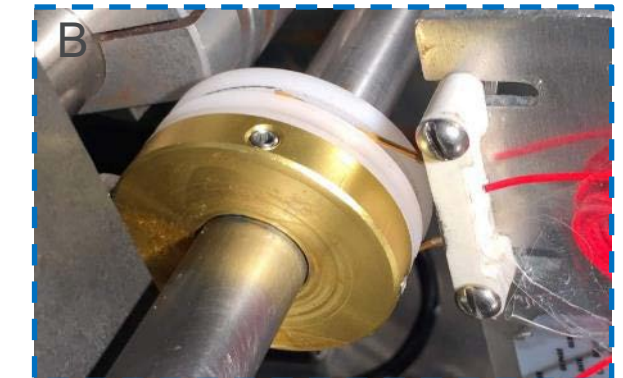
- Benchtop rig was modified to enable application of controlled electric current across contact
- Accommodates testing in both oil and grease

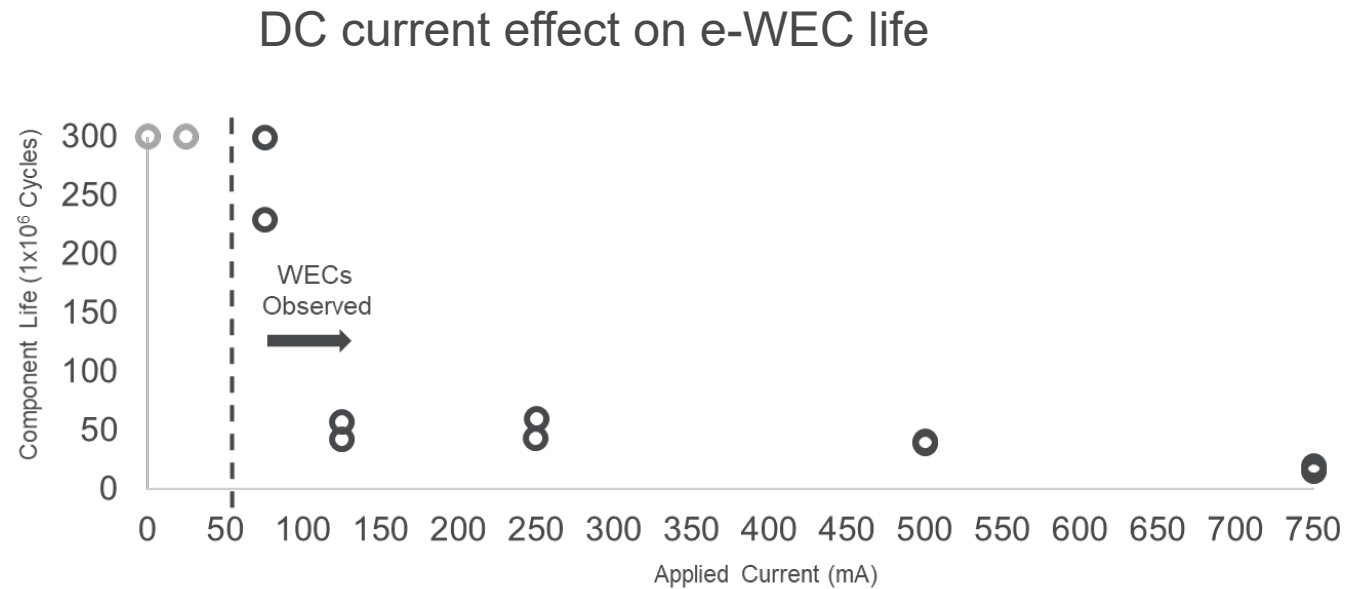
- WECs are significantly accelerated for wind turbine gear oils when electrical current is applied
- Observe a strong dependence of e-WEC on current level in wind turbine gear oils, >75mA

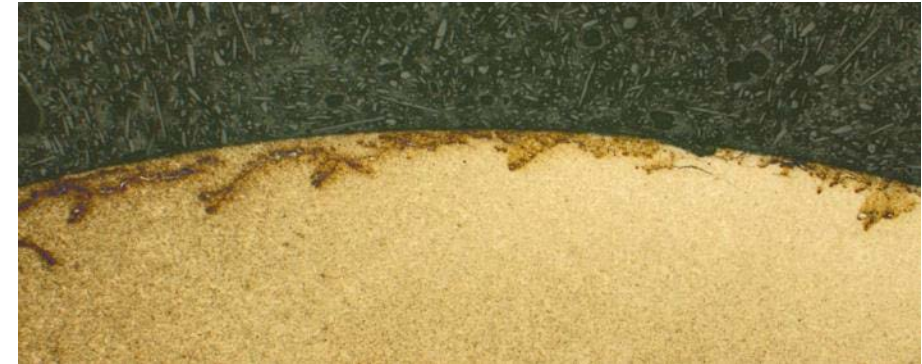
e-WEC density under test track

- Six tested gear oils all showed e-WECs within run-out limit
- Propensity of e-WECs are higher than other WEC drivers
- Oils 1–5 are commercial wind turbine gear oils, 6 is a PFPE oil that does not contain hydrogen (hydrogen is not required to form WECs)
- Oils 1–4 have the same base oil but different additive chemistry
- Initial results show coatings are effective but not preventative

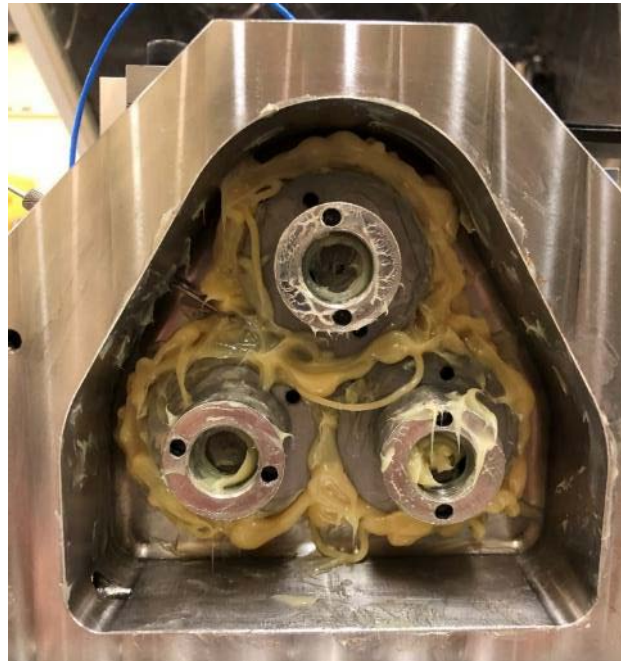
- Similar to oils, greases also show a strong dependence in time-to-failure rates on formulation.
- Lubricants that are designed to mitigate fluting may show no improvements for electrically accelerated fatigue.

Effect of 250mA DC current on greased bearing life
