# Aerosol Envelope Sealing of Existing Residences

May 2024

Recipient: Center for Energy and Environment

This report, *Aerosol Envelope Sealing of Existing Residences*, explores the best methods for aerosol envelope sealing of unoccupied, existing residences and documents typical leakage reductions.

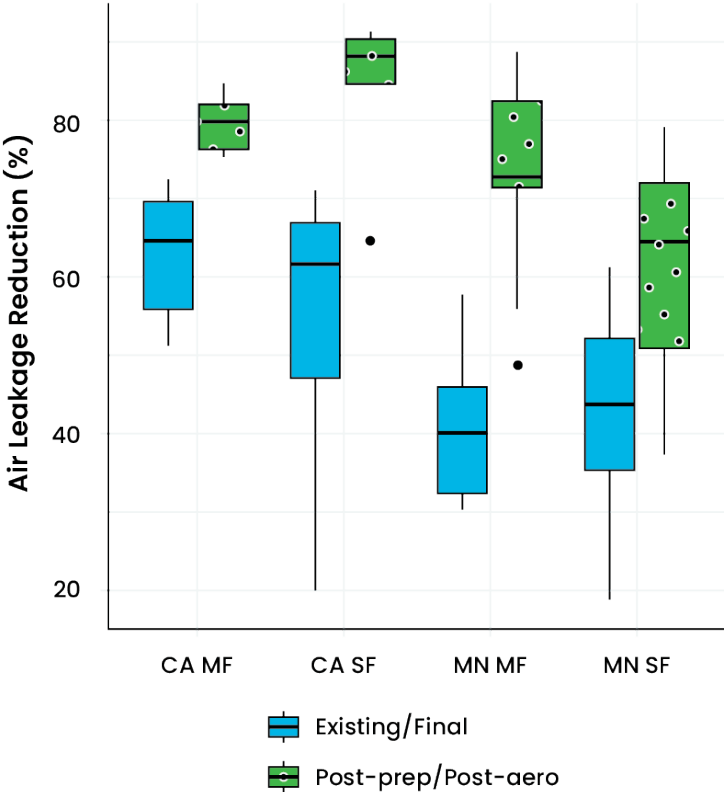
Figure ES-2 also shows the percent reduction immediately before and after the aerosol sealing

Figure ES-2. Air leakage results summary for all residences

when the preparations were in place (green boxes). With preparations in place, the aerosol process reduced leakage by an average of 72%. This indicates that the aerosol process sealed almost three quarters of the leaks that were not covered by preparations.

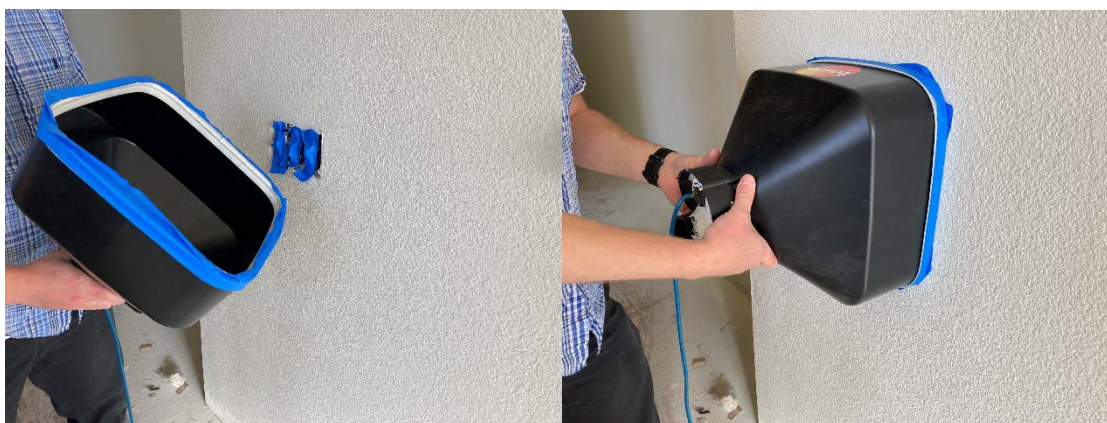
Figure 6. Leakage measurement tool used to measure leakage of light switch

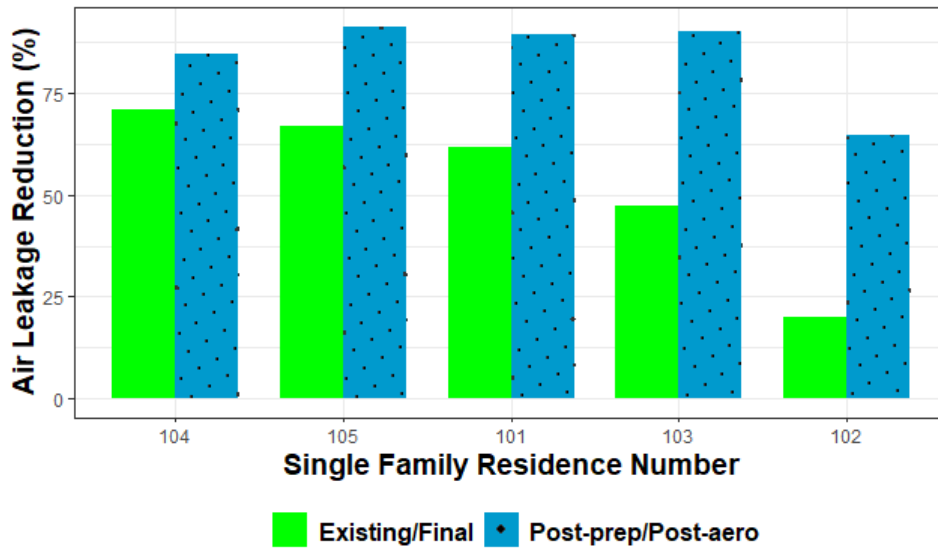
Figure 14. Comparison of percentage air leakage reductions of California single-family homes

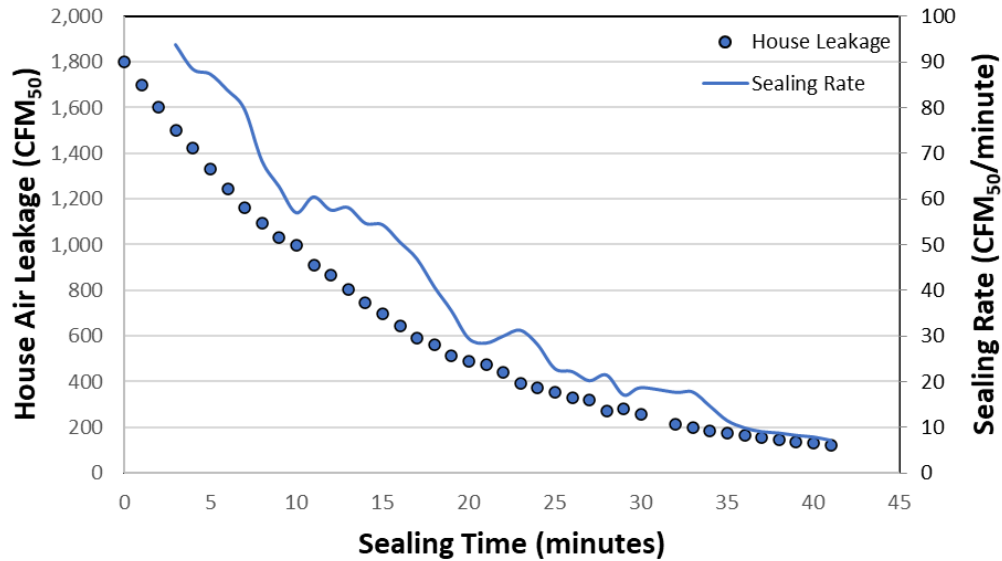
Figure 16. Sealing profile for California residence 101

Figure 16 shows the sealing profile and Figure 17 shows air leakage test results for residence 101. In this case, the sealing time was short, requiring only 41 minutes of injection compared to the average of 1.6 hours for all five California houses. The sealing rate started around 95 CFM<sub>50</sub>/min and went down to 5 CFM<sub>50</sub>/min at the end of the process. The air leakage test results show the amount of leakage covered by surface protection (4.10 ACH<sub>50</sub>) and the amount uncovered at the end of sealing (3.91 ACH<sub>50</sub>), suggesting the tightest the building could be sealed through the aerosol process was around 4 ACH<sub>50</sub>. Most of the air leakage covered by surface protection appeared to be from the floor, which was built on a raised foundation. The aerosol sealing process reduced the leakage by 89%, from 8.5 ACH<sub>50</sub> down to 0.9 ACH<sub>50</sub> before removing the surface preparation, and after removing the protection the final building leakage ended up at 4.8 ACH<sub>50</sub>. For this house, the covered and uncovered air leakage were in general agreement. As a result, the leakage reduction measured by the AeroBarrier equipment immediately before and after the aerosol sealing (7.60 ACH<sub>50</sub>) was nearly equal to the reduction measured before and after sealing with no surface preparation in place (7.79 ACH<sub>50</sub>). In some cases, the amount of leakage covered differed from the amount measured when uncovering, which is discussed in more detail in a later section.

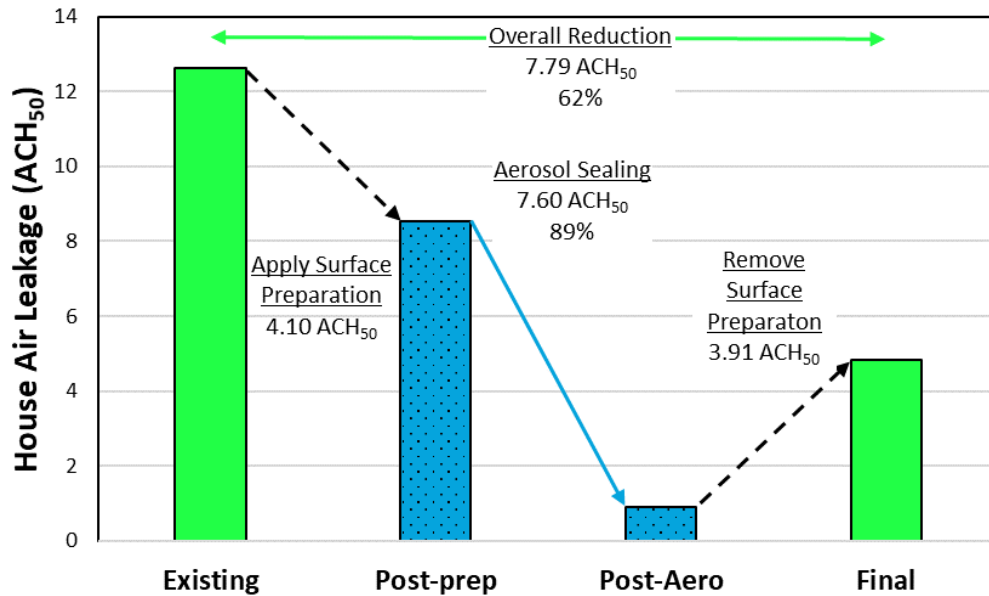
Figure 17. Leakage results summary for California residence 101

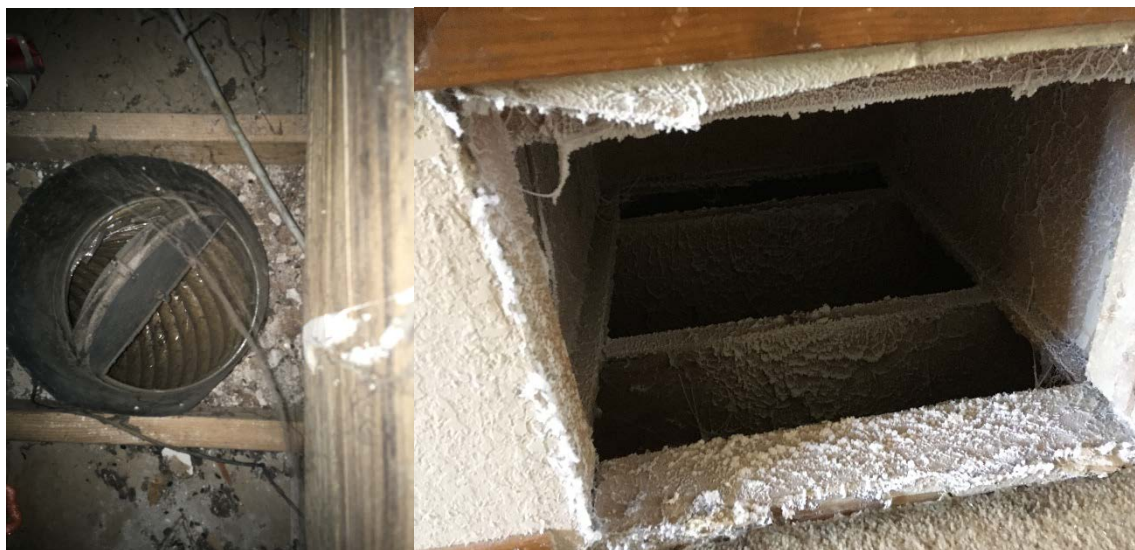
One significant source of leakage was the duct system that used interior building cavities as part of the distribution system and had significant leakage to outside. The return plenum was left open to evaluate whether the aerosol envelope sealing would reduce air distribution leakage to outside while sealing the rest of the home. In this case, the air handler was blocked to prevent sealant from reaching the blower and heat exchanger coils. Figure 19 shows aerosol deposition in and around the return plenum opening and supply ducts, suggesting significant leakage and sealant flow. The amount of deposition on the edges of the wall leading to the return plenum would only have occurred if extremely high air velocities were present. Typically, velocities would be low around a large opening that leads to smaller leaks in the plenum, so this deposition indicates a substantial amount of airflow entering the return cavity and escaping outside.

Figure 19. Return plenum opening inside wall cavity (left) and return entrance showing significant deposition (right)

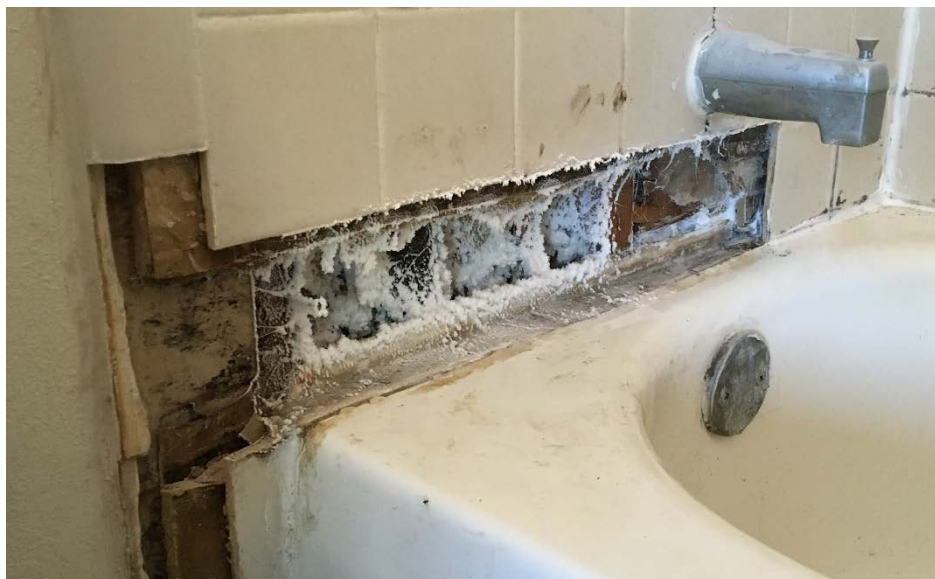
Figure 20. Construction in bathroom exposing the wall cavity where significant sealant collected due to high amounts of leakage

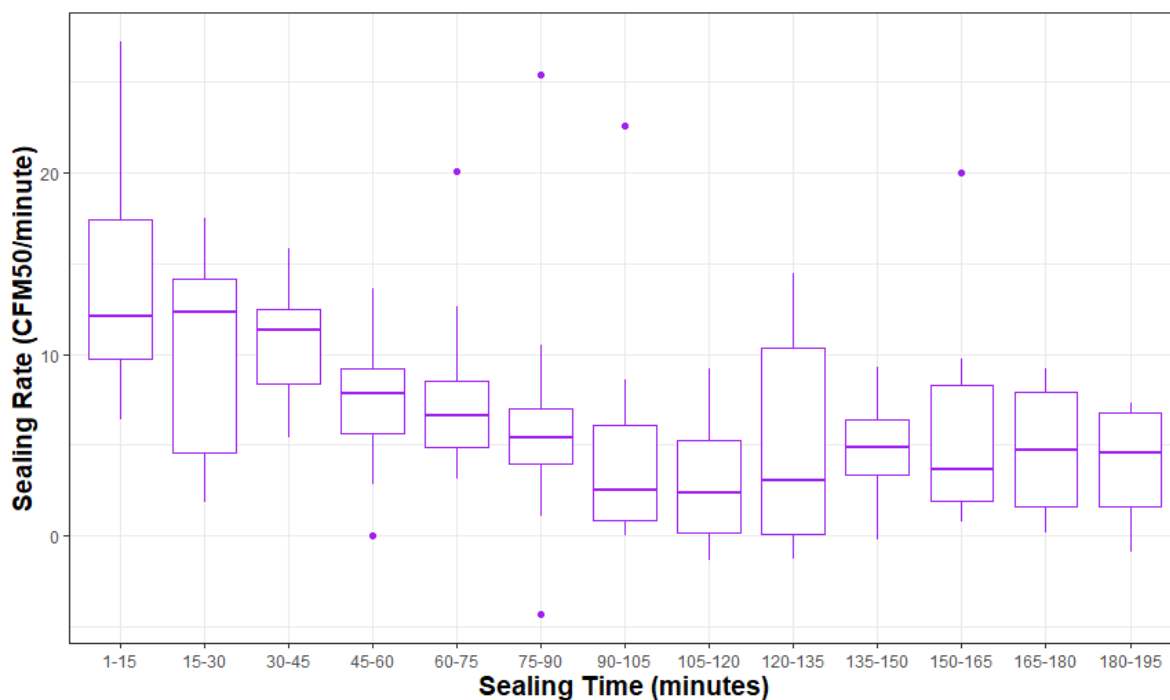
Figure 23. Aerosol sealing rate for 12 Minnesota single-family homes

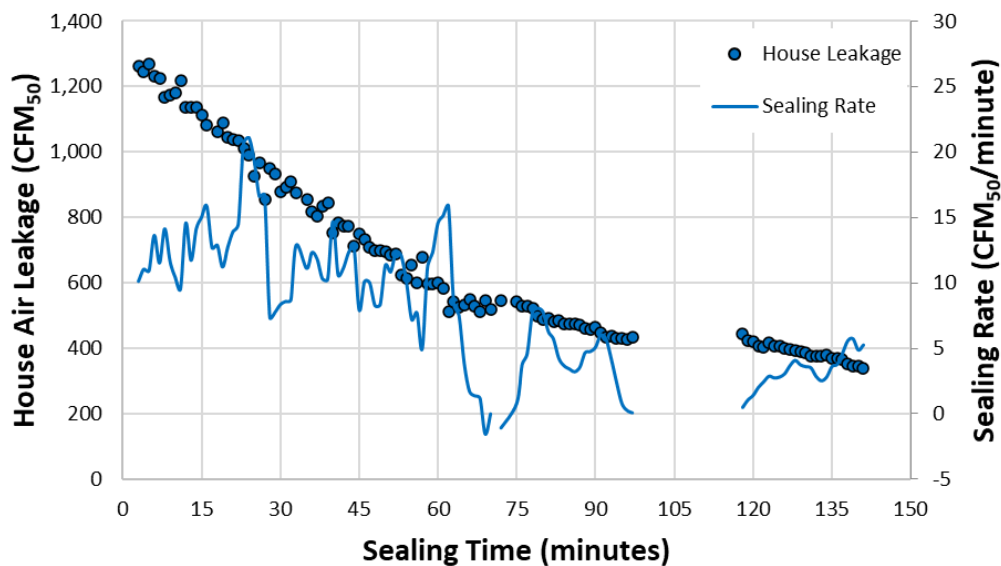
Figure 24. Sealing profile for Minnesota residence 7

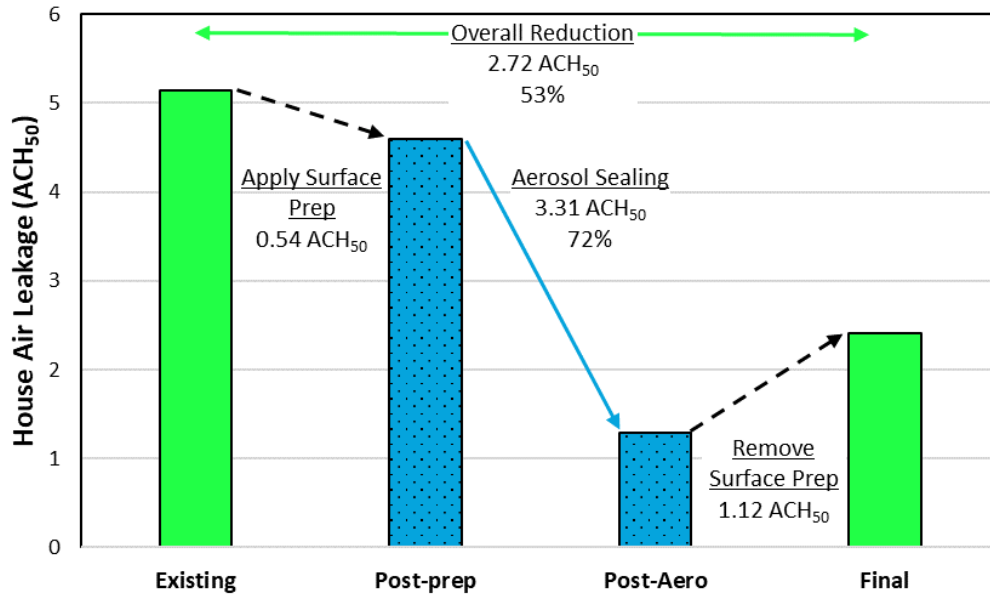
Figure 25. Leakage results summary for Minnesota residence 7

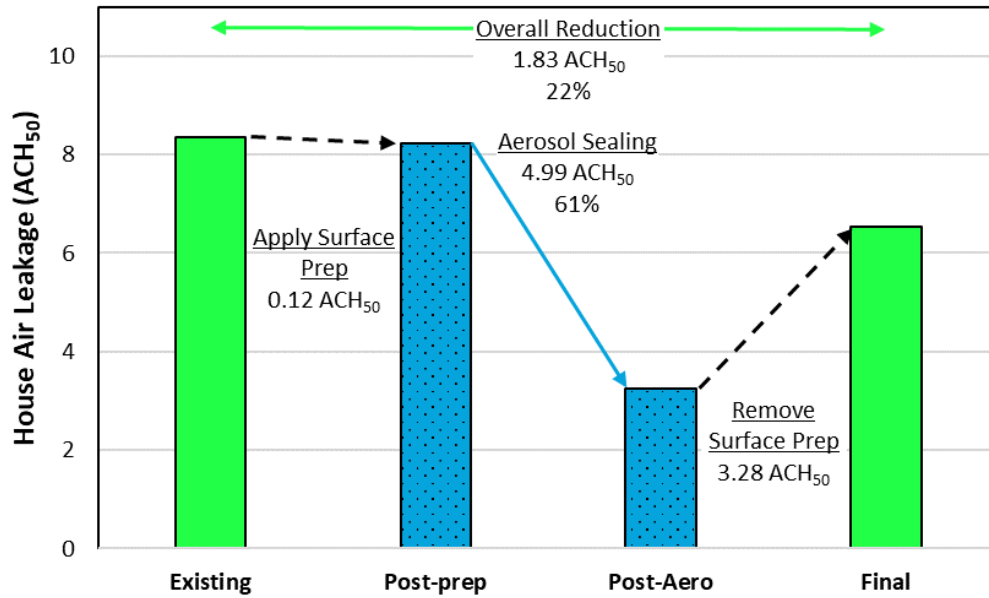
Figure 35. Leakage results summary for Minnesota residence 9

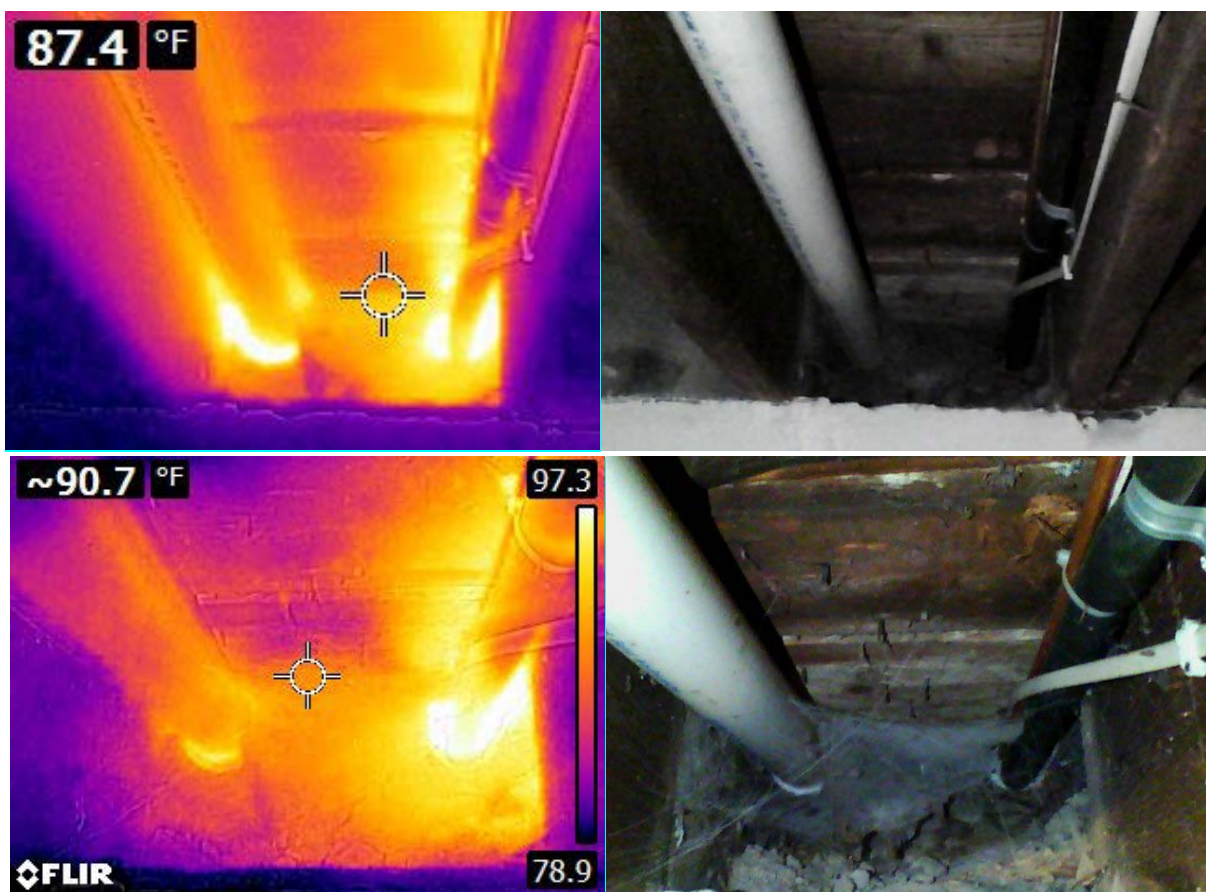
Figure 37. Pre- (top) and post- (bottom) sealing infrared and visual images of basement rim joist showing reduced air leakage through penetrations and joints

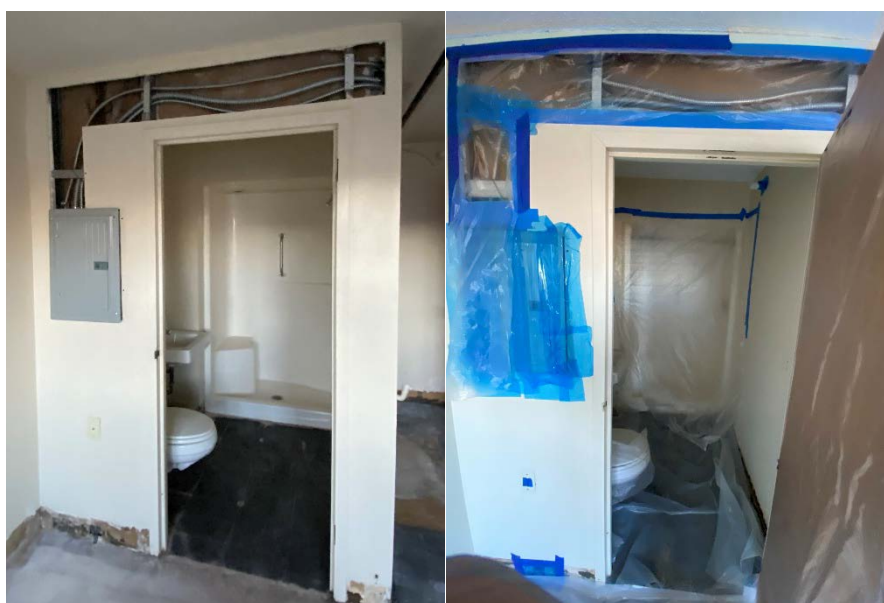
Figure 46. Drywall cut open for renovation (left) and temporary sealing (right)

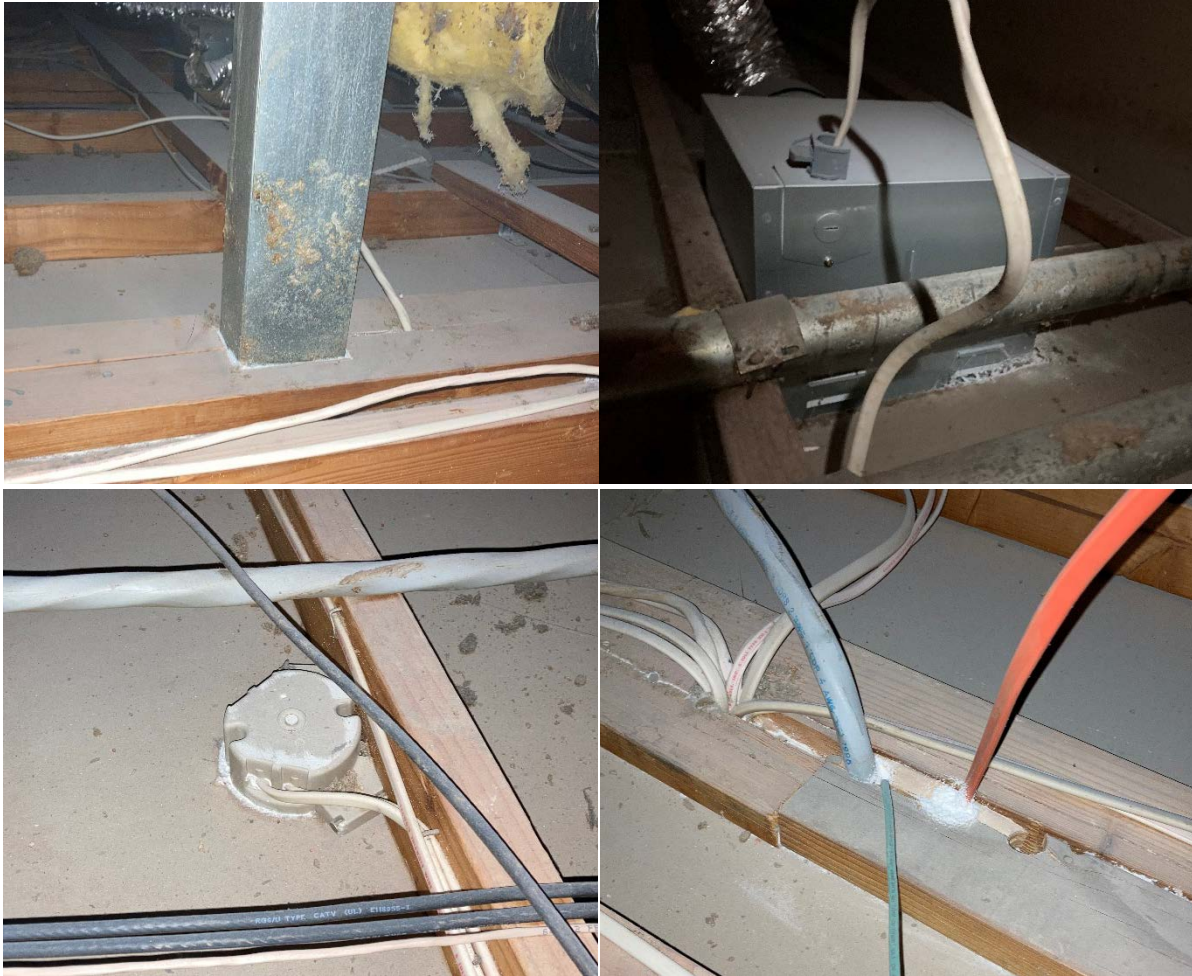
Figure 55. Attic seals made at duct (upper left), fan housing (upper right), ceiling light box (lower left), and wire penetrations (lower right)

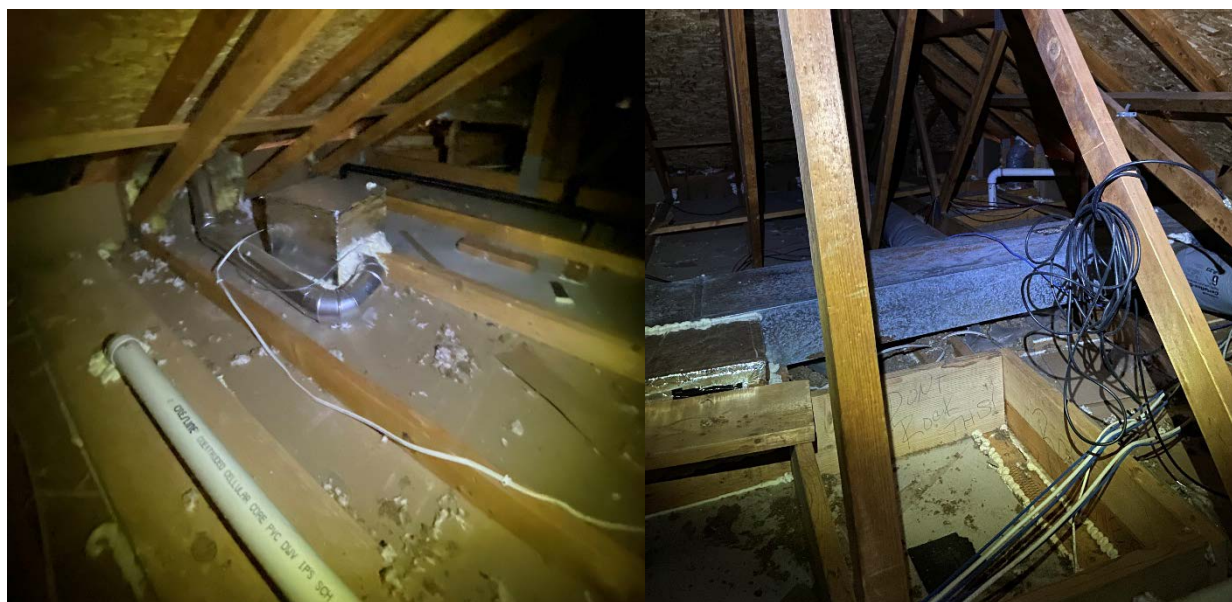
Figure 58. Manual sealing performed before aerosol sealing

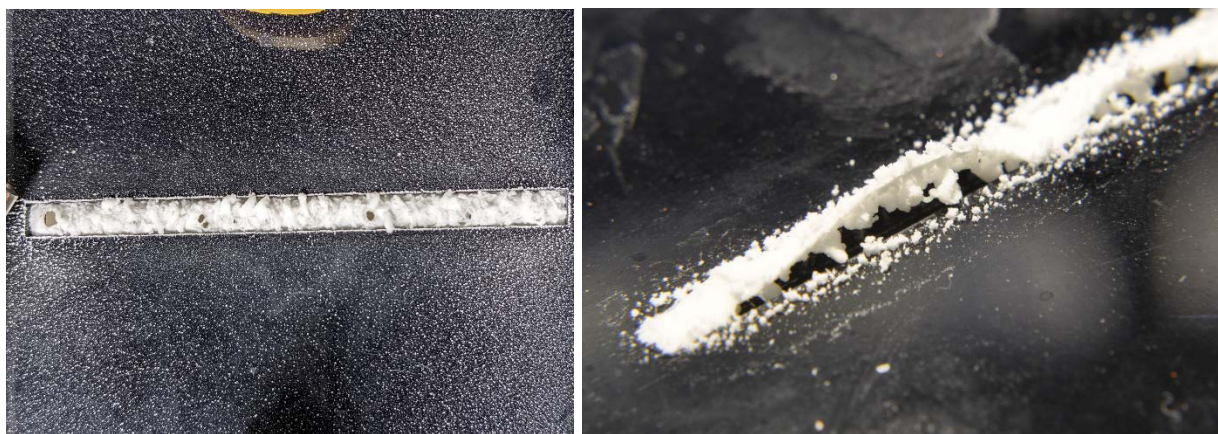
Figure 64. Failed seals occurring in the middle (left) and edge (right) of leak

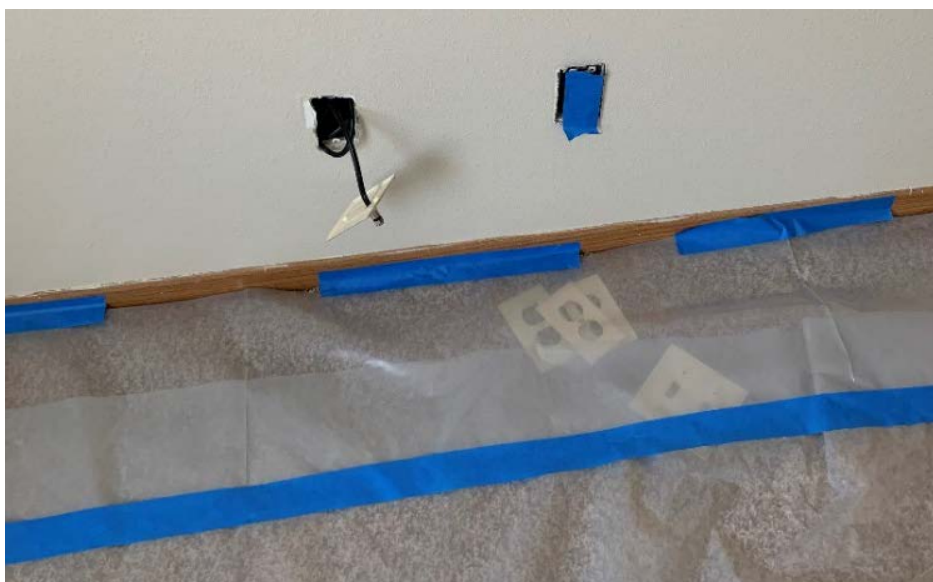
Figure 73. Poly sheet protection for flooring over slab or above finished space

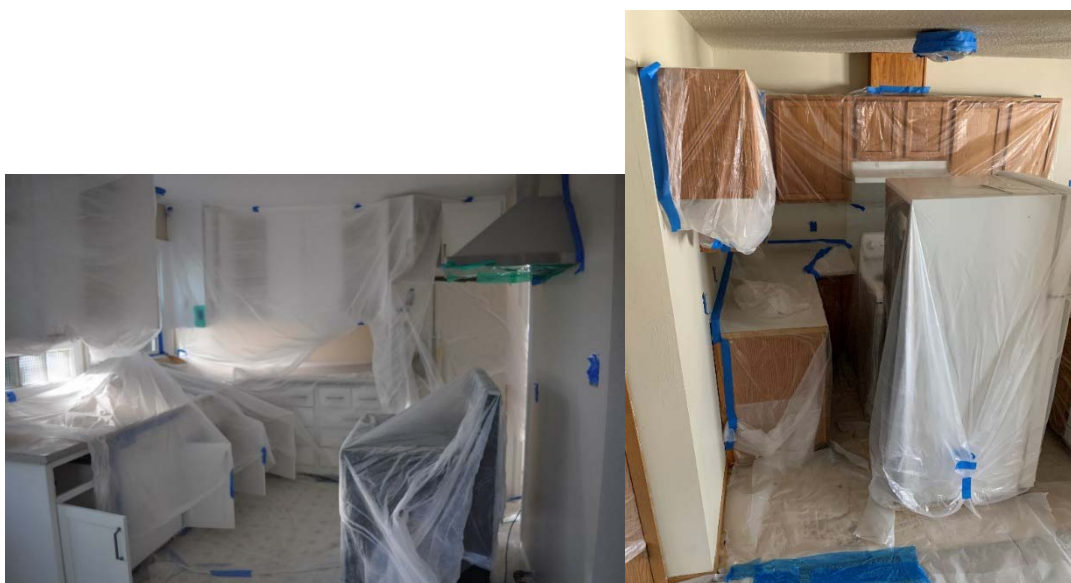
Figure 79. (Left) Cabinet doors open and (right) cabinet doors closed

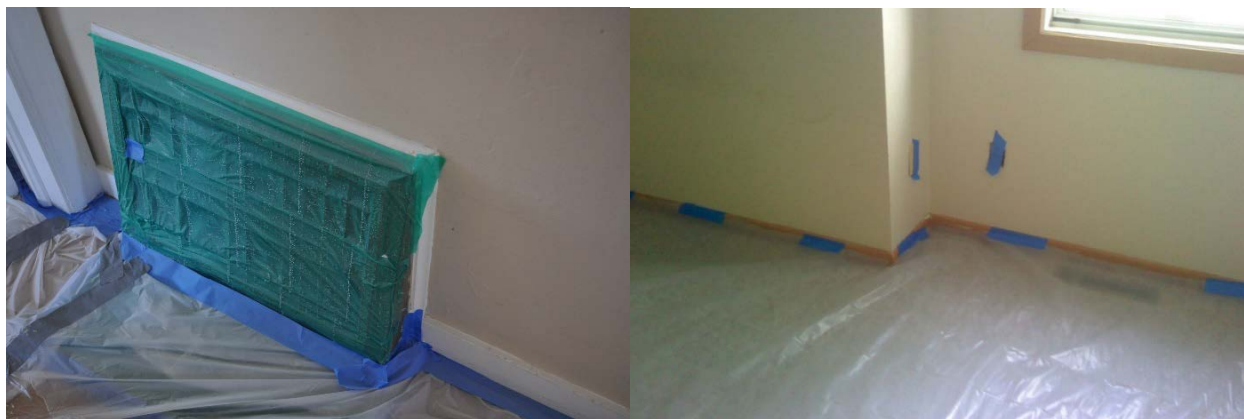
Figure 91. Poly sheet and duct mask over air distribution system grilles

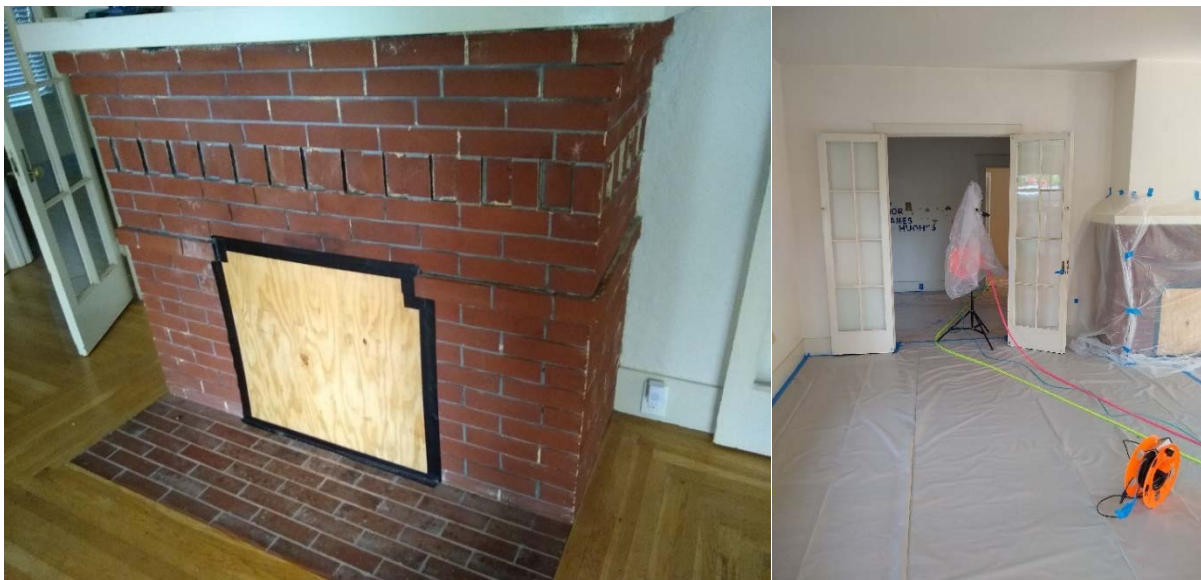
Figure 98. Plywood and poly sheet to protect fireplace opening
