Structural Characterization of Deployed Thermoplastic and Thermoset Composite Tidal Turbine Blades

Technical Report
NREL/TP-5000-88713
April 2024

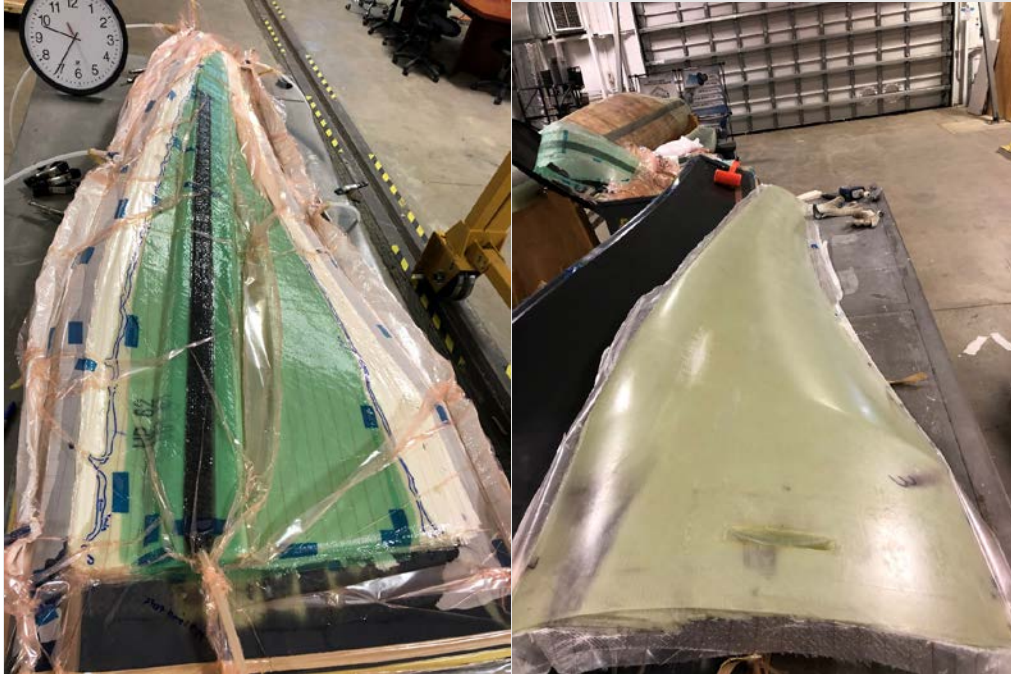
Figure 3. High-pressure thermoplastic blade skin mid-infusion (left) and completed high-pressure skin (right).

Figure 3 shows the infusion process on one of the blades and a completed high-pressure thermoplastic blade skin. Figure 4 shows a completed blade, three thermoplastic blades, and the data acquisition system on the Verdant hub ready for turbine assembly. Four blades were made in total, one for dry structural testing prior to deployment and three for deployment. Only the deployment blades were painted.

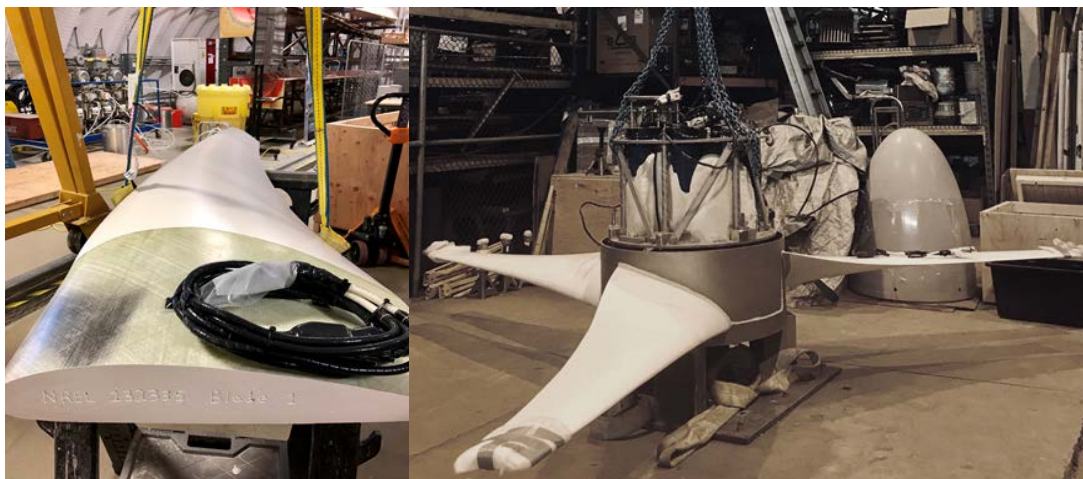
Figure 4. Completed thermoplastic blade (left) and thermoplastic blades in the Verdant Power hub ready for turbine assembly (right).

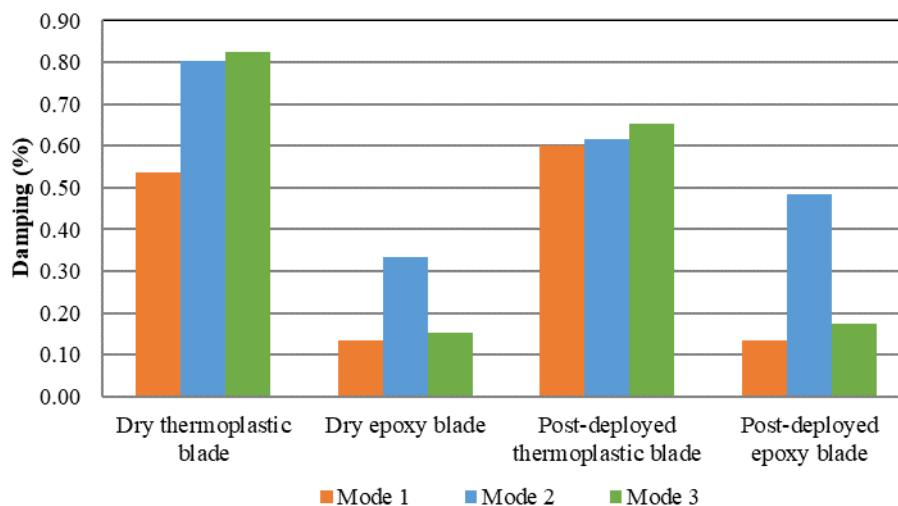
Figure 7. Modal damping properties of pre- and post-deployed thermoplastic and epoxy blades

The dry thermoplastic and epoxy blades had frequency responses within 5% of each other, with the thermoplastic blades being slightly stiffer. However, the thermoplastic blades had 3 to 4 times more damping than the epoxy blades in Mode 1 and Mode 3. The higher edgewise damping of the post-deployed epoxy blades is unexpected. These results speak to the challenges of damping estimation and the sensitivity to things like boundary conditions and the analysis method used. It was also noted that these short and relatively stiff blades had complex modes, with flapwise and edgewise modes being harder to identify separately than in large wind turbine blades. A larger sample size or repetition of experiments would help to increase accuracy of these damping values but was not possible for the one-off nature of these blades. In general, an increase in damping could have positive effects by decreasing the loads transferred to the rest of the downstream turbine components. Structural damping will be the focus of future thermoplastic blade research efforts.

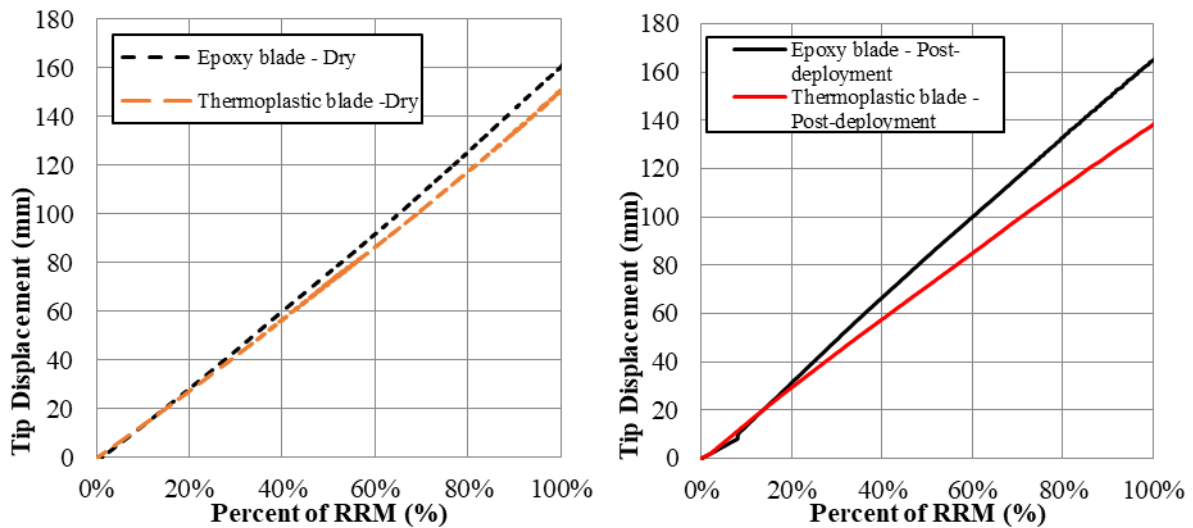
Figure 8. Epoxy and thermoplastic blade tip displacement as a function of RRM for (left) dry blades and (right) post-deployed blades

All three of the post-deployed thermoplastic blades had tip displacements within 2.85% of each other at the maximum load level, and all three of the post-deployed epoxy blades had tip displacements within 1% of each other. This suggests that manufacturing differences between the three thermoplastic blades made using vacuum infusion were relatively low, and also that the manufacturing differences between the three epoxy blades made in an autoclave process were relatively low. The post-deployed epoxy blade has a nonlinearity at the 8% load level which was observed for all ten static pulls of the post-deployed epoxy blades, but not for the post-deployed thermoplastic blades. We suspect this to be a result of a setup misalignment or loose fixturing such as the saddle settling under load, however, we were not able to inspect the test setup as it was taken apart prior to data processing. Even with this nonlinearity at the start of the epoxy tests, all four blade types had highly linear displacement-load trends.

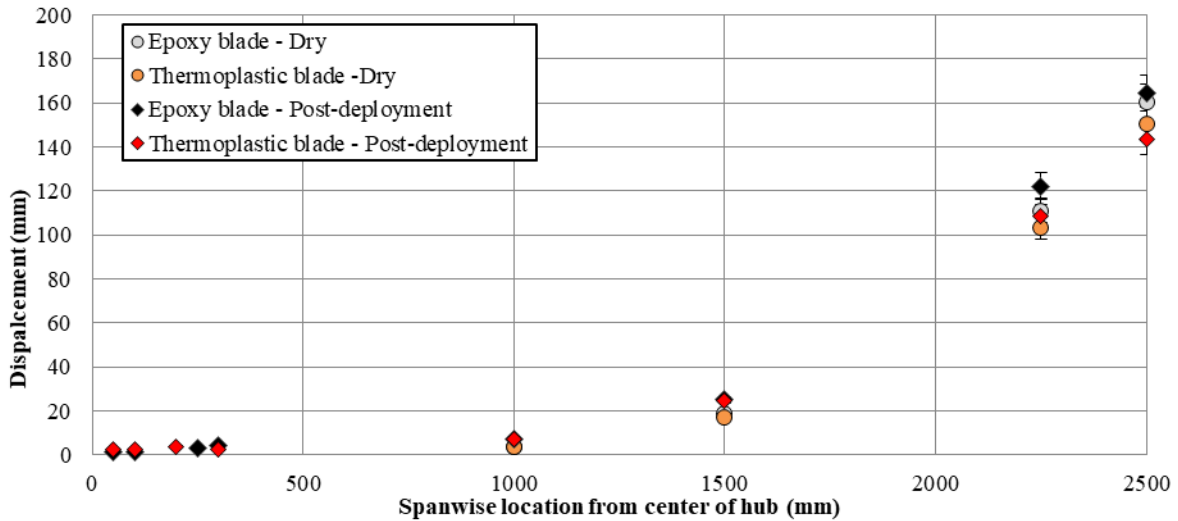
Figure 9. Spanwise displacements of epoxy and thermoplastic pre- and post-deployed blade at the RRM

Figure 9 shows the displacements of each blade type at the RRM as measured by the LDT at various locations close to the root of the blade, and as measured by the three string potentiometers and actuator. Figure 10 shows the LDT blade root displacement measurements at locations 50 mm (root/hub interface), 100 mm, 250 mm, and 300 mm from the center of the hub. All measurements are taken at the 40% chordwise location on the spar cap of the blade.

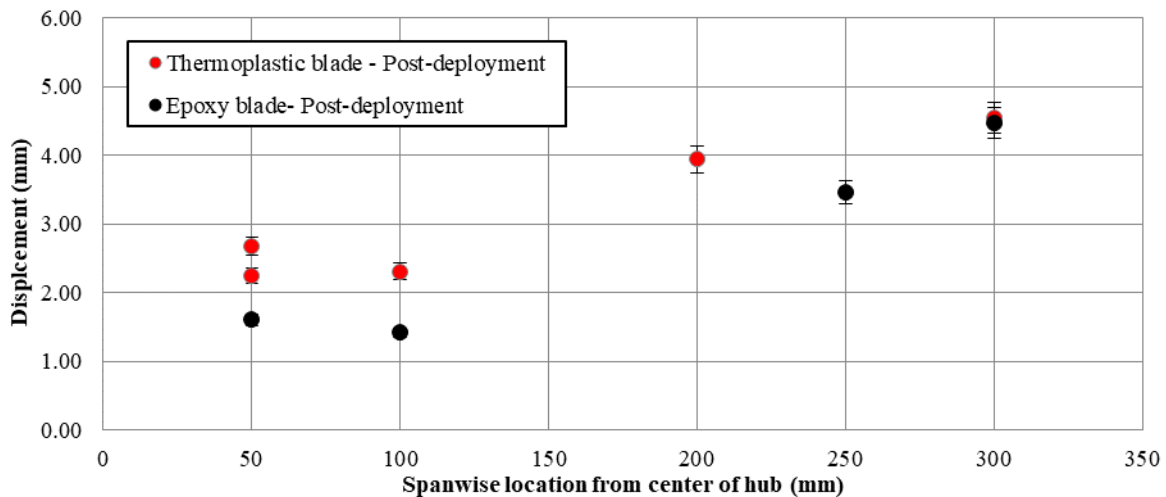
Figure 10. Spanwise displacements of epoxy and thermoplastic pre- and post-deployed blade at the RRM measured by LDT on the spar cap of blade

At 300 mm from the root of the blade, the post-deployed blades had ~4.5 mm of displacement as measured by an LDT placed at this location (shown in Figure 10), as compared to the dry blades that had less than 1 mm displacement at the root at the RRM (Figure 9). This is consistent with the less rigid boundary conditions from the test setup for the post-deployed rotor. The increased angle at the root of the post-deployed blades could, however, amplify the outboard blade displacements. For example, this increased root movement results in a blade angle of about 0.9 degrees at the root, which can have up to a 30-mm effect in the blade tip displacement for the post-deployed blades. This means that the displacements between the dry and post-deployed blades should not be directly compared. For this reason, the strain measurements make for a better side-by-side comparison for dry and post-deployed blade performance.

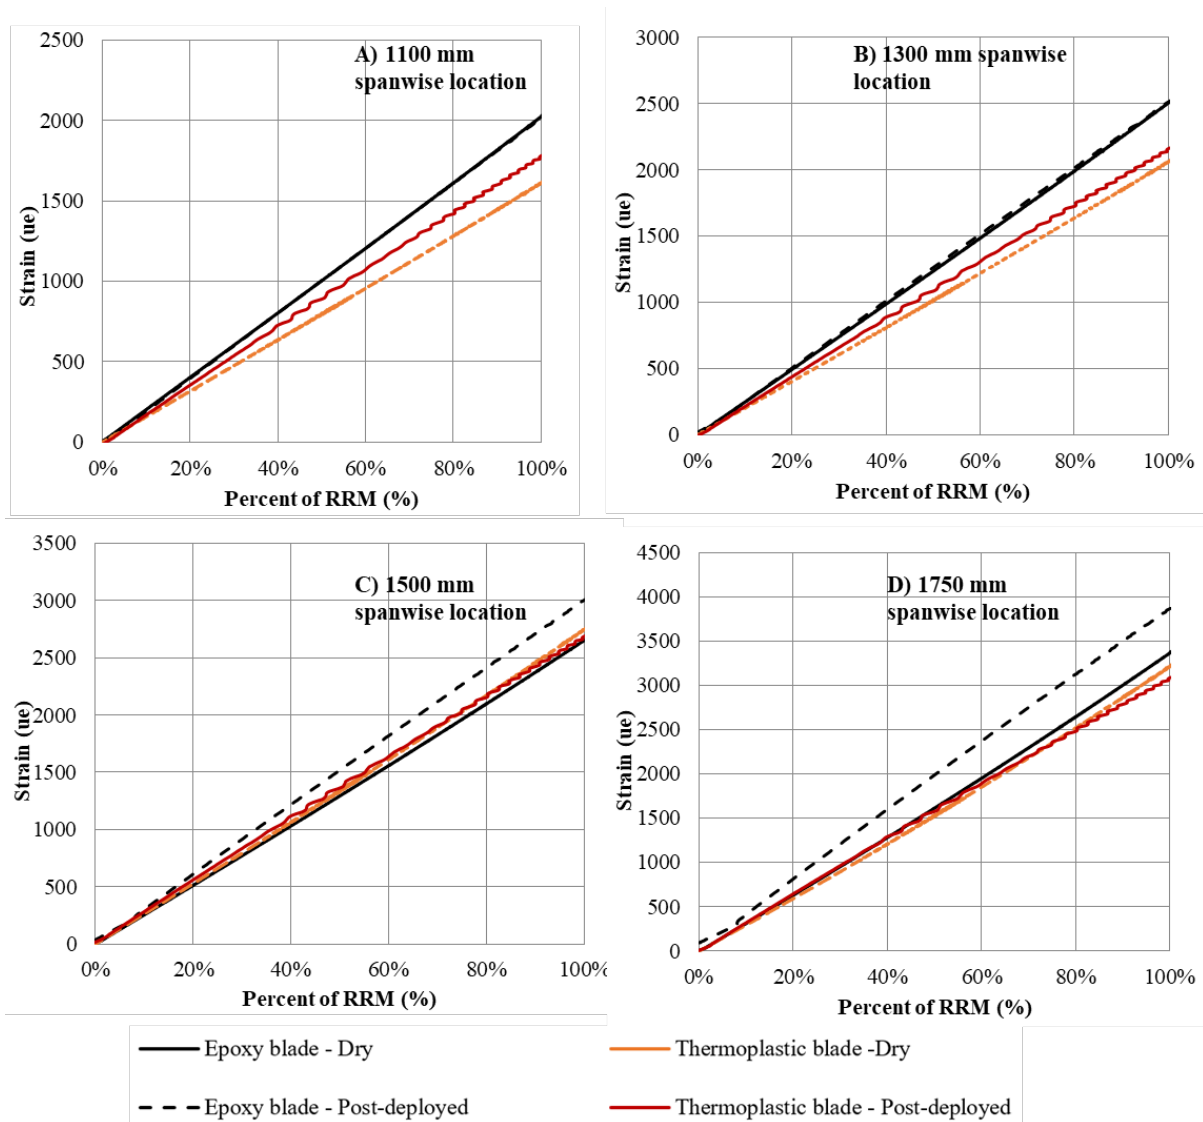
Figure 11. Epoxy and thermoplastic tensile strain at various spanwise spar cap locations as a function of applied blade root moment: (a) 1,100-mm spanwise spar cap strain gauge, (b) 1,300-mm spanwise spar cap strain gauge, (c) 1,500-mm spanwise spar cap strain gauge, (d) 1,750-mm spanwise spar cap strain gauge

Figure 11 shows the tensile strains, and Figure 12 shows the compressive strains at different spanwise spar cap locations as a function of load.

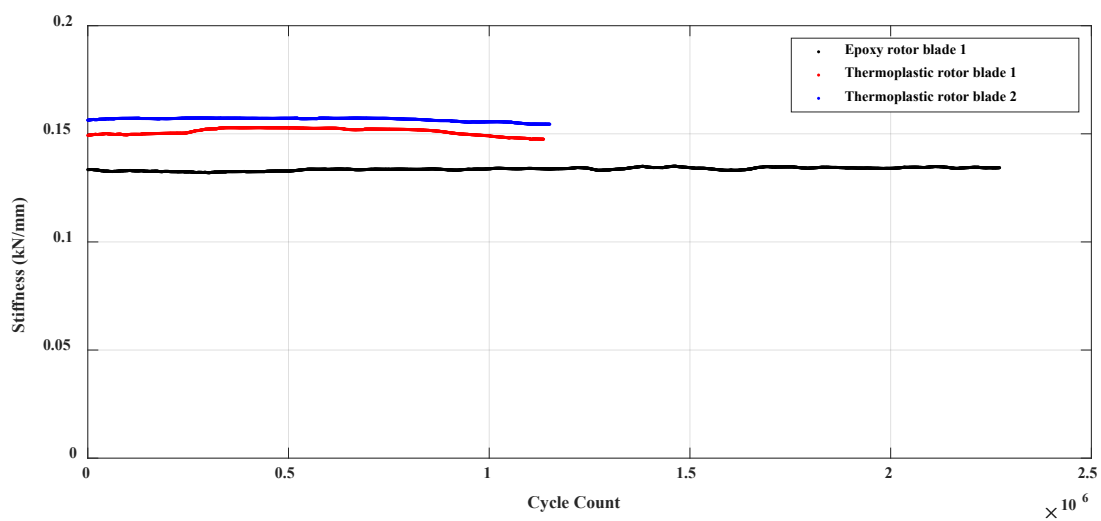
Figure 13. Blade stiffness at saddle location as a function of cycle count, smoothed data

The epoxy blades reached the full 2 million cycle test duration with no significant change in stiffness. As early as 400,000 cycles the first thermoplastic blade stiffnesses started to slowly decrease; having a 3% decrease in stiffness by 900,000 cycles. Following this, stiffnesses abruptly decreased and the test interlocks were triggered, thereby shutting down the test at 1.2 million cycles. A crack in the leading edge of the blade was observed, as shown in Figure 14, at approximately the 2,000 mm spanwise location close to the location of the saddle. The second thermoplastic blade also had a decrease in stiffness with the test operated until a small crack was observed at 1.2 million cycles. The first blade was cut from the hub and segmented spanwise to enable an internal inspection, shown in Figure 14.

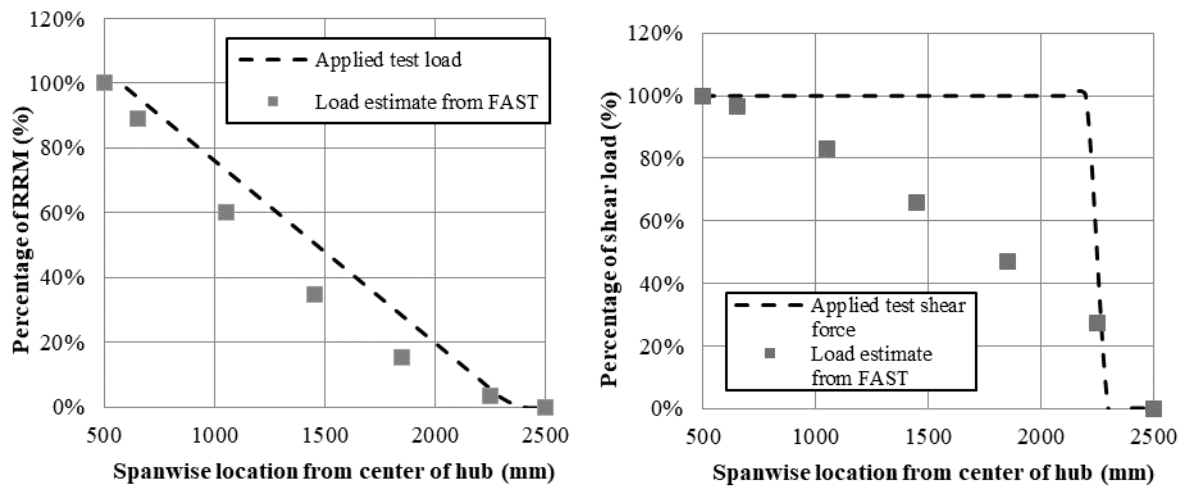
Figure 15. Applied test loads compared to predicted loads from OpenFAST model showing root bending moment and shear loads.

From Figure 15, the applied test loads track the predicted OpenFAST bending moments fairly well, however, the shear forces on the blade due to the single point applied test load are significantly higher than the shear loads that the turbine is expected to see based on OpenFAST predictions. For example, at the 2,000 mm location where the blade failure was observed, the applied shear force was 66% higher than the OpenFAST load that the blade is estimated to experience during a deployment. In a laboratory test, there are always going to be areas of a blade that are overloaded and areas that are underloaded; it's up to the blade designer to determine which areas are of most importance so that the test can be appropriately designed. In this case, limited structural design data was prohibitive to test design. For short and stiff blades such as tidal turbine blades, future tests are recommended to apply test loads at multiple points along the blade to better match the design shear loads of the blades and avoid overloading in shear.

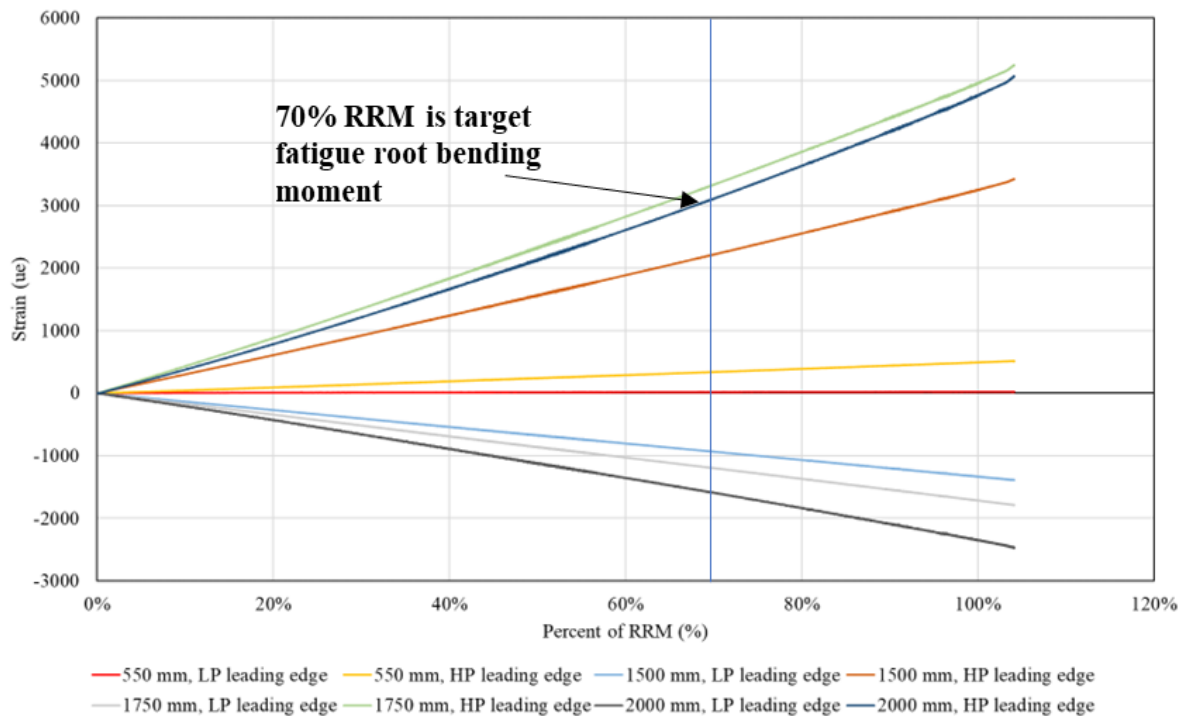
Figure 16. Dry thermoplastic blade leading edge strain gage measurements along length of blade for a static load pull. LP denotes low pressure (compression) and HP denotes high pressure (tension).

estimate the leading-edge strains that the post deployed blades may have seen. From these gages, shown in Figure 16, the strains in the leading-edge of the dry thermoplastic blade were over 3,000 ue in tension and over 2,500 ue in compression at the 2,000 mm location (where the fatigue failure was observed).
