Growing Panes: Investigating the PV Technology Trends Behind Frequent Early Failures in Modern Glass-Glass Modules

Elizabeth C. Palmiotti¹, Martin Springer¹, Jarett Zuboy¹, Timothy J. Silverman¹, Jennifer L. Braid², Dirk C. Jordan¹, Salil Rabade¹, Andy Walker¹, Teresa M. Barnes¹

DuraMAT Webinar January 13, 2025

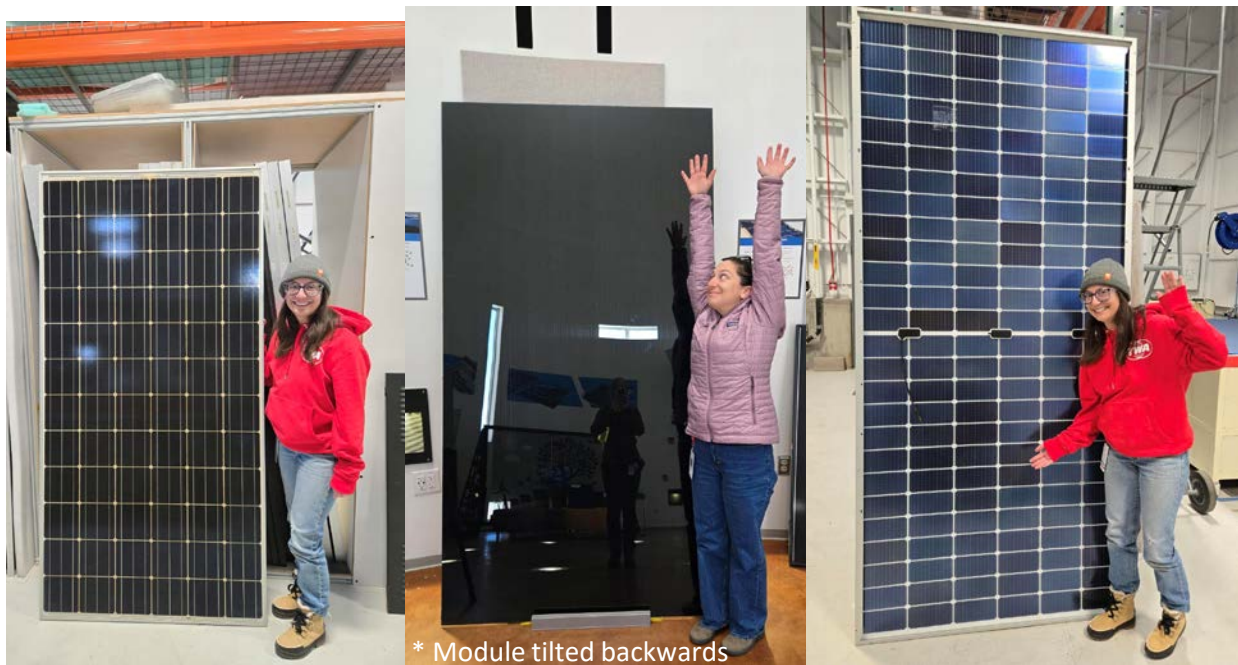
Crystalline silicon
ca. 2014

Thin film
ca. 2024

Crystalline silicon
ca. 2024

Multiple changes increases the damage risk more than any of the changes alone.

- Larger module area
- Thinner cells
- Thinner glass
- Less-supportive framing
- Less-supportive mounting

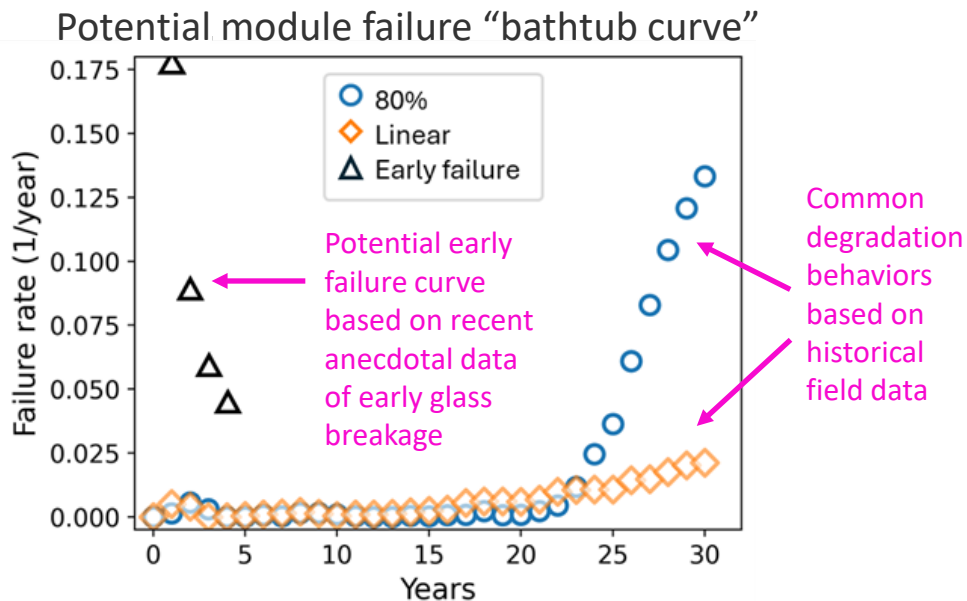
Failure rates as defined by a decrease in power below 80% of the original output (blue circles) and linear degradation greater than 0.8%/year (orange diamonds) compared with increased failure rates during early-life (black triangles). Sources: Springer et al., “Future-proofing photovoltaics module reliability through a unifying predictive modeling framework,” *Prog. Photovolt. Res. Appl.*, 2023, <https://doi.org/10.1002/pip.3645>; Weber et al., “Glass Breakage: A Growing Phenomenon in Large-scale PV,” PV magazine webinar, Nov. 20, 2023, www.pv-magazine.com/wp-content/uploads/2023/10/All-presentations-5.pdf.

The dramatic impact of early failures on the module failure rate curve is illustrated in Fig. 1. In previous work, some of the authors used a Monte Carlo simulation of common PV module degradation behaviors to construct a module-specific failure rate curve [4], [13]. Because different definitions of “module failure” have been used historically, the concept is shown using two different definitions. First, failure can be defined as the power output of a module decreasing below 80% of its original rating (blue circles). Second, failure may also be defined to occur when the linear degradation exceeds 0.8%/year, which aligns with typical linear warranty rates [4] (orange diamonds). In the field of reliability, the failure rate curve is often envisioned as a “bathtub curve” because of its increased rates in the early- and late-life stages [14]. The two definitions of failure lead to different onsets of increased failure rates in the curve’s wear-out phase after 15–25 years, but the early-life phase has much lower failure rates than the wear-out phase under both definitions—in alignment with failure rates obtained

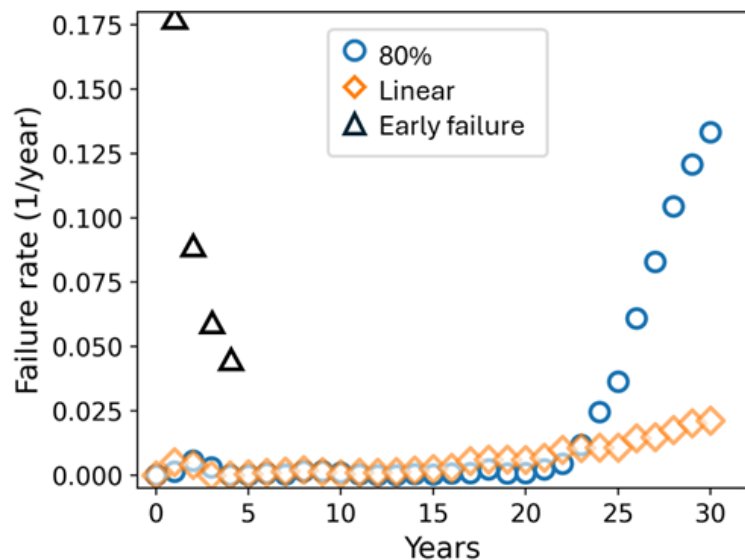
Potential module failure “bathtub curve”

Key Assumptions

System size	100 MW _{dc}
Analysis period (project life)	30 years
Crystalline-silicon module cost*	\$152 each
Labor hours per module replacement	0.1 hour
Labor rate (journeyman electrician)	\$24.12/hour
Module downtime during replacement	162 hours
Power affected by each module downtime	5.74 kW _{dc}
Discount rate	6.53%
Inflation rate	2.50%
Value of lost production (\$/kWh)	\$0.05/kWh
Escalation rate value of lost production	2%/year

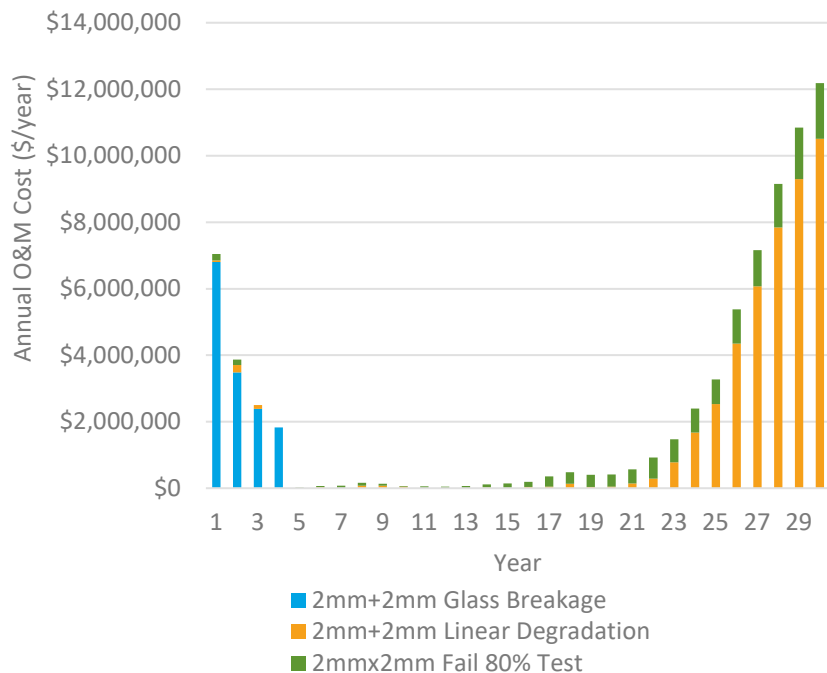
Annual O&M Cost

Monetary results are in present dollar values.

- Adding the high early glass breakage rate increases LCOE by \$0.01 (1 cent) per kWh.
 - Equivalent to ~20% of current U.S. average LCOE for utility-scale systems.
- Analysis is sensitive to assumed failure distribution.

Results	No Early Breakage	Early Breakage
Annualized O&M costs (\$/year)	\$1.60 million	\$2.55 million
Annualized unit O&M costs (\$/kW/year)	\$16.00	\$25.48
NPV O&M costs (\$)	\$27.90 million	\$44.42 million
NPV (\$) per Wp	\$0.279	\$0.444
NPV annual O&M cost per kWh	\$0.0145	\$0.0233
NPV lost production (\$)	\$0	\$1.90 million
NPV lost production per kWh	\$0	\$0.001

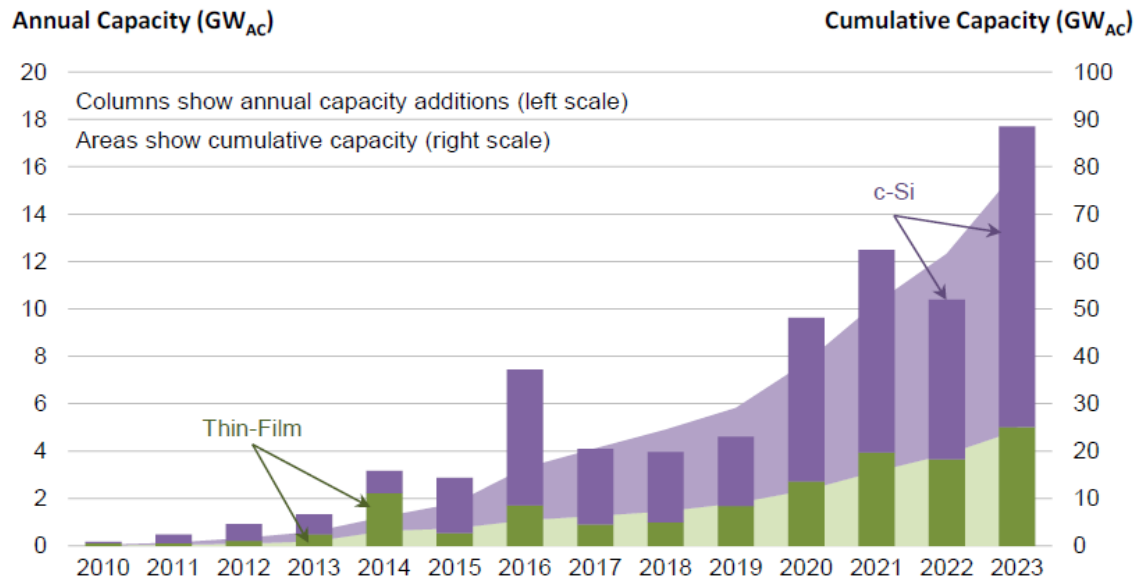
U.S. shares of silicon and thin-film modules in utility-scale systems

PV project population: 1,494 projects totaling 79.3 GW_{AC}

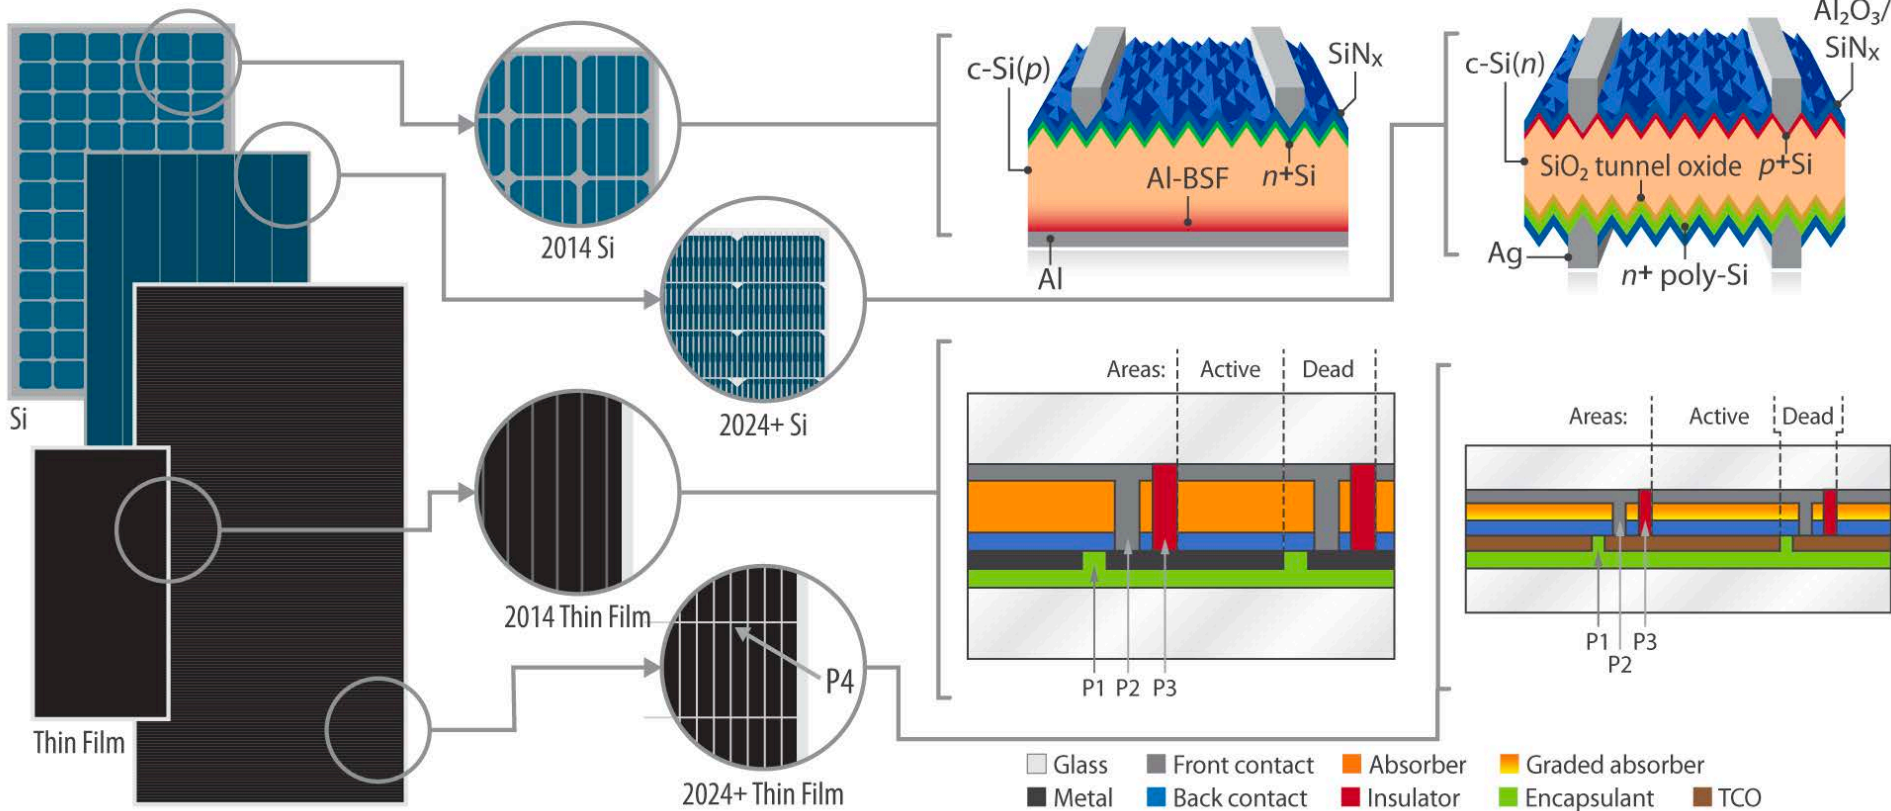
Packaging trends are converging for c-Si and thin film modules

Module cross-section layers: ■ aluminum frame ■ encapsulant ■ silicone ■ cell □ backsheet □ glass ■ edge seal ■ adhesive

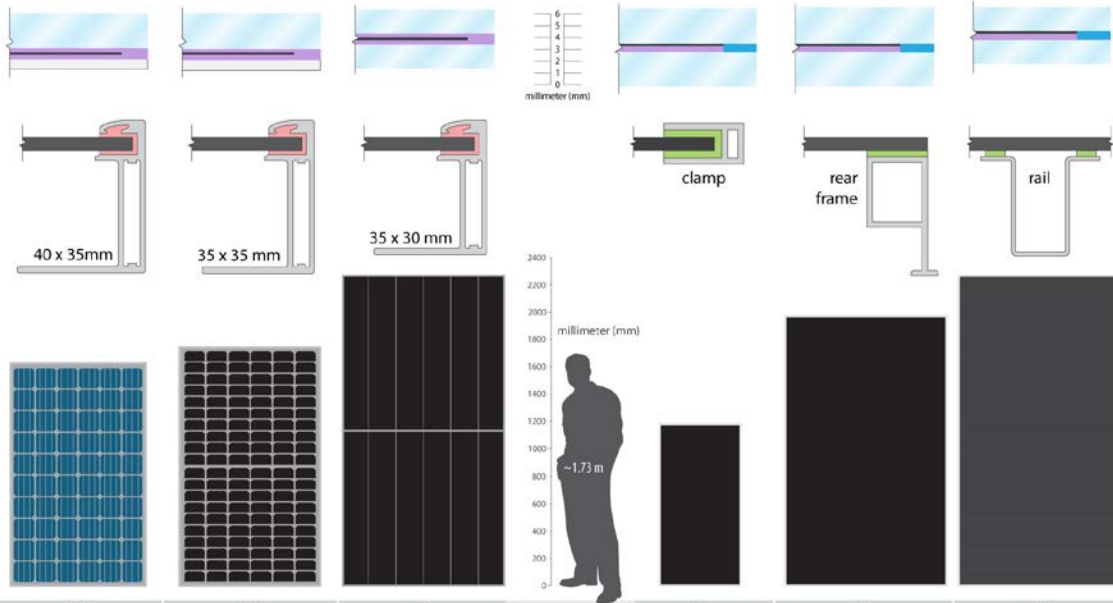
- Glass-glass architecture
- Glass is getting thinner
- Modules are getting bigger!
 - ❖ $1.75 \text{ m}^2 \leq L < 2.25 \text{ m}^2$
 - ❖ $2.25 \text{ m}^2 \leq XL < 2.75 \text{ m}^2$
 - ❖ $2.75 \text{ m}^2 \leq XXL < 3.25 \text{ m}^2$
- ...and heavier

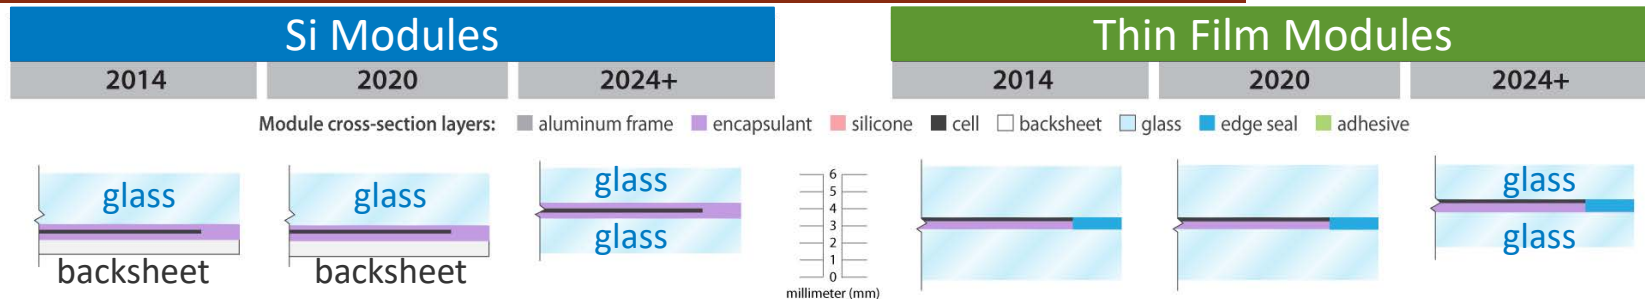
Glass trends for c-Si and thin film modules

- Trend to glass-glass from glass-backsheet to enable benefits of bifacial cell technologies
- Trend toward thinner glass
- Heat treatment trend unclear based on data sheets

- Typically heat strengthened glass in thin film modules
 - Limited by deposition temperature
 - Sometimes one sheet is tempered
- Trend toward thinner glass

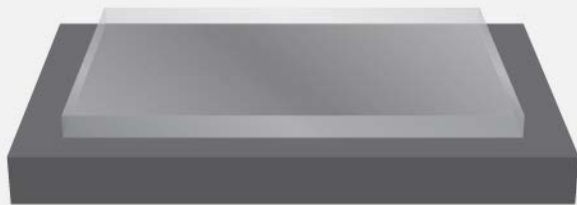
float vs rolled glass

float glass process

rolled glass process

- Most c-Si modules use rolled glass on the front and back
 - Results in dimpled pattern which has no documented benefit
 - Refractive index match between encapsulant and glass eliminates the dimples' optical effect
- Most thin film modules and a small fraction of c-Si modules use float glass
 - Better thickness control and planarity of surface for depositing thin films
 - High substrate temperatures available in the float line, which saves on energy costs

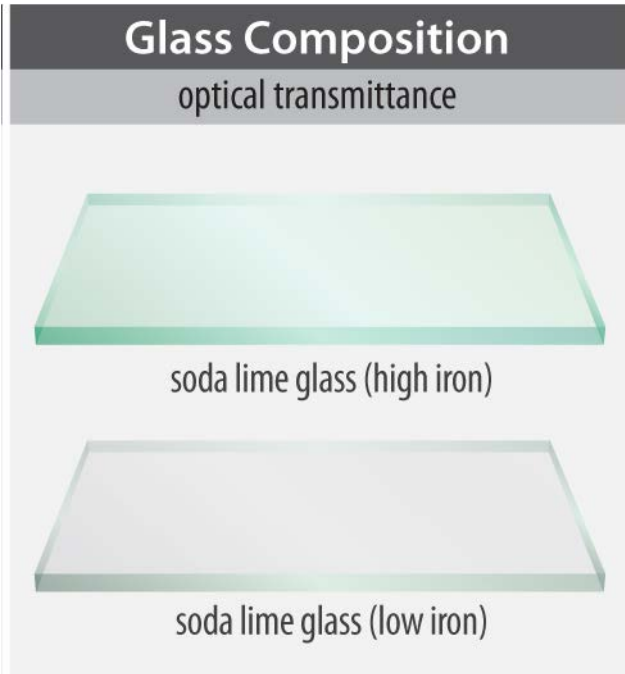
Glass Composition

- Glass for PV is low-iron soda lime glass designed to minimizing light absorption and reflection
 - Optical transmittance of 91%
 - Anti-reflective coatings bring this to 94%
- Contamination (ex: nickel sulfide) could manifest as foreign particles which could act as stress concentrators or initial flaws
 - Rare
 - Not documented in PV glass

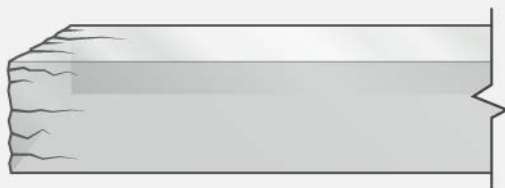
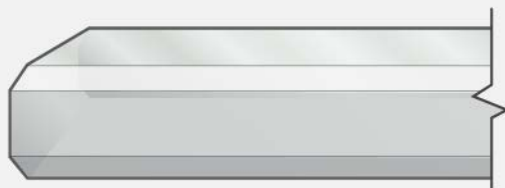
cut vs polished

cut edge

polished edge (chamfered 45° angles)

- Cutting module glass from larger sheets results in a cut edge with mechanical damage that can serve as the origin for breakage
 - Drilling or cutting holes for junction boxes in the rear glass sheet also creates mechanical flaws
- Edges can be ground and polished to change the size and number of flaws, improving the strength of the glass sheet
 - Prevalence in PV is unknown

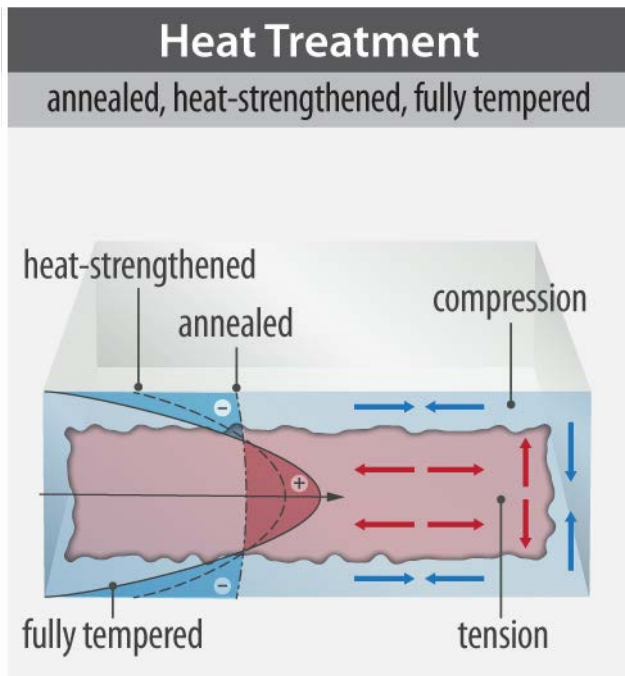
Heat Treatment

- Heat treatment introduces built-in stress (compressive region) that prevents flaws from opening
 - Compressive region balanced by tensile region
 - Flaw overcoming compressive region causes fracture
 - Different heat treatments have different compressive stresses

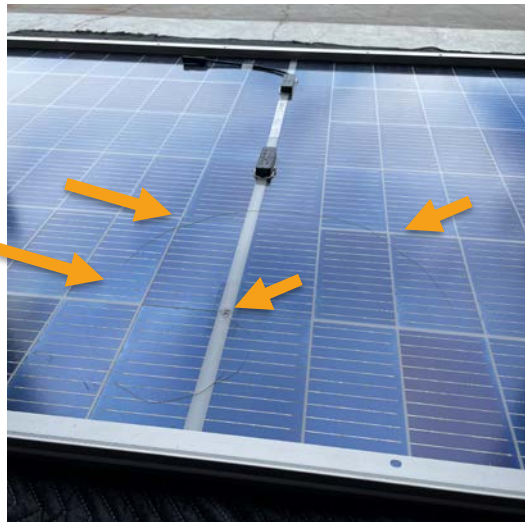
low energy fracture pattern

this single crack was formed through a big flaw on an unloaded module

(big flaw, low load)

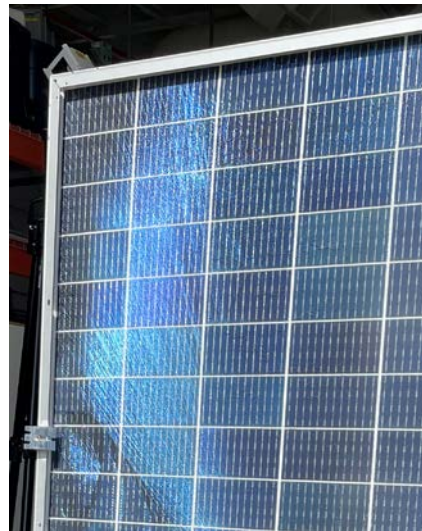
high energy fracture pattern

this fracture pattern was formed through static mechanical testing.

(small flaw, high load)

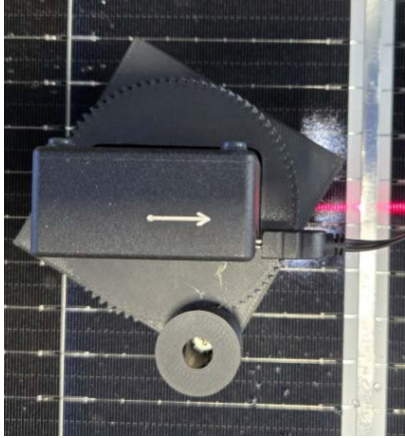
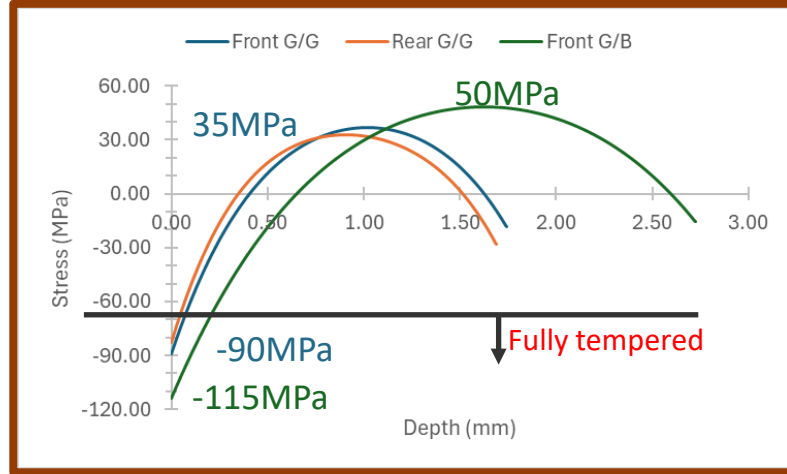
Scattered light polariscope

XXL Glass/Glass Module
144 HALF CUT MONO
PERC CELL 525-555 W
with 2.0mm Glass

Front: -82.7 MPa
Rear: -89.2 MPa

L Glass/Backsheet Module
with 3.2mm Glass

Front: -114.1 MPa

2.0 mm glass can be fully tempered!

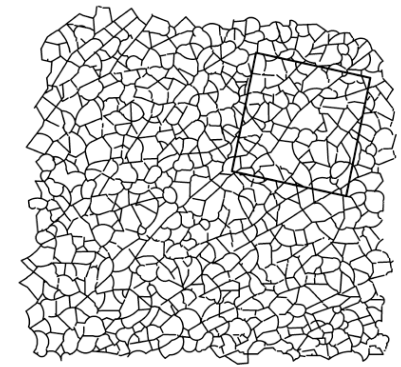
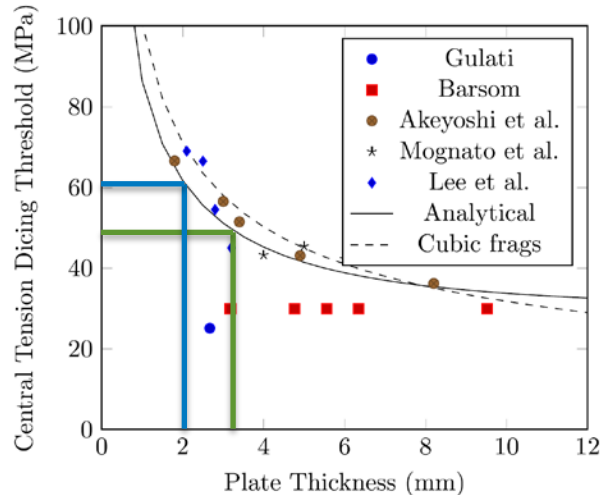
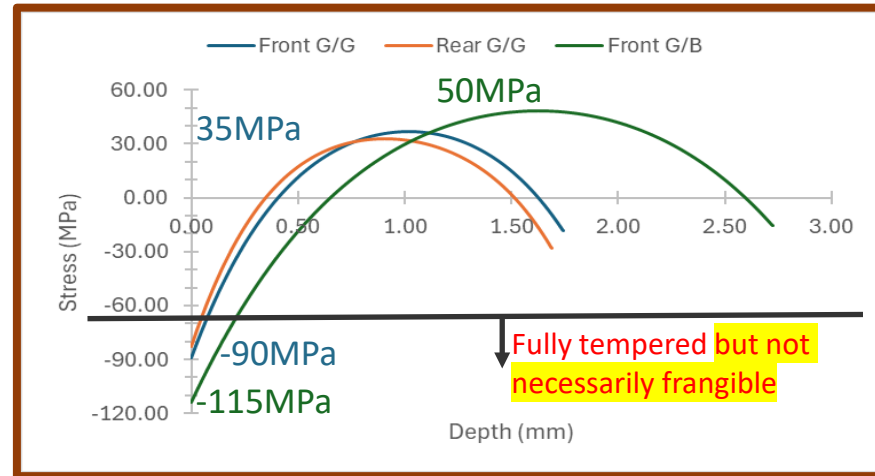
Frangibility of Glass

“The core of tempered glass may have sufficient tension to drive the crack automatically with no need of external loads. There could be enough tension in the core to drive the crack up to high enough speeds to cause the crack to branch repeatedly. This attribute is referred to as frangible and results in a fragmented glass sheet.”

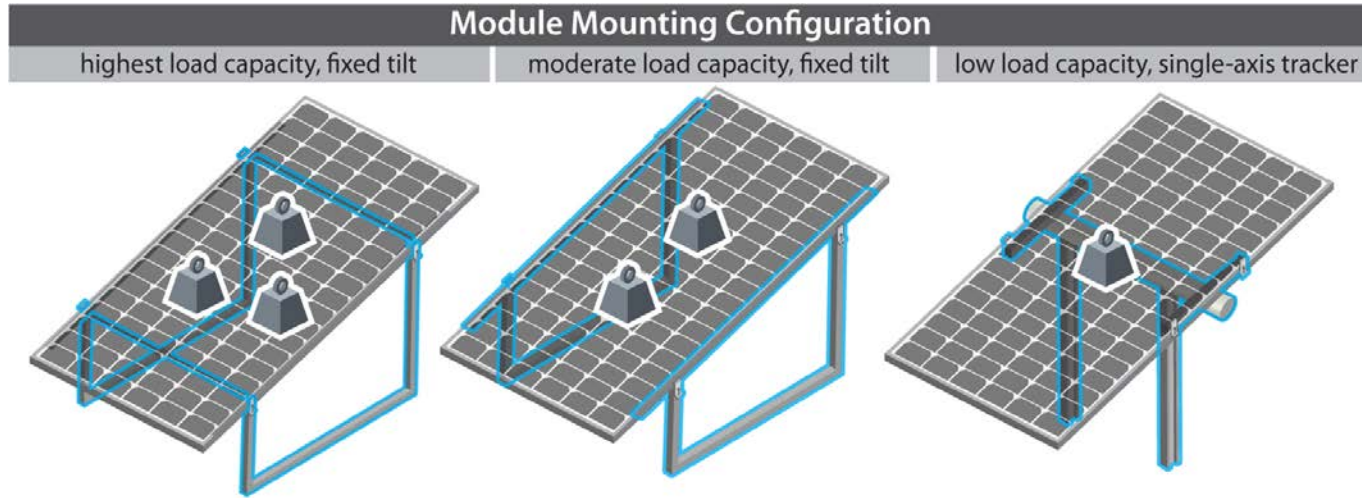
PV Framing and Racking Strategies

- Module is fully supported
- Steel substructure is the main load-bearing component
- Stiff mounting points through cross braces

- Module is partially supported
- Steel substructure is still the main load-bearing component
- Mounting points are more compliant.

- Module frame is used to transfer loads to short mounting brackets

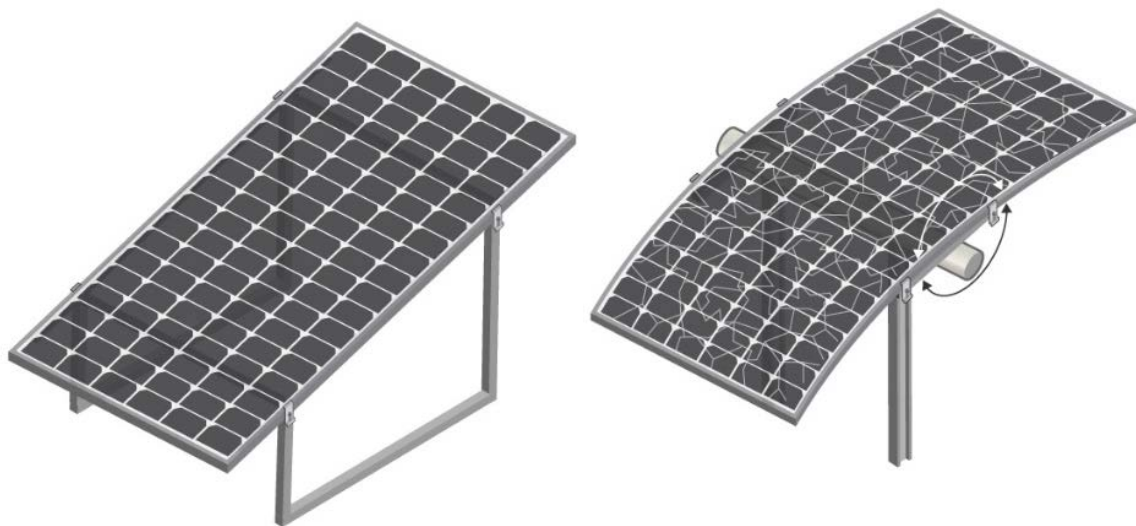
Qualification testing

Test load = 1.5 (safety factor) x design load

The minimum required design load per this document is 1600 Pa, resulting in a **minimum test load of 2400 Pa.**

if the module is to be qualified to withstand heavy accumulations of snow and ice, the test load is increased to 5400Pa

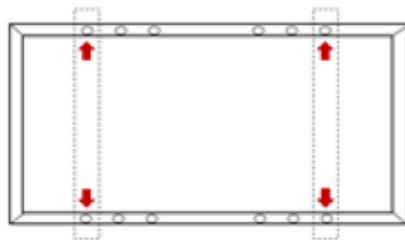
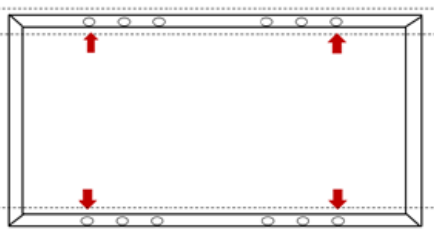
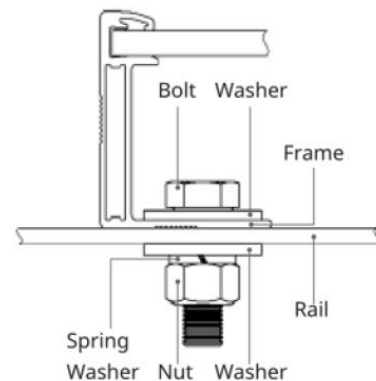
Outer four holes installation method

O-A	O-B
+5400Pa/ -2400Pa	+3600Pa/ -2400Pa

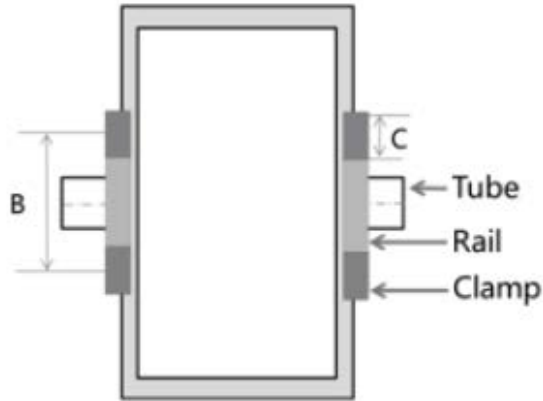
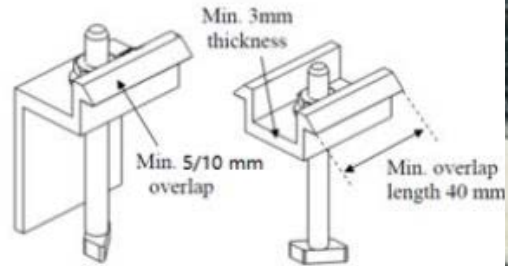
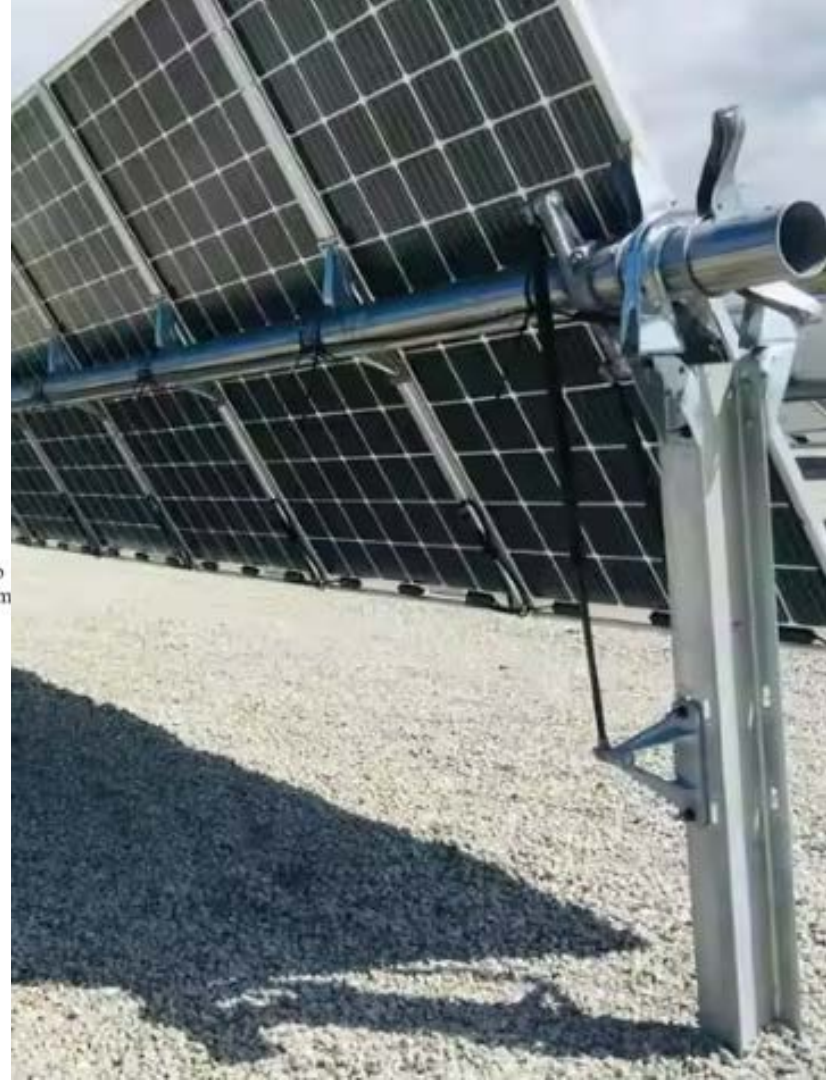
tracker installation

B Value (mm)	Clamp length C (mm)	Test load (Pa)
≥400	≥40	+1500/-1500

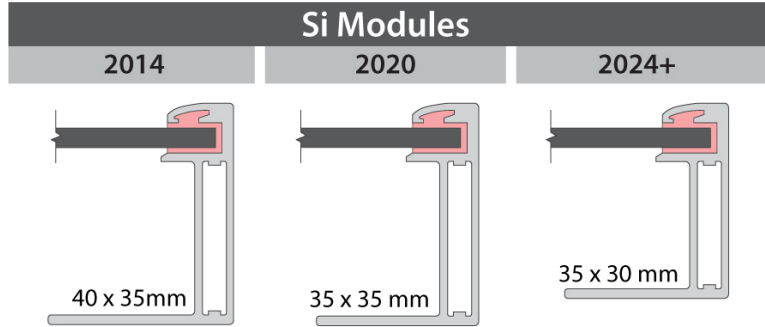
Evolution of frame design

- Trend to smaller frames
- A lot of manufacturer variability

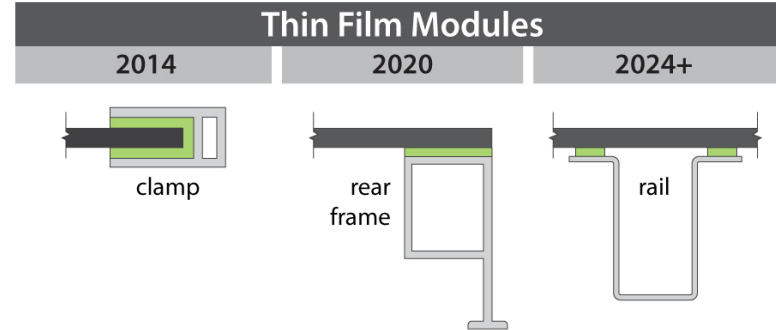
- A lot of manufacturer variability
- Trend to rear mounting (rear rails)
- Exposed glass edges

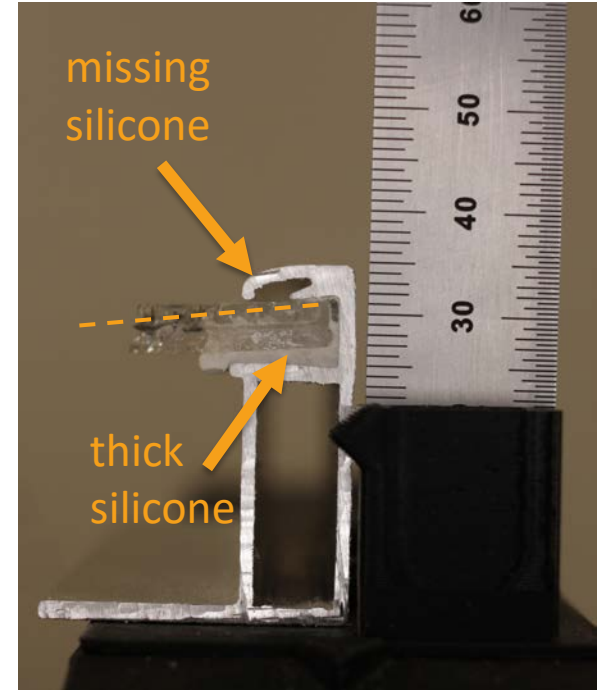
Possible silicone distribution issues

- Glass contacting frame
- Current QA checks only for silicone weight
- Does not check for equal distribution after lamination
- Downwards angled frame

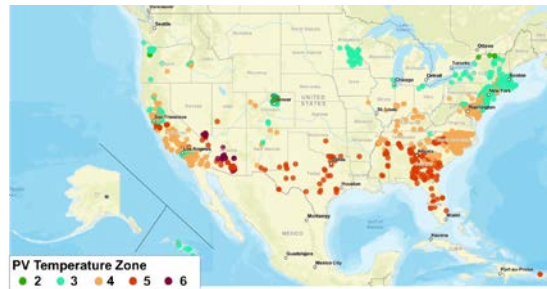
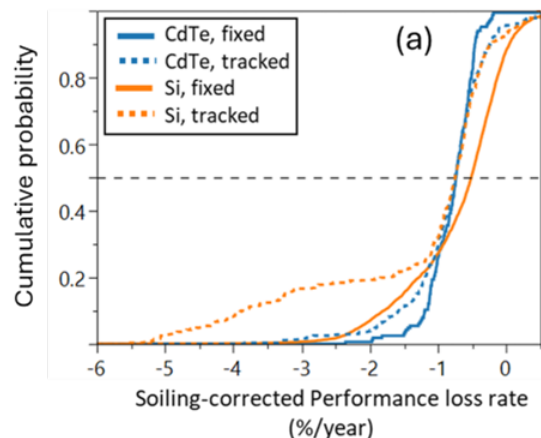
PVFleet analysis – Mounting and racking

- We looked at CdTe/Si and fixed/tracked systems
- fixed-tilt c-Si exhibit a median PLR of around -0.5 %/year
- while the other categories show a median of -0.75 %/year

➔ Is this evidence that fixed tilt systems perform better?

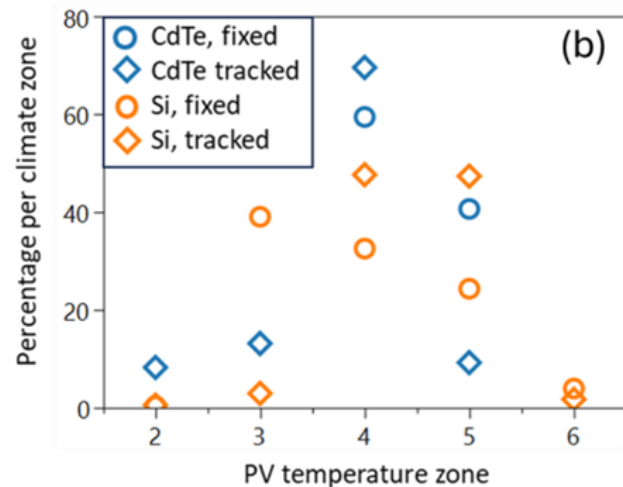
PVFleet analysis – PV mounting and racking

- Multiple factors may contribute to the lower degradation rate observed in these fixed-tilt systems.
- The c-Si fixed category contains a larger percentage of systems in a cooler climate which can correspond to a more modest performance loss
- In addition, the systems in the fixed c-Si category are considerably smaller than systems in the other categories.
- Because of these confounding variables, the impact of system configuration cannot be isolated.

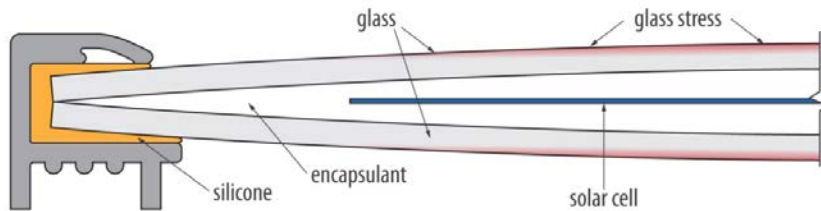
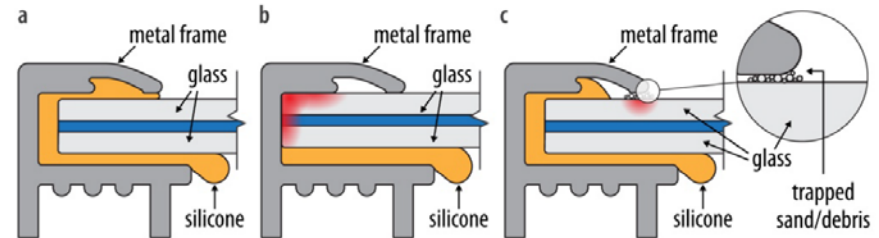
Edge pinch has been observed in many XL and XXL G/G modules.

Insufficient silicone may cause contact between frame and glass.
