FIELD OBSERVATIONS OF MODULE FAILURE AND DAMAGE

February 25, 2014

BLACK & VEATCH
Building a world of difference.®

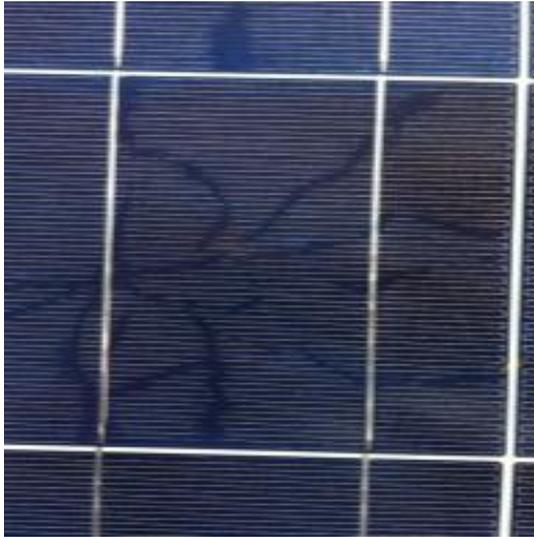
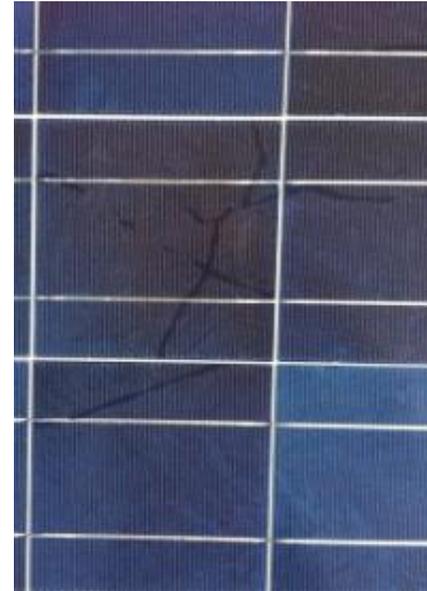
CASE STUDY #1: SNAIL TRAILS

Snail trails and microcracks observed on installed modules.

Lesson Learned: The causes of snail trails should be investigated, monitored, and mitigated by the manufacturer.

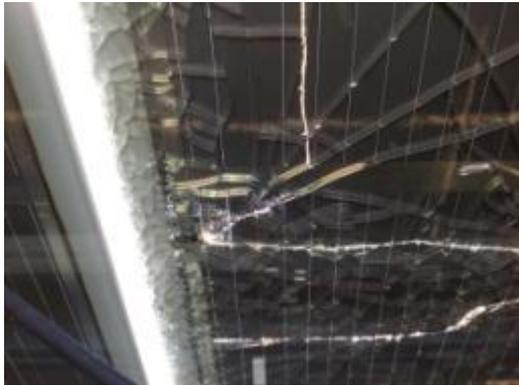
Module back glass cracked due to rock from mowing equipment.

Lesson Learned: Diligent O&M oversight and security is critical in preventing module damage.

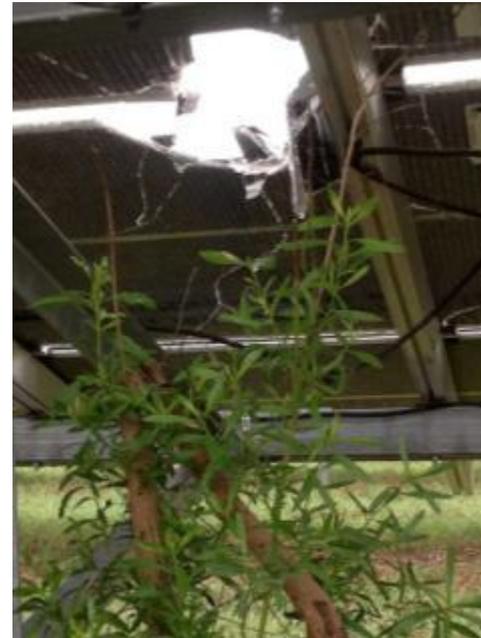
Broken modules due to growth of tree under modules.

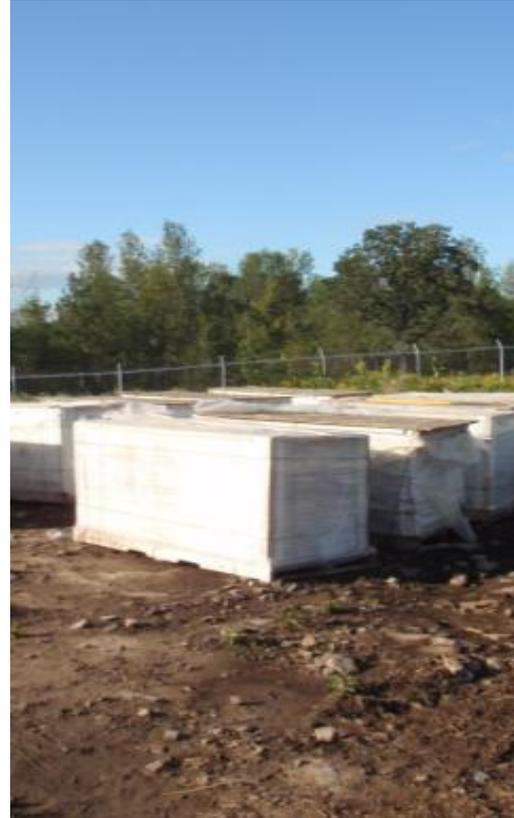
CASE STUDY #4: IMPROPER MODULE STORAGE DURING CONSTRUCTION

Water accumulation in modules caused corrosion in junction boxes and connectors.

Lesson Learned: Consider storage environments when designing packaging.
