Acceleration of Potential-Induced Degradation (PID) by Salt-Mist Preconditioning in c-Si PV Modules

Soh Suzuki ¹, Naoki Nishiyama ², Seiji Yoshino ³, Takumi Ujio ², Shin Watanabe ³, Takuya Doi ⁴,
Atsushi Masuda ⁴, and Tadanori Tanahashi ¹ (¹ ESPEC, ² JFE-Techno Research, ³ NPC, ⁴ AIST)

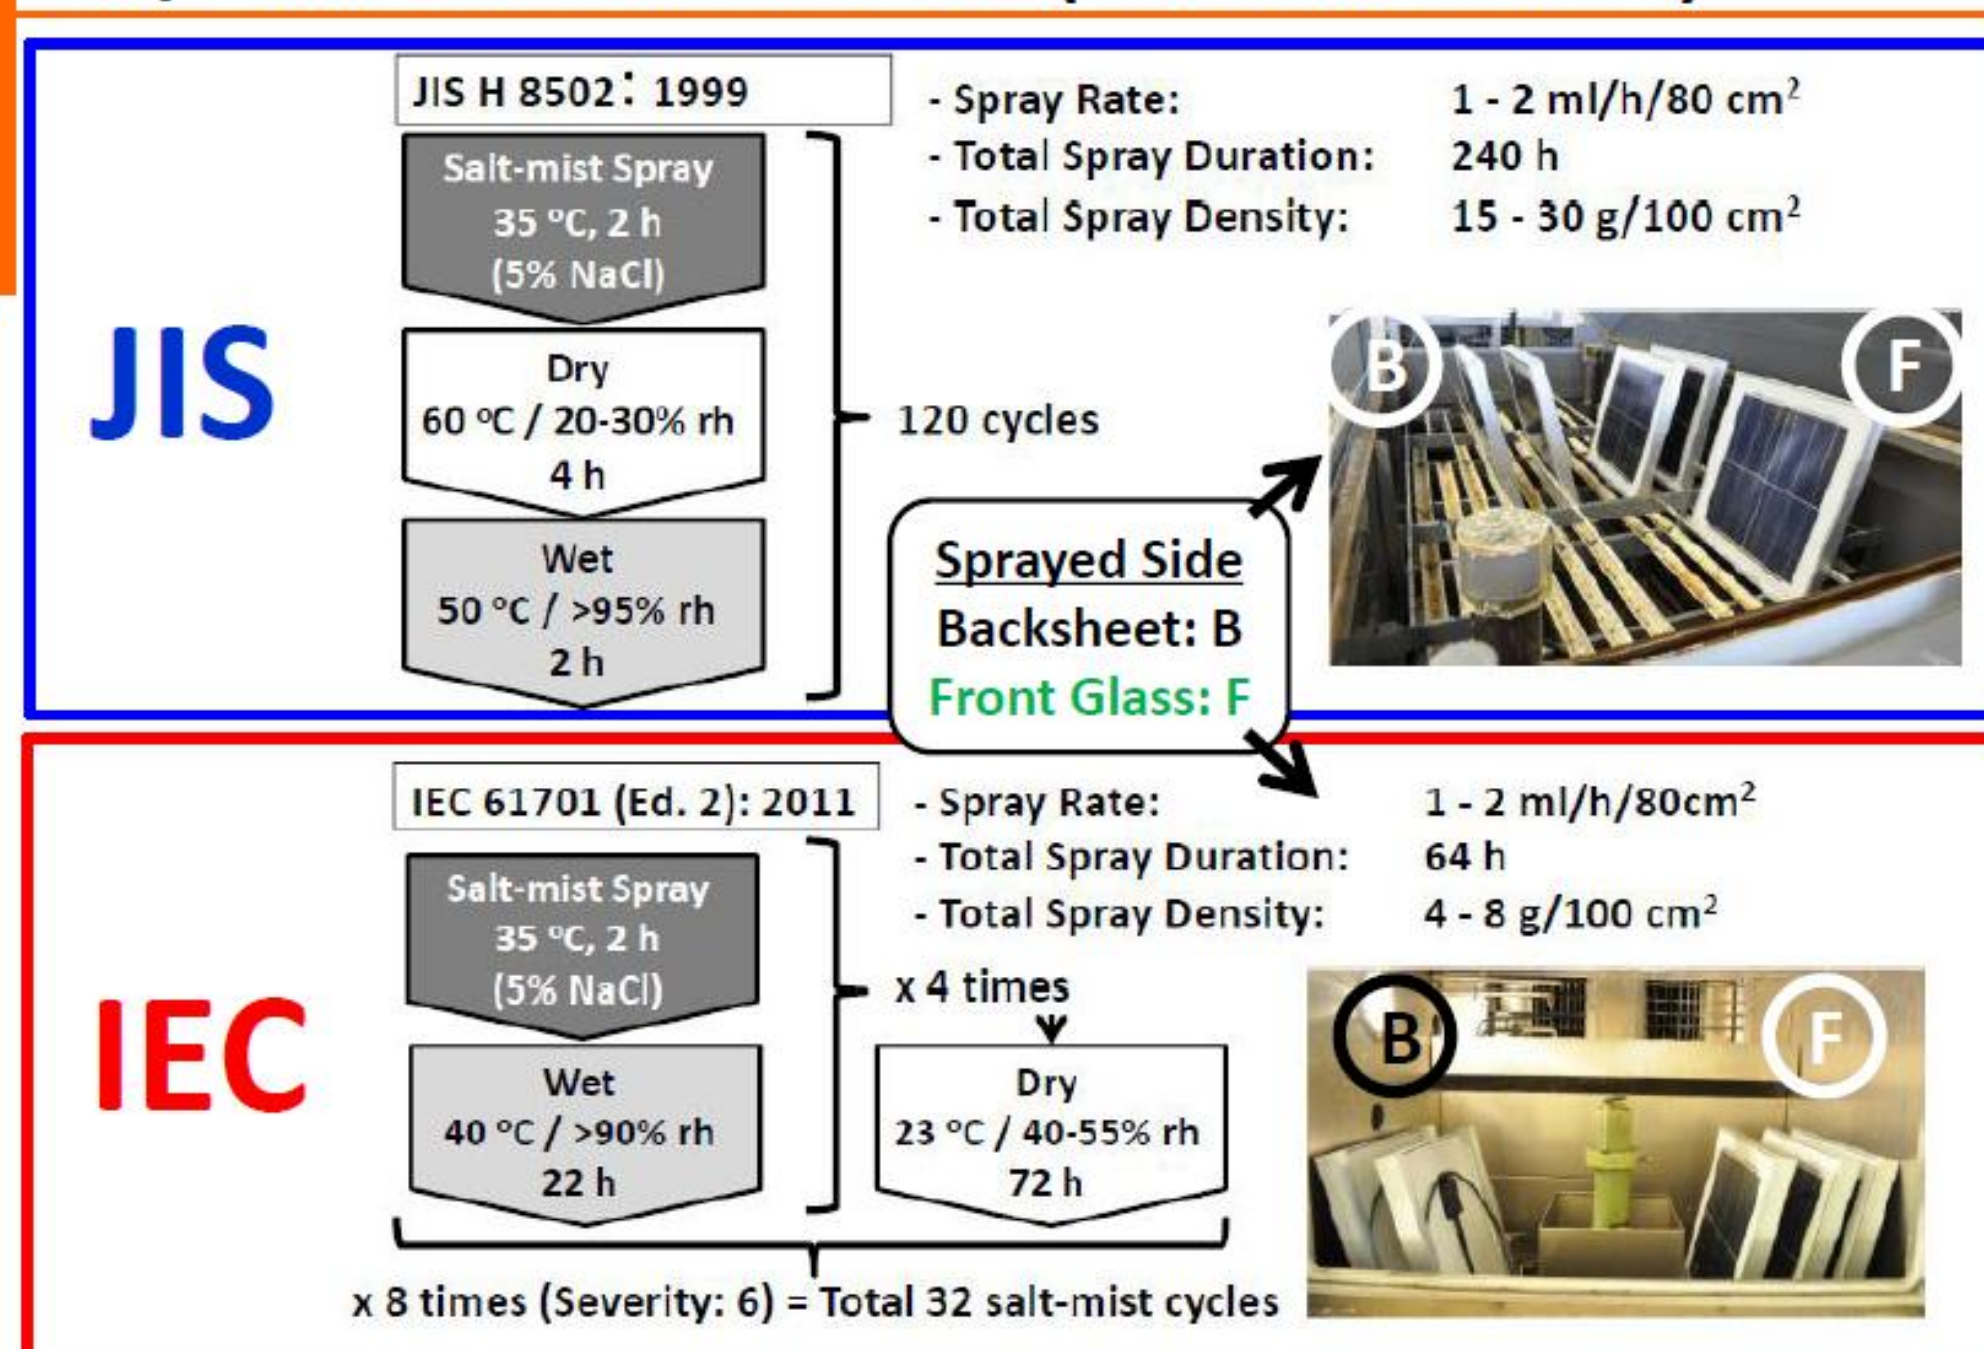
Experimental Procedures (Salt-Mist Stress)

Salt-Mist Stress: - decrease the insulation level.
- not induce the drastic power loss.

It is assumed that the degradation by salt-mist stress will be relatively slowly compared to the PID from their characteristics.

- PID accelerated by salt-mist stress crucially depended on the wet incubation just after the salt-mist spray [Experimental Procedures & Panel 13], but not the penetration through Edge-Slit [Panel 13].

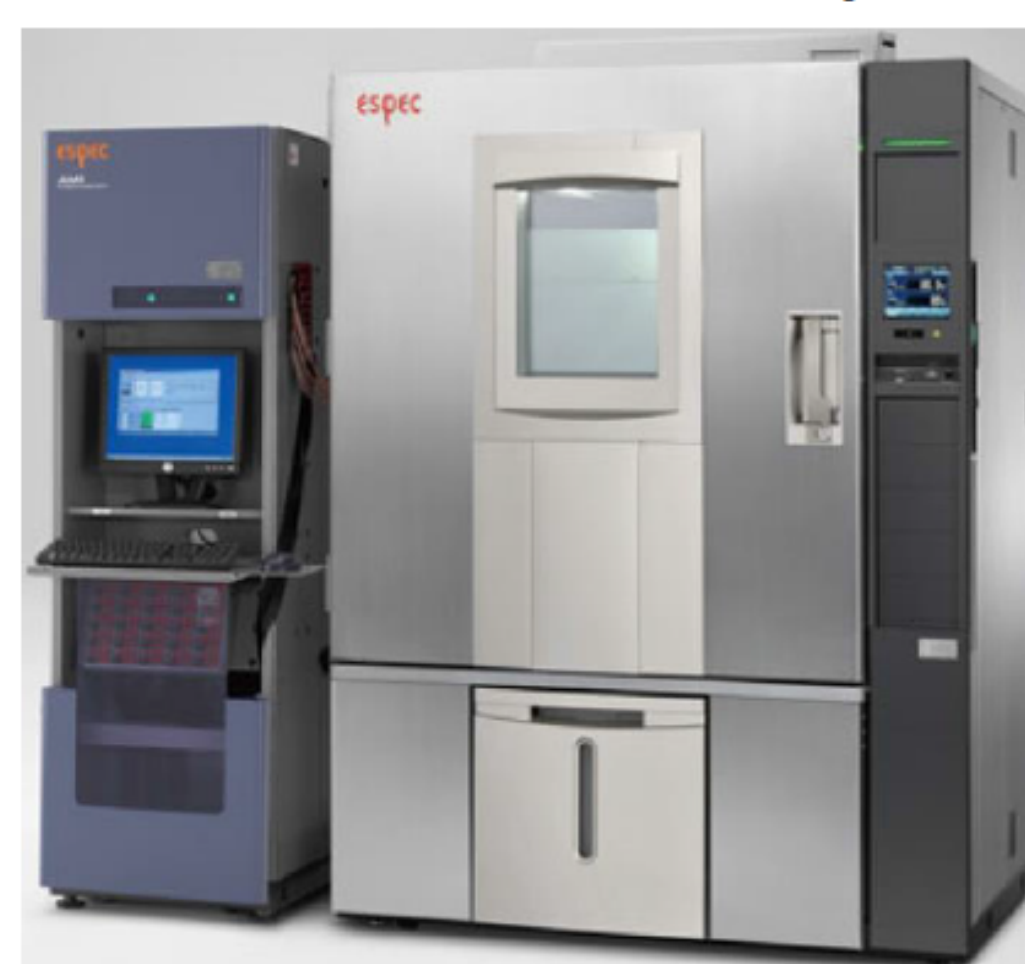
ESPEC PID Evaluation System for Mini-PV Module

AMI-020-PID

Applying Voltage:

+/- 10 ~ +/- 2,000 V

Measurable Leakage Current:

+/- 0.1 pA ~ +/- 1 mA

Exp. Conditions in Present Work
60 °C / 85% rh
-1,000 V
based on IEC 62804 draft

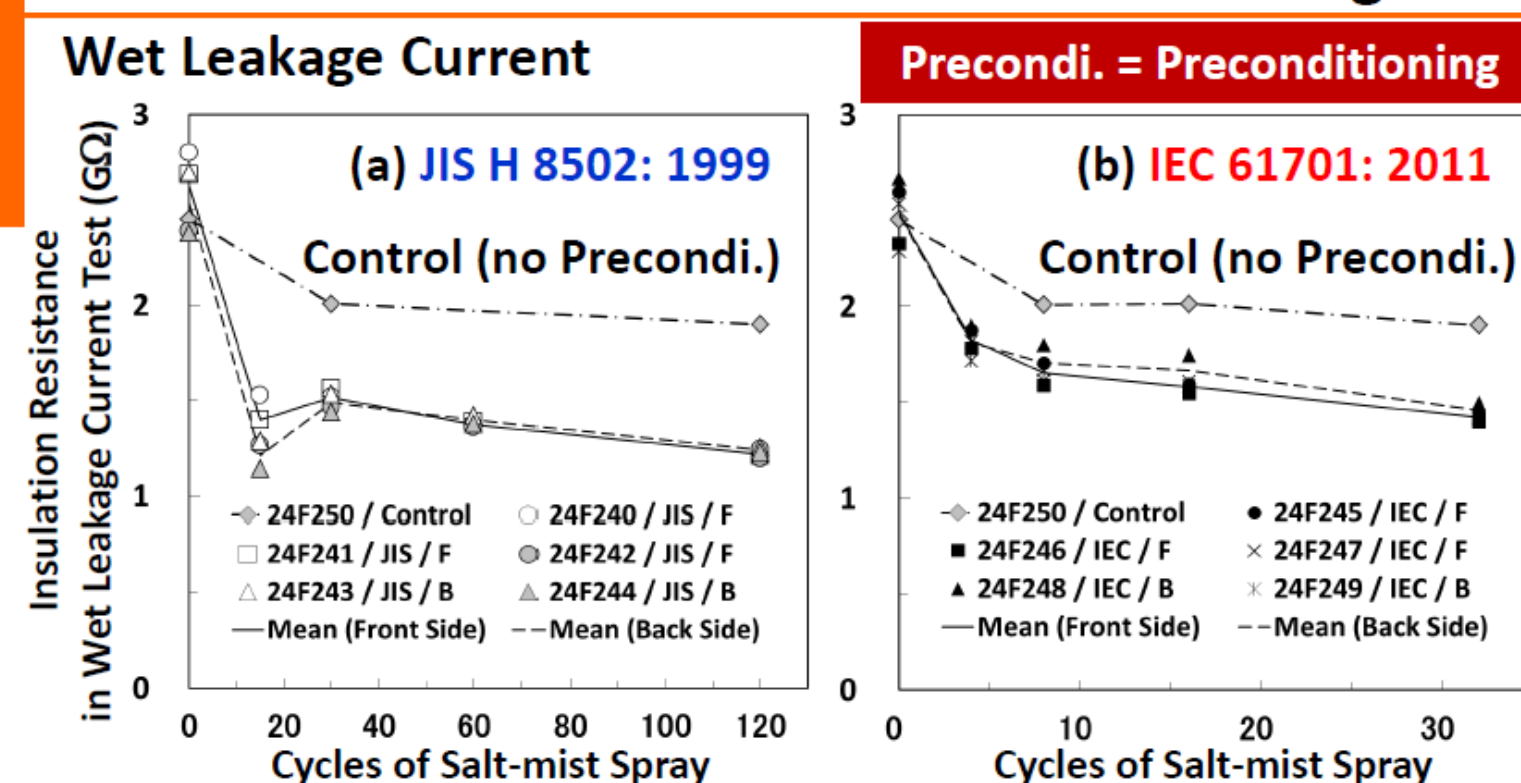
Panel 2

Salt-Mist Corrosion Test: Preconditioning

The insulation resistance was reduced by two-thirds (JIS protocol) and by three-quarters (IEC protocol), relative to controls. However, this resistance remained well above the critical value (250 MΩ in this module) specified in IEC 61215: 2005, clause 10.15.

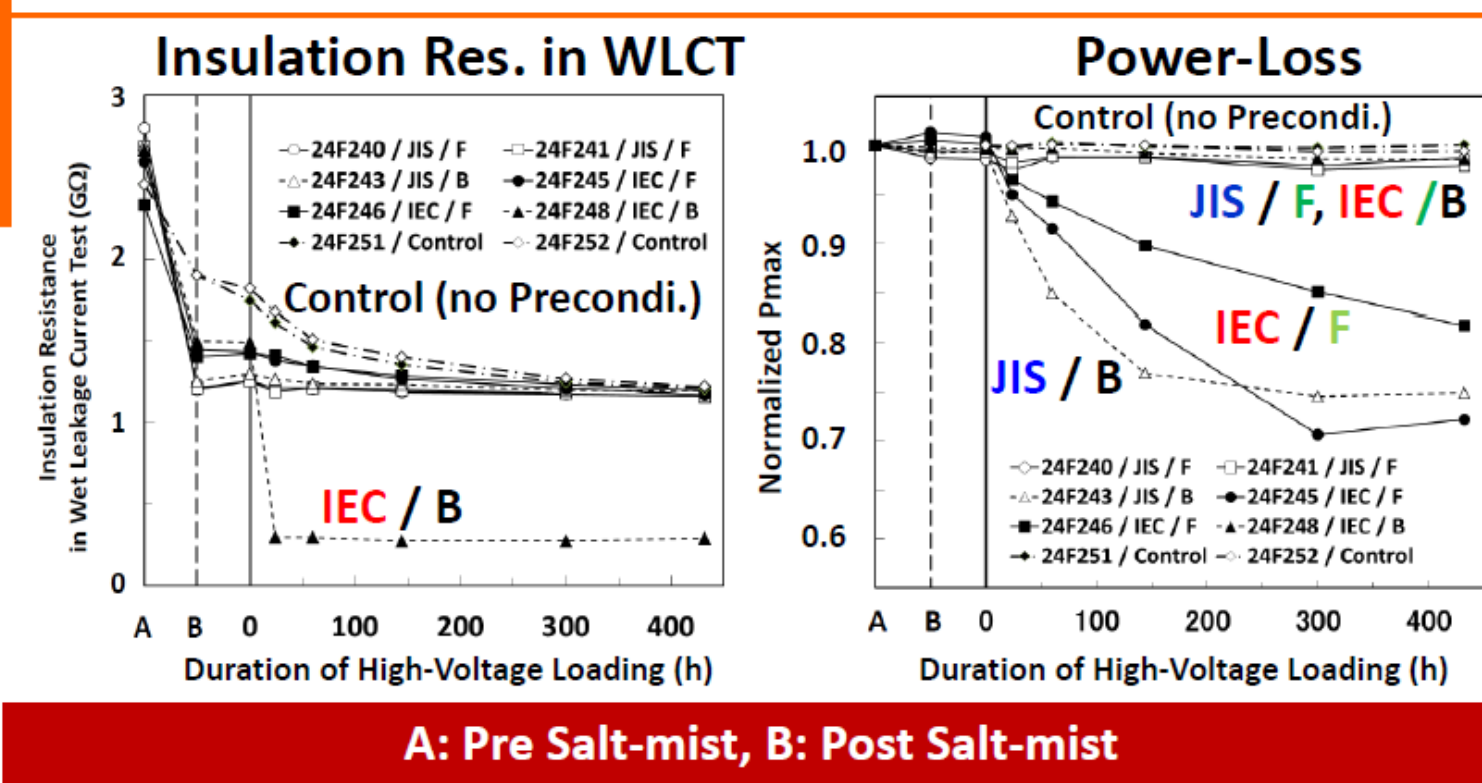
Panel 3

High System-Voltage Loading (PID Testing)

IEC / B module was the only module that came close to having its electrical insulation fail in the initial phase of high-voltage loading. Two types of salt-mist preconditioning can induce a critical loss of power during high-voltage loading, but “Control” was not degraded.

- We demonstrated that the drastic degradation of PV modules was caused by the salt-mist stress followed by the high system-voltage stress [Panel 3].
- It is concluded that PID is accelerated by the salt-mist preconditioning, because the degradation profiles obtained by the current-voltage characteristics [Panel 6 & 7], EL image [Panel 8], LBIC image [Panel 9 & 10], LIT image [Panel 9 & 10], and the characteristics of PV parameters (increasing of ideally factor [n] and decreasing of Rsh) [Panel 12] are closely similar with those of PID phenomenon.

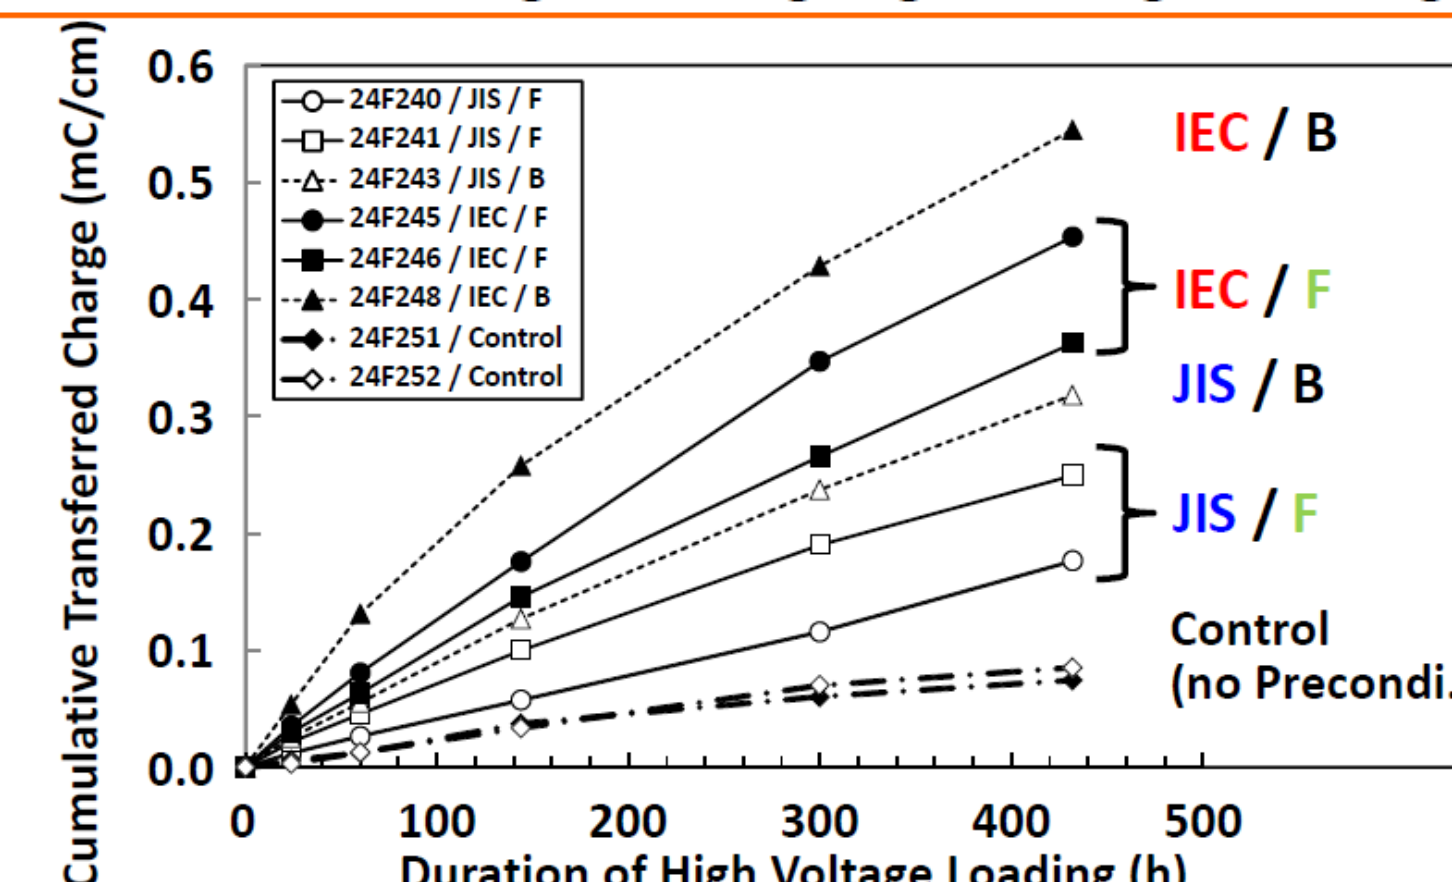
Panel 4

Transferred Charges during High-Voltage Loading

The properties that cause the charge transfer during high-voltage loading are imprinted during the salt-mist preconditioning phase.

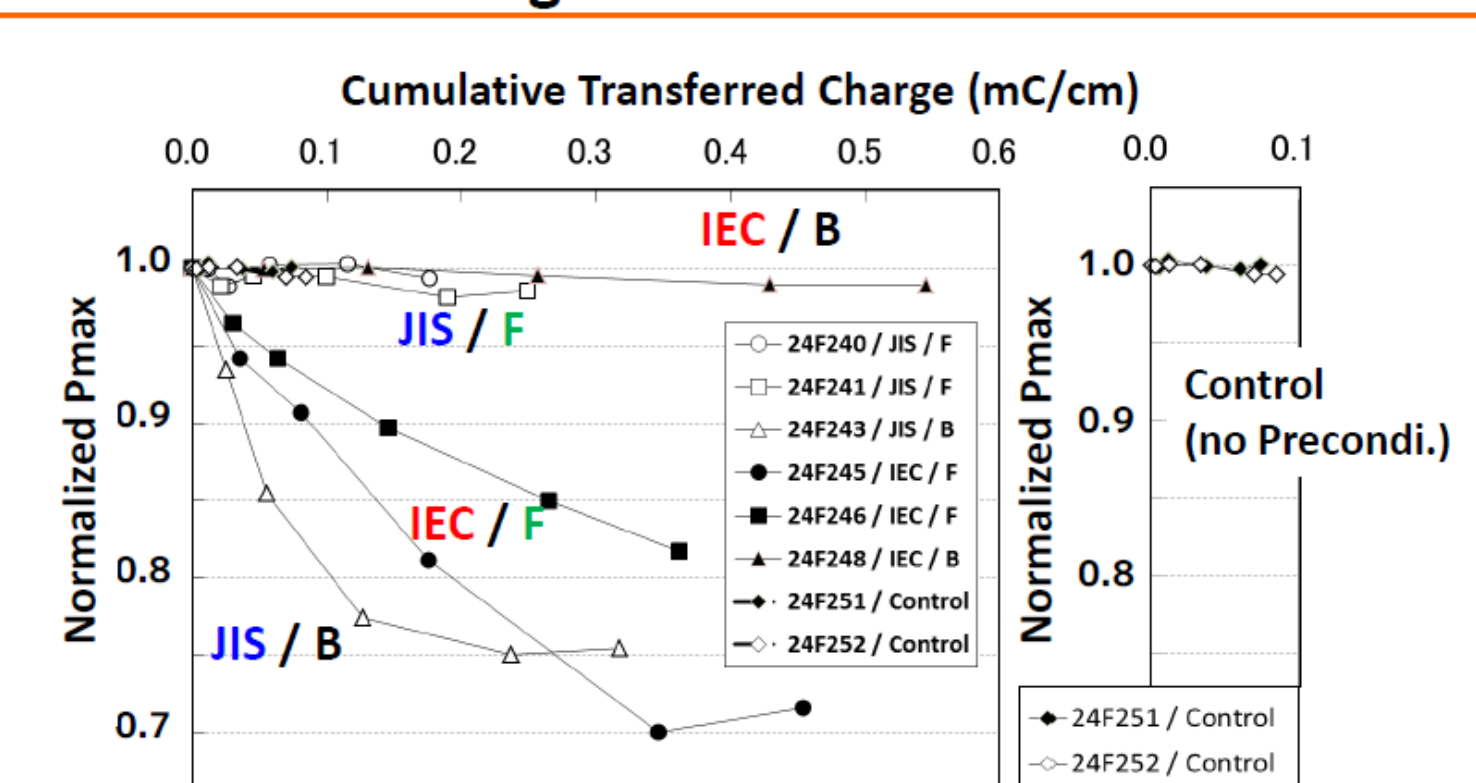
Panel 5

Transferred Charges – Power Loss Correlation

The total amount of transferred charge does not directly correspond to the reduction of output power.

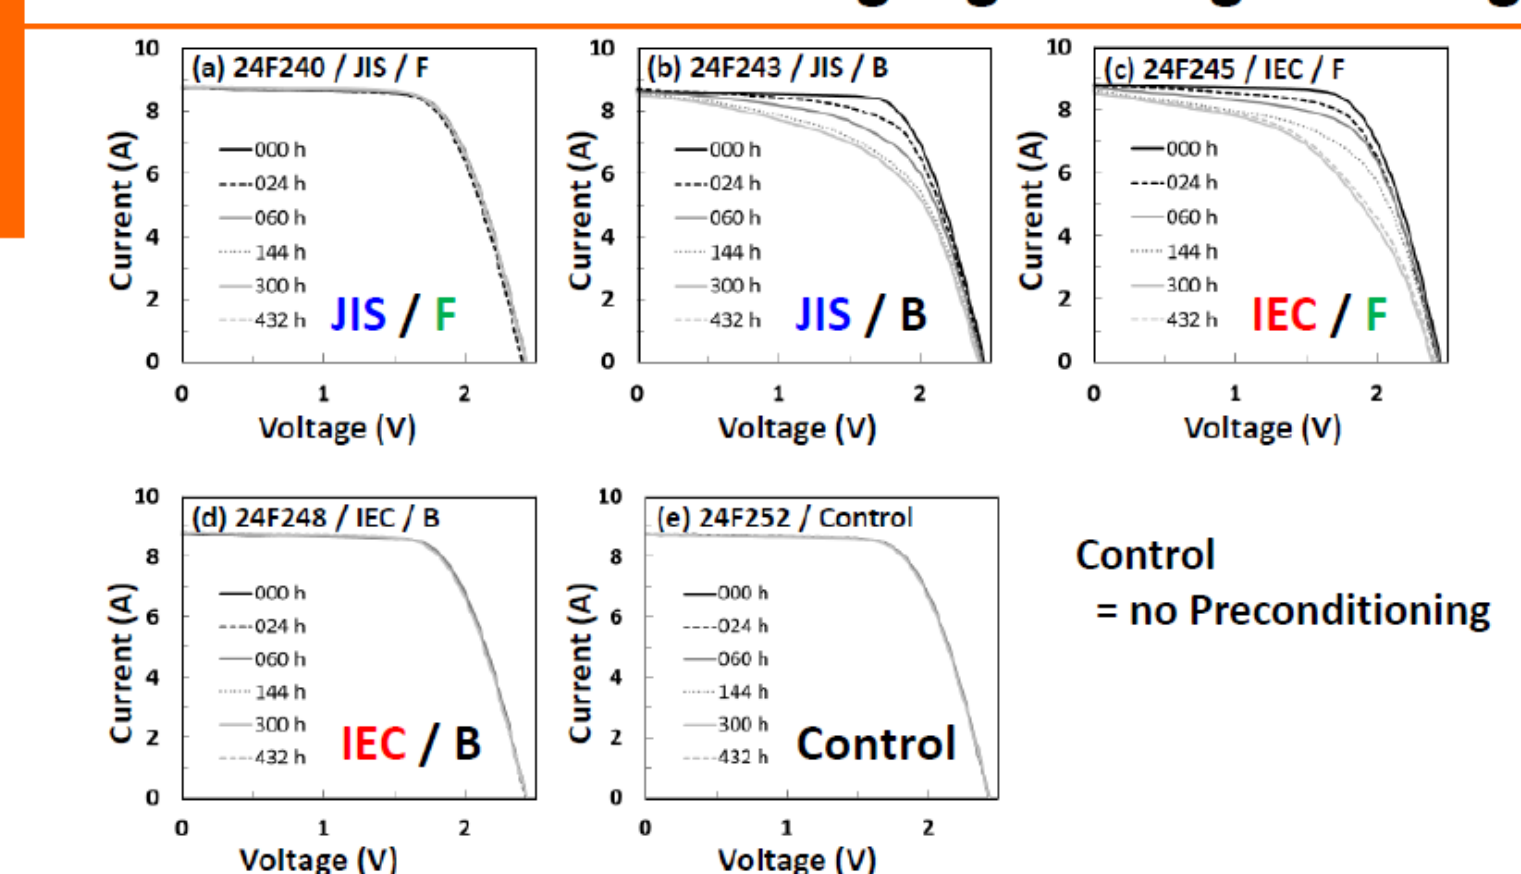
Panel 6

Illuminated I-V Curves during High-Voltage Loading

In the “JIS/B” and “IEC/B” modules, FF decreased from approx. 69% to 52-54%, depending on the duration of loading, however FF remained at 69% in other modules.

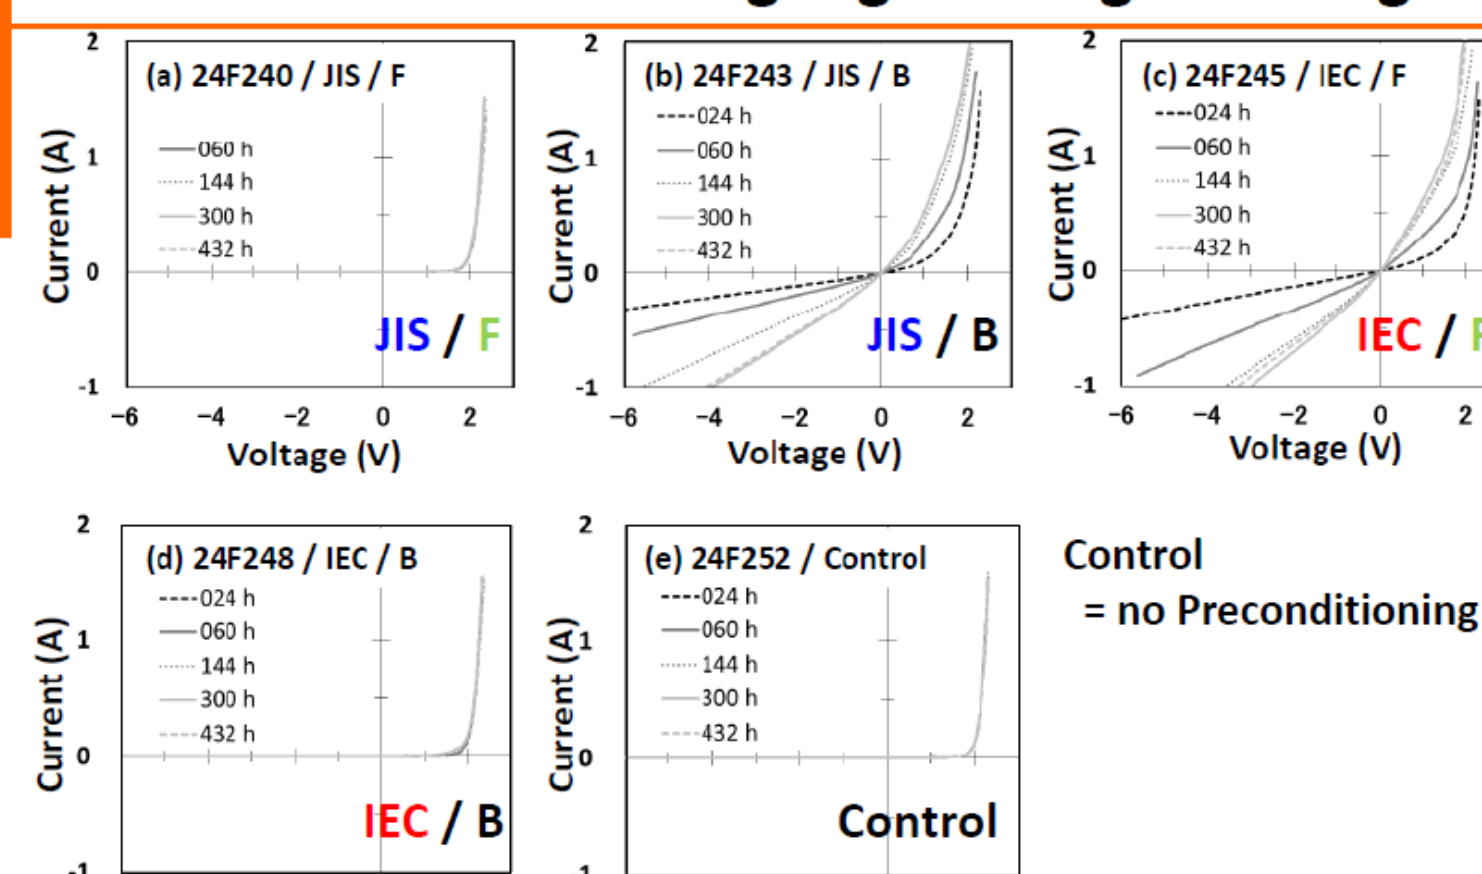
Panel 7

Dark I-V Curves during High-Voltage Loading

The current-voltage curves in “JIS/B” and “IEC/B” modules exhibited ohmic behavior with a reduction of shunt resistance.

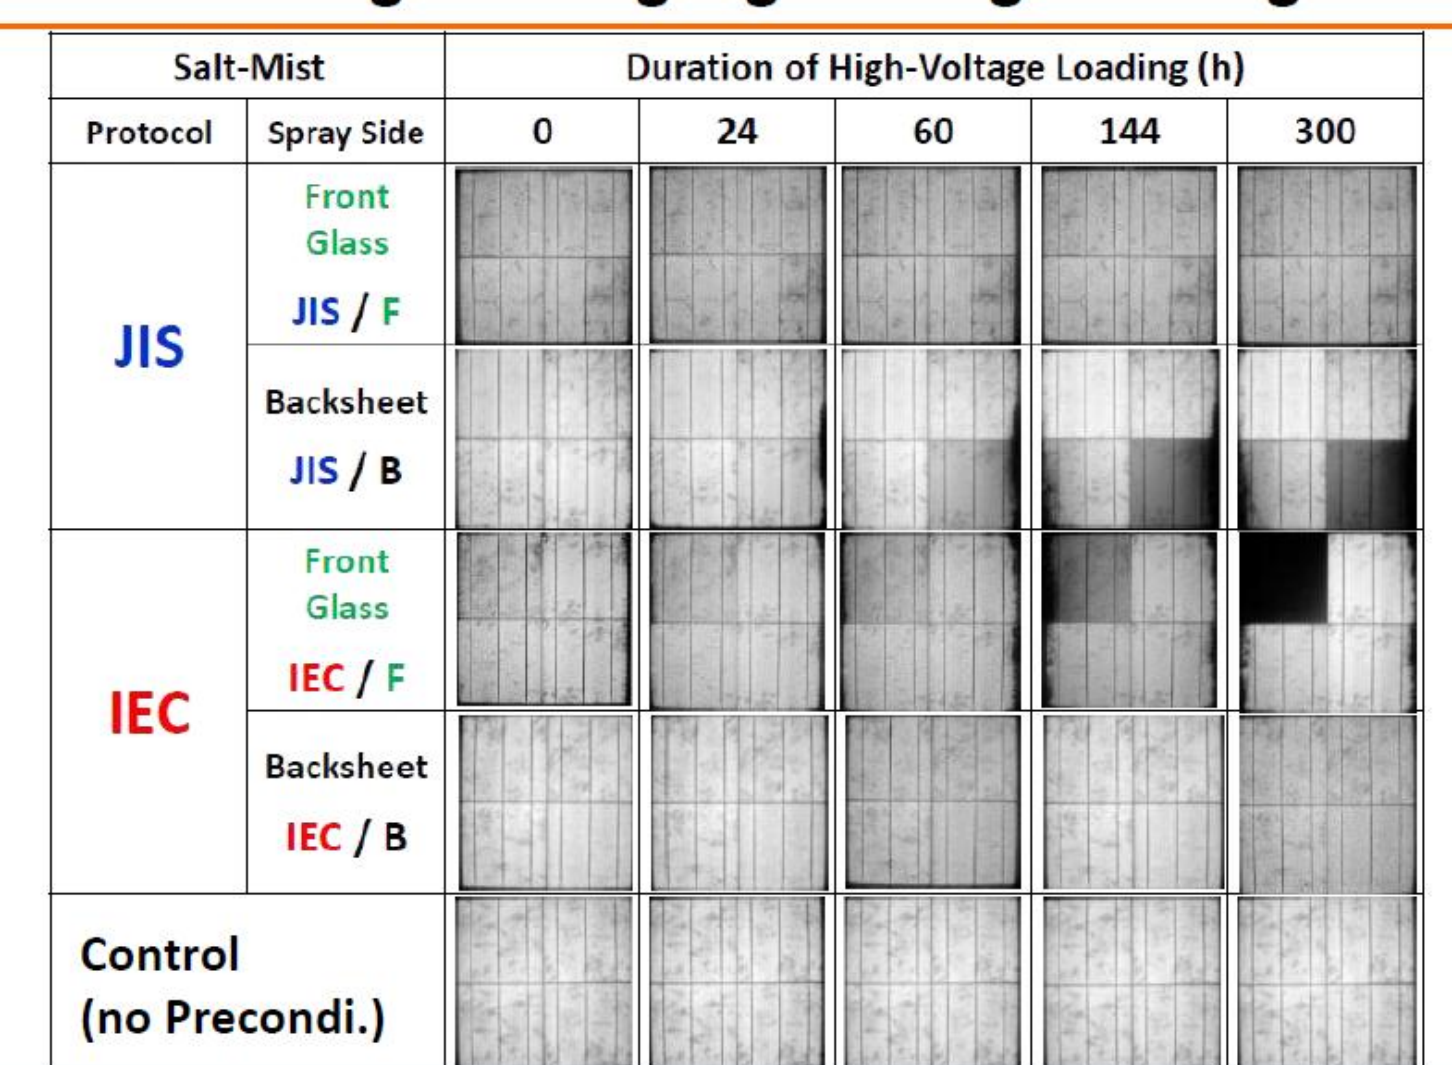
Panel 8

EL Images during High-Voltage Loading

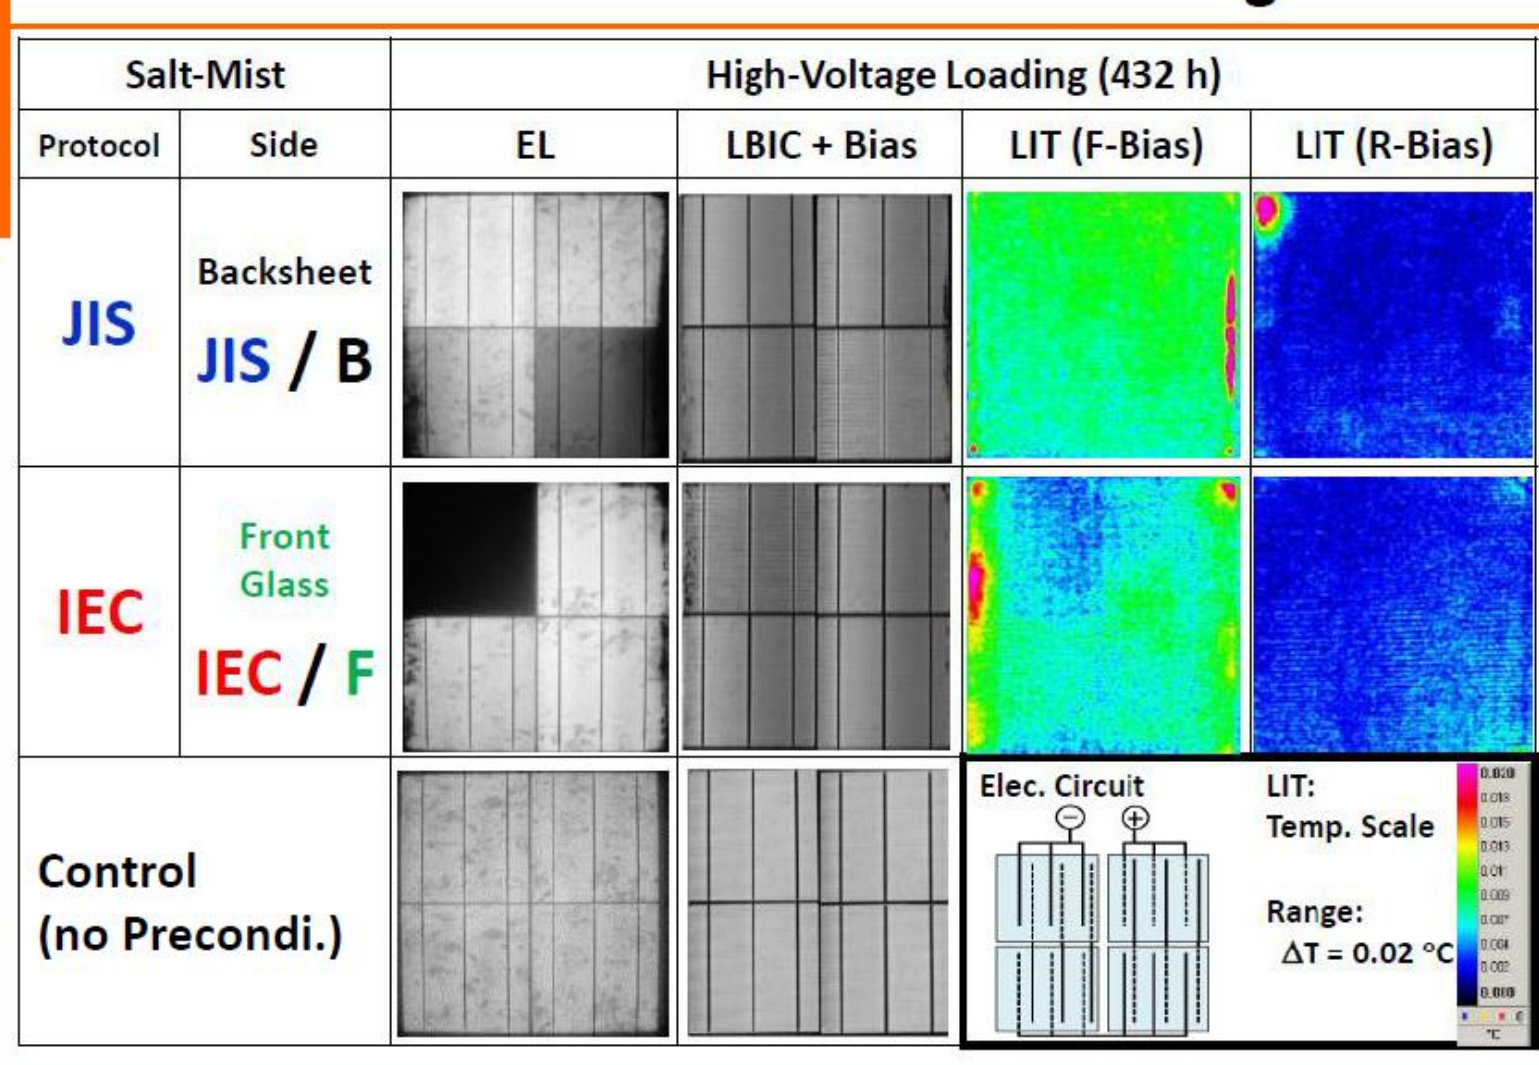
Panel 9

Detection of Severe Rsh-Decreased Regions

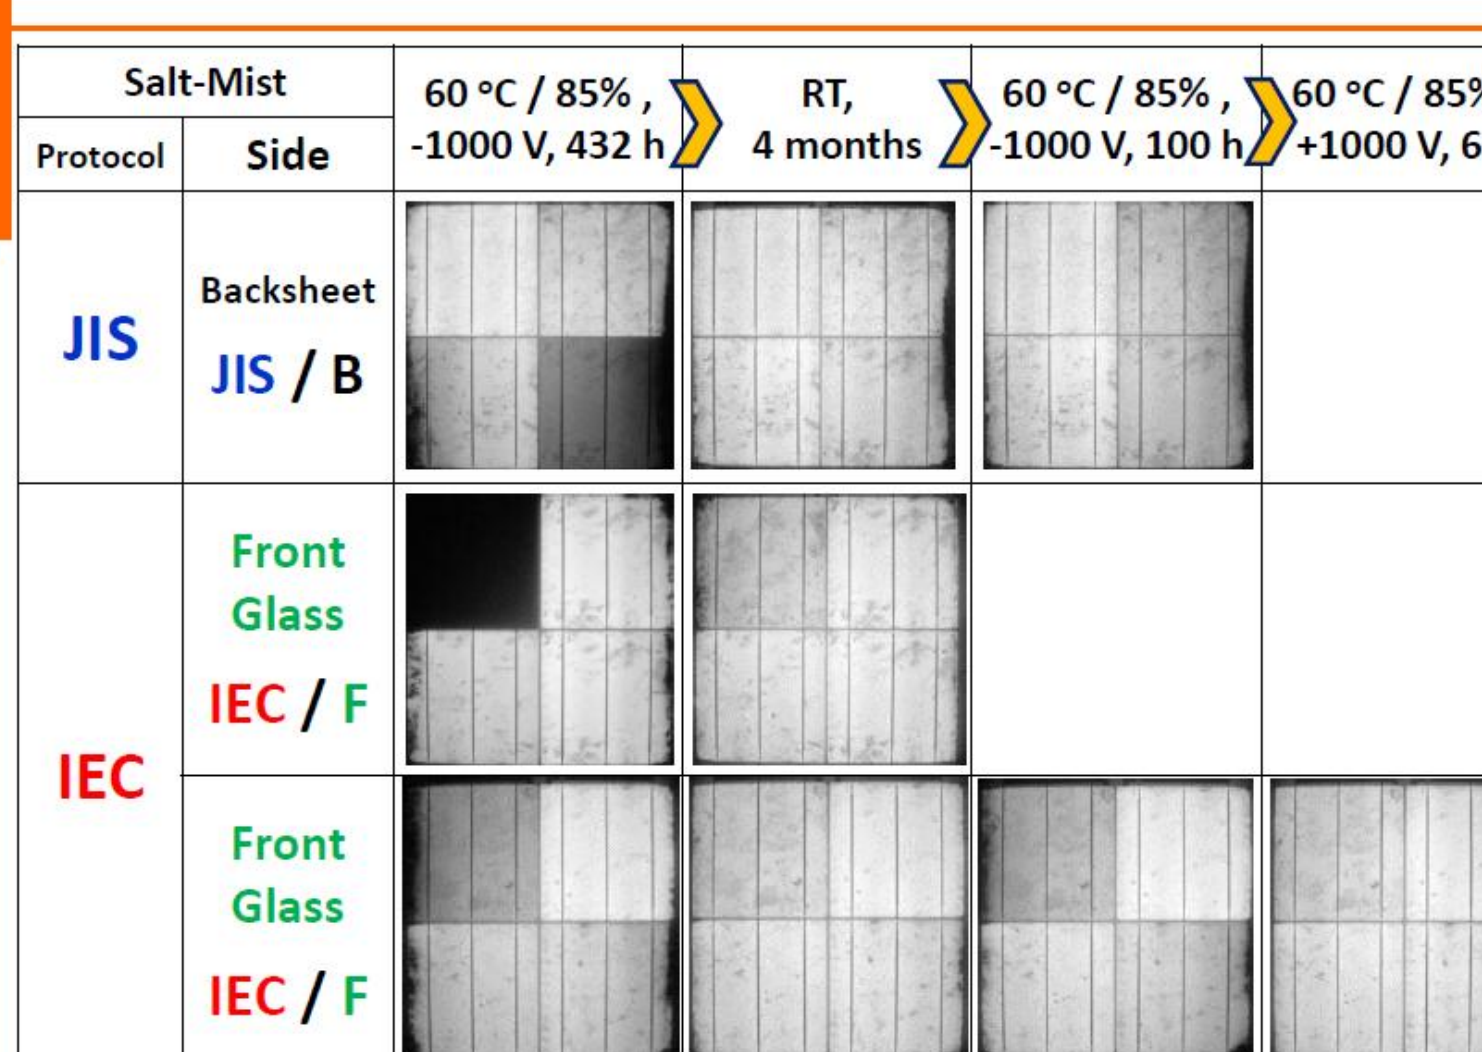
Panel 11

Evolution of PID in Alternation Manner

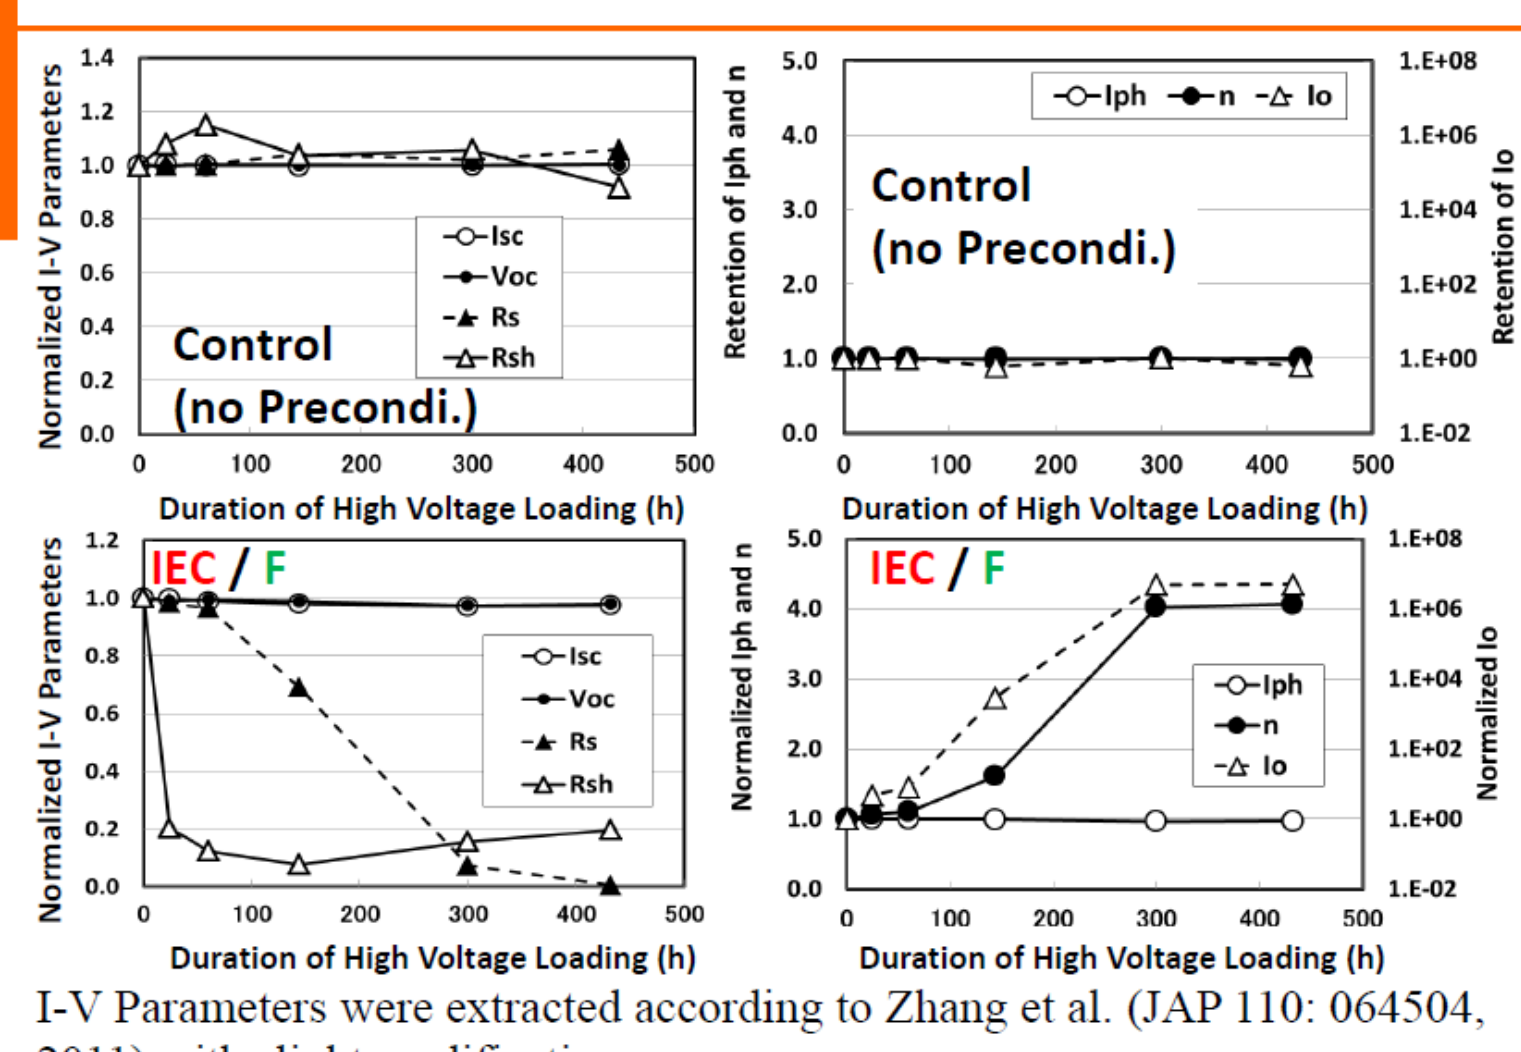
Panel 12

Extracted I-V Parameters from Illuminated I-V Curves

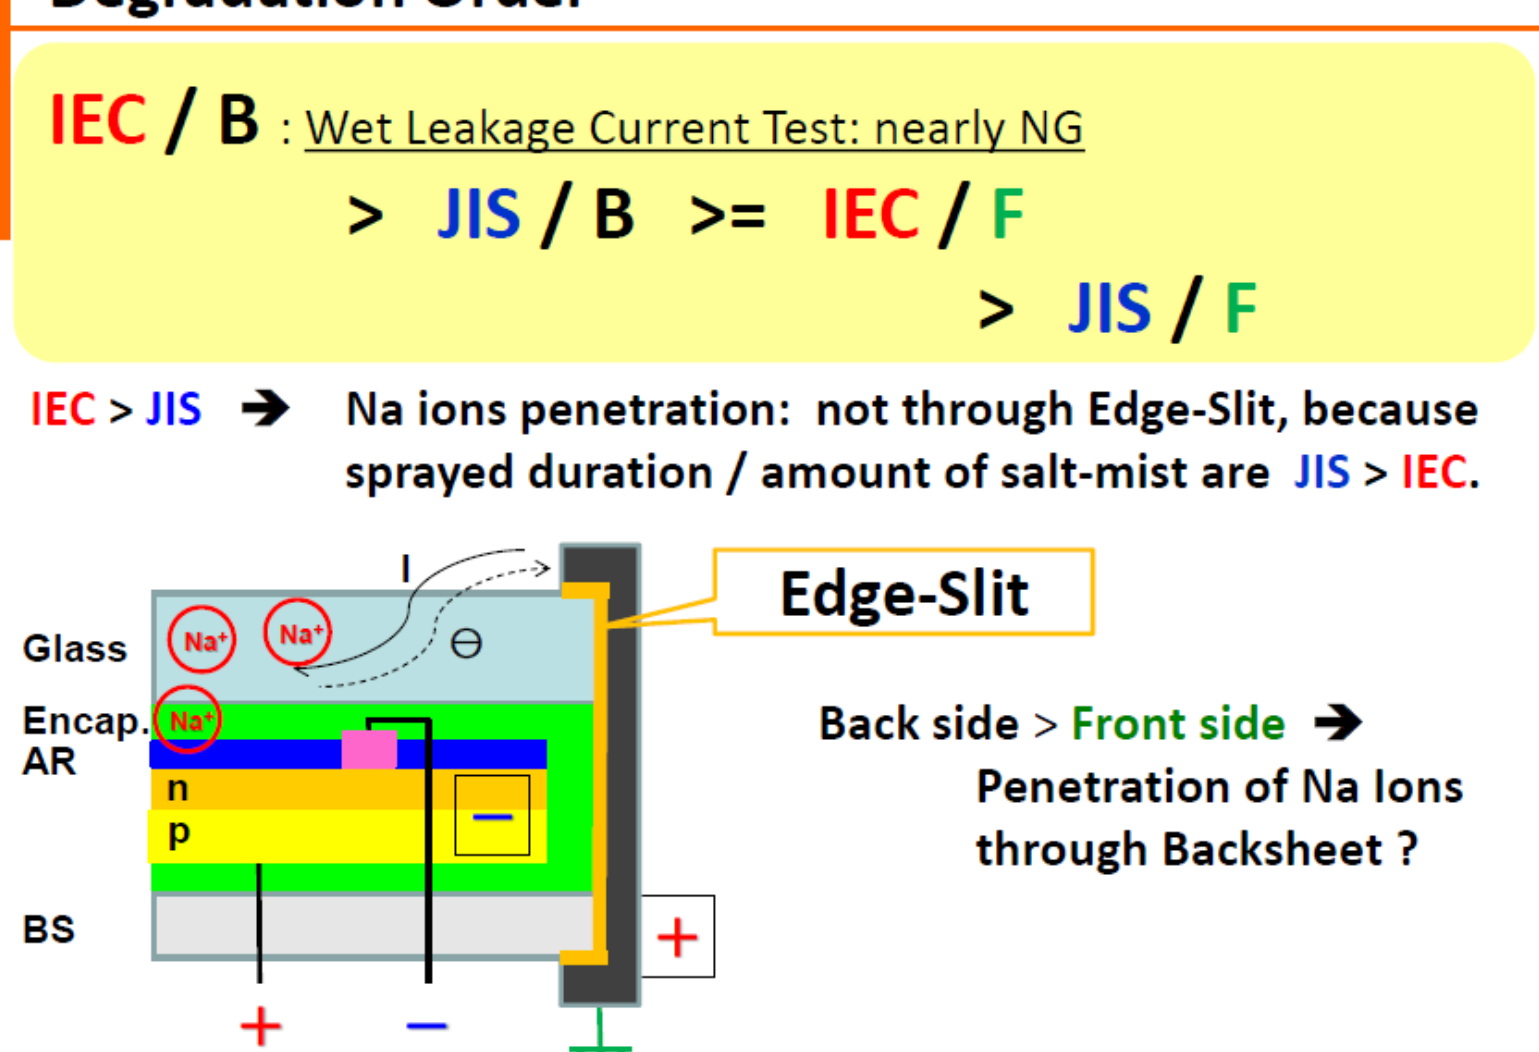
Panel 13

Degradation Order
