Cell defect analysis post Dynamic Mechanical Load and thermal cycling Testing at Jabil

Vivek Gade, Jared Opalewski and Philip Capps, Jabil Photovoltaic Certification and Testing Laboratory St. Petersburg, Florida.

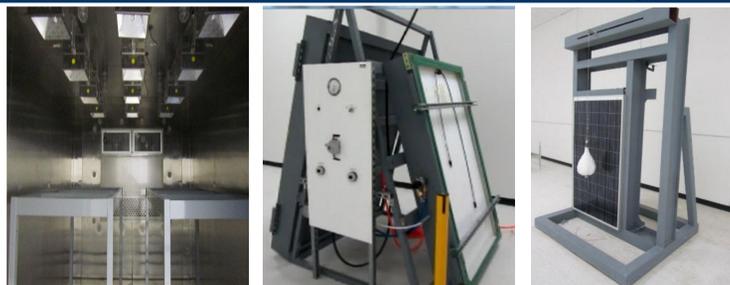
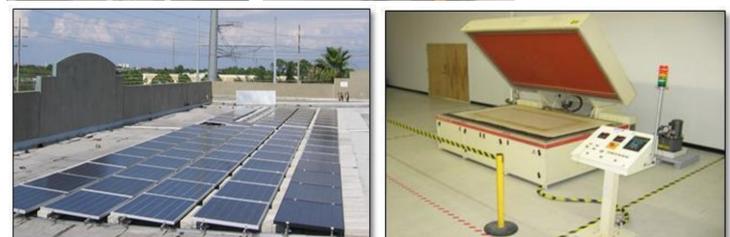
Jabil's state-of-the-art photovoltaic certification and testing laboratory in St Petersburg, Florida provides wide range of photovoltaic testing services such as prototyping, certification, product validation, extended testing and Failure analysis. Specialized tests such as potential induced degradation, glass soiling, array & individual module monitoring and dynamic mechanical load testing is regularly performed in the Jabil laboratory. Technical Data is presented here involving dynamic mechanical load testing performed using a unique test set up that very closely simulates the field conditions as observed by the mounted module. A group of modules were studied and analyzed as part of new cell validation and qualification process. Modules were taken through the sequential tests involving 1000 cycles of dynamic mechanical loading performed at 1440 Pascals followed by 50 thermal cycles similar to IEC 61215 10.11. Cell area defects particularly cracks were mapped to understand root cause and help further improve yield in manufacturing. Some of the data and analysis is presented in this poster.
