LONG-TERM SOILING IN A MODERATE SUBTROPICAL CLIMATE

Tony Sample*, Juan Lopez-Garcia and Alberto Pozza

European Commission, Joint Research Centre, Institute for Energy and Transport, Renewables and Energy Efficiency Unit, Via E. Fermi 2749, TP-450, I-21027 Ispra (VA), Italy.

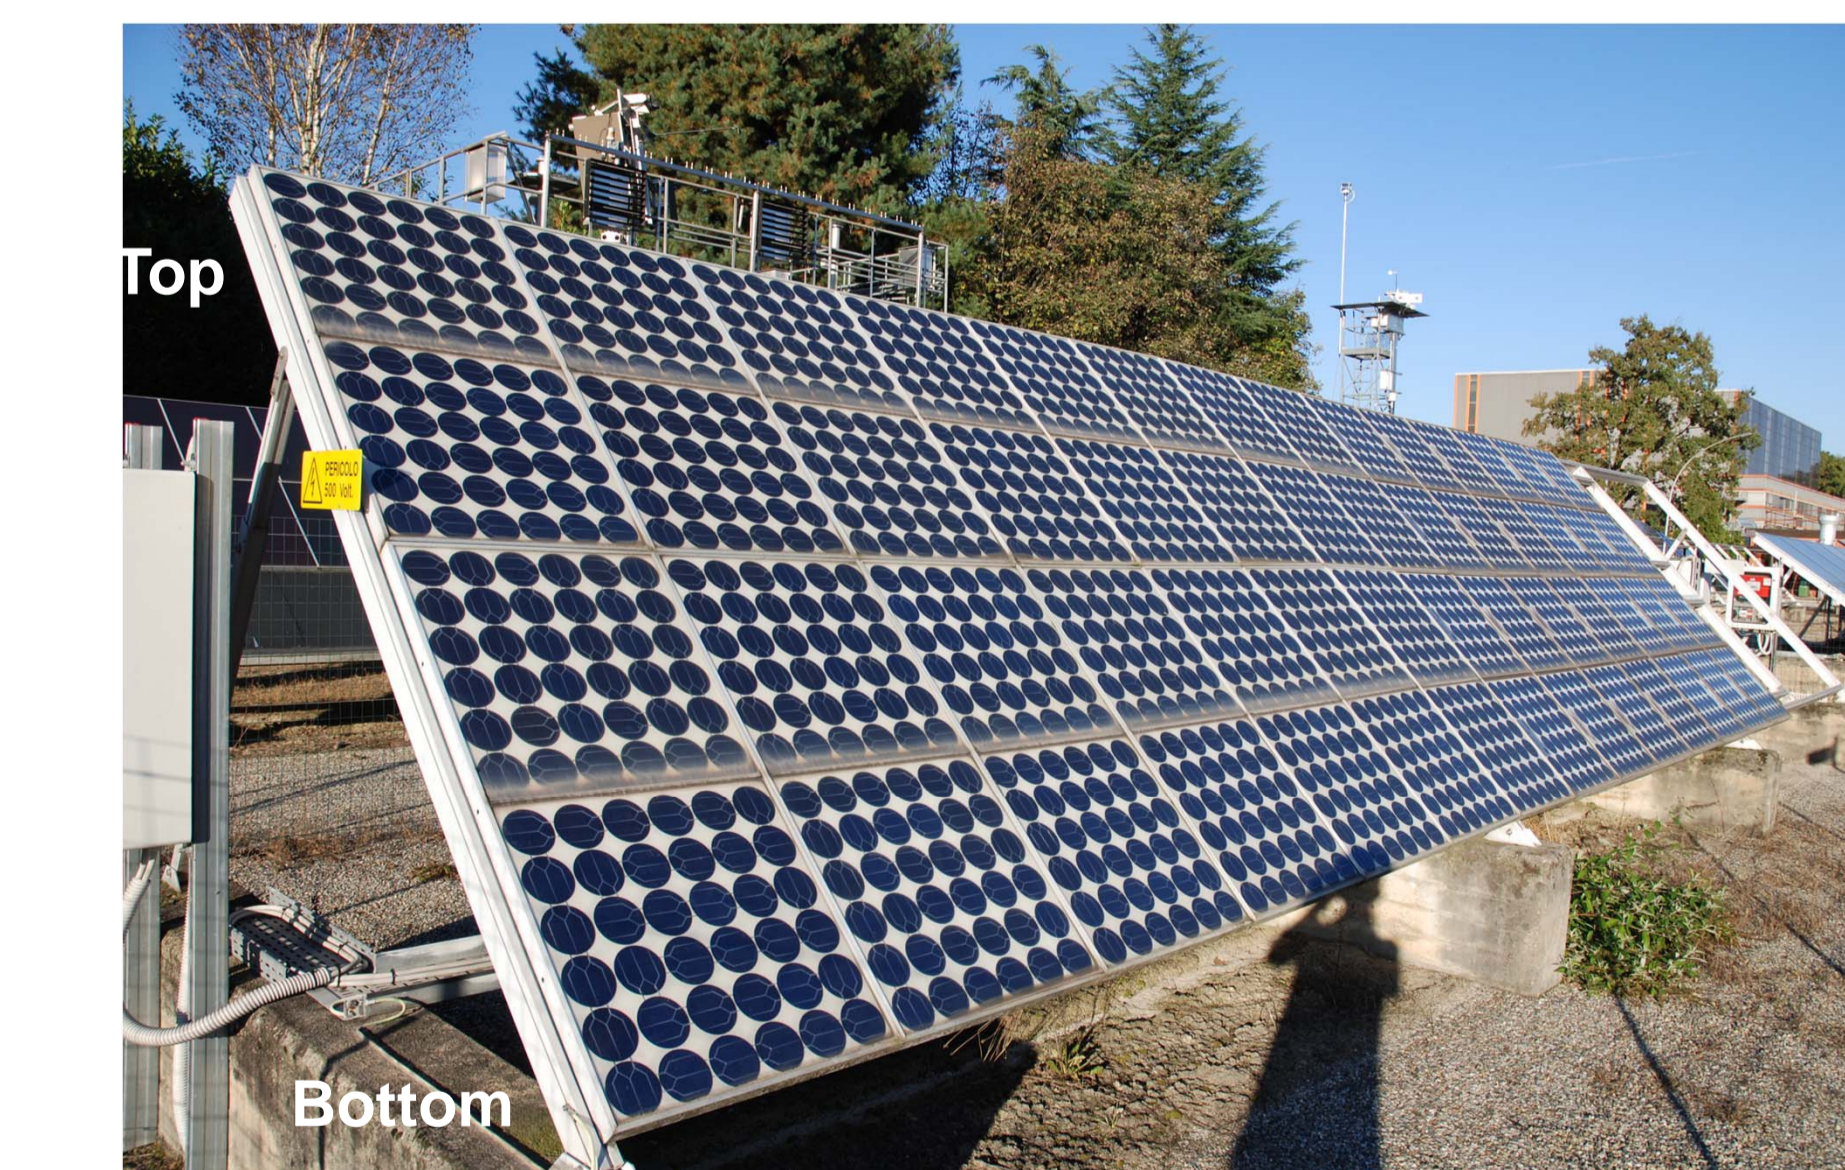
Fig. 1 (above) Single Si module, detail of the soiling between laminates and view of the complete array (bottom).

The modules main design details are listed in Table I; four types are represented. Fig. 1 shows the typical soiling distribution on the modules and the view of the complete array before removal from the rack.

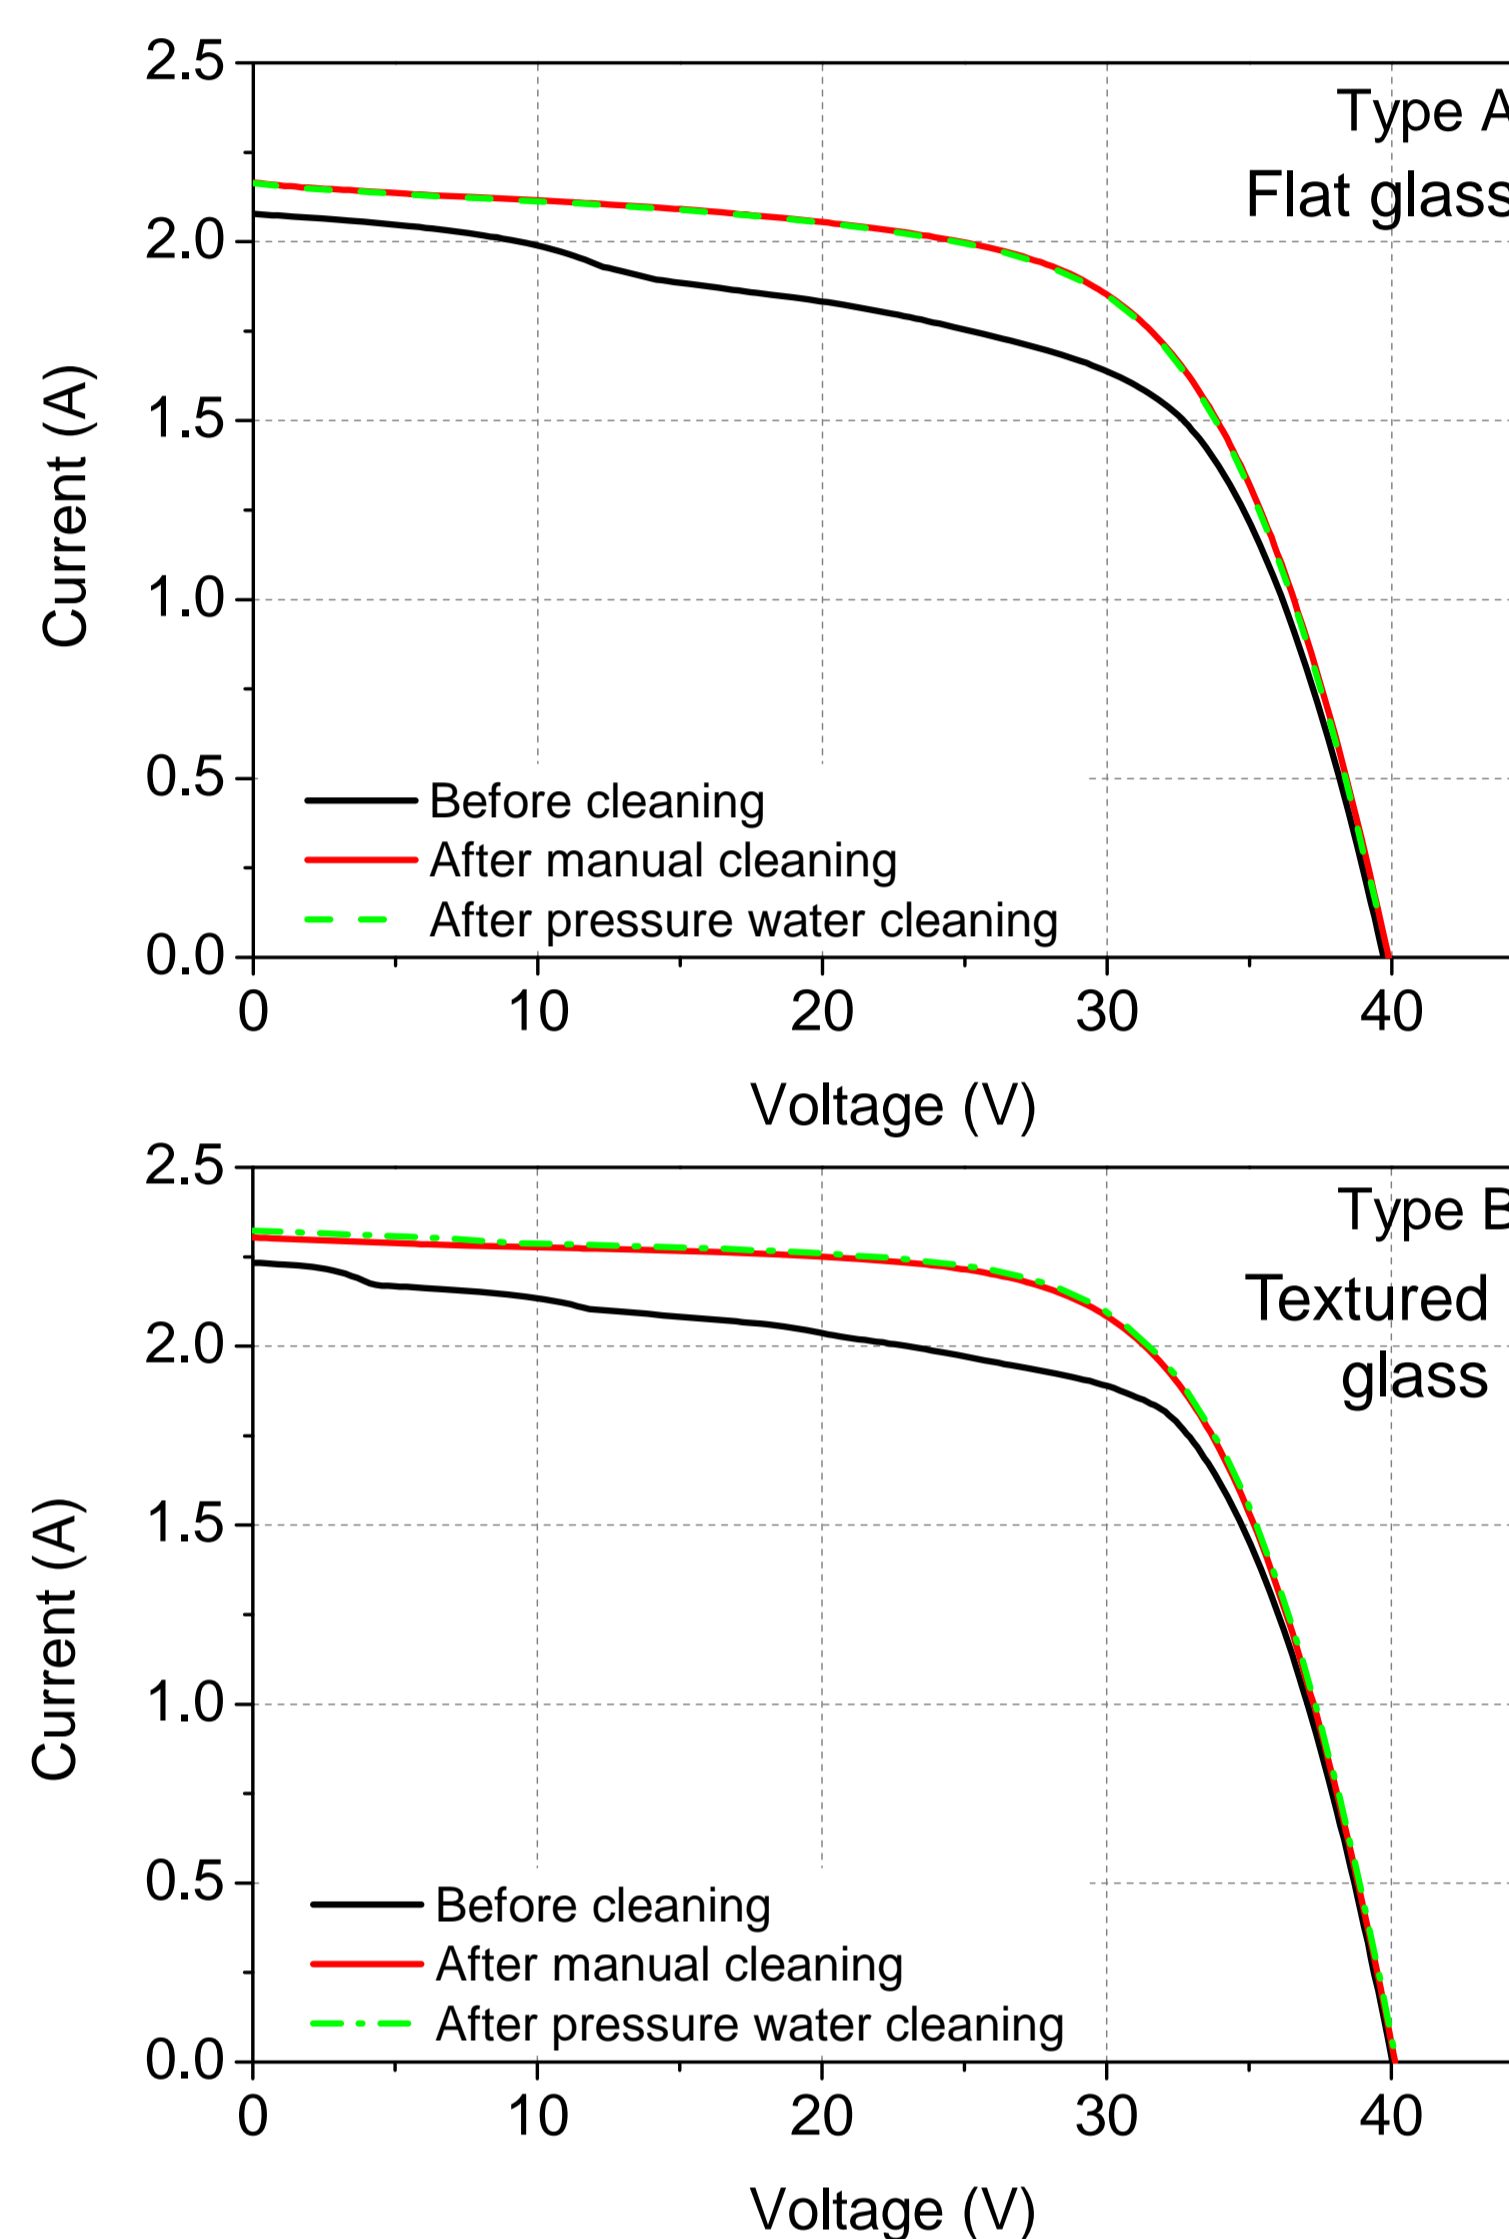
Fig. 2 IV curves of soiled modules of type A and B, cleaned manually, and with an additional pressure water procedure.

- Manual cleaning is effective on all the modules.
- Additional high pressure water spraying gives no additional improvement to plain glass modules.
- Textured glass modules show a further small improvement using a high pressure water spray, following manual cleaning.

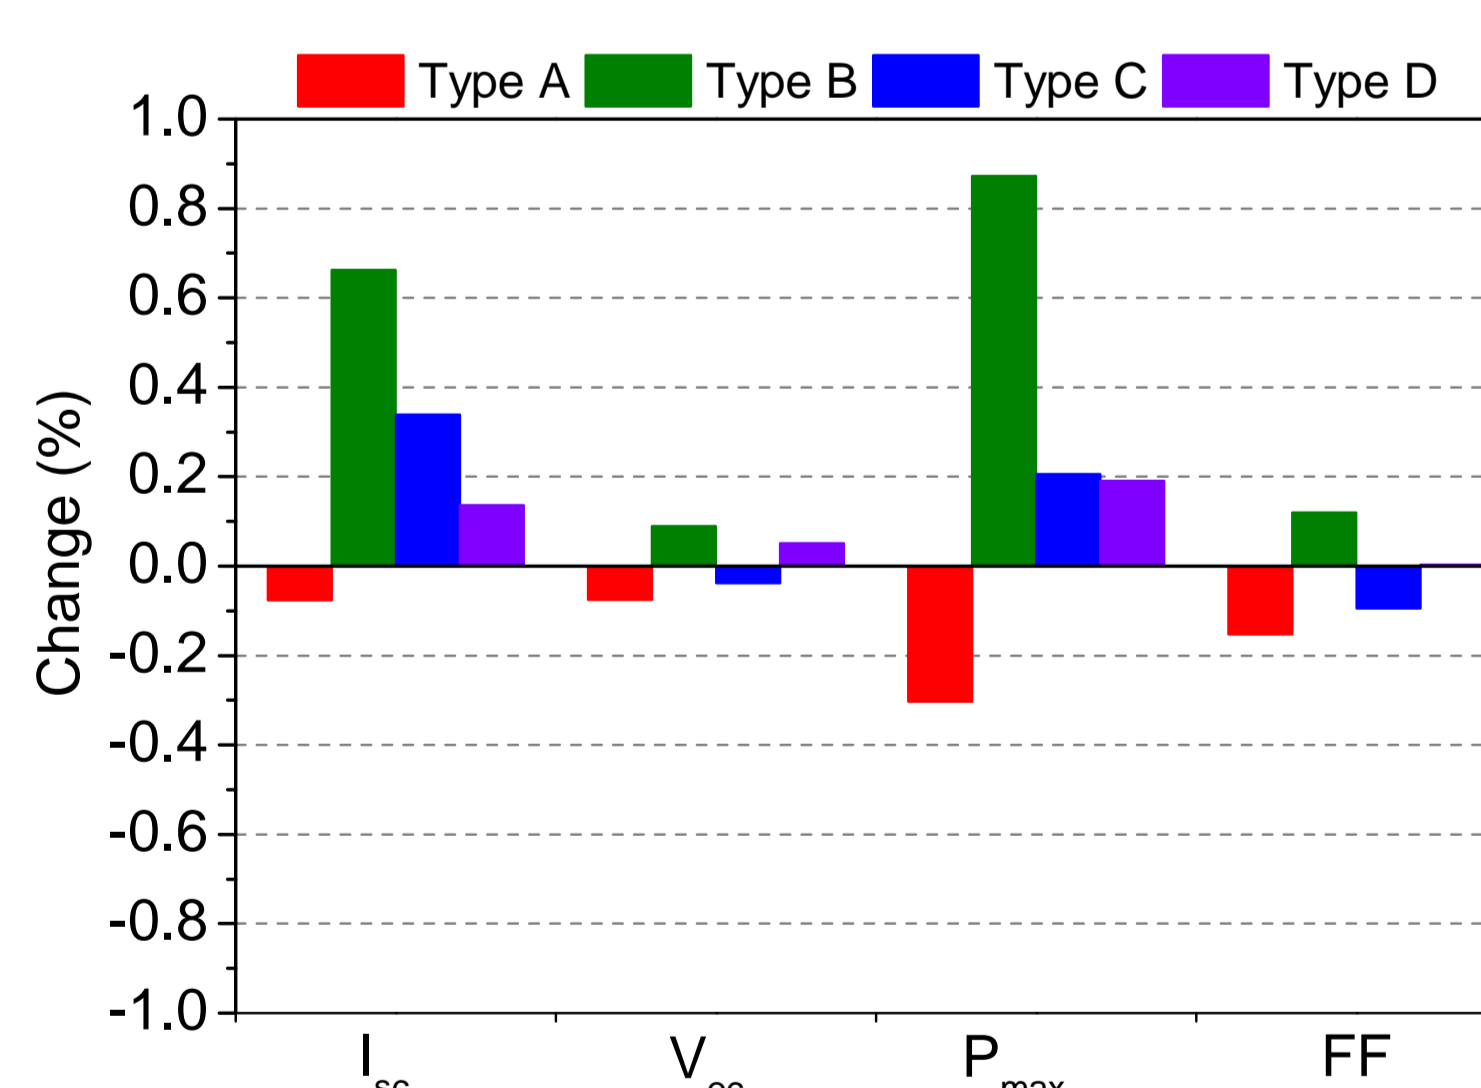
Fig. 3 Average change in % of representative modules of each type measured after additional cleaning with high pressure water, in comparison to manual cleaning.

A batch of 14 representative modules were cleaned manually and with a pressure washer. As shown in fig. 3 there are very small differences between manual cleaning and the additional cleaning with high pressure water. As such, the whole set of modules were measured after both cleaning processes.

- The slight increase in the P_{max} (~0.9%) of type B modules after the additional cleaning with high pressure water is mostly due to an increase of the I_{sc} (fig. 3).

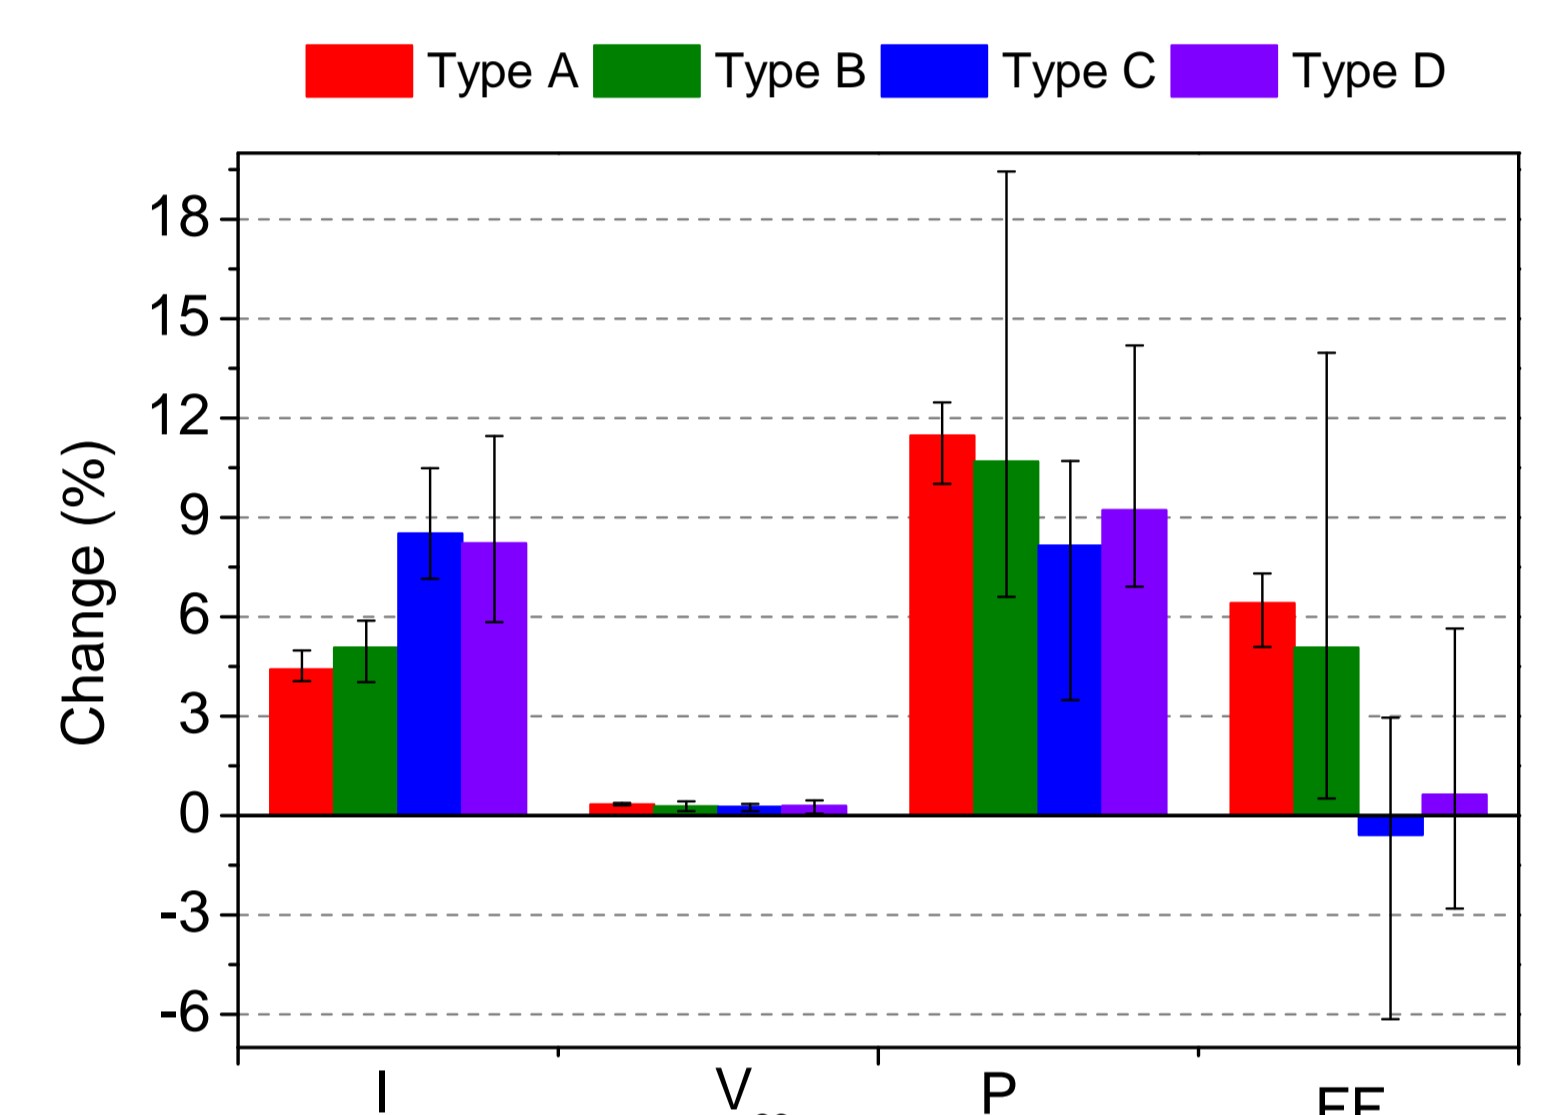
Fig. 4 Average change (%) of modules parameters following both manual cleaning and high pressure water, compared to the initial soiled modules (black bars indicate the max. and min. values)

The average increase in P_{max} after both cleaning procedures, compared to the soiled modules, is greatest for type A (11,5%). However, the variation in the extent of soiling for the textured glass modules is much higher (Fig. 4).

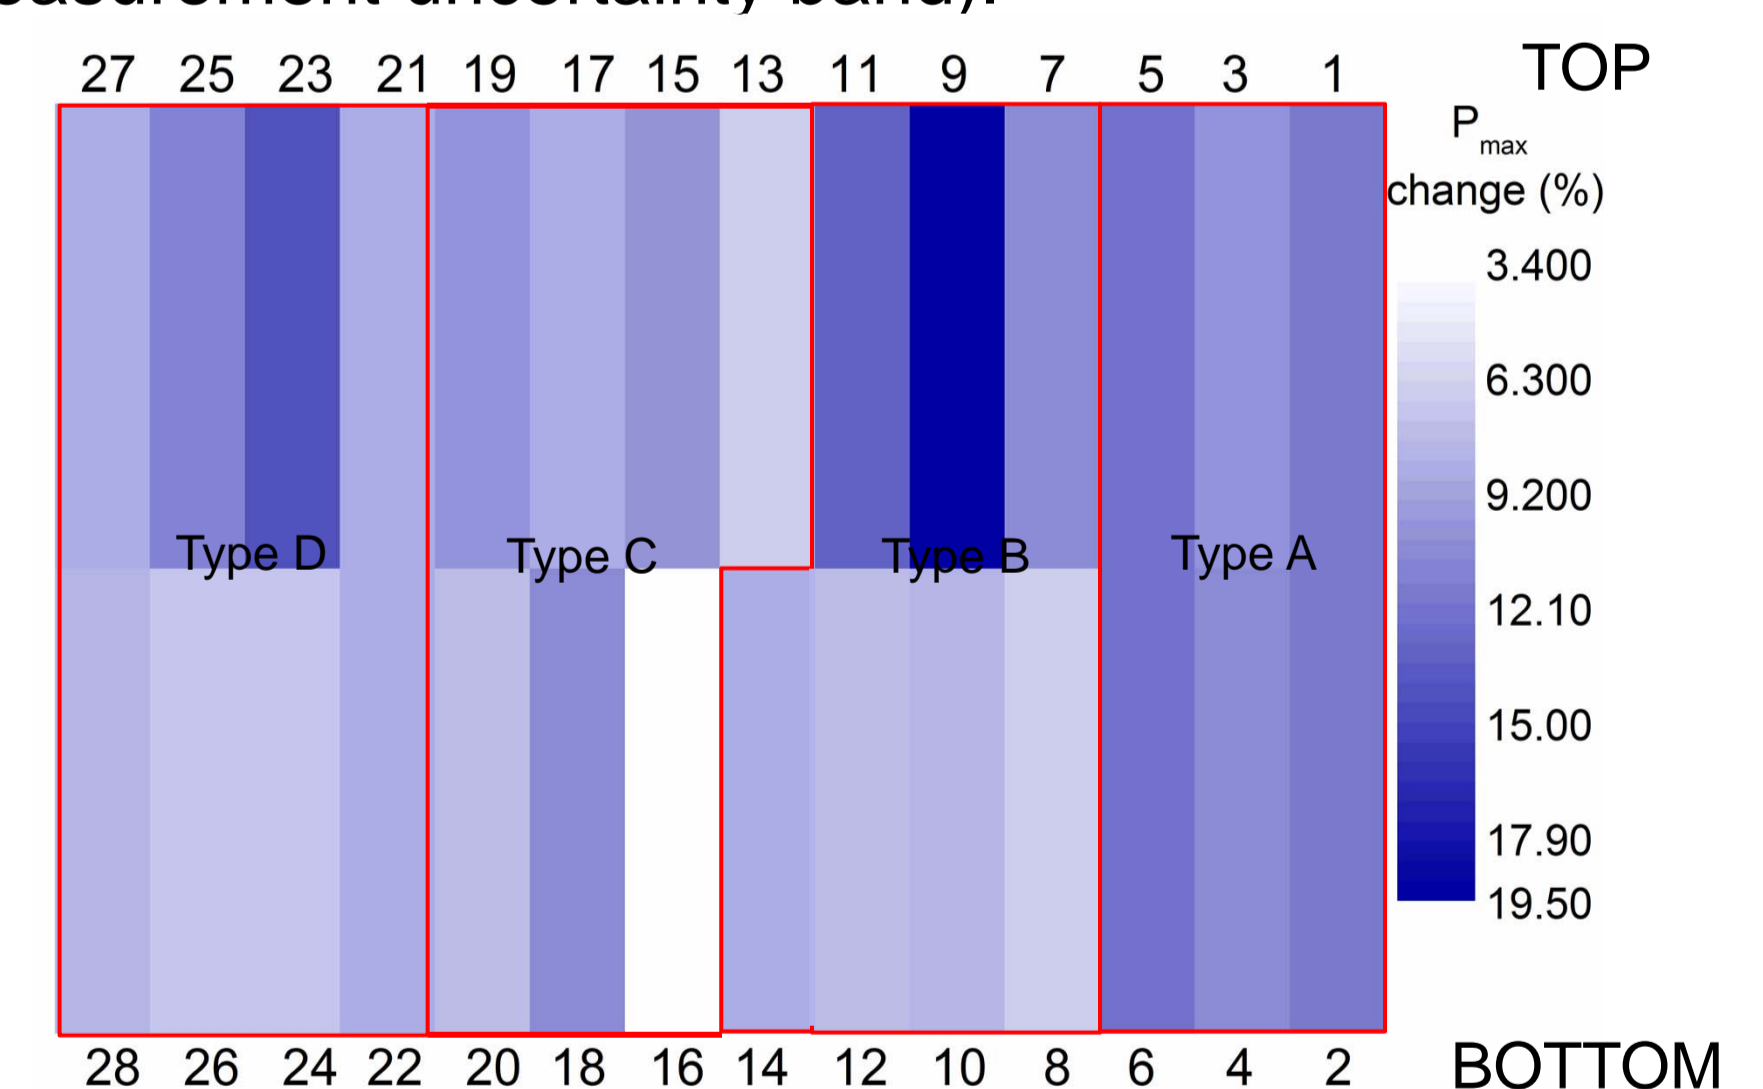
Fig. 5 Average change (%) distribution of the whole array in the same position than in the field (viewed from the front).
