Thermal Assessment and In-Situ Monitoring of Insulated Gate Bipolar Transistors in Power Electronic Modules

Preprint

Presented at ASME 2019 International Technical Conference and Exhibition on Packaging and Integration of Electronic and Photonic Microsystems (IPACK2019)

Conference Paper
NREL/CP-5400-73583
February 2020

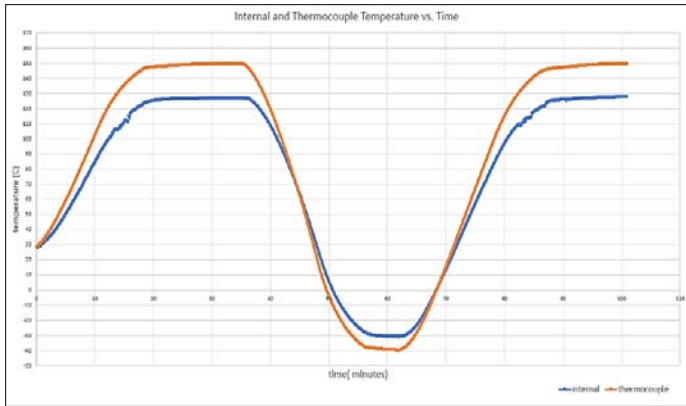
FIGURE 4: SAMPLE DATA OBTAINED DURING TEMPERATURE JUNCTION RECORDING - INTERNAL DIODE (BLUE) VS. INSERTED THERMOCOUPLE (ORANGE).

Two different approaches were examined for determining the junction temperature. First, the power module internal temperature sensor was used to collect data. The sensor outputs a voltage proportional to the substrate temperature, and that value is then converted to temperature in degrees Celsius. The other method involved a pre-calibrated Type-K thermocouple inserted through the protective layer of silicone gel on the IGBT power module. The thermocouple was mounted on the top surface of the chip and was connected to a data logger for temperature monitoring. The thermocouples used were calibrated at 0°C and 100°C respectively. According to the temperature profile in Figure 4, the thermocouple's temperature (shown in orange) was fairly consistent with the IGBT internal thermal diode (shown in blue) at room temperature, but it starts to deviate at temperatures above 80°C and below -20°C.

However, the thermocouple gives readings similar to the internal temperature sensor of the thermal chamber when set to a specific temperature. Since the thermocouple showed data readings closer to the thermal chamber sensor, it was used as the temperature reading during this research rather than the internal IGBT thermal diode.

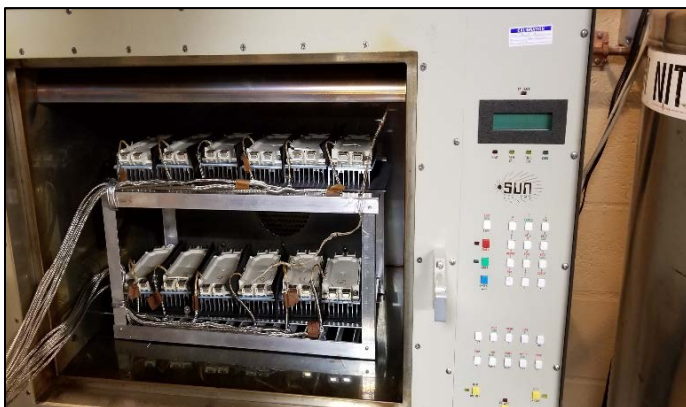
FIGURE 5: SETUP OF POWER MODULES FOR SIMULTANEOUS THERMAL CYCLING.

In order to accelerate failure, thermal cycling was applied simultaneously to all 12 modules. The devices were placed together in a rack inside a temperature chamber. Figure 5 shows a photograph of the samples as placed and arranged inside the temperature chamber. A data logger was used to monitor the temperature of the modules during testing and the temperature chamber was programmed to thermally cycle the modules between -45°C and 155°C . The chamber uses an internal temperature sensor to verify that the interior is reaching the desired temperature. Liquid nitrogen was used during the cooling period in the thermal cycle and each cycle was of approximately one-hour duration.

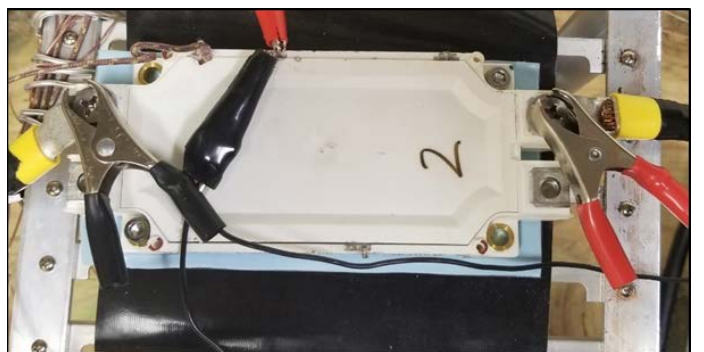
FIGURE 7: TOP VIEW OF INDIVIDUAL SETUP FOR A POWER MODULE USED FOR POWERING ON.

After every 100 thermal cycles, the modules were taken from the thermal chamber and subjected to a powering assessment. This was done to observe any changes in the junction temperature resulting from a degradation in the thermal path due to the temperature cycling. In order to conduct this step, the same Type-K thermocouples used during thermal cycling were also used to monitor the temperature during powering assessment, while collector-emitter voltage (V_{CE}) was recorded at the same time. A power supply AEHR 20V 300A was used to power each individual module, and a datalogger was used to record the data. Each module was powered on individually for 2 minutes and then powered off until it cooled to room temperature (one channel at a time: A and B). The overall and individual setup for turning on the power modules can be observed in Figure 6 and Figure 7 below.

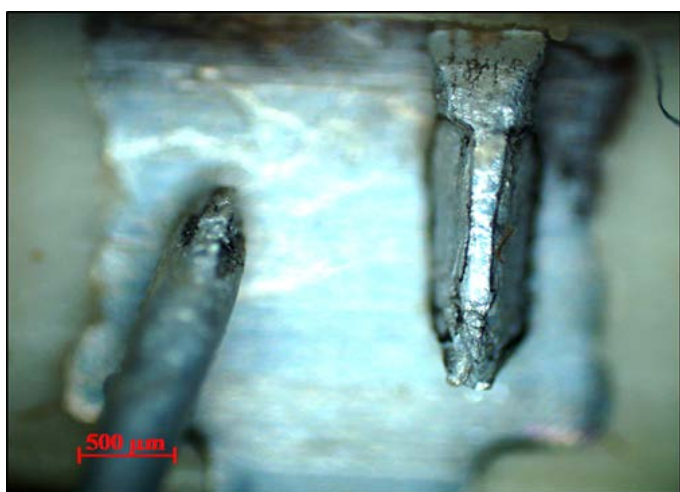
FIGURE 12: MICROSCOPE IMAGE OF A HEEL FRACTURE OBSERVED IN WIREBOND FROM POWER MODULE.

The increase in the variation in this electrical parameter led to further characterization and inspection of the device for potential damage. All power modules were examined with a light optical microscope and inspected with x-rays to assess any potential damage in the device, particularly in the solder attach. While it was expected that an increase in temperature would be due to solder attach damage, this was not observed. X-ray imaging showed no evidence of cracks or delamination in the solder attach (see Figure 11). Some of the modules experienced a small oscillation of the V_{CE} and temperature throughout the test but did not fail within the 1500 cycles. The modules that did fail showed a similar oscillation in temperature and V_{CE} until a complete open circuit failure was observed as a spike in V_{CE} (see Figure 10). These failed samples were then opened for inspection and it was found that they failed by wirebond heel fracture (see Figure 12).
