Electricity Supply Infrastructure Improvements

Final Technical Status Report
December 2010

Daniel Piekarski and Dana Brad
Northern Indiana Public Service Company
Merrillville, Indiana

Subcontract Report
NREL/SR-5500-49793
February 2011

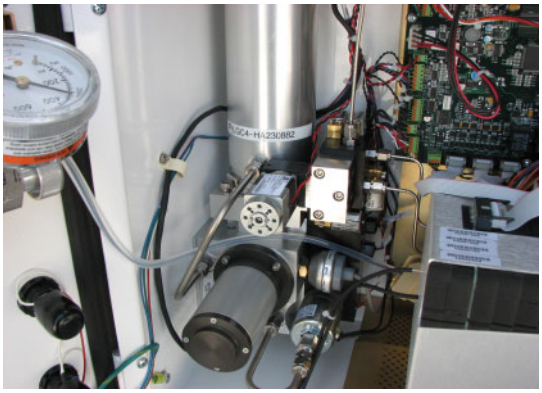
Figure 15
PUMP ASSEMBLY

We currently have 9 Serveron TM8 gas monitors in service at NIPSCO. After several years of operation, we have experienced numerous issues with the Serveron TM8 units. We replaced the oil pump, helium and calibration gas bottles on one unit and the sled (main instrument component) and main board on the other unit.

We have had multiple sled issues, moisture transmitter problems, pump concerns and display malfunctions.

The chronic issues we have been dealing with occur most frequently in the cold weather. January temperatures that fall into the single digit range cause many of the issues we continue to see with the Serveron units. After speaking with other utilities in the southern regions of our country, the concerns increase exponentially in the cold ambient temperatures. Serveron is aware of the cold weather issues and are in the process of engineering a cold weather climate kit. This kit is estimated to be complete and ready for production in the last quarter of 2010.

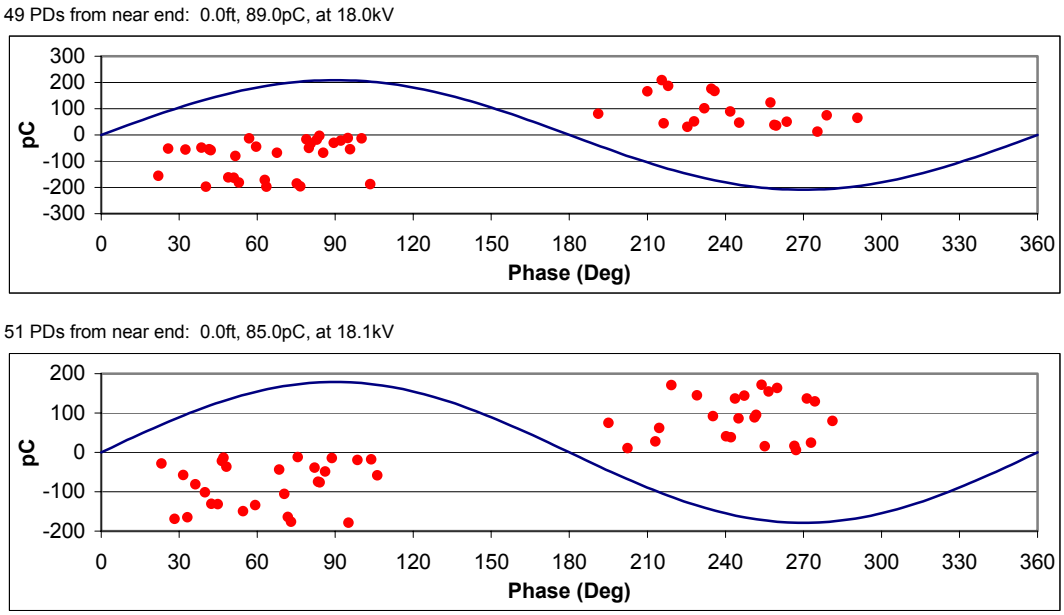
Figure 31 Partial Discharge Detail

The detail in figure 31 above is an example of an information level reviewed by the IMCORP, and in this case, the partial discharges are from the end termination and are mitigated in the field. This level of detail is included in the customer documentation.

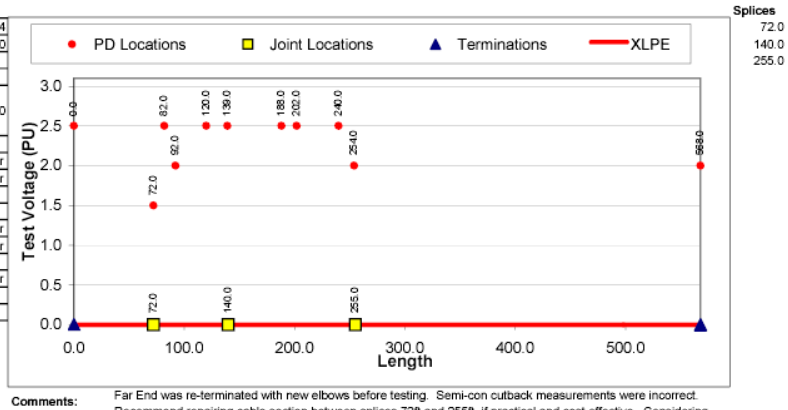
Discharge Type	**Location**	**pC**	**#/Cycle**	**Test kV**	**Recommend**
Splice	72.0	22	35	10.8	Monitor
Cable	92.0	44	31	14.4	Immediate Repair
Cable	254.0	14	229	14.4	Immediate Repair
FE Termination	568.0	9	2	14.4	Monitor
NE Termination	0.0	84	7	18.0	Monitor
Cable	82.0	19	34	18.0	Immediate Repair
Cable	120.0	20	9	18.0	Immediate Repair
Splice	139.0	64	5	18.0	Monitor
Cable	188.0	20	27	18.0	Immediate Repair
Cable	202.0	19	9	18.0	Schedule Repair
Cable	240.0	9	8	18.0	Schedule Repair

Comments: Far End was re-terminated with new elbows before testing. Semi-con cutback measurements were incorrect. Recommend repairing cable section between splices 72ft and 255ft, if practical and cost effective. Considering the length of the cable, it may be more realistic to replace the section.

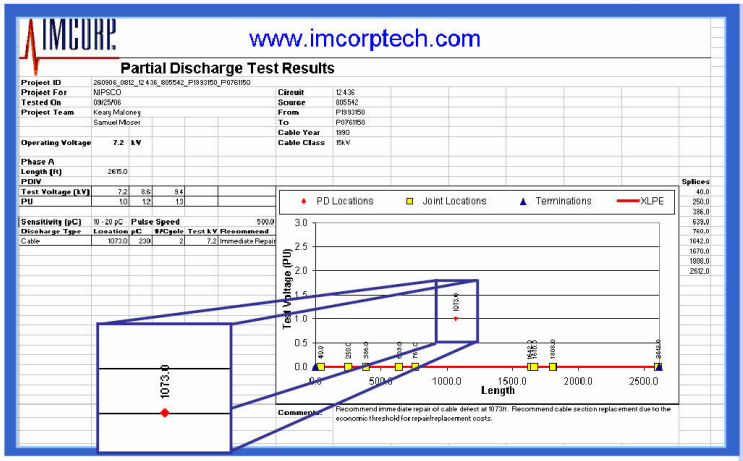
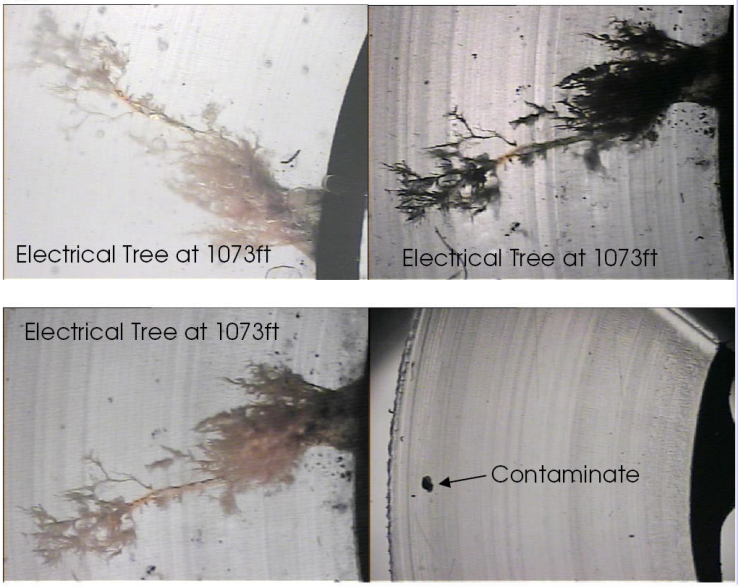
Figure 35 Dissection Analysis Report

Background: On 9/25/06 the cable parallel to Connecticut Dr in Merrillville, IN was tested for partial discharge activity and location. As the 60Hz voltage was increased to simulate voltage transients, a partial discharge site was located very close to nominal voltage of the cable. As a result, the defect was located using a location matching system and removed by NIPSCO crews. The sample was sent to the IMCORP sample laboratory and dissected finding the following defects, the most significant being the electrical tree the source of the PD.

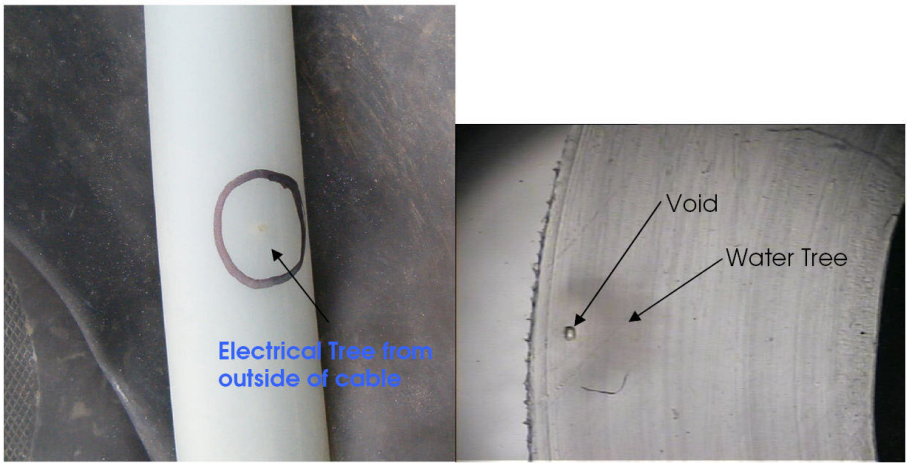
Figure 36 Additional Electrical Tree Example

Since this was near the start of the Condition Assessment Survey, early dissection analysis was helpful to relate the technology and reports to the actual defect that is detected and in this case, removed.
