# Wind Turbine Lightning Protection Project

1999—2001

Brian McNiff  
*McNiff Light Industry*  
*Harborside, Maine*

**National Renewable Energy Laboratory**

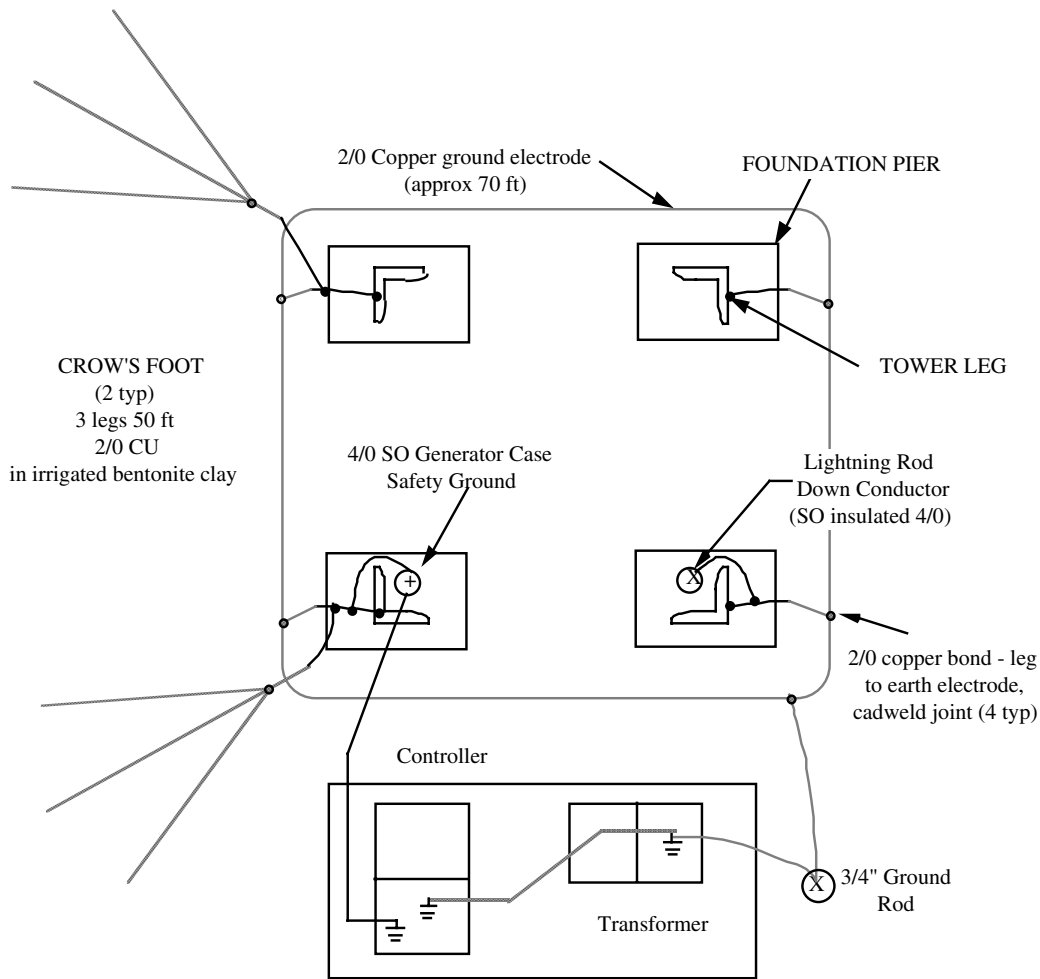
**Figure 13. CSW turbine grounding plan view**

The grounding details are described for a typical turbine in Figure 13 and Figure 14. The grounding electrode was significantly modified with a retrofit designed by Rich Kithill at the National Lightning Safety Institute (NLSI). Some observations of the details follow:

- The generator J-Box (generator ground) is connected by insulated 4/0 Cu conductor to a tower bond 1.5 m (5 ft) from base (below sensor) and control box.

- The controller path to ground is either via the neutral cable or via the feeder transformer box into a ground rod and the ring electrode.
- The controller and uptower generator surge protection device clamps to SP ground.

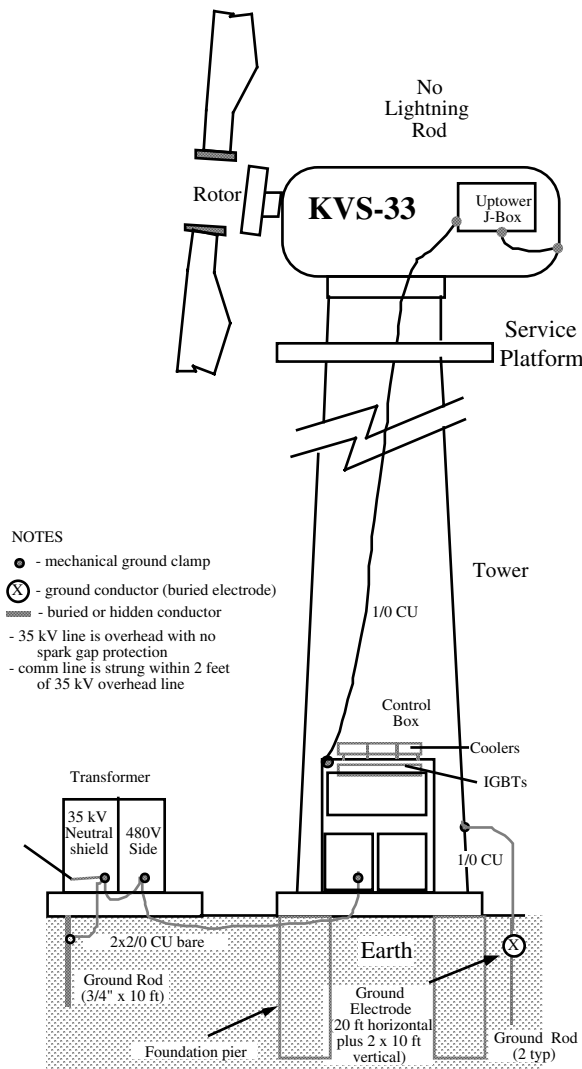
Figure 15. KVS-33 grounding scheme

There are no blade conductors in the Kennetech fiberglass blades. They have taken dozens of strikes that have led to catastrophic blade failures, and, unfortunately, replacement blades are difficult to acquire due to the Kennetech bankruptcy. Also, there is neither a lightning rod nor metal in the nacelle cover that would afford protection for operators. It is recommended that such a system be instituted.

The grounding system is inadequate for the dry soil at the site, and the bonding practices were observed to be poor. Figure 15 shows the grounding scheme. Some observations follow:

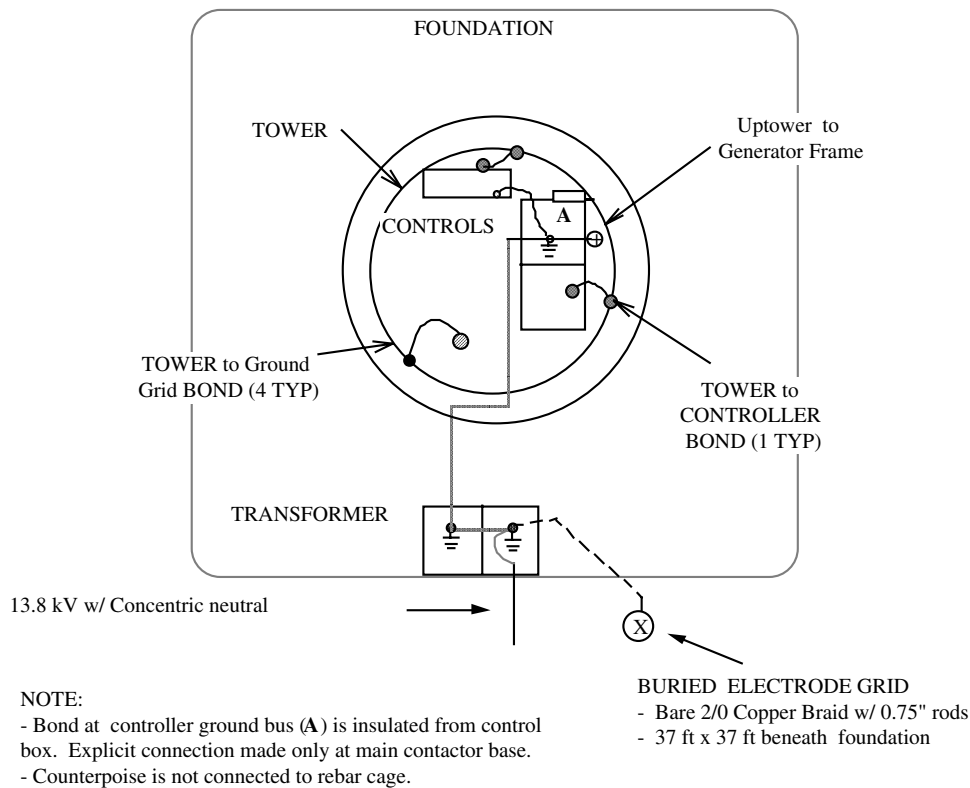
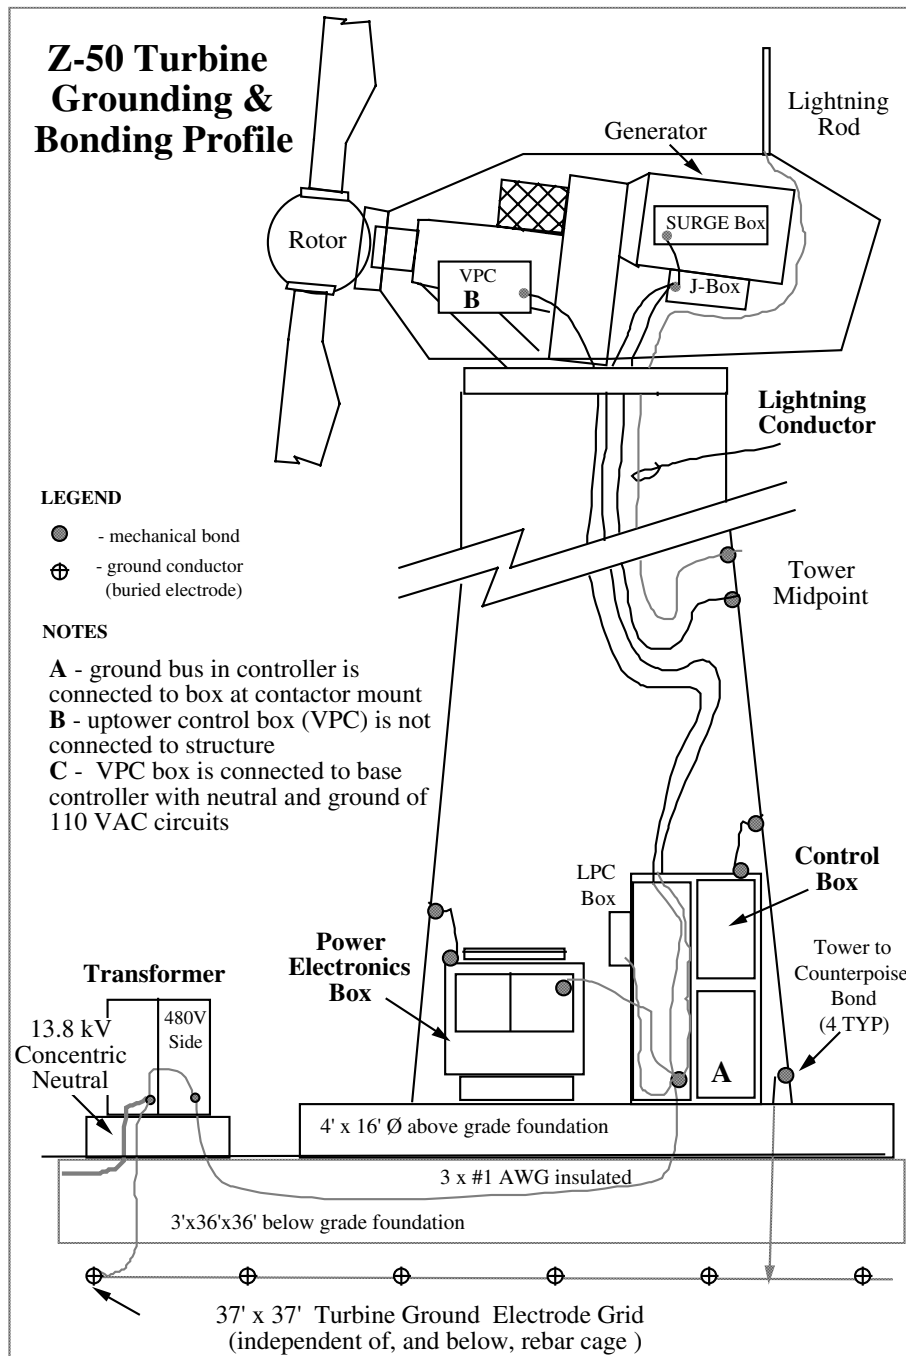
**Figure 18. Algonza Z-50 grounding and bonding profile**

There is little or no metal in the nacelle cover that would afford protection for operators. However, there is a lightning rod that provides a moderate amount of protection for personnel and meteorological instruments on the nacelle. The rod is not connected to the local turbine steel. Instead, it is connected to the midpoint of the tower via a droop cable (4/0 CU insulated SO), as is the generator safety ground.

The grounding system is good, but the in-turbine bonding practices were observed to be poor. Figure 18 and Figure 17 show the grounding schema. Following are observations regarding the grounding system:

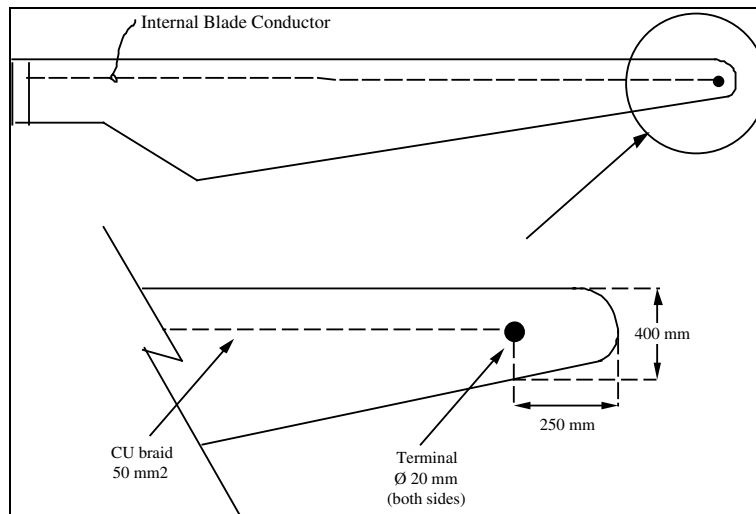
Figure 21. IVPC Vestas V44 blade protection

The fiberglass blades have threaded inserts at the root to accept mounting bolts into the pitch bearing. A 50 mm<sup>2</sup> (No. 1 AWG) copper lightning down conductor from each tip is glued periodically to the inner surface of the blade. It is attached to one of the threaded inserts at the root and bonded to the inside of both blade terminals 250 mm (9.8 in.) inboard on either side of the tip (see Figure 21). These 20 mm (0.7 in.) diameter stainless steel terminals are mounted flush with the outer surface of the blade skin and are intended to receive the lightning stroke and safely conduct it to ground (see Figure 22). These are installed during blade manufacture.

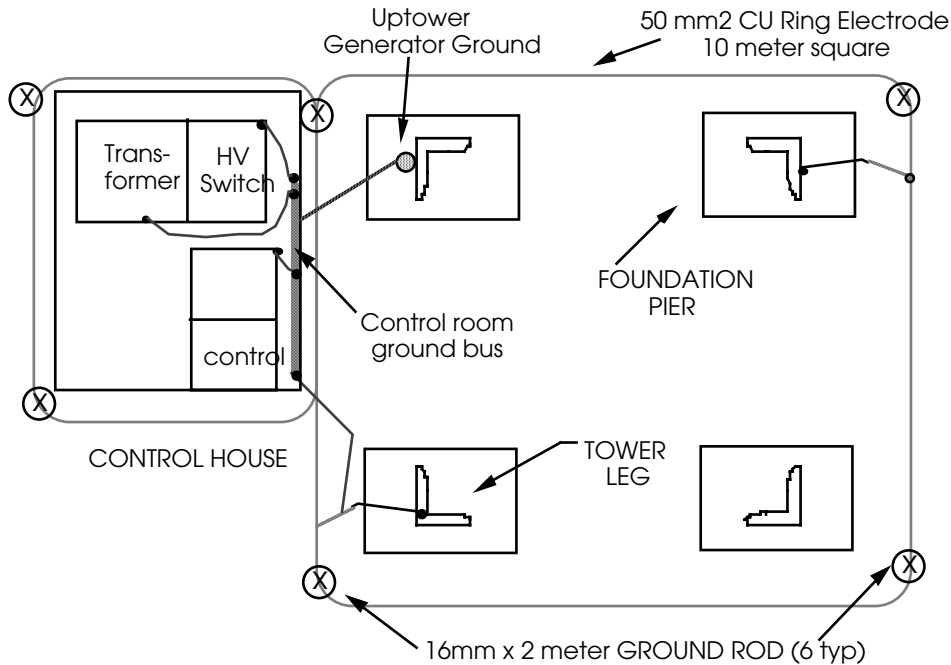
**Figure 23. IVPC Vestas V44 grounding**

These installations were equipped with a rather significant earth electrode (see Figure 23) to terminate and dissipate lightning strokes to the wind turbine structure. The electrode in the ground is 50 mm<sup>2</sup> (No. 1 AWG) copper installed in a pair of loops about the tower foundation and the control house buried at about 1 m (3.3 ft). It amounts to over 50 m (164 ft) of electrode with 6 ground rods (vertical electrodes) of 16 mm by 2 m (0.6 in. by 6.5 ft). The primary high-voltage conductors are buried in a trench with a bare conductor that connects the adjacent grounding electrodes.

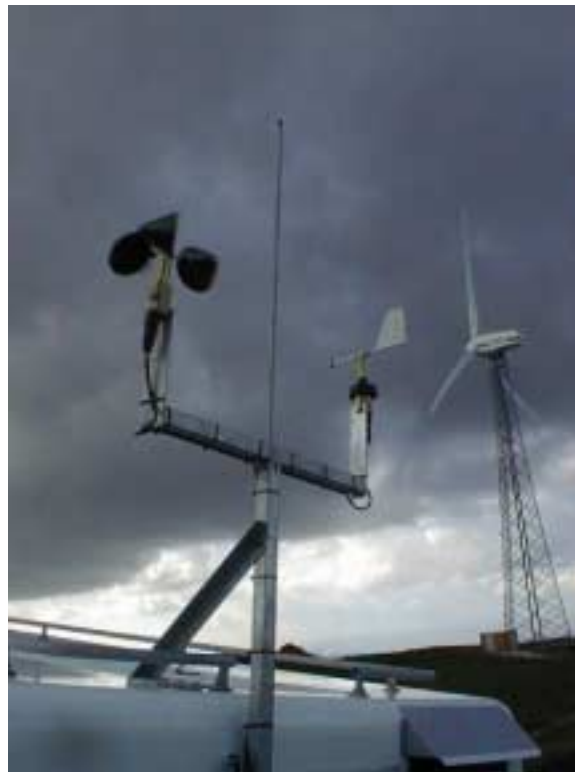
Figure 24. IVPC/Vestas V44 nacelle protection

for safety (see Figure 24). These also provide additional protection from direct strikes to people inside the nacelle. They are also well bonded to the structure.

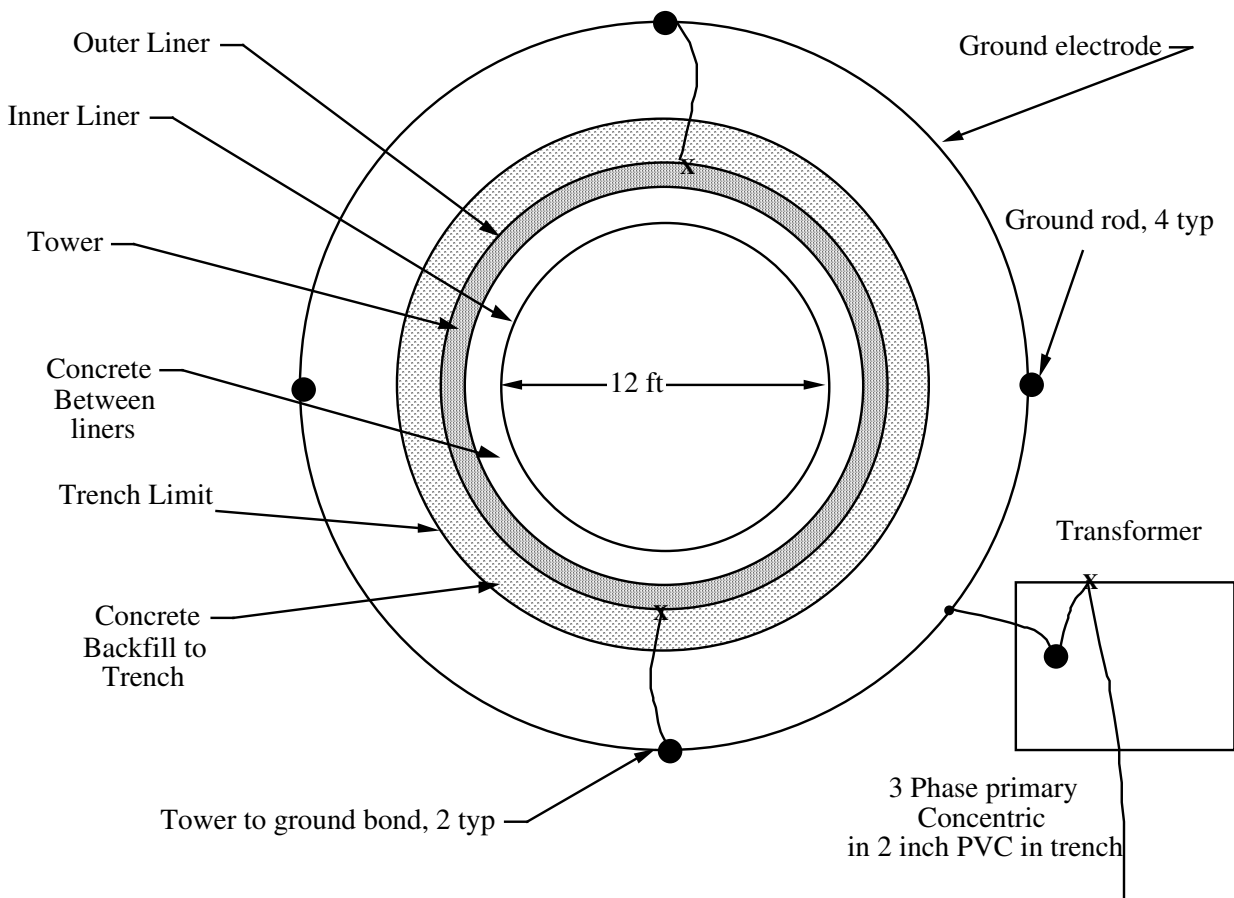
Figure 25. Big Springs/York research grounding detail

The foundation is shown in an overhead view in Figure 25. It was constructed by installing two concentric sheet steel tubes (like culverts) into a drilled 4.5 m (15 ft) diameter hole in the existing soil to depths of 8.2 m (27 ft). Concrete was poured in the vertical (annulus) space between the culverts along with lined foundation bolts. A ground ring was buried outside this foundation at about 0.76 m (2.5 ft) deep. This grounding ring is bonded to the outer culvert, the tower (twice), vertical ground rods (four locations) and the distribution line ground. This is a good grounding system design for both personnel safety and strike dissipation for the hardpan soils in West Texas.
