# Performance Evaluation and Opportunity Assessment for St. Bernard Project

Bruce Dickson  
*IBACOS, Inc.*

June 2011

## **Technical Report: Performance Evaluation and Opportunity Assessment for St. Bernard Project**

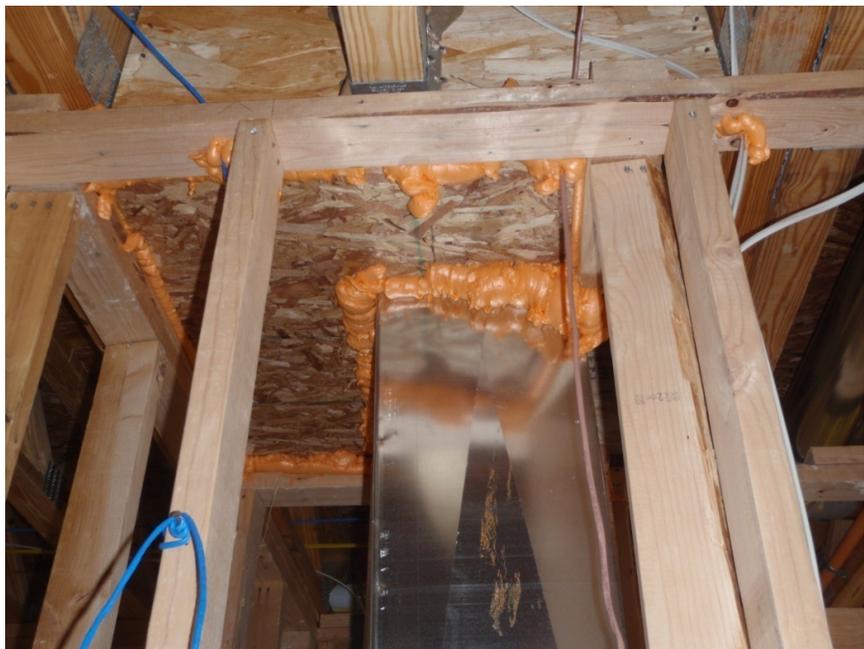
Figure 11. Photo of Sealed Mechanical Chase Lid

Not sealing the lid at the top of duct or other mechanical chases may lead to 1) increased utility bills for the homeowners due to decreased thermal performance, 2) comfort issues due to the unwanted exchange of air from unconditioned to conditioned spaces.

The best method to seal duct chase lids is to install a panel product over the top of the chase and then cut the duct penetration through. This enables the installer to create a better fit through the lid and makes it much easier to seal. Fiberglass chinking is minimally effective in preventing the passage of air and so should not be used for air sealing. Expanding foam is the most effective sealant to use at this location.

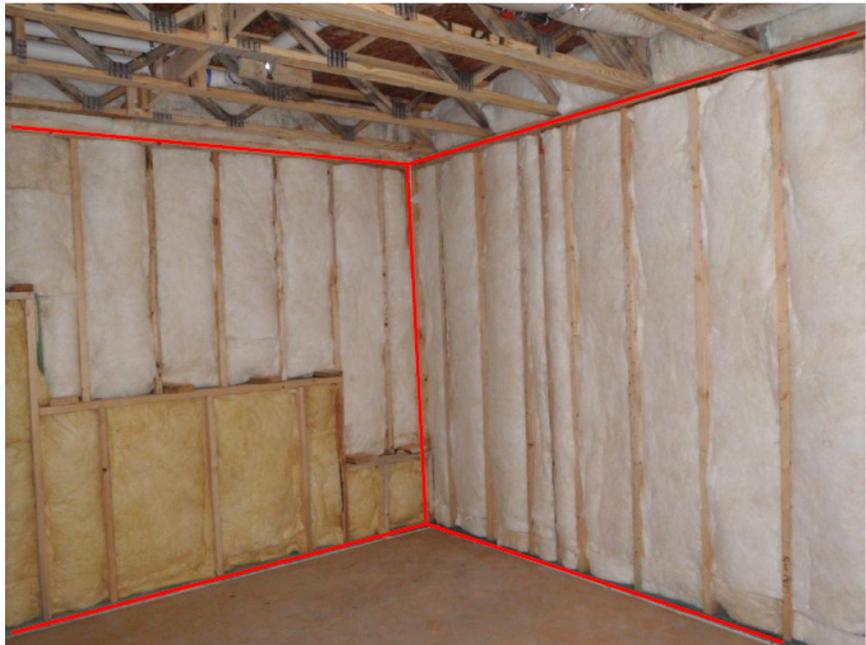
Figure 15. Illustration of Continuous Drywall Application

In homes with ceilings that are taller than the standard 8 feet a large gap was left open at the base of walls. While baseboard will cover this area it will still permit air infiltration or exfiltration if left unsealed.

Gluing the drywall to the perimeter framing will greatly increase the overall effectiveness of the insulation and air barrier.

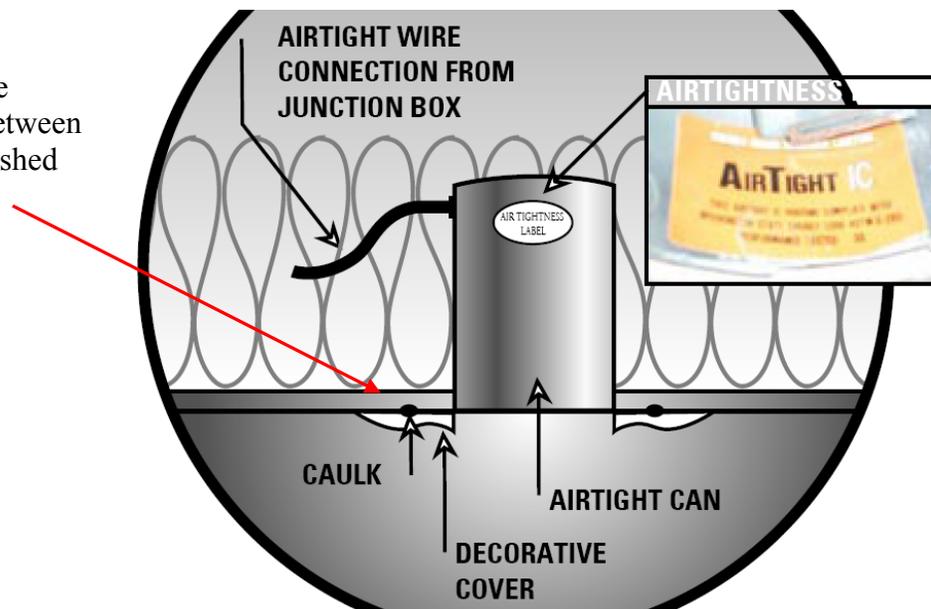
Figure 17. Illustration of Proper Air Sealing at Recessed Fixtures

Drawing showing the location of sealant between the trim ring and finished ceiling.

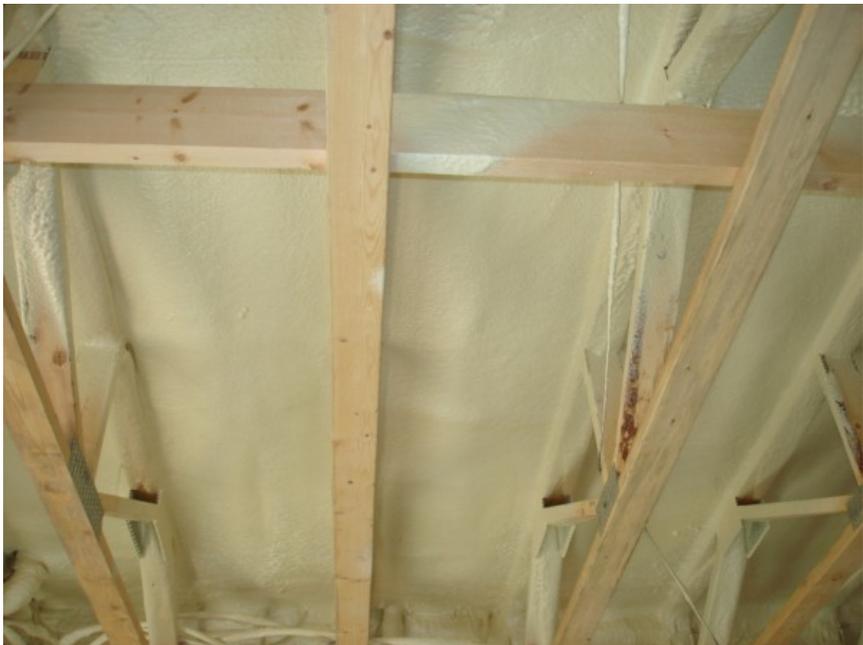
Figure 23. Photo of Closed Cell Foam Under Floor Decking

A consistent strategy to maintain the thermal boundary at raised floors on open pier foundations needs to be established.

The most effective insulation and air sealing solution at framed floors on open pier foundations is to use a wash of closed cell foam over the entire underside of the floor system. Thickness of closed cell foam will be dependent on desired R-value of the floor system.

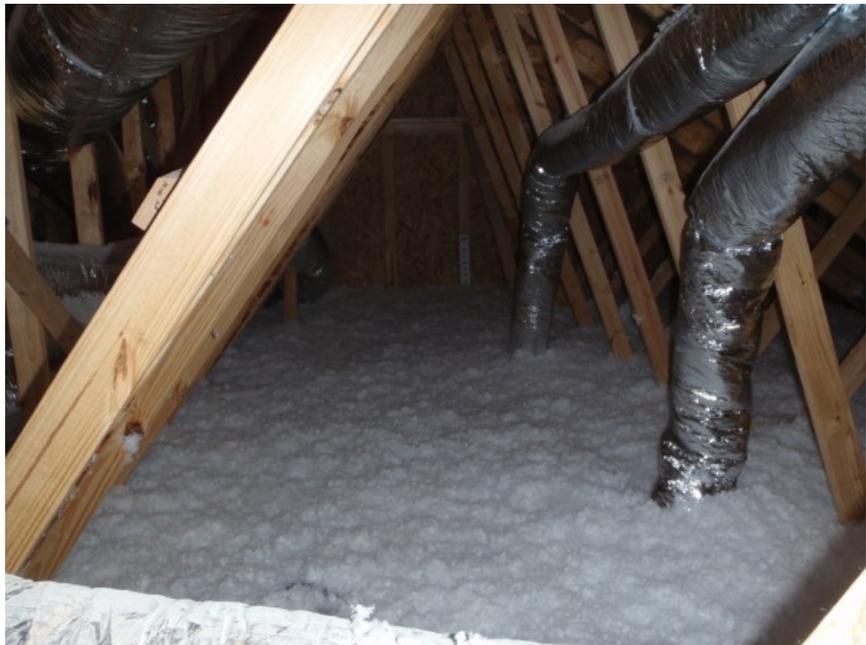
Figure 25. Photo of Well Insulated Attic at Ceiling

Instances of missing insulation and air sealing at penetrations were observed in most attics.

The best practice at attics is to inspect the attic before insulation to ensure that all penetrations are sealed and then use a loose fill fiberglass blown in insulation (R-30) over the entire attic floor.

Due to the moisture retention capabilities of cellulose insulation, fiberglass fill is recommended for the hot humid New Orleans region.

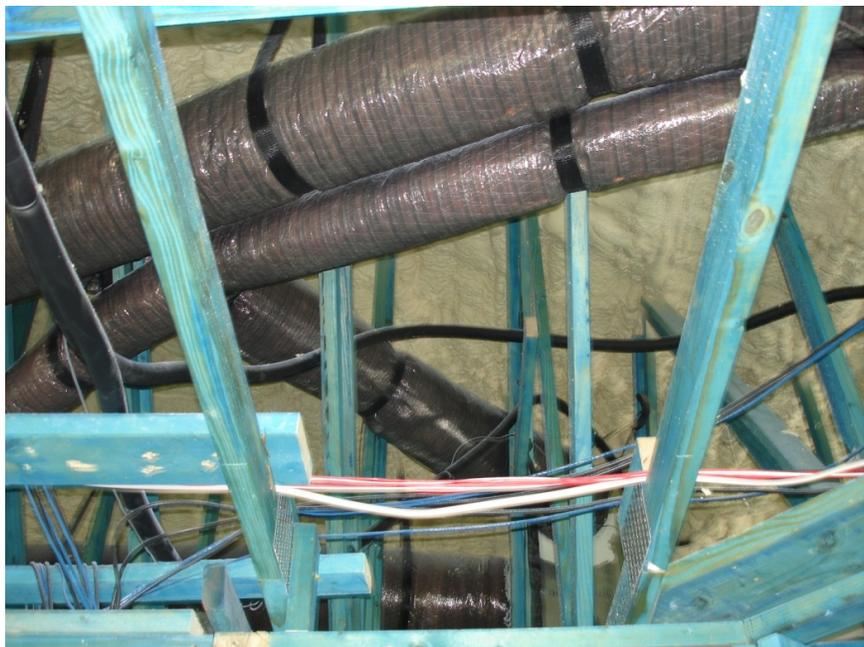
Figure 27. Photo of Attic Insulation Under Roof Deck

Another instance of missing insulation in the attic.

An alternate method of insulating the attic would be to insulate against the roof deck with closed cell foam. This practice provides a total air seal and thermal boundary that minimizes the extreme temperature effects on the air handling equipment and ductwork.

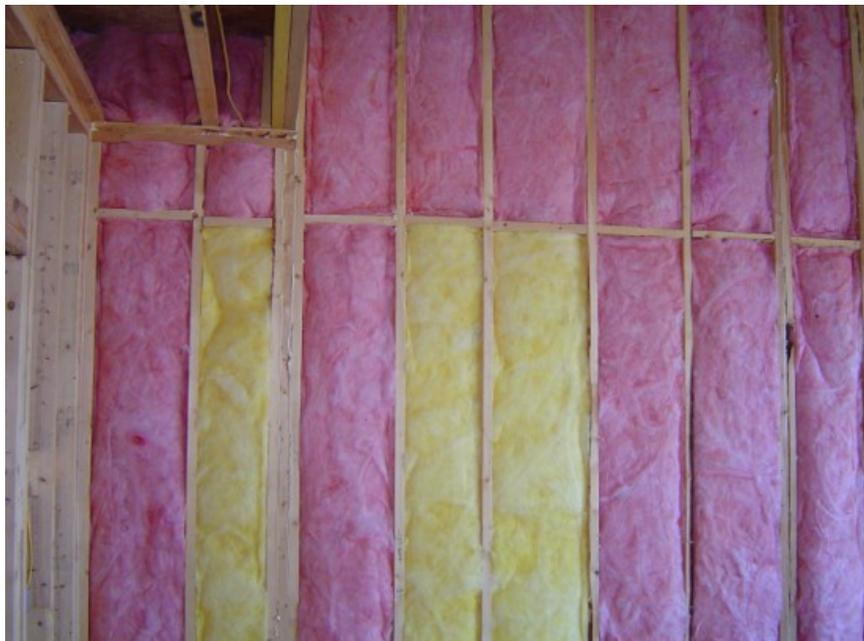
Figure 29. Photo of Proper Installation of Unfaced Batts

The use of Kraft-faced batts is not recommended for hot and humid climate regions. The use of unfaced batts is the better approach that will provide more drying capability to the wall assembly.

Use of fiberglass insulation without any vapor barrier allows the wall assembly to breathe and dry to the inside. Additionally, it is far easier to do a thorough installation with unfaced batts.

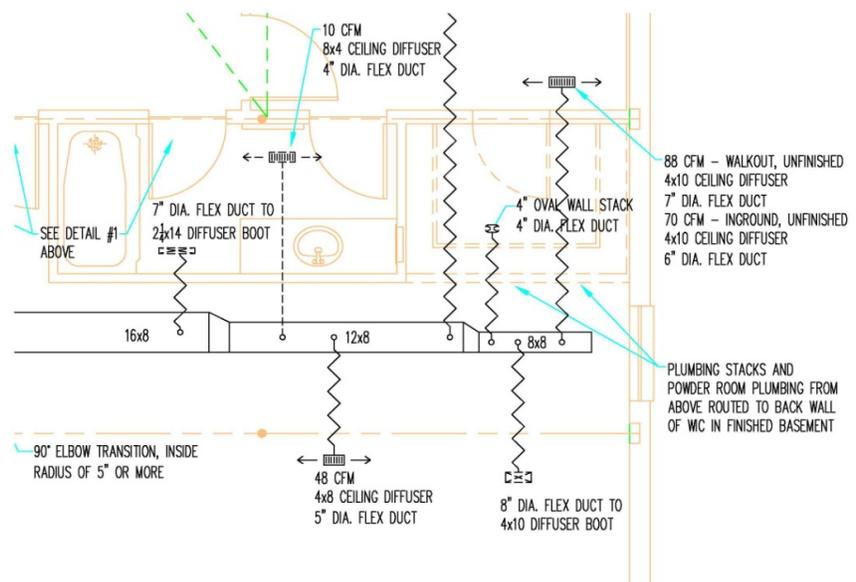
Figure 33. Diagram of Properly Sized Duct Systems

Many of the duct systems that were observed did not seem to have any definitive sizing strategy. Duct systems that use similar size branch ducts may not deliver the necessary air amounts to certain rooms. This practice may result in comfort and efficiency issues that a homeowner will compensate for by adjusting the thermostat.

Requiring the mechanical contractor to follow and submit the ACCA Manual D “Residential Duct Systems” procedure will help to ensure that required air flows to specific areas of the house are met. Manual D is a nationally-recognized standard for designing residential HVAC duct systems.

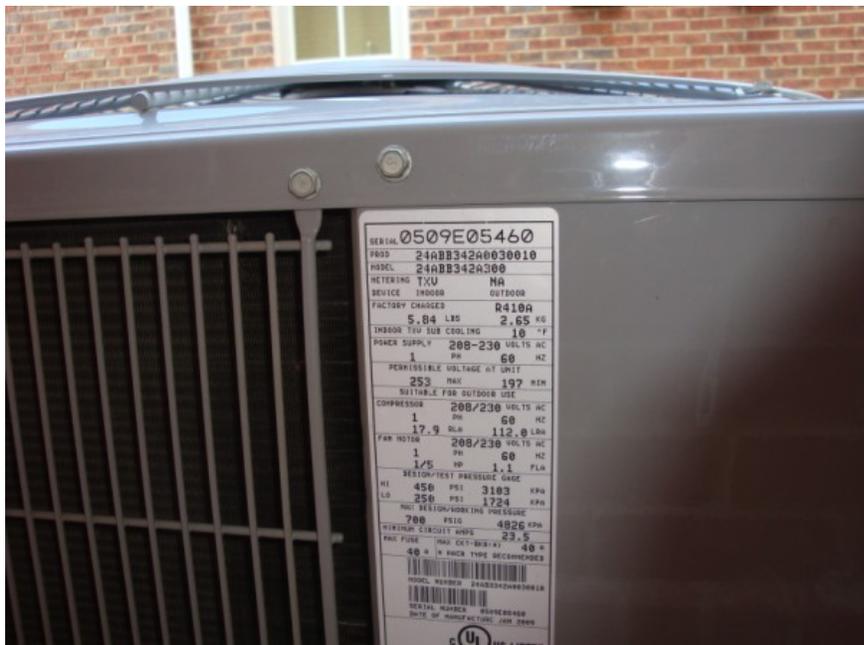
Figure 35. Photo of Properly Sized HVAC Equipment

Sizing of air handlers and cooling system should be verified to Manual J loads on each dwelling. This will maximize efficiency and allow better humidity control and comfort within the living spaces.

Utilizing protocols outlined in the ACCA Manual J “Residential Load Calculation” design guidelines will ensure the properly sized equipment will match the parameters of the home and result in optimum operation and long term performance.

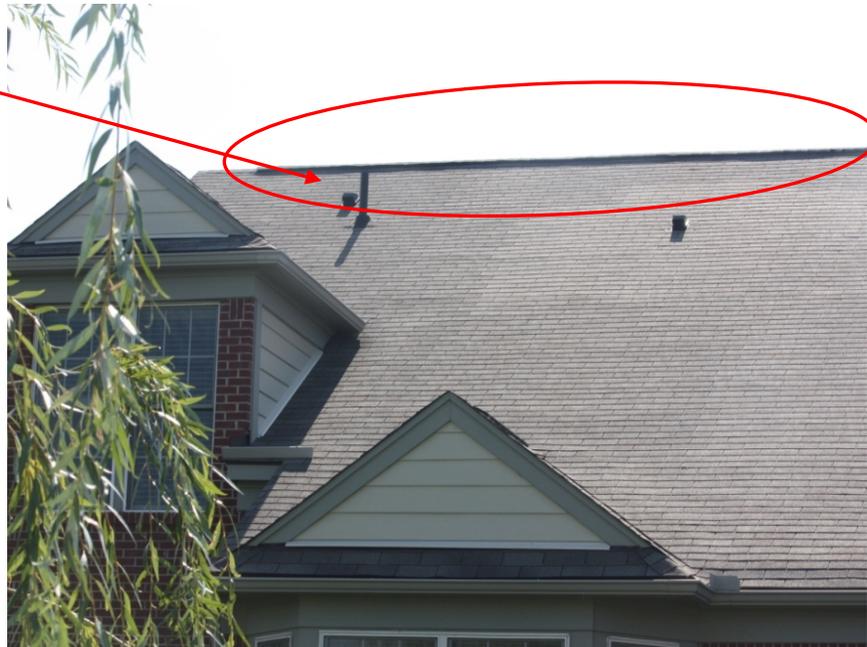
Figure 37. Photo Attic Ridge Venting

Concerns regarding attic exhaust fans exist due to the lack of a comprehensive and thorough air sealing between the attic and living space. Without a tight air barrier, the attic fan can pull conditioned air from the living space and induce air intrusion from outdoors.

Installing the appropriate soffit and either ridge or off ridge venting to remove excess heat from the attic is a better practice than the electric exhaust fan due to the impact on the living space that the fan can induce.

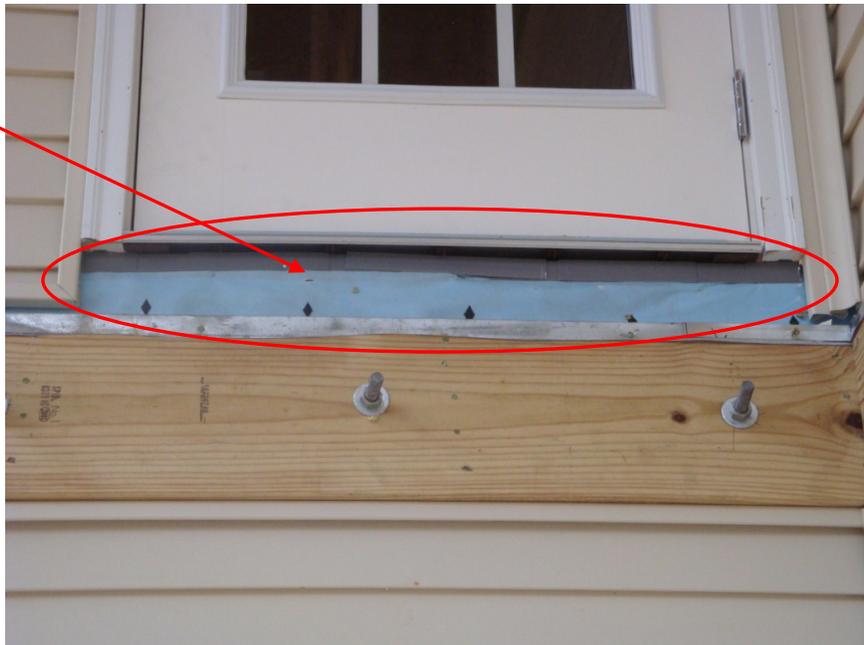
Figure 39. Photo of Proper Door Sill Flashing Installation

No comprehensive flashing strategy was observed at exterior entry doors. Standardizing a complete strategy that includes a pre-formed sill pan beneath the threshold and integrating the sill pan with self-stick flashing at the jambs and head will insure a weather tight assembly.

Example of a pre-formed sill pan beneath an entry door with the front lip extending out and over the drainage plane.

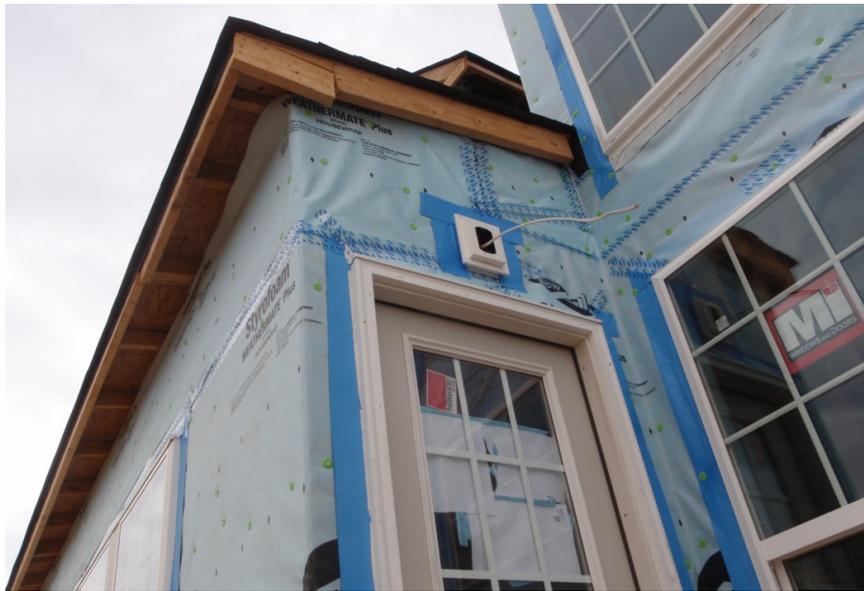
Figure 41. Photo of Proper Door Flashing Installation

No comprehensive flashing strategy was observed at entry doors.

Standardizing a flashing strategy for new door installations that includes a sill pan beneath the threshold and properly applied self-stick flashing and drip edge over the head will minimize any potential for water intrusion at doorways.

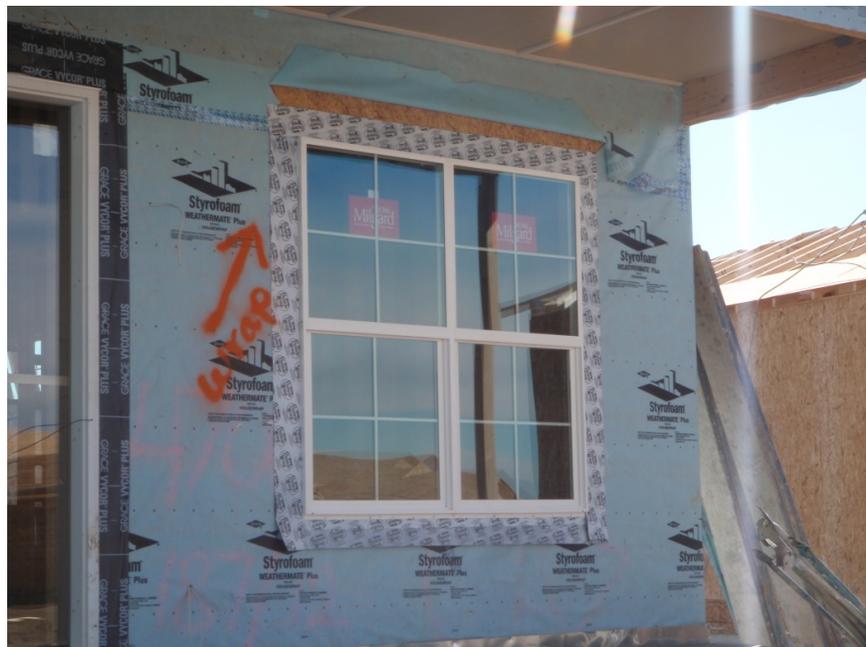
Figure 46. Photo of Proper Window Flashing Installation

Self-stick window flashing was observed on exposed windows. Often the flashing pieces were mis-lapped with one another and did not maintain the shingling effect.

Flashing should start at the sill with the side jamb pieces layering over the sill and the head over the jambs. Cutting 2 angle cuts in the house wrap at each corner of the head and creating a flap that can be folded over the flashing and taped is the best strategy at maintaining the shingling effect when flashing windows.

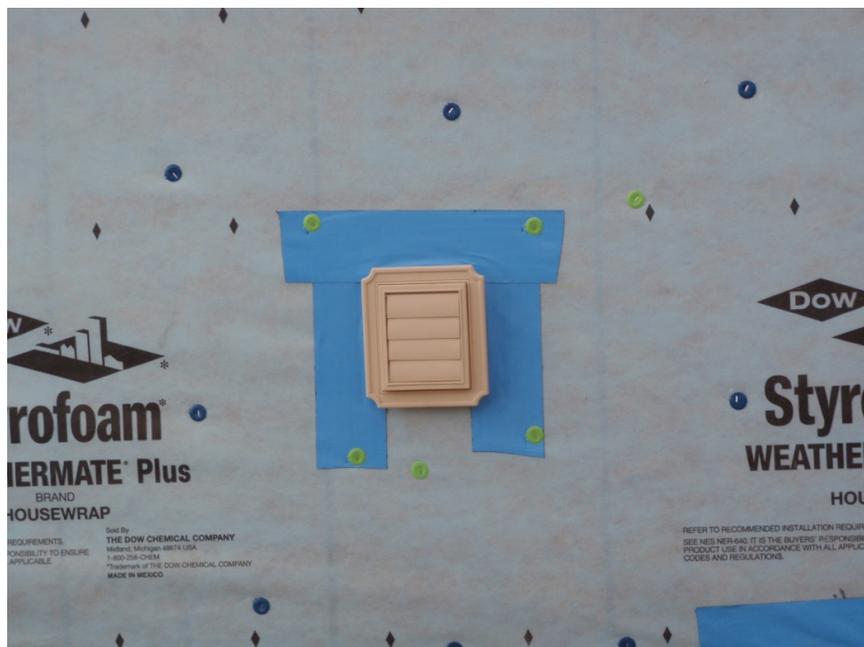
Figure 48. Photo of Properly Sealed Wall Penetration

Wire penetrations and decorative trim boxes are common leak points if not detailed correctly.

Utilizing self-stick flashing in the proper shingling sequence will minimize any potential for water intrusion at these locations.

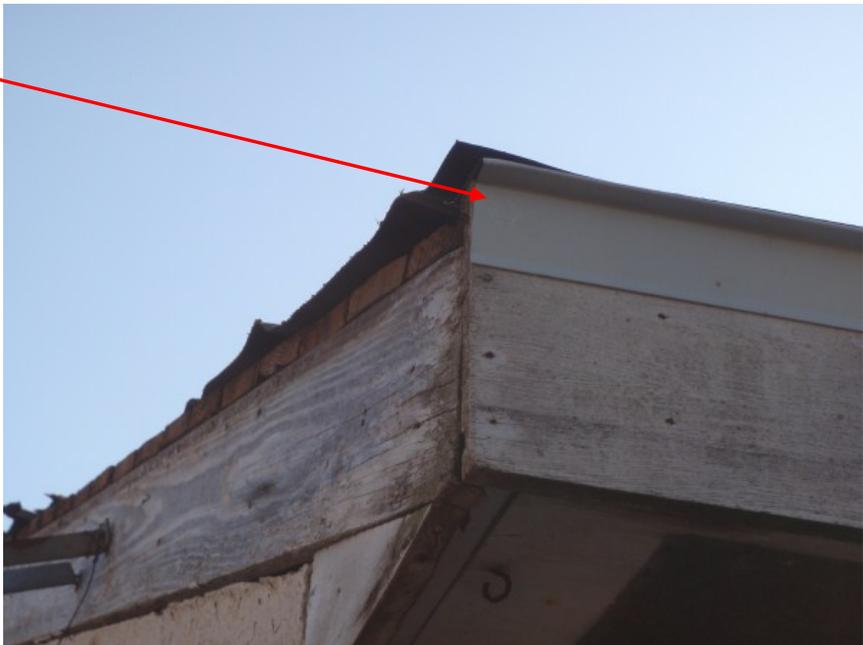
Figure 50. Photo of Properly Installed Drip Edge

Inconsistent practices were observed at drip edge applications at roof edges. The drip edge should be installed directly against the roof deck at the eave followed by the underlayment paper followed by the drip edges on the rakes. This layering sequence maintains the shingling effect to the gutters.

In this instance, the drip edge was installed correctly with the drip edge installed first at the eave and the underlayment over the edge followed by drip edge at the rakes.

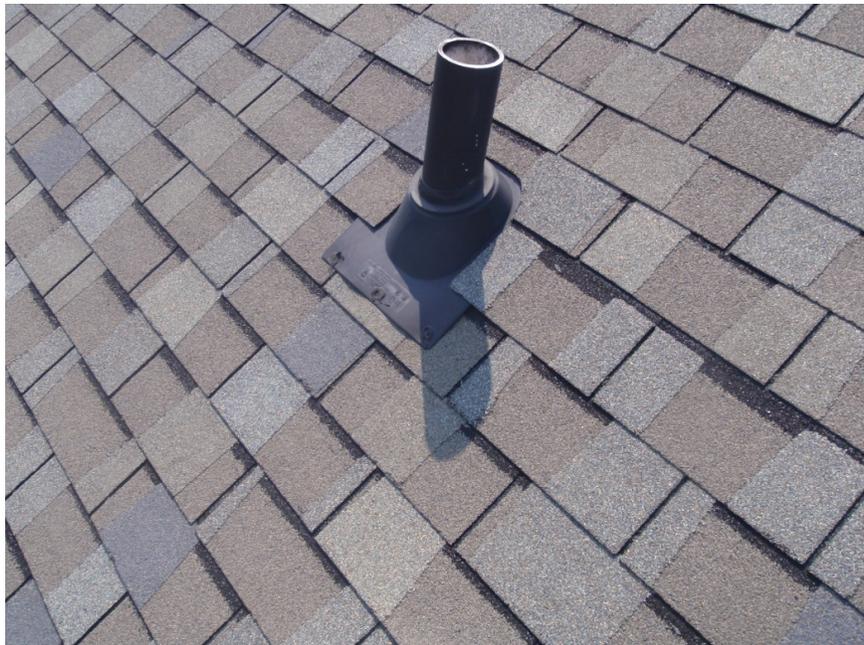
**Figure 52. Photo of Proper Roof Boot Installation**

Example of a proper installation. The lower part of the flange overlaps the lower shingles and the side and upper shingles overlap the flange.

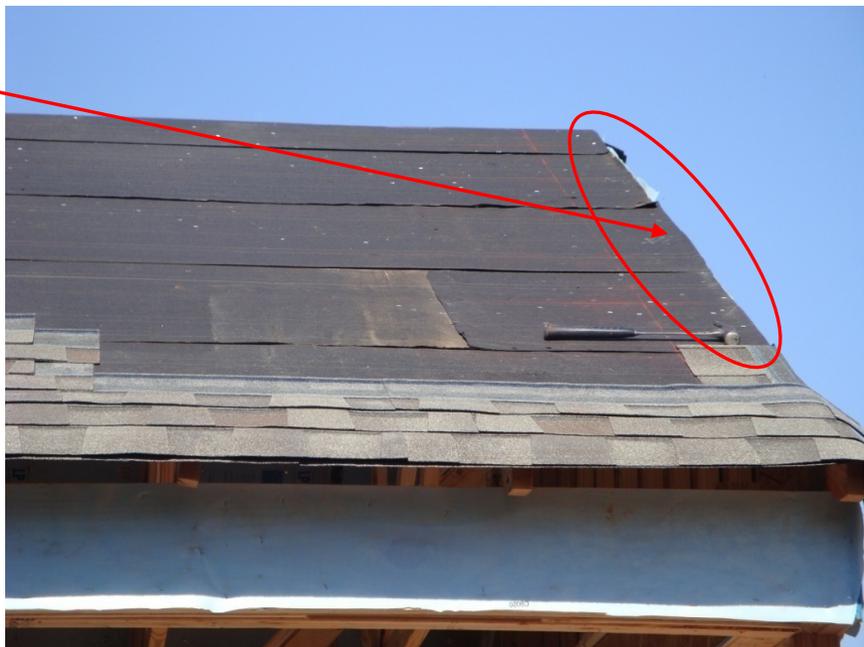
Figure 54. Photo of Proper Underlayment Installation at Roof Edge

When roofing practices were observed, the roofing paper underlayment did not completely cover the roof rake edges.

Running each course of building paper all the way to the rake edges is the best practice.

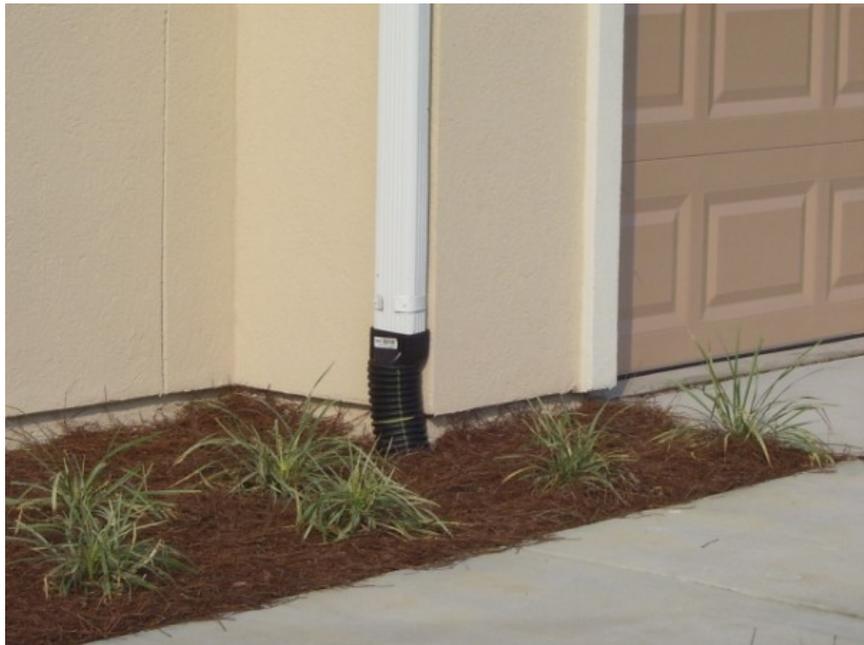
**Figure 56. Photo of Effective Roof Drainage Discharge**

In many instances, gutter downspouts deposit bulk water from the roof next to foundations.

The best way to eliminate any potential moisture issues at the foundation is to direct water from downspouts to a yard bubbler or sump pit in the yard.

If that is not feasible, at a minimum, taking the time to properly position splashblocks at downspouts so as to direct bulk water away is recommended.

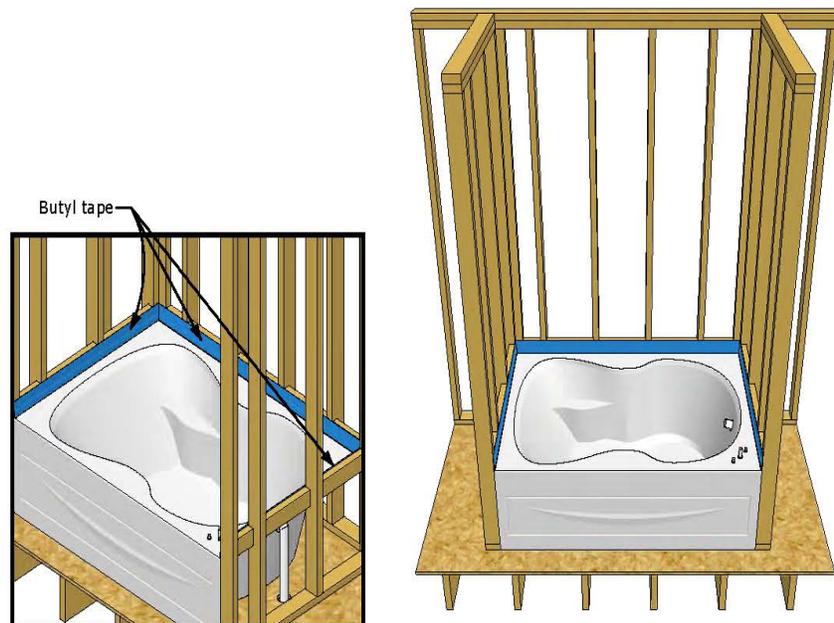
Figures 60 and 61. Illustrations of Proper Tub Surround Flashing

No comprehensive flashing strategy was observed at the nailing fin of tub and shower units. In most cases the wall board was installed directly upon the unit. This detail will eventually deteriorate due to the wicking ability of the gypsum based backer board.

Install 4” butyl flashing over the nailing fin of the tub unit and stick to the installed blocking. Installing a 4” butyl tape over the tub/shower nailing fin to the surrounding framing can prevent water from getting into the wall cavity.

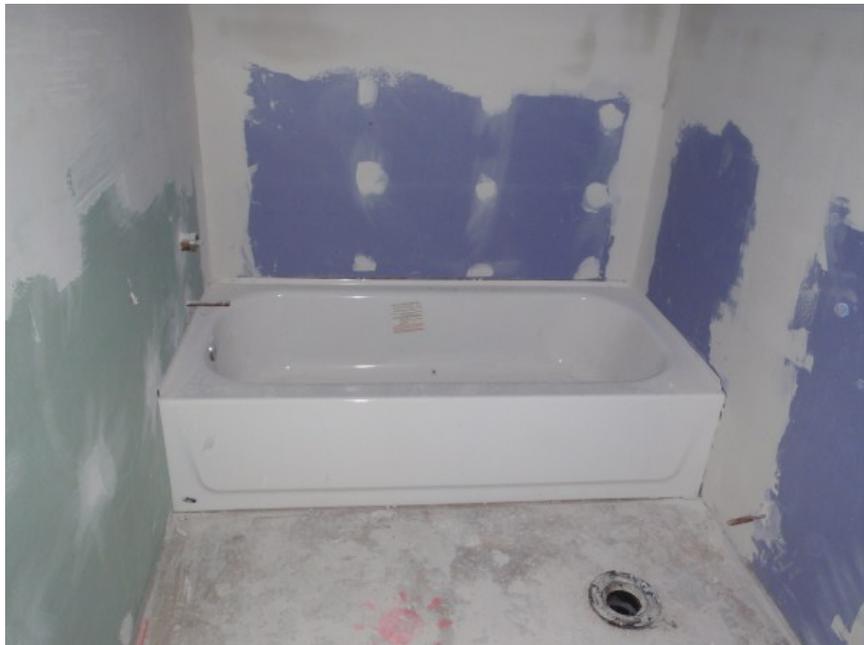
Figure 63. Photo of Proper Back Board Installation

In this instance the backer board was held up and installed on the top edge of the fin. This practice is acceptable as long as the previously described flashing detail is carried out.
