Leveraging Limited Scope for Maximum Benefit in Occupied Renovation of Uninsulated Cold Climate Multifamily Housing

K. Neuhauser, D. Bergey, and R. Osser
Building Science Corporation

March 2012

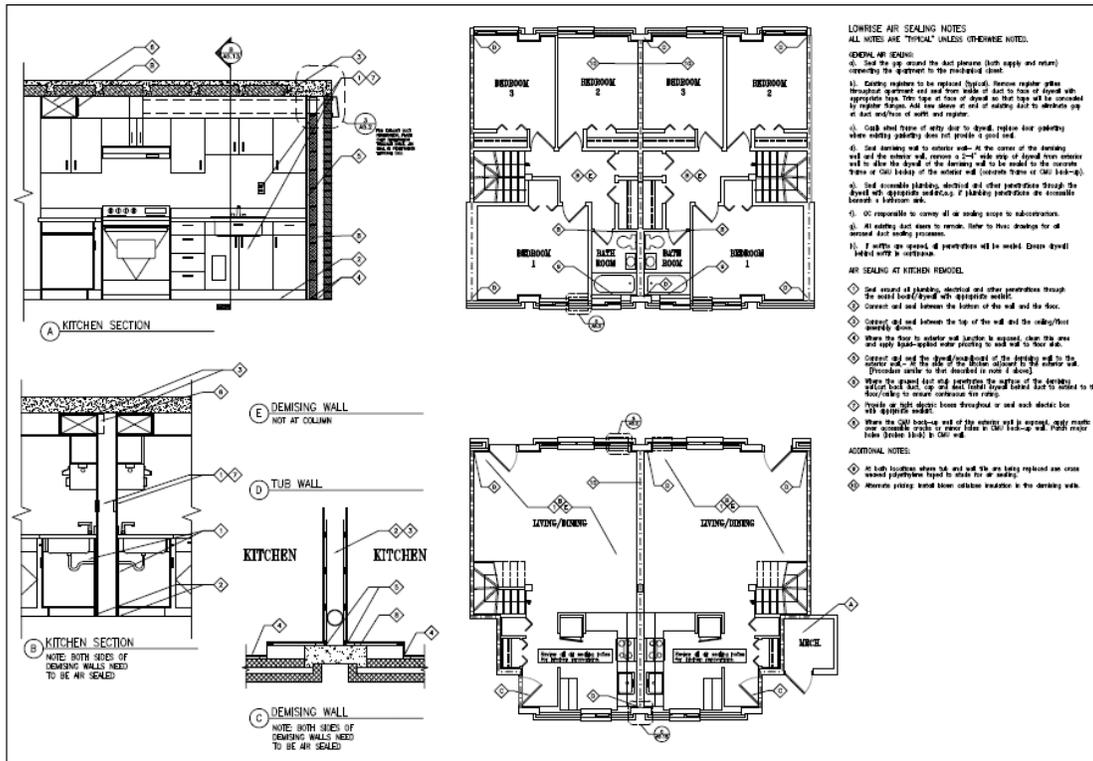
Figure 10. Air sealing scope in construction drawings.

The architect conveyed this air sealing scope in construction drawings reserved exclusively for air sealing details (see Figure 10). In addition to the explicit air sealing scope, other scopes of work impacted air leakage control. The window details in particular were developed to provide robust air leakage control. The air sealing objectives were also reinforced throughout the project specification. BSC and the architect wrote a performance testing quality assurance protocol that was written into the project specifications (see Appendix B). The owner's representative also

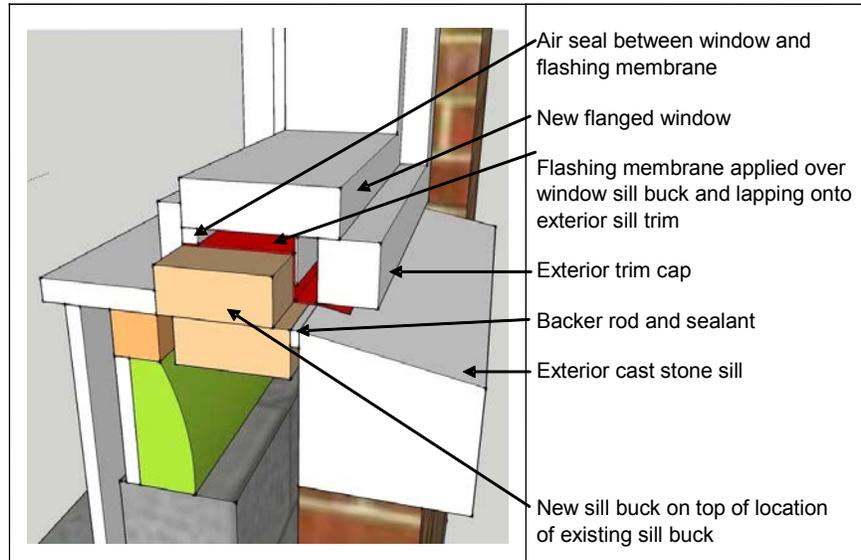
Figure 12. Early schematic detail for low-rise window replacement

BSC provided comment and review of architectural details, including those for the window. As details evolved in the course of the design process, BSC provided technical guidance to ensure that critical control functions were evinced in the details.

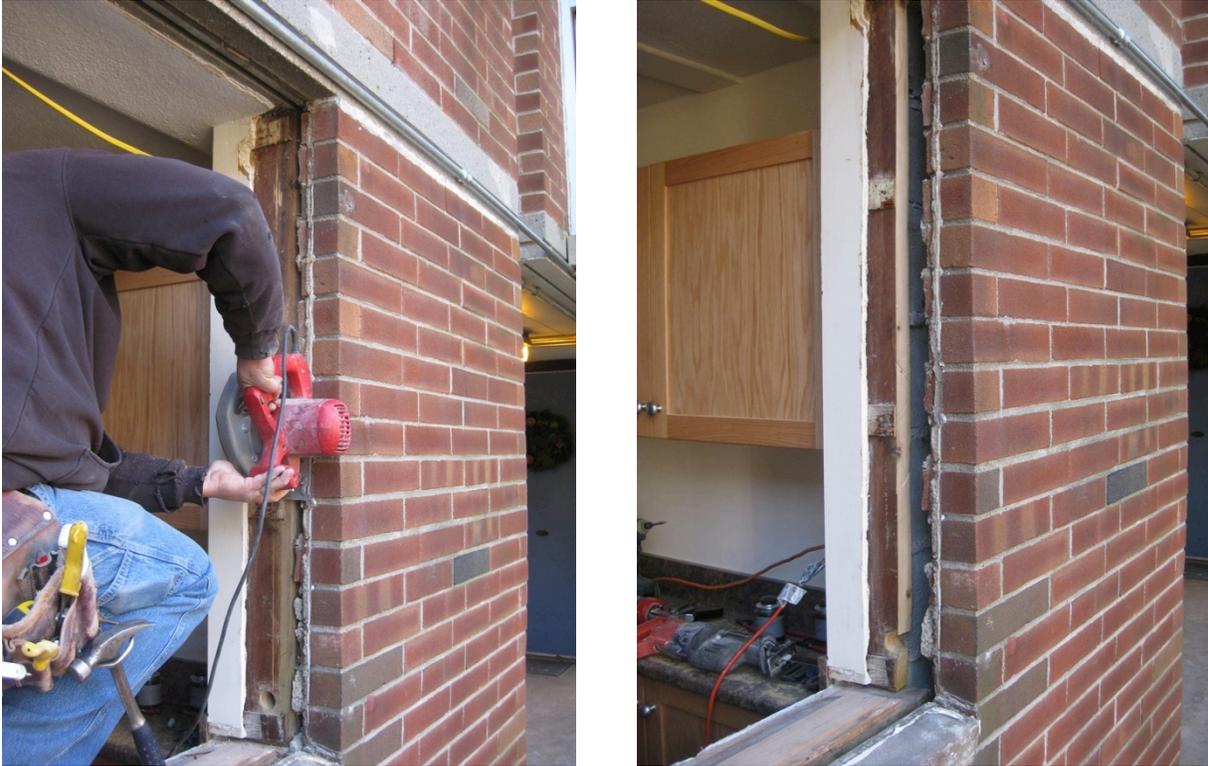
The window installation details in the construction bid documents called for drilling the wood bucks at regular intervals and injecting a foam sealant into the gap. This was a less-than-desirable solution because it did not offer the opportunity to visually verify a continuous seal. The window installation subcontractors devised and demonstrated an alternate approach involving cutting the wood bucks to allow access to the gap to be sealed. The wood buck is cut approximately flush with the face of the CMU backup wall. The gap between the wood buck and the CMU opening is then accessible through the cavity between the brick and the CMU.

Figure 13. Left: Wood jamb buck being cut to allow access to joint between buck and masonry opening; Right: Wood jamb buck cut showing both working and visual access to the gap to be sealed.

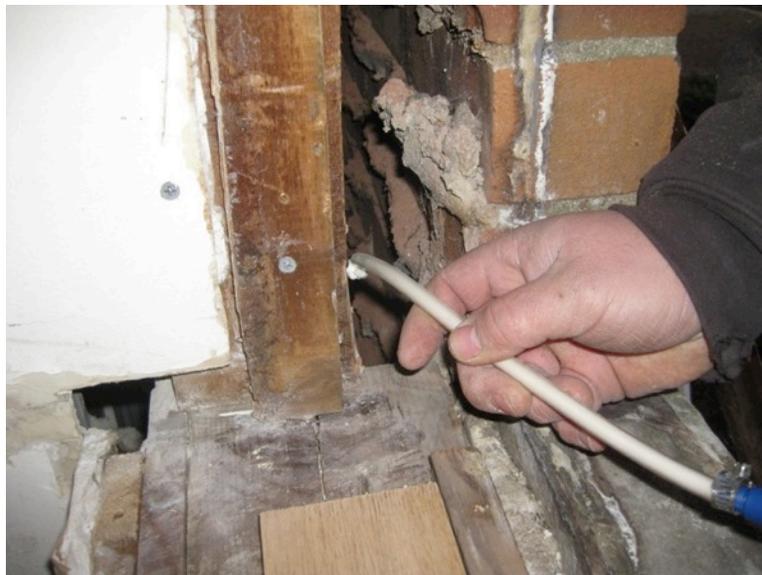
Figure 14. Foam sealant being applied between off-cut wood buck and CMU

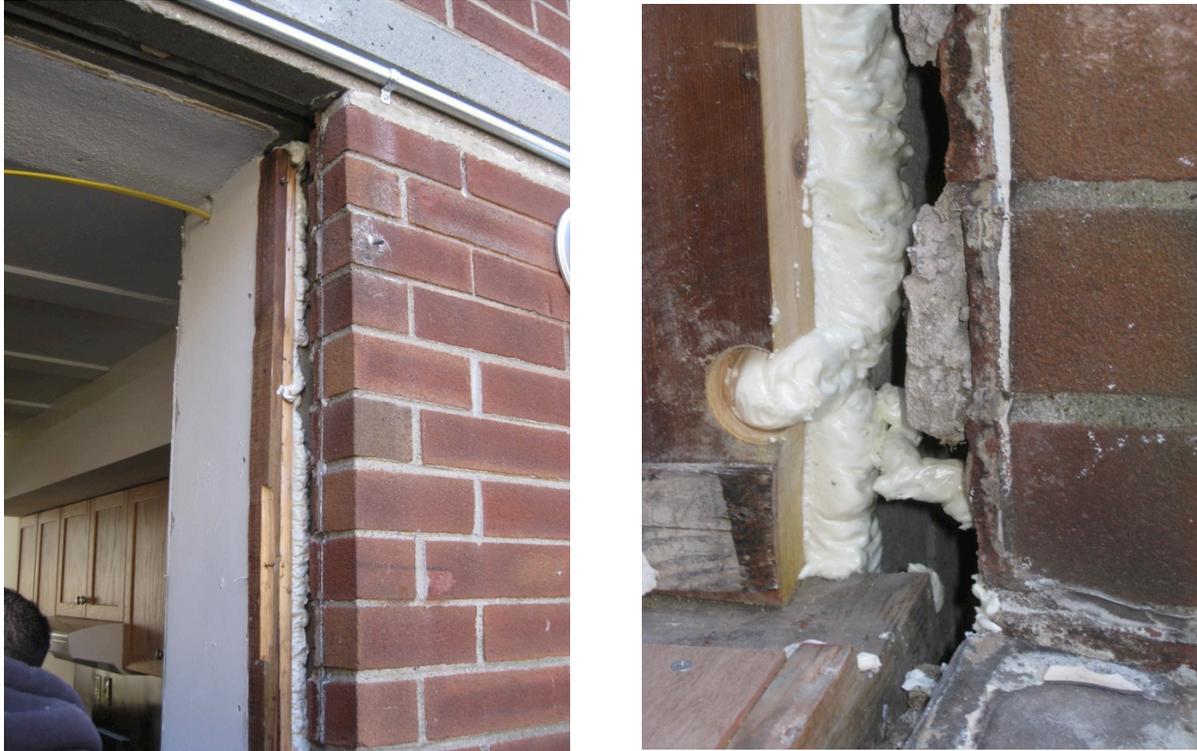
Figure 15. Left: Visual access enables verification of seal between buck and masonry opening; Right: Foam sealant in gap between wood buck and CMU backup wall.

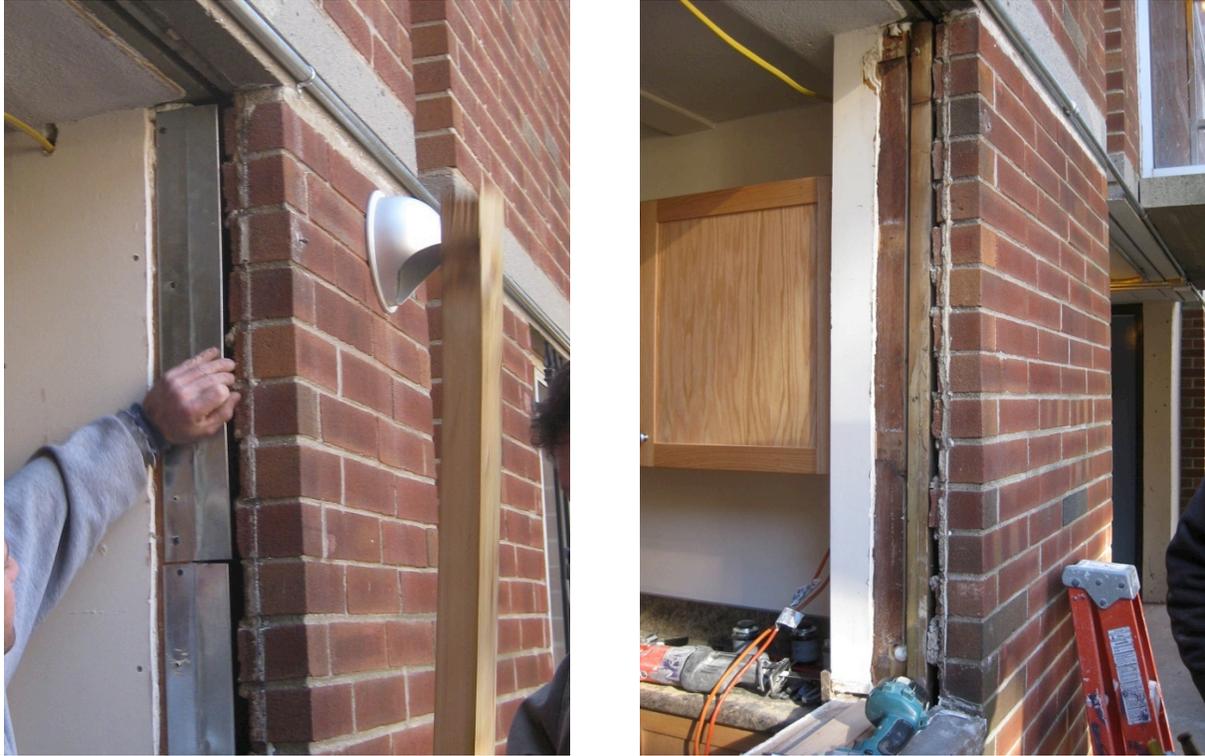
When the wood buck was cut away approximately flush with the face of the CMU backup wall, it left a significant gap between the buck and the brick. The window unit covers this gap, but a jamb flashing is needed at the jamb of the opening. Therefore, a substrate for the jamb flashing was needed to allow this flashing to bridge the cavity between the CMU backup wall and the brick. A piece of metal coil stock was used in the first mock-up unit window installation. Subsequently, the window installation subcontractor demonstrated that the off-cut of the wood buck could be reattached as a substrate for the jamb flashing membrane provided that the application of foam sealant at the jamb buck was not excessive.

Figure 16. Left: Metal coil stock support for jamb flashing between wood buck and brick return; Right: Wood buck off-cut reattached as jamb flashing support.

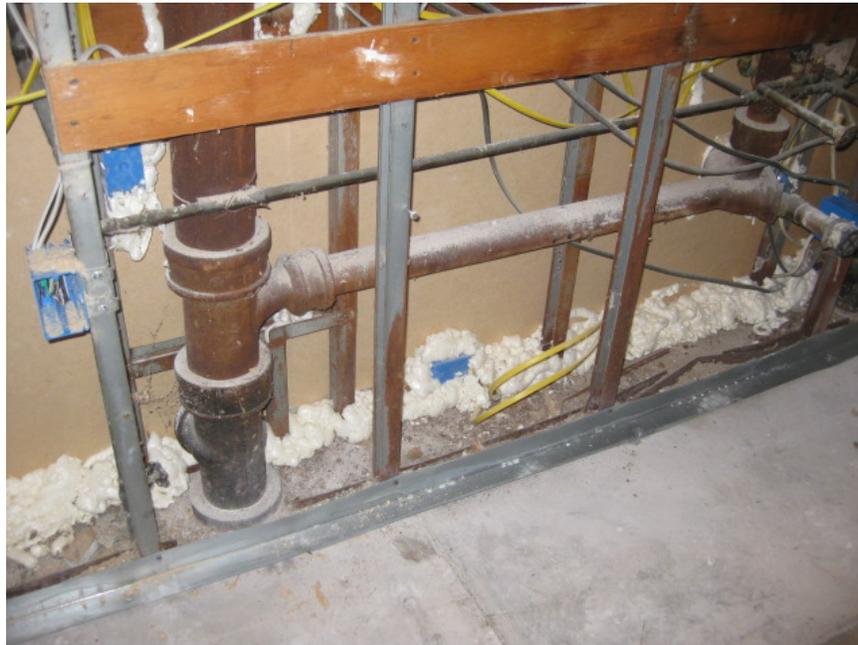
The drywall subcontractor and the general contractor identified an opportunity afforded by the sequence of the renovation work. Because one side of the demising wall at the kitchen is opened shortly after the wall on the other side of the wall is refinished, there is an opportunity to thoroughly seal the demising wall from the open side of the wall. This enabled better visual confirmation of the sealing work. The sealing sequence also made it possible for the contractor to seal the demising wall to the exterior wall without cutting the drywall of the exterior wall, as had been indicated in the architectural air sealing drawings.

Figure 21. Demising wall at kitchen air sealed from open side of wall.

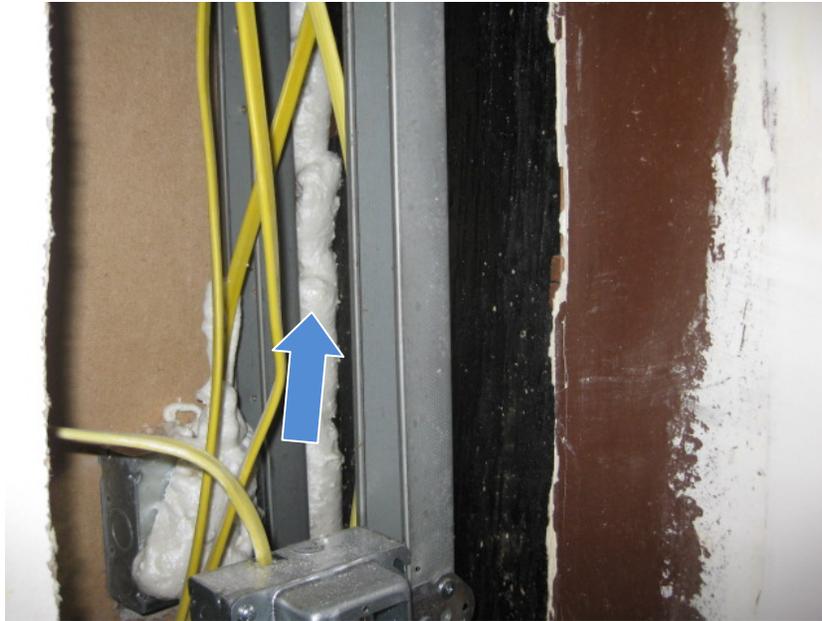
Figure 22. Airflow control connection between drywall and exterior wall achieved through open side of wall.

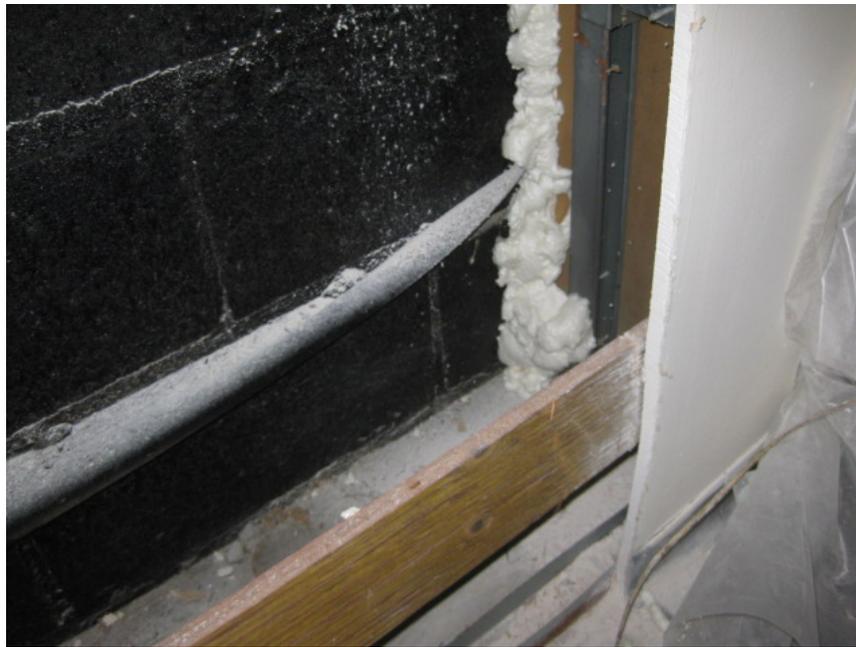
For the exterior wall assembly of the Castle Square low-rise apartments, the primary airflow control layer is the CMU wall and concrete frame. The interior face of these elements is coated with an asphaltic damp proofing material that is presumed to render the CMU a reasonable air barrier. If it is clearly communicated to the air sealing contractor that the back of the CMU wall is the primary airflow control layer, the contractor is more likely to understand that the proper method of sealing the exhaust duct penetration is to cut away the exterior wall drywall to allow access to the duct penetration through the CMU layer.

Figure 24. Inside of CMU layer in exterior wall. Note dampproof coating and through-wall flashing

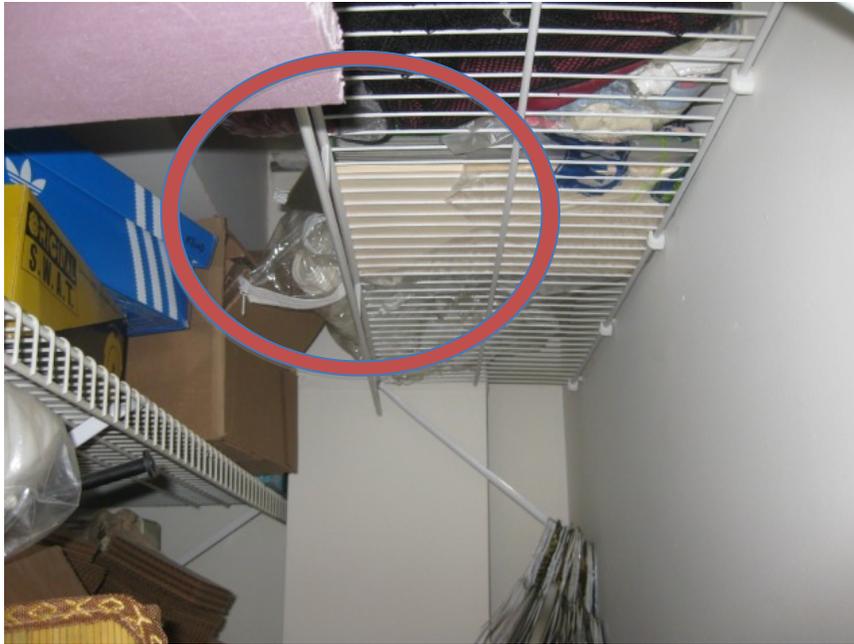
The opening observed at the intersection of the duct riser and duct soffit (see Figure 18 and Figure 19) provides an example of how variations in the building construction would impact the construction crews' ability to implement effective air sealing. Figure 19 shows a wide berth between the duct riser and the sidewall of the closet. This provided room for the drywall subcontractor to install a drywall patch to close the face of the duct soffit. In other apartments, it was observed that the space between the duct riser and sidewall was approximately 1 in., thus making the drywall patch remediation impossible. In unit 18B of Building 16, which is an end-unit apartment, this connection between the duct riser and duct soffit occurs at the back of a narrow closet rather than at the side of a wide and easily accessible closet. As shown in Figure 26, access to this connection is constrained by the geometry of the closet and by tenant belongings.

Figure 26. Duct riser to duct soffit connection at the back of a narrow closet in end-unit apartments.

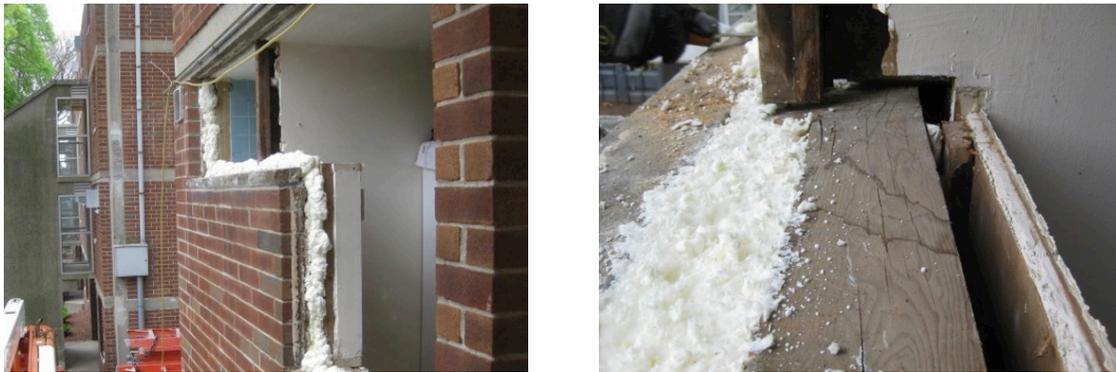
Figure 28. Left: Expanding foam sealant installed to bridge the cavity between the brick and the CMU; Right: Expanding foam sealant trimmed to provide substrate for flashing membrane.

The risks inherent in this approach are twofold. First, there is no opportunity to visually verify the air seal at the critical juncture, that is, between the CMU opening and the wood bucks. Second, where the foam sealant bridges the brick cavity, this could lead to the mistaken interpretation by subsequent installation crews that the brick is the airflow control layer. With the weep holes and generally porous nature of the brick, it is not an air barrier component.

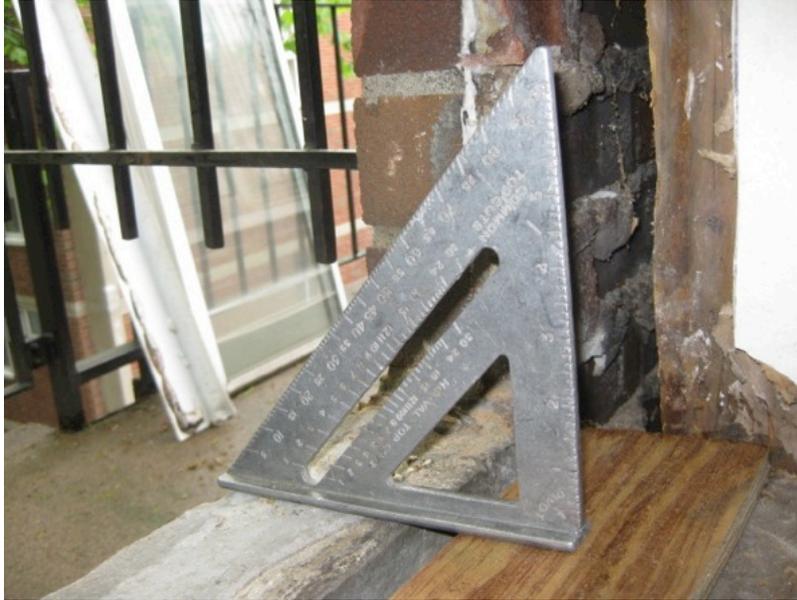
At the first apartment where windows were installed as part of the regular construction process, problems with the size of the window became apparent. Although the windows fit within the rough openings given by the existing wood bucks, the height of the stone sill at the exterior relative to the height of the sill buck varies. For the sill flashing to be above exterior sill trim and/or slope onto the exterior sill trim, the window openings require varying amounts (heights) of blocking at the sill. Because of the tight tolerances of the window size relative to the rough opening, the window installers were not always able to install sufficient blocking to raise the sill flashing above the exterior trim (see Figure 29 and Figure 30).

Figure 29. Sill blocking even with height of exterior sill prior to installation of exterior sill trim piece.

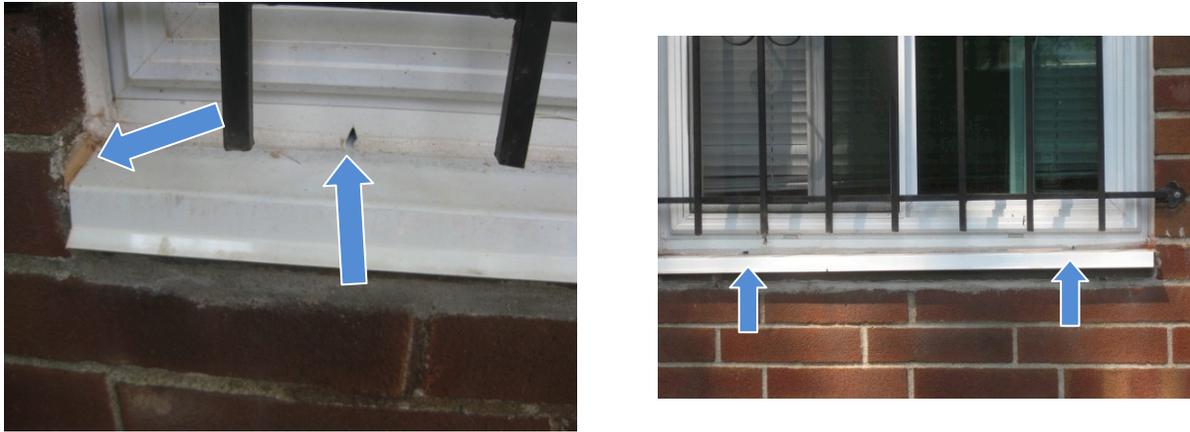
Figure 34. Left: Sealant joint between sill aluminum sill trim and brick, and “V” cut weep notched into sill trim closure; Right: Weep holes at $\frac{1}{4}$ points of the sill closure trim.

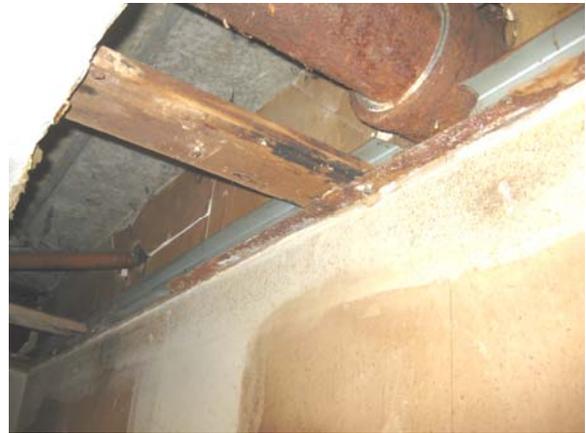
Figure 2: Soffit above kitchen

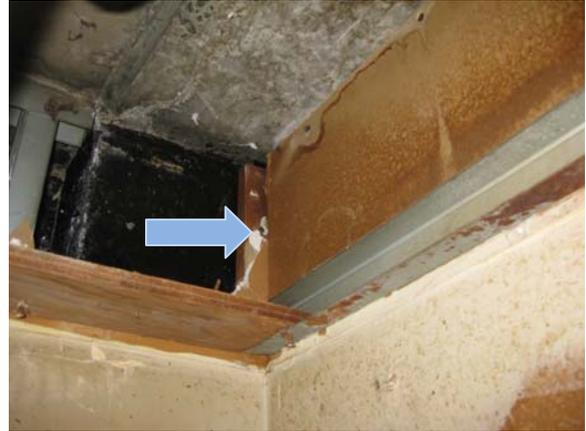
A gap at this intersection was evident in the kitchen soffit (see **Figure 4**). A piece of wood strapping is fastened to the wall at this location. Sealing the demising to the exterior wall will require 1) sealing the demising wall to the strapping and 2) sealing the strapping to the demising wall.

Figure 4: Intersection of demising wall and exterior wall structure in kitchen soffit

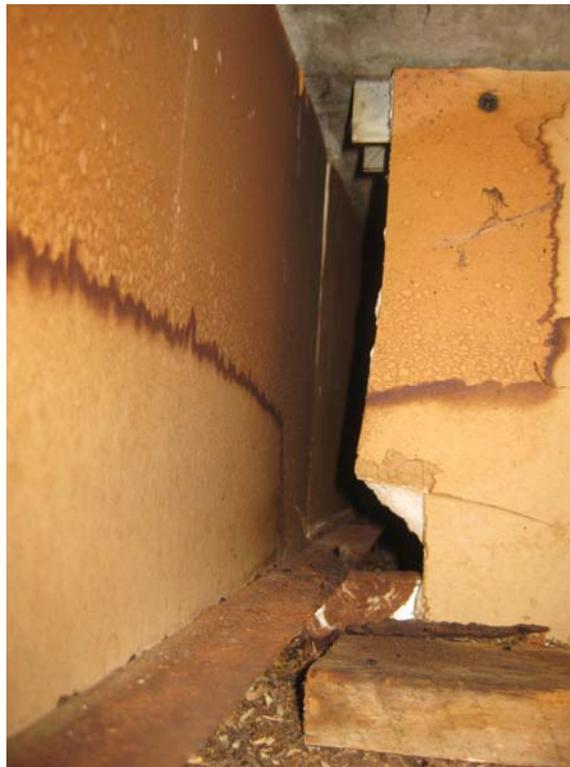
The duct soffit that runs perpendicular to the demising wall was not opened at the time of my visit. From the vantage point of the kitchen soffit, it was not apparent to me whether or not the duct stub penetrates the demising wall. Regardless of whether the duct penetrates the surface of the demising wall, it will be important to open this soffit to seal openings into the demising wall at this location.

Figure 5: View from kitchen soffit (demolished) into perpendicular soffit containing supply duct

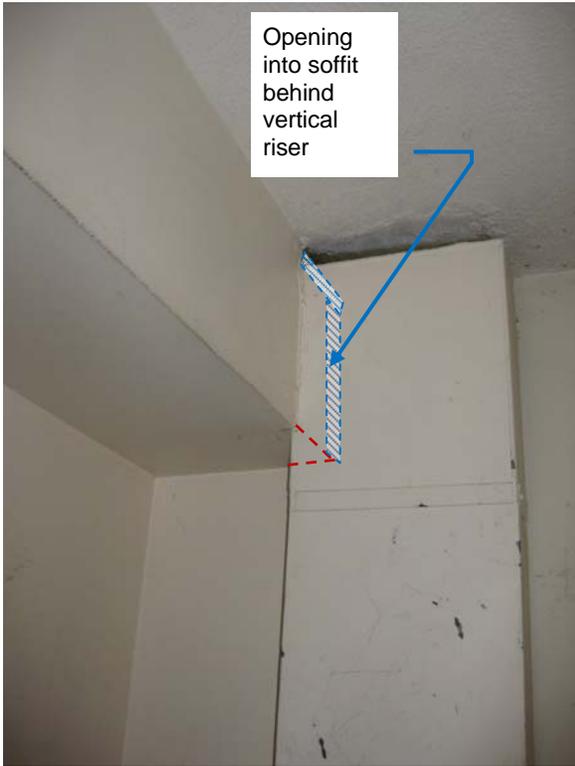
This note refers to the opening into the duct soffit found adjacent to the connection with the vertical duct riser that is exposed in a second floor closet. In the previous mock-up unit, access to the approximately inch-wide gap was very constrained. The position of the vertical duct relative to the bathroom partition wall in the present mock up unit provides for a more easily feasible closure of this gap.

Figure 6: Opening into soffit at second floor of previous low-rise mock-up apartment
