Structural Testing of the Blade Reliability Collaborative Effect of Defect Wind Turbine Blades

M. Desmond and S. Hughes
National Renewable Energy Laboratory

Technical Report
NREL/TP-5000-63512
June 2015

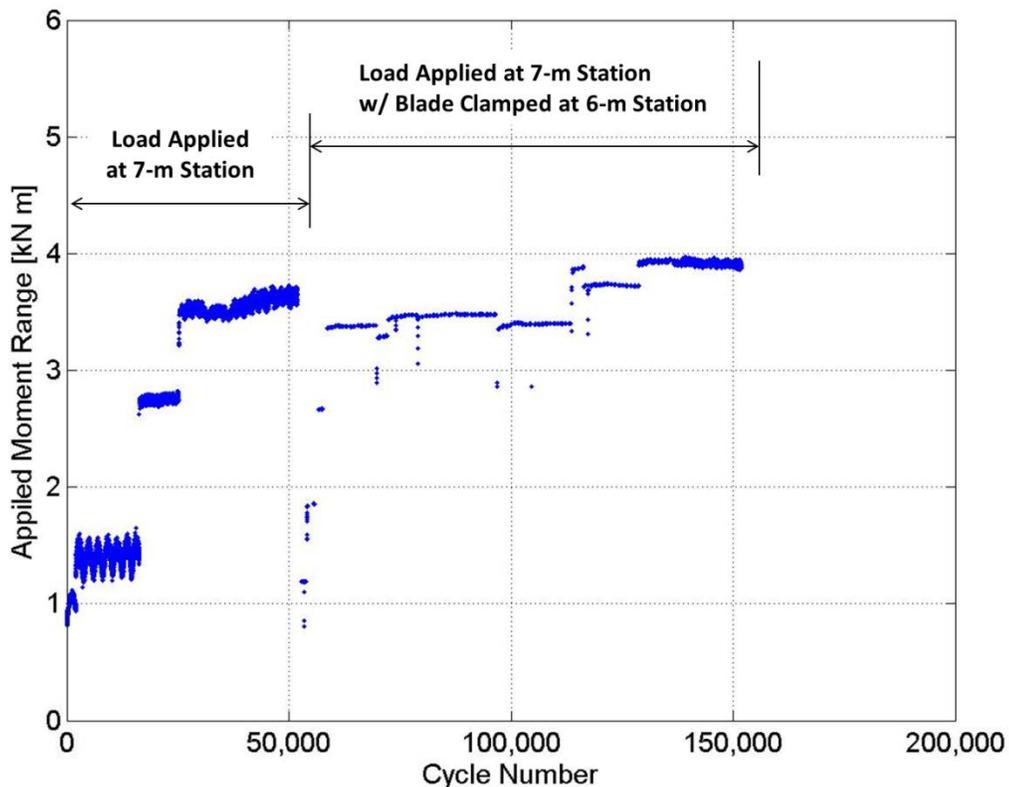
Figure 21. Moment range versus cycle number at the 6.2-m station, carbon fiber spar cap blade

The carbon fiber spar cap blade was cut at the 7.1-m station, with the blade cavity filled with epoxy, to directly attach the actuator to apply the outboard load case at the 7-m station. The first load block applied a cyclic load with a maximum load of 1.4 kN and a minimum load of 0.1 kN. The maximum and minimum loads were increased over 10 different load blocks encompassing 154,546 test cycles, with the final load block applying a maximum cyclic load of 5.1 kN and a minimum load of 0.5 kN. The blade was then clamped at the 6-m station for several load blocks because the required test displacement exceeded the displacement capacity of the actuator. Test loads were applied at frequencies ranging between 0.8 and 1.0 Hz. Fatigue loading continued until a blade failure occurred on the low-pressure surface at the 6.2-m station. Figure 21 shows the test bending moment range applied to the 6.2-m station for all load blocks applied at the 7-m station.

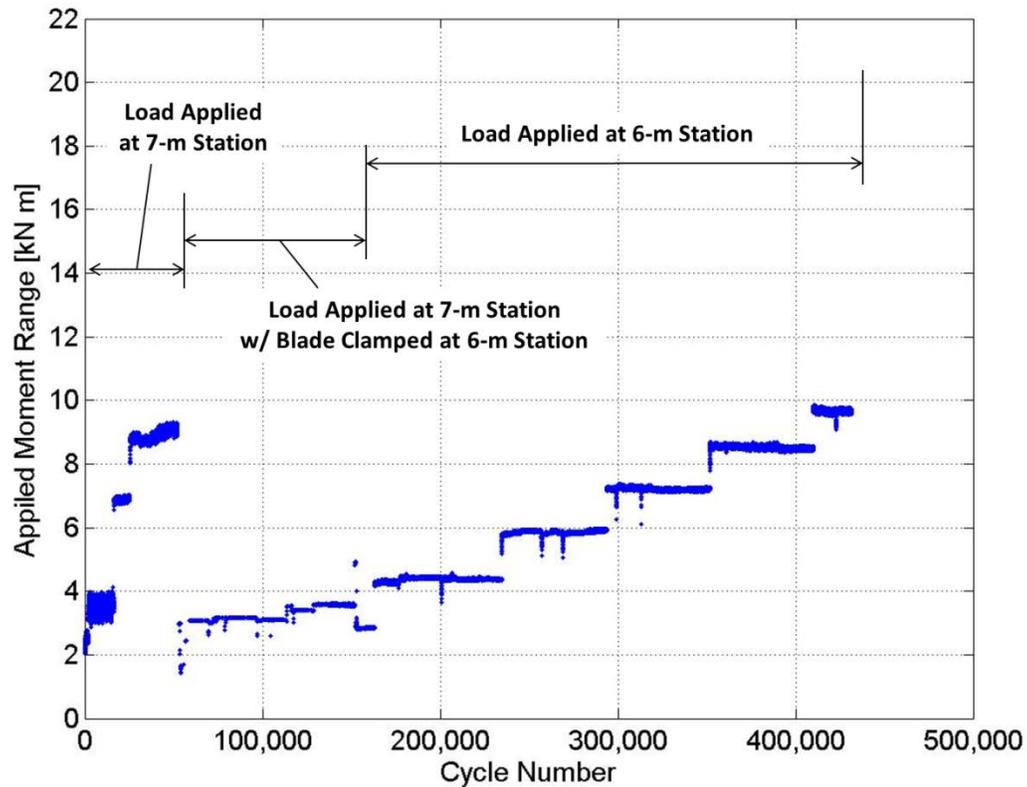
Figure 23. Moment range versus cycle number at the 5-m station, carbon fiber spar cap blade

After the blade failed at the 6.2-m station, the blade tip was cut from the blade and the test was configured to apply loads at the 6-m station for the midspan load case. A load saddle was attached to the blade for applying actuator loads. During the midspan load case, the blade was subjected to a total of 278,913 test cycles. Loads were applied with a test cycle frequency of 0.75 Hz. The amplitude of the actuator force for the mid-span load blocks ranged from an initial range of 3.2 kN maximum and 0.3 kN minimum to the final load block that applied loads of 11.2 kN maximum and 1.1 kN minimum. DIC imaging was not performed during loading at the 6-m station. The blade failed during the final load block on the low-pressure surface at the 5-m station. Figure 23 shows the test bending moment range applied at the 5-m station, including loads applied at both the 6-m and 7-m stations. The total cycle count including load cases applied at both the 6-m and 7-m stations was 433,459 cycles.

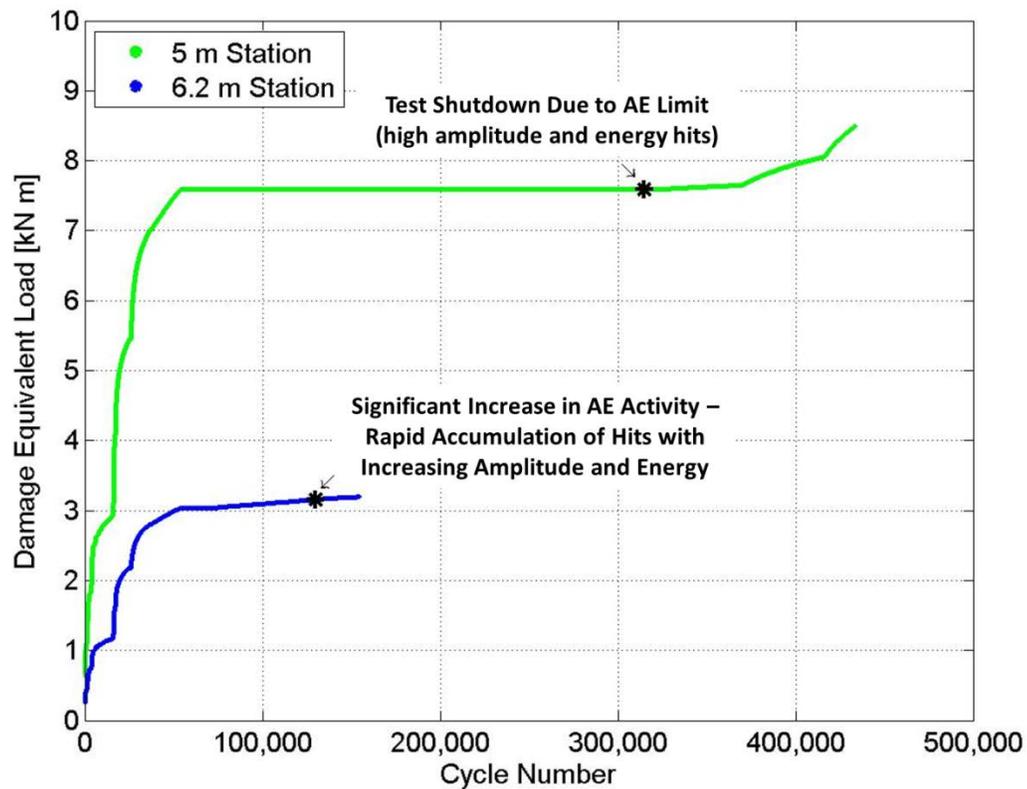
Figure 25. Carbon fiber spar cap blade, DEL curves at failure stations of 5 m and 6.2 m

Figure 25 provides the DEL at each of the failure stations for testing the carbon fiber spar cap blade. The DEL as shown includes all test moments applied at the respective station from all load cases and load blocks. The figure also indicates where notable observations were made from the AE, thermography, and DIC systems. Similar to the fiberglass spar cap blade, AE activity was seen to increase prior to detecting damage by visible observation. One interesting difference was that the number of AE hits observed during the carbon fiber spar cap blade was an order of magnitude less than the hits observed during the fiberglass spar cap blade test. This difference may suggest that the damage to the embedded defects in the carbon fiber spar cap blade were more abrupt and progressed faster than damage to the embedded defects in the fiberglass spar cap blade.

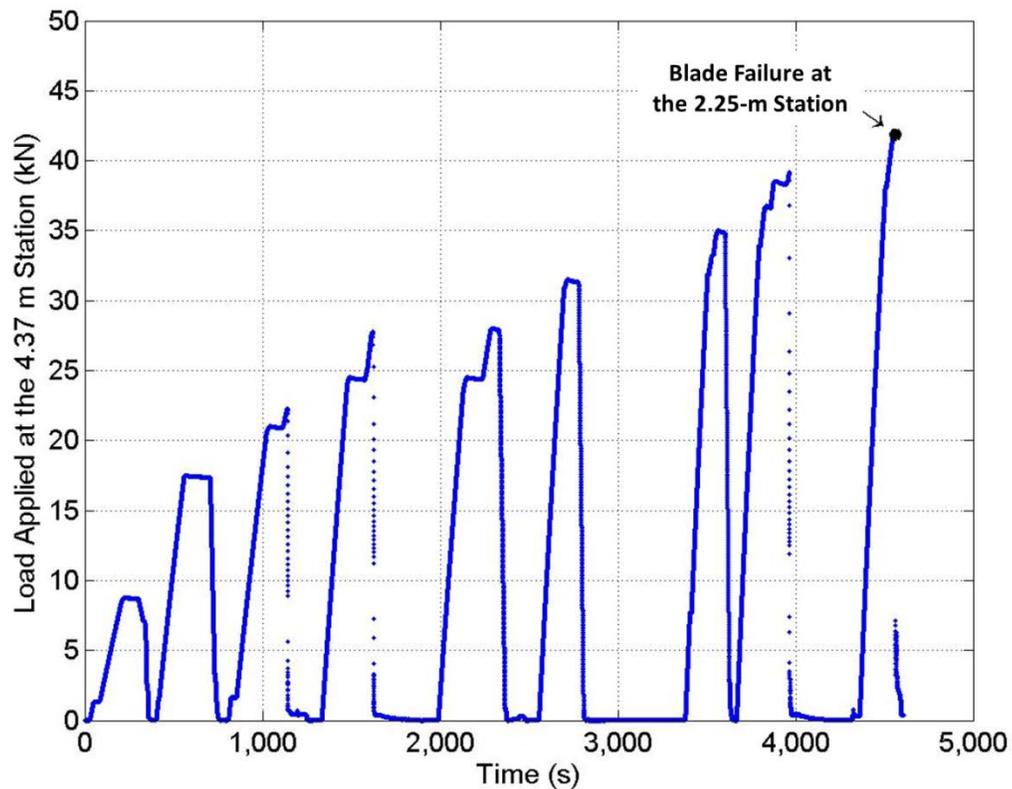
Figure 26. Static load steps applied at the 4.37-m station, carbon spar cap blade

Following completion of the midspan fatigue load case, it was determined that a static load to failure would be conducted on the inboard span of the blade using a single point-load applied at the 4.37-m station. The load was applied by a hydraulic actuator in discrete load steps until a catastrophic failure occurred on the low-pressure surface of the blade at the 2.25-m station. Figure 26 shows the force versus time data for each of the static load steps up to failure.

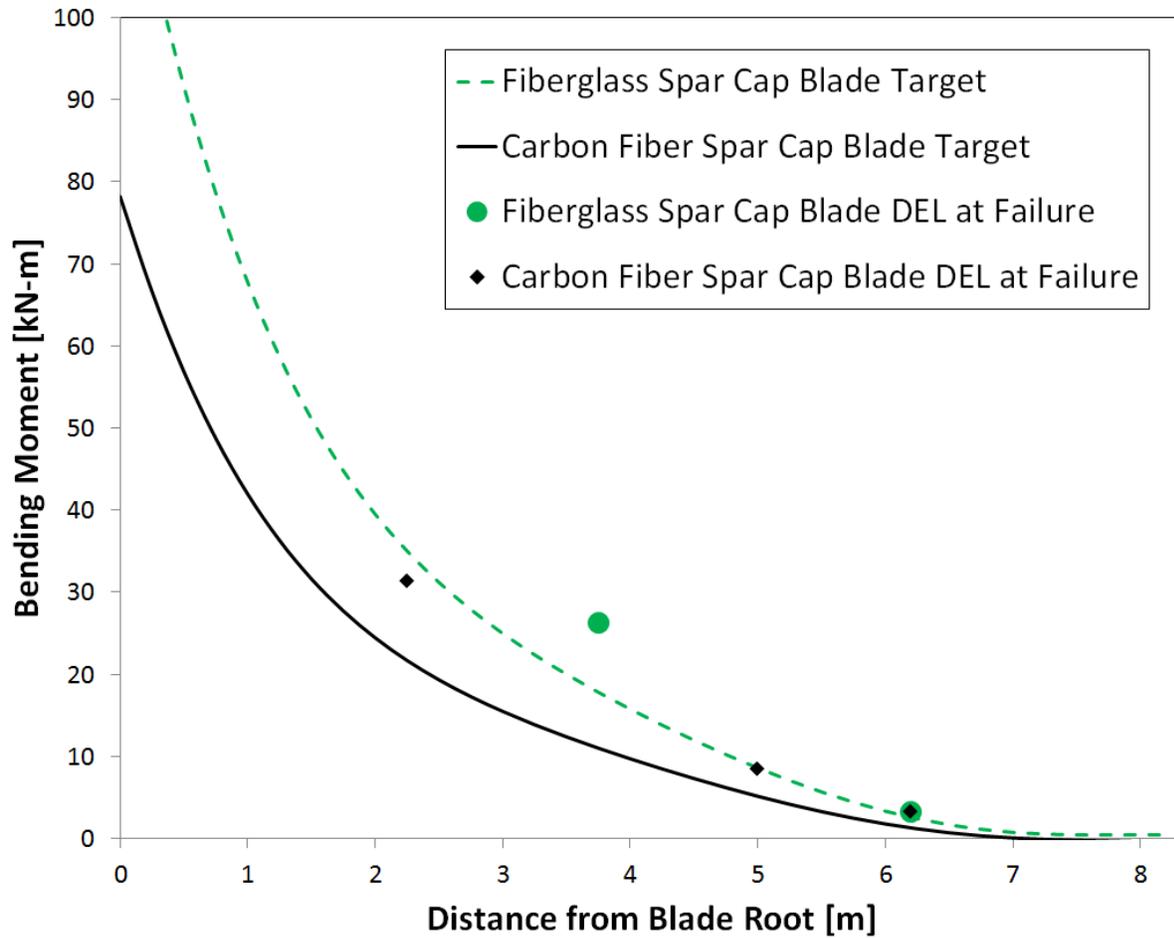
Figure 28. Comparison of target bending moment distribution and applied DEL at failure locations

Wind turbine blades that were 8.3 m long, with flaws intentionally built into the structural laminate, were tested to failure. Two blades were tested, one blade was manufactured with a fiberglass spar cap and the second blade was manufactured with a carbon fiber spar cap. Testing focused on loading specific spanwise areas of the blade that contained the intentional defects. The experiments successfully tested to failure multiple embedded flaws. Each failure region with embedded flaws contained either in-plane or out-of plane waves in the spar cap of the blade. Table 4 provides a summary of the applied test loading at the time of failure for each of the embedded flaws. Figure 28 provides a chart of the DEL at failure for each of the fatigue failure locations, compared with the target bending moment distributions for both the fiberglass and carbon fiber blades.
