Mariah Windspire Project Summary

As part of the National Renewable Energy Laboratory and U.S. Department of Energy (NREL/DOE) Independent Testing project (<http://www.nrel.gov/wind/>), NREL was testing Mariah Power's Windspire Giromill small wind turbine at the National Wind Technology Center (NWTC) through January 14, 2009 when NREL terminated its testing.

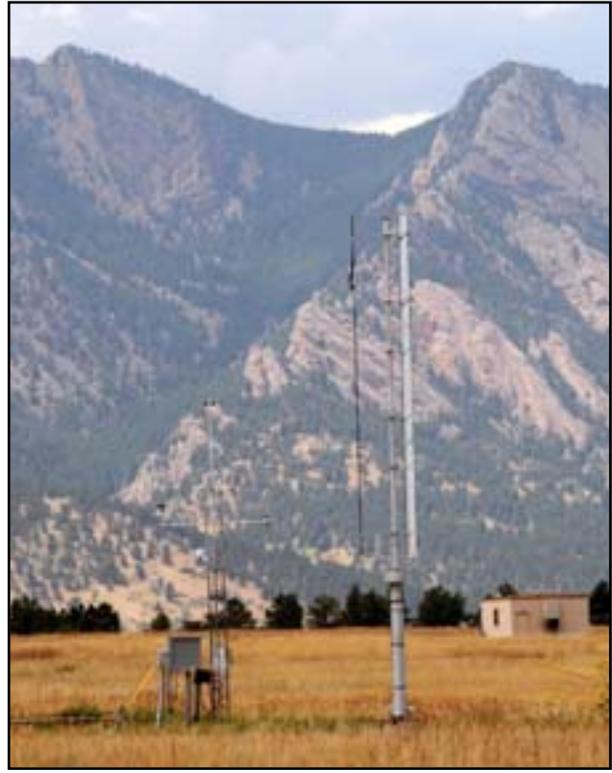
The Windspire is a 1.2-kW vertical-axis small wind turbine. The turbine tower is 9.1 meters tall, and its rotor area is 1.2 x 6.1 meters. The turbine has a permanent-magnet generator with a single-phase output at 120 volts AC.
