Yakama Nation Housing Authority, Adams View: System Retrofit Research Report and Case Study Summary

February 23, 2004–January 15, 2005

CARB (Consortium for Advanced Residential Buildings)
Norwalk, Connecticut

Subcontract Report
NREL/SR-550-38263
November 2005

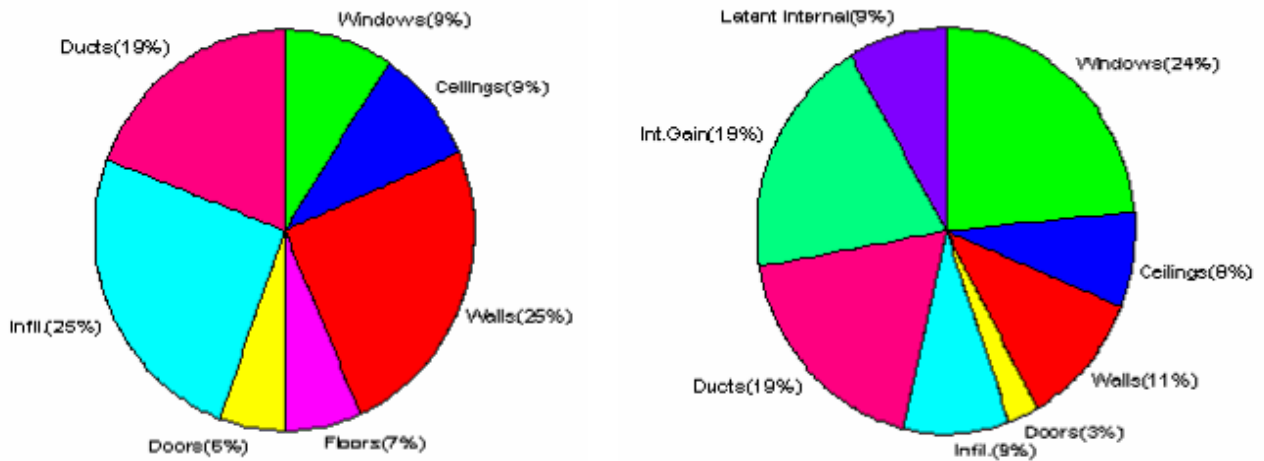
Figure 12. Air leakage in winter and summer

From CARB’s evaluation of the Adam’s View project, it is evident there are additional opportunities to increase performance of these units through further air sealing and the installation of tight ductwork. The test values for air infiltration and duct leakage were inputted into the energy modeling software to assess the impact of air and duct sealing on the design loads for these homes. The pie charts (Figure 12) show that air leakage (through the building envelope and ductwork) still accounts for 44% (25% infiltration + 19% ducts) of the winter heating design load and 28% (9% infiltration + 19% ducts) of the summer cooling design load.

Winter Heating Design Load - 21,484 Btu/hr

Summer Cooling Design Load - 12,334 Btu/hr

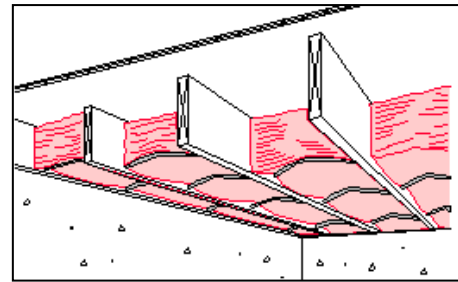
Figure 13. Spring rod installation ⁴

CARB has some concerns with the quality control of the floor truss insulation installation. It was observed in several of the crawlspaces that batt insulation placed in the floor is falling out in various places. This will allow for greater heat transfer through the floor and will derate the overall U-value of the floor. During the winter months, this poor installation will be more noticeable as homeowners will likely have comfort issues because of the cold spots and potential condensation problems.

Either greater care needs to be taken in placing these batts or something like spring rods/batt hangers should be used during the installation (Figure 13). In addition, the PEX piping should have continuous insulation wrap on it. Exposed piping in the crawlspace will greatly increase hot water distribution losses (Figure 14).
