# High-R Walls for Remodeling: Wall Cavity Moisture Monitoring

J. Wiehagen and V. Kochkin  
*NAHB Research Center*

December 2012

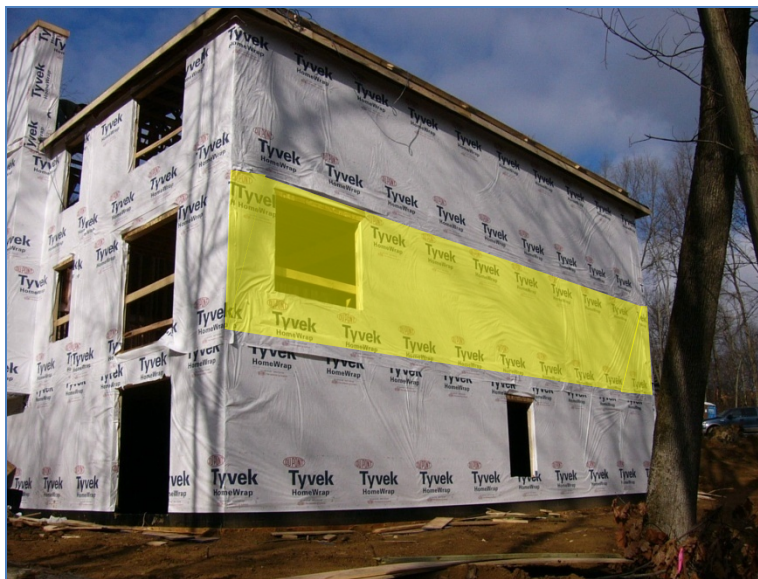
The home located in Valencia, Pennsylvania (Jobsite 2) had a wood framed walk-out basement such that one end of the home had three framed stories. The test wall for this home was at the second level as shown in Figure 14.

**Figure 14. Jobsite 2 east wall (test wall highlighted), three stories framed**

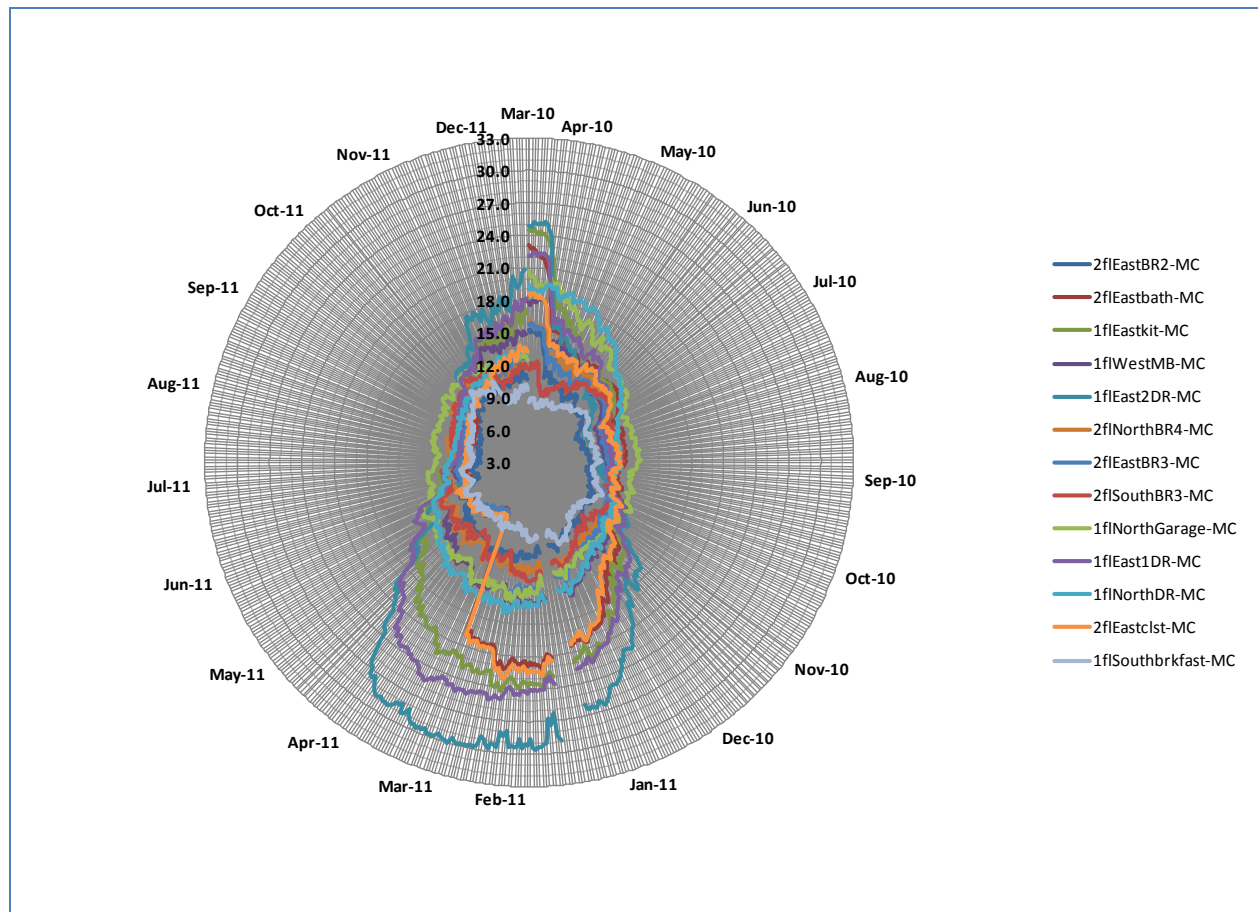
**Figure 18. Jobsite 2 OSB MC, all available data**

As seen in the previous charts, Jobsites 2 and 5 show elevated MC in some wall cavities. The MC measurements indicate levels reaching to slightly greater than 30% in a few wall cavities. This level of MC suggests a fiber saturation point state of the OSB panels.

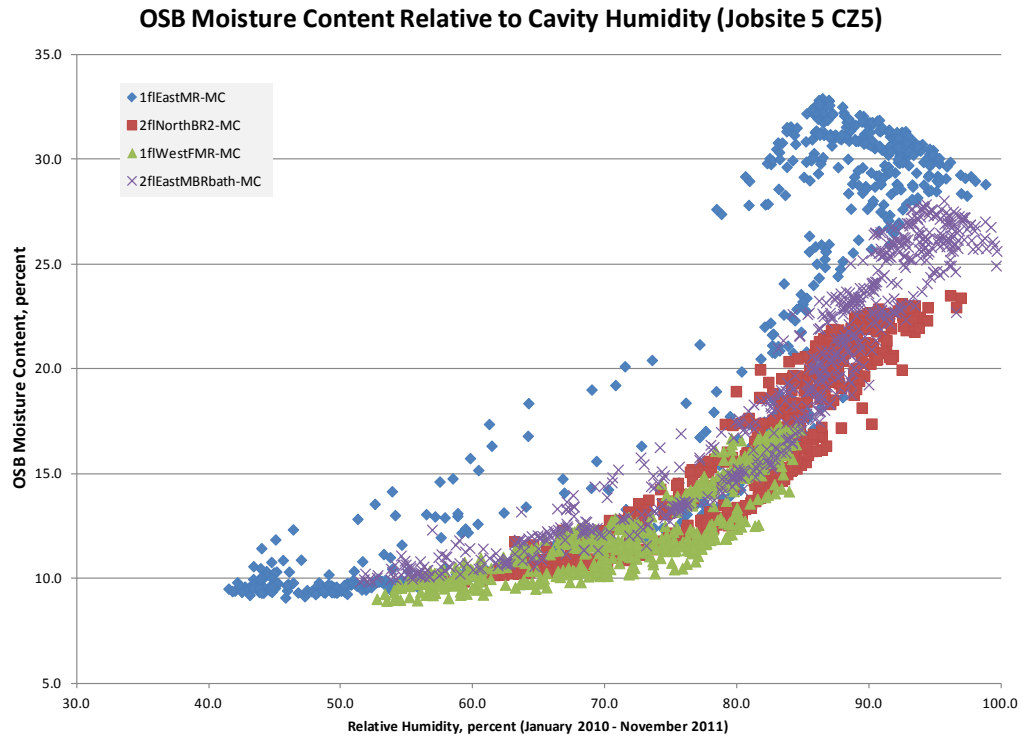
**Figure 50. Jobsite 5 MC relative to humidity**

Figure 47 through Figure 51 show the relationship between the OSB MC and the RH in the wall cavity for each of the jobsites. Wall cavities with higher level MCs are selected for the comparison.

The Jobsite 5 home appears to have the greatest potential for moisture-related problems; however, no problems have been reported. It is not known how the cyclic behavior of the wall cavity moisture characteristics is representative of long-term problems. Moreover, the ASHRAE 160 criteria appear to be intended as a lower bound set to ensure that mold growth does not occur rather than as an indicator of a trigger at which mold growth does occur. Particularly, criterion A
