# Analysis of Joist Masonry Moisture Content Monitoring

Kohta Ueno  
*Building Science Corporation*

October 2015

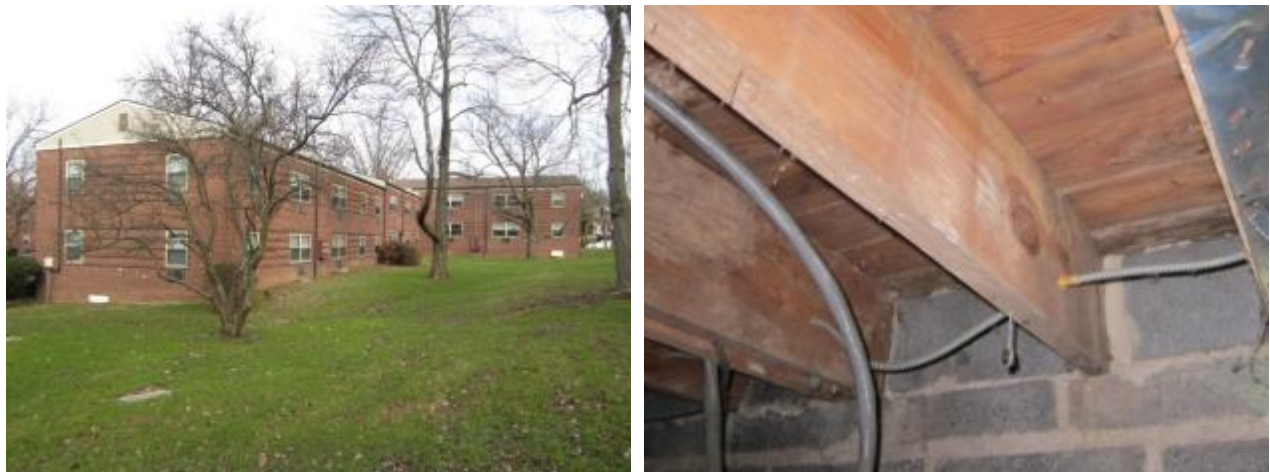
**Figure 2. Overview of apartment complex (left); preretrofit joist ends in concrete masonry unit walls (right)**

Rudd (2014) described the retrofit of a crawl space in a circa 1940 multifamily building in the Philadelphia area (zone 4A). The crawl space foundations were ungrouted (hollow) concrete block with a brick veneer (Figure 2, left); above-grade walls were wood frame with a brick veneer. The first-floor framing (sawn lumber) was grouted in place and embedded in the concrete masonry unit wall (Figure 2, right).

Joist MCs were measured: initially, they were 6%–10% in the main space and only 1–2 percentage points higher near the joist ends. However, the site later flooded (immersing the floor framing), and some joist ends remained at 40%+ MC. The author recommended cutting back insulation  $\frac{1}{2}$  in. around the joist ends to facilitate drying. Other joist ends had lower (10%–12%) MCs.

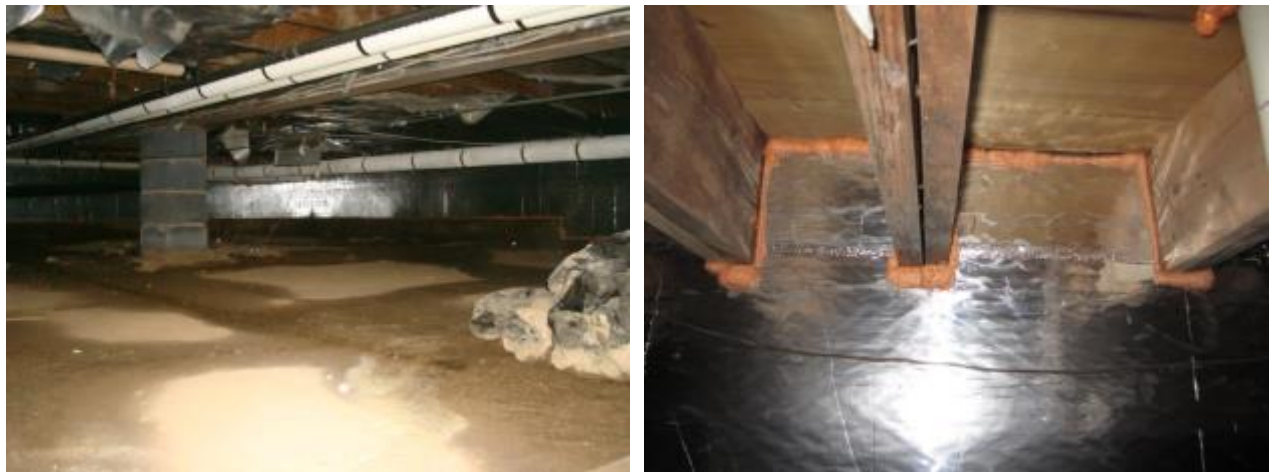
**Figure 3. Postretrofit crawl space conditions (left); insulation board sealed at joist ends (right)**

As an energy upgrade, the crawl space was converted from conventional vented/unconditioned to sealed and conditioned crawl space, per §R408.3 of the International Residential Code (ICC 2009a). Rigid foil-faced polyisocyanurate was installed on the crawl space walls and sealed around the joist ends (Figure 3). A continuously running exhaust fan was added to draw air from the crawl space; it pulls makeup air from the units above and provides a continuous supply of dry, semiconditioned air to the crawl space.

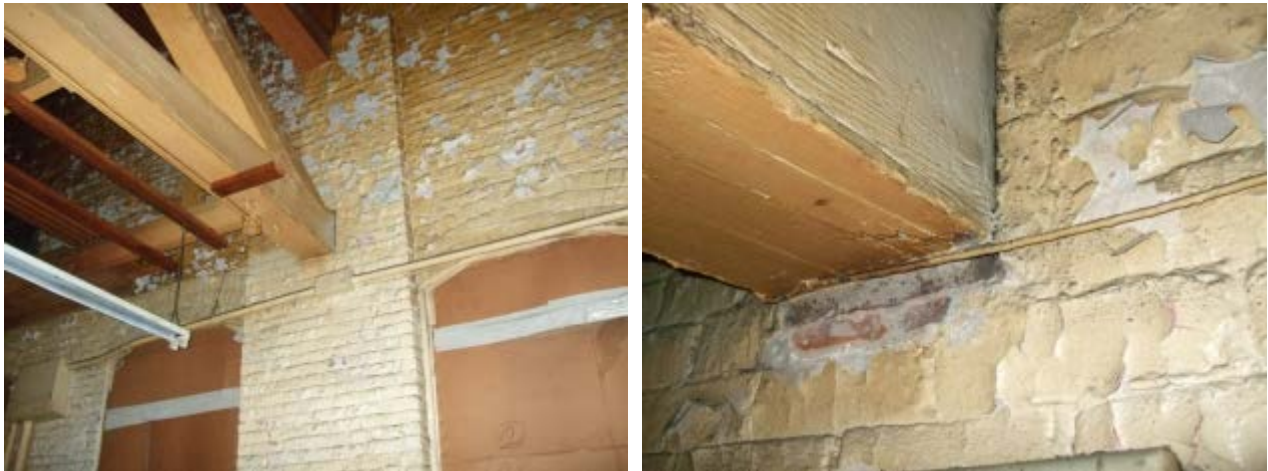
**Figure 6. Large timber beam pocket (left); iron or steel bearing plate (right)**

These types of beams are typically pocketed with a steel or cast-iron plate to support it at the masonry wall (Figure 6). This plate was presumably installed for structural reasons (to distribute the beam's load on the supporting masonry and form a flat surface), but it also functions as an effective capillary break to eliminate water wicking from the masonry below.

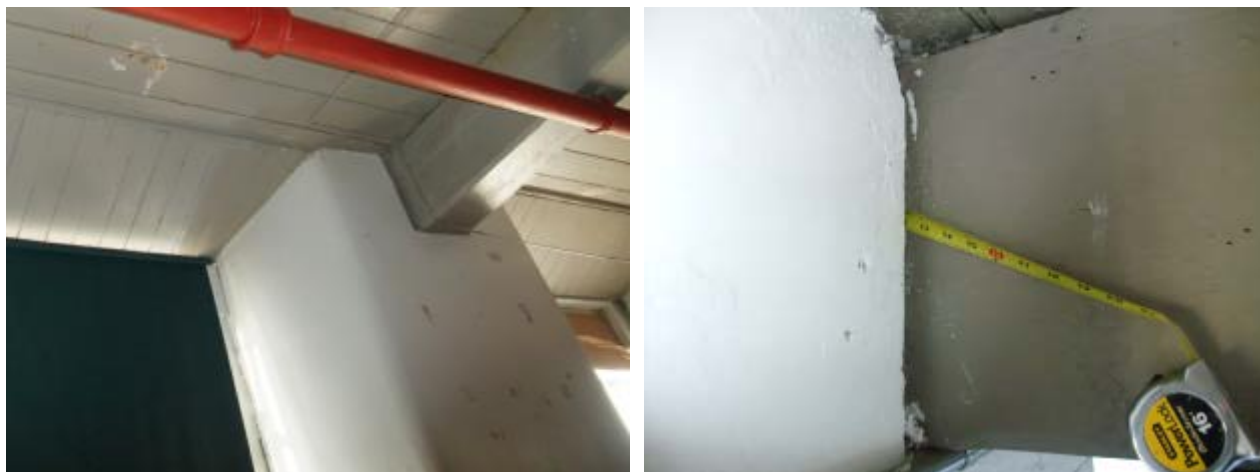
**Figure 7. Beam pocket gap on sides; conditions vary by building**

The sides of the beam sometimes have an air gap between the wood beam and the masonry; Figure 7 shows a relatively large ( $\sim 3/4$ -in.) gap. However, these conditions vary widely from building to building; some buildings have masonry tight against the beam.

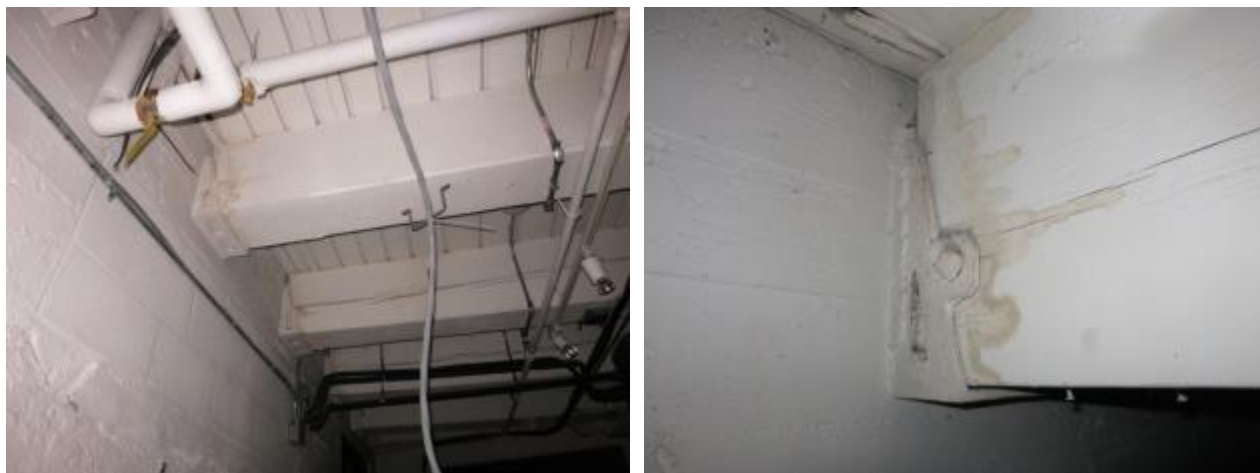
**Figure 8. Steel saddle hanger detail, with beam clear of masonry wall at grade**

One historic design in a Boston-area building clearly acknowledges the risks that are associated with wood beams near grade. Beam pockets were used for most of the building; however, at the basement level (with beam ends near grade), cast-in steel plate saddle hangers were used to support the beam (Figure 8). This detail completely removes the vulnerable wood from contact with the masonry (Figure 9, left). Several areas were stained (Figure 8, right) with paint blow-off; however, measurement of the wood MC showed dry conditions, even at extensively water-stained areas (Figure 9, right). Keeping the wood beam end clear of the wall (with this saddle detail) allows significant drying of any incidental wetting in service.

This wetting might have been caused by interior-sourced flooding, based on the water stain patterns (e.g., visible staining between subfloor gaps). Whatever the wetting source, however, this detail allows for greater drying than an embedded beam.

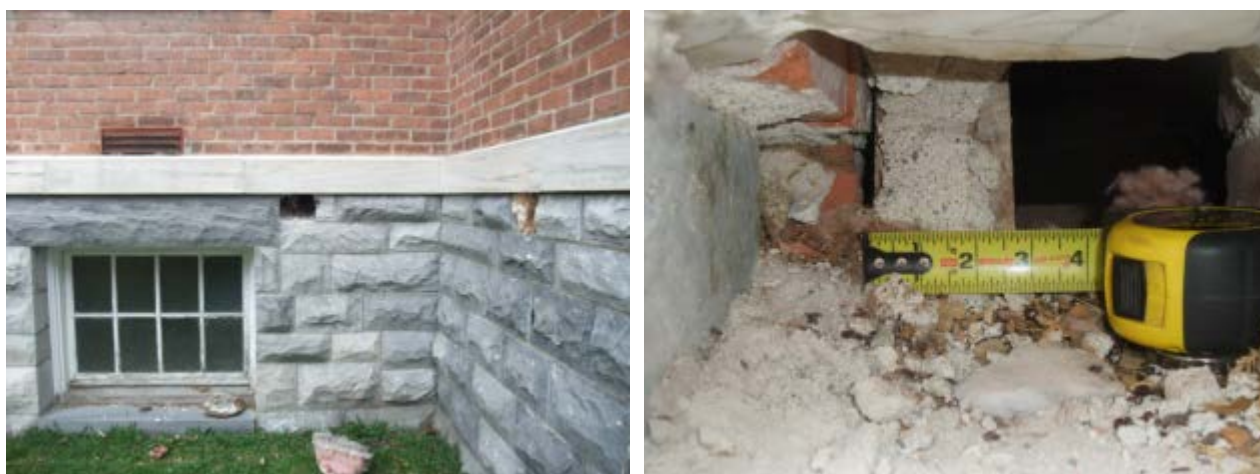
**Figure 10. Embedded joist end from exterior showing dimensions and fire cut**

Individual joists that are composed of dimension lumber (2–3 in. width) at a close spacing (12–16 in. on center) constitute the other common geometry that is seen in residences and small commercial buildings (Figure 10).

These joists are fire cut and typically have no metal bearing plate. Pocket conditions vary, but grouting the joists into the pocket is not uncommon.

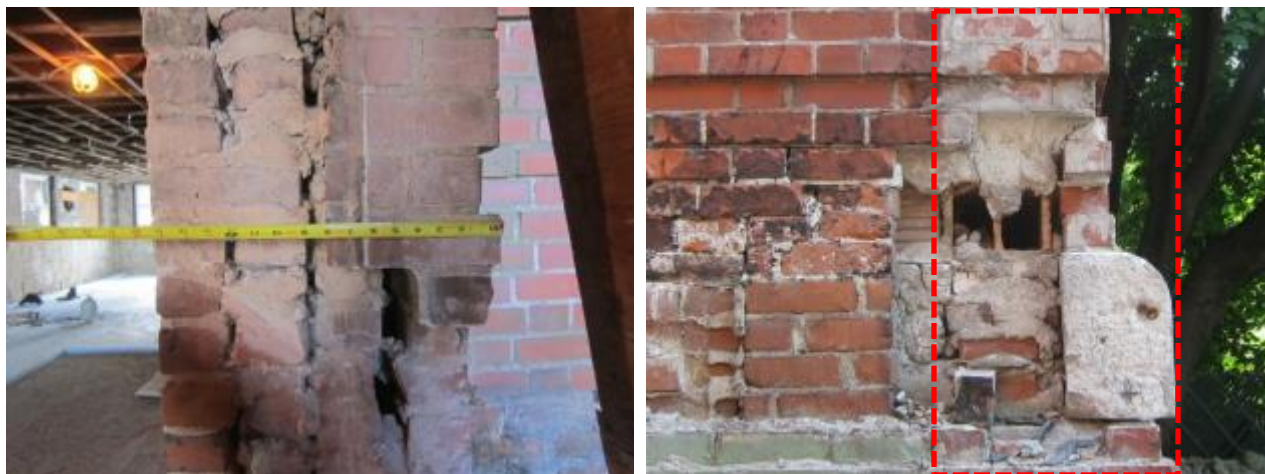
**Figure 17. Wall section at solid brick (left); at hollow clay block infill (right) conditions**

Although these assemblies appear from the interior and exterior to be monolithic, the building has a variety of interconnected spaces such as the incompletely filled collar joints between brick wythes (Figure 17, left) and the hollow cores of the clay blocks (Figure 17, right).

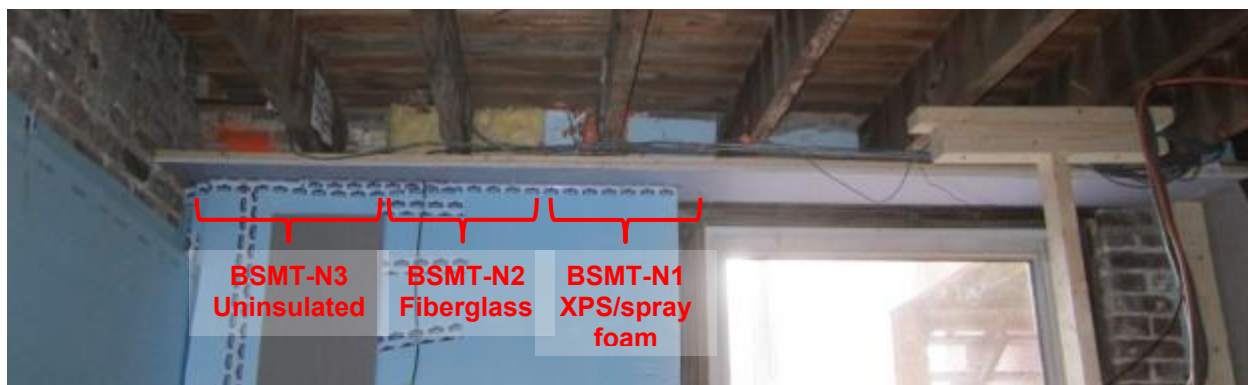
**Figure 23. Comparison of insulation strategies for joist ends BSMT-N-1/2/3, predrywall**

Basement ceiling joists are monitored on all four orientations, including multiple measurements on some orientations; all are embedded in solid brick masonry. BSMT-N1/N2/N3 are joists with identical exposure; however, each uses a different retrofit strategy (Figure 23 through Figure 26):

- BSMT-N1 is insulated per the remainder of this project, insulated and air sealed with rigid XPS foam and urethane spray foam.
- BSMT-N2 is insulated with air- and vapor-permeable insulation (two R-13 layers of fiberglass batt, or R-26), which captures the effect of insulating, while still allowing airflow.
- BSMT-N3 is left uninsulated, similar to assemblies described in Morelli et al. (2010).

These test joists were intentionally placed in a common area; therefore, if monitoring indicates that one of these strategies causes excess moisture accumulation, the finished ceiling (gypsum board) can be opened, and the poor performer will be retrofitted with another strategy.

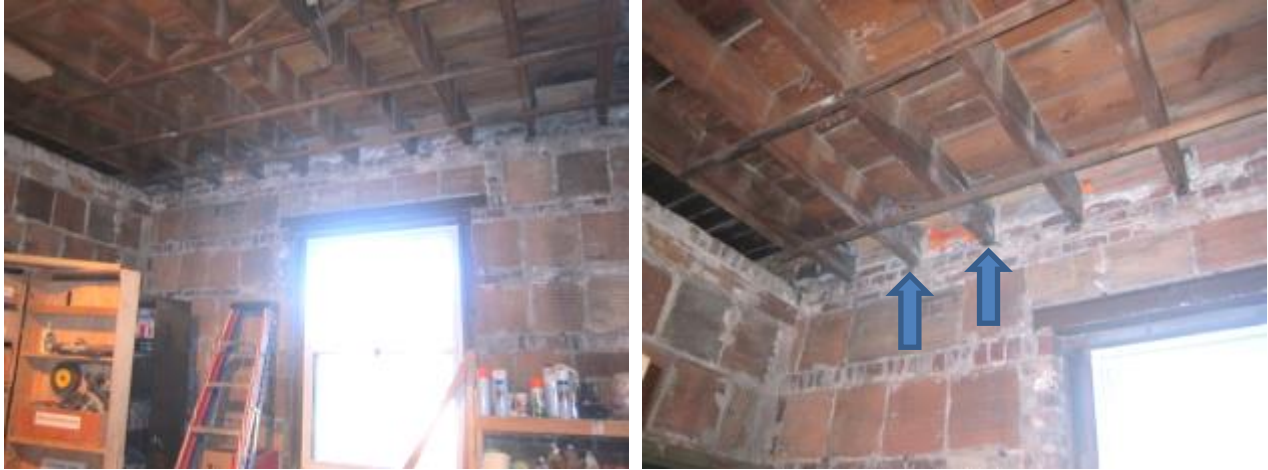
**Figure 27. FIRST-N joists showing brick and clay block wall construction**

On the first floor, joists were monitored in the addition (hollow clay block) walls only, because the joists in the original first-floor wing were inaccessible. Figure 27 shows the FIRST-N monitoring locations, and that the hollow clay block backup walls were actually constructed with alternating layers of block and brick.

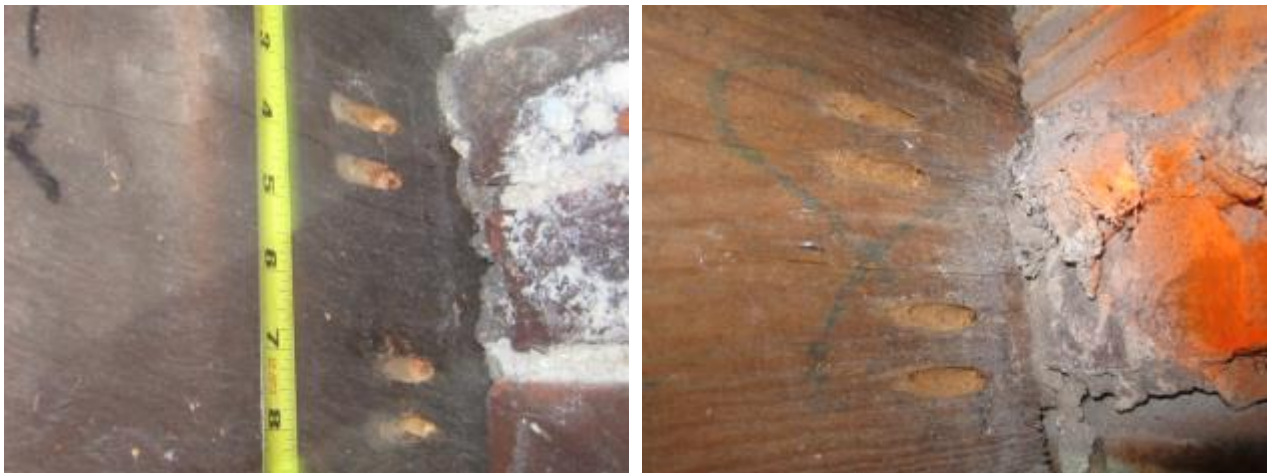
**Figure 28. Wood color comparison at BSMT-E1 joist (left); FIRST-E joist (right)**

First-floor monitoring was installed in north, south, and east-facing joists. The east-facing joist appears to be a different species: the wood is noticeably softer and is a different color (see Figure 28). This difference in wood species may affect MC measurements via electrical resistance.

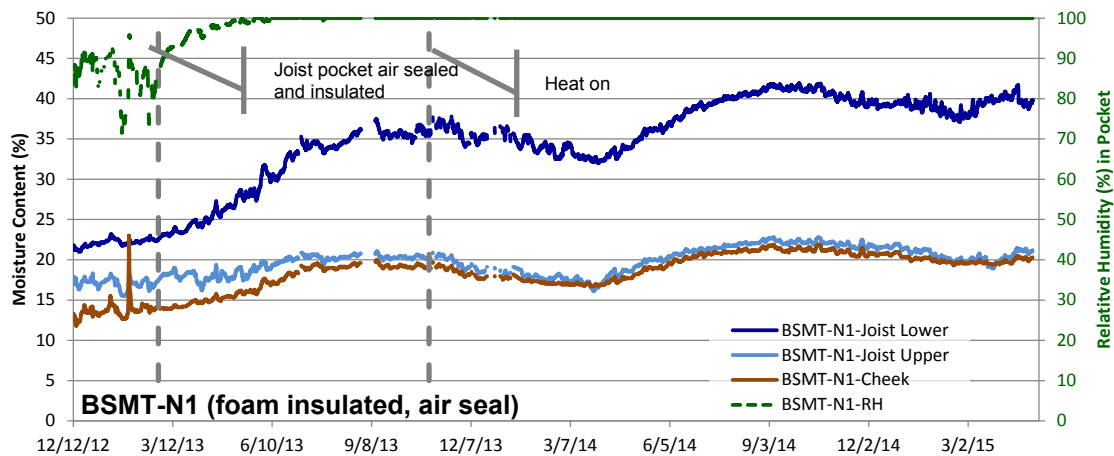
Figure 42. BSMT-N1 (insulated) joist end MCs and RHs

The joist pocket RH measurements showed high levels of either constant 100% (BSMT-N2 and BSMT-N3), or a quick rise from 80% to constant 100% (BSMT-N1). The reason for the RH difference between BSMT-N1 and BSMT-N2/N3 was not evident from visual or infrared observations (Figure 24). Temperature measurements showed that the largest differences between joist ends were 1°F (0.5°C), and visual inspection of the temperature and RH sensor installation showed no significant installation differences between the three joists.

The joist end MC levels were higher than recommended for durability: lower joist ends were 20%–40%+ (BSMT-N1 joist lower was wettest by far), and upper joist ends were typically 15%–36%. Joist cheek MCs were safer (10%–22%). The high moisture levels might reflect unheated or “mothballed” building conditions (previous 2 years of operation). However, no damage to the beam ends was evident during sensor installation.

Moisture levels did not differ markedly between the three joist ends: although N1 (insulated) had very high “lower” MCs, measurements at other parts of the joist were drier than N2 and N3. High MCs were found at all three joist ends.

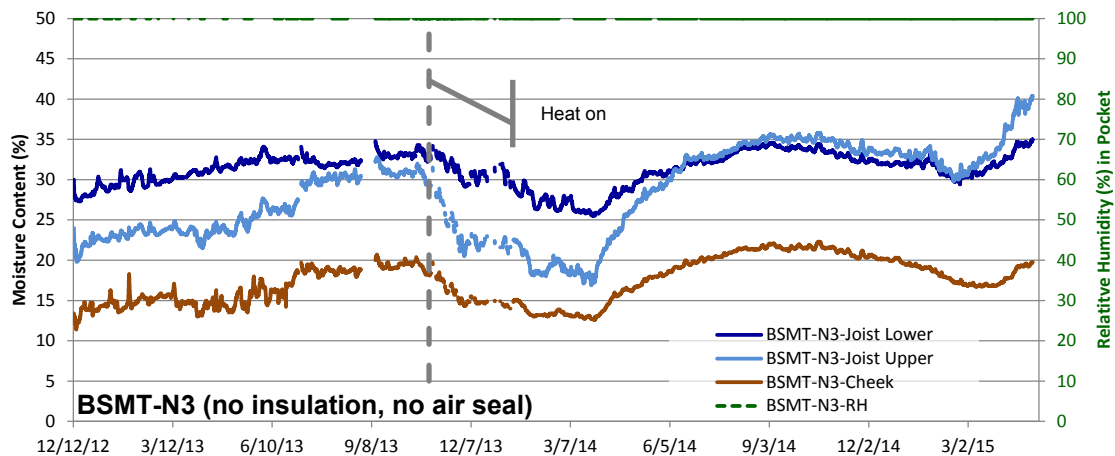
**Figure 44. BSMT-N3 (uninsulated) joist end MCs and RHs**

MCs demonstrated a distinct seasonal cycle: peaks occurred during late summer and early fall (September). More importantly, MCs dropped when heat was introduced in October 2013, especially in N3 (uninsulated). An outward temperature gradient would result in outward drying of the beam end; summer conditions have an inward temperature and water vapor gradient.

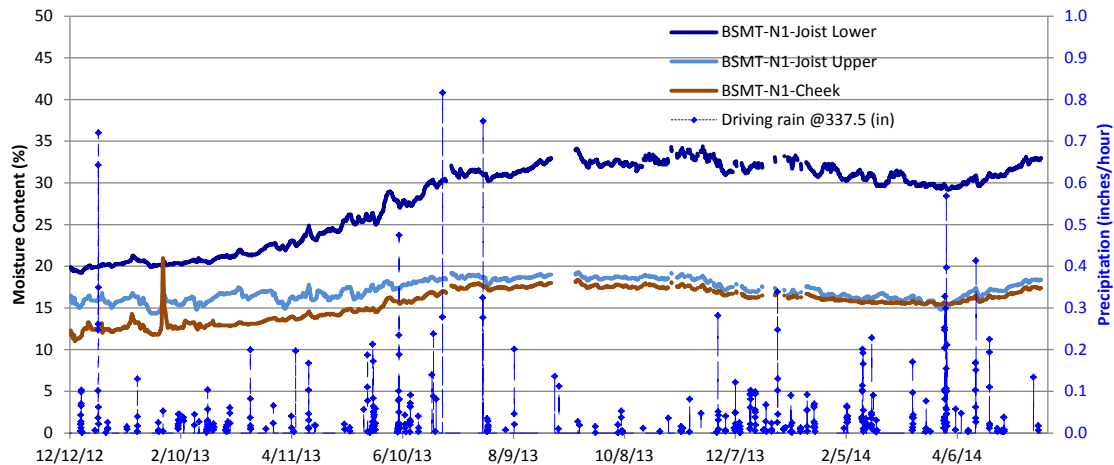
**Figure 45. BSMT-N1 joist end MCs with calculated driving rain**

The MCs were plotted with driving rain deposition on the north wall, which was calculated using methods from Straube and Burnett (2005) (Figure 45) from late 2012 to mid-2014. Distinct rain events showed no discernable responses in the measured data.

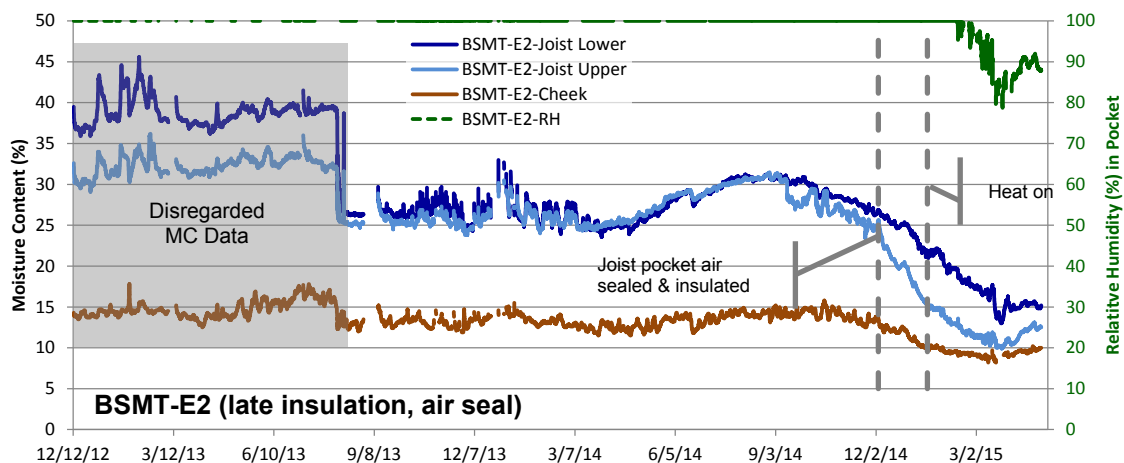
**Figure 46. BSMT-E2 joist end MCs and RHs**

Measurements from the east-facing joist from the rear of the building (BSMT-E2) are shown in Figure 46: the sensor measurements underwent a step change downward in August 2013 (highlighted in gray). Given the parallel and sudden shift of all three MC levels, it was clearly a sensor (electrical) issue as opposed to a true MC change. Previous work has shown that MC pins can be short-circuited by wet masonry. Construction activity repeatedly damaged sensors (given the monitoring of an active jobsite), which required return trips for repair. This was often manifested as failures or electrical anomalies in the data. Based on these facts, data before August 2013 were disregarded.

BSMT-E2 was in a part of the building that had minimal wintertime heating (similar to BSMT-N1/N2/N3) and was insulated and air sealed late in the construction process (December 2014). It had similar patterns to the previous graphs, including high peak MCs (25%–31%), cheek measurements that were drier than the embedded joist ends, a seasonal swing (with peak in summer), and drying into the winter (especially with the addition of heating). RH also dropped from its continuous 100% in the final winter, which was consistent with a drop in the joist end MCs.

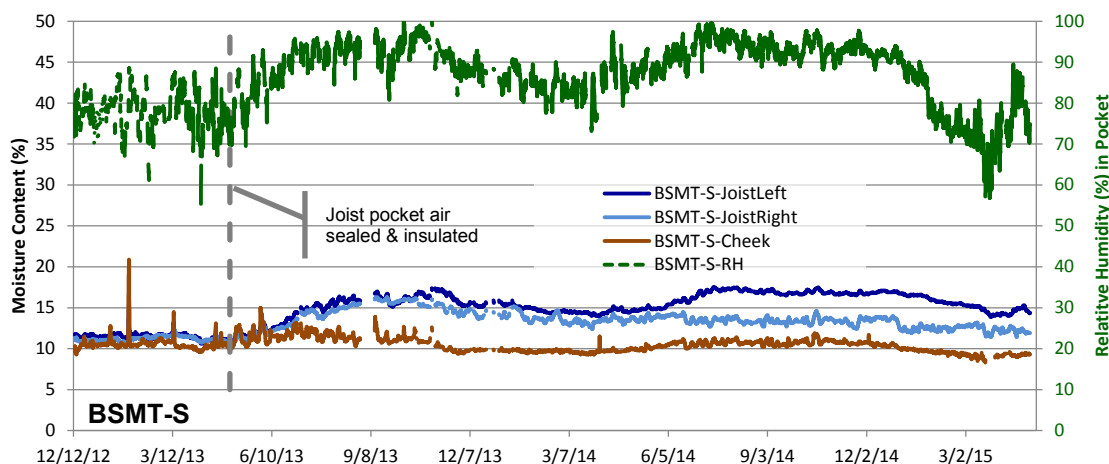
**Figure 47. BSMT-S joist end MCs and RHs**

The south-facing basement joist is plotted in Figure 47; it also had minimal wintertime heating (the same interior conditions as BSMT-N1/N2/N3). MCs were substantially lower (~10%–16%) than the north- and east-facing basement joists, and the RH in the joist pocket was markedly lower (seasonal rise and fall of ~70%–100%). This is attributed to the warmer temperatures due to solar gain on this orientation. These drier conditions are a function of solar heating, which is evident if north and south temperatures are compared (Figure 48 for part of winter 2012–2013). The south side was slightly but consistently warmer in winter, and joist end temperatures converged as outdoor temperatures rose.

The BSMT-S joist end measurements are a left/right pairing, not an upper/lower pairing; both are in the lower joist position.

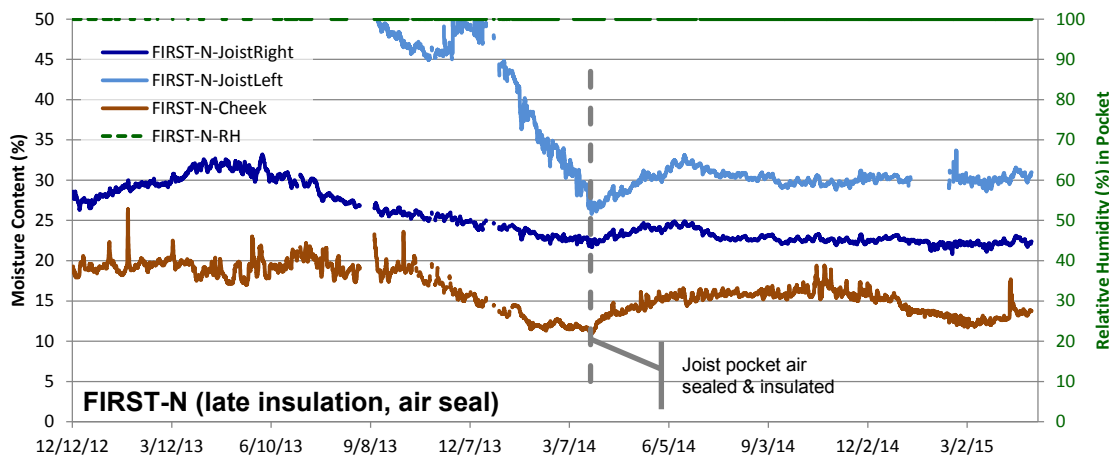
**Figure 51. First-N joist end MCs and RH**

The north-facing joists (left/right pair) measurements are shown in Figure 51; the left-facing joist (FIRST-N-JoistLeft) had initial measurements in the 60%+ range (off the graph). The MCs gradually fell over time and reached a range that was consistent with the other joists by winter 2013–2014. This was far higher than any other measurements in the building; the reason for this

anomaly has not been positively determined, but electrical issues are suspected (as opposed to massive moisture loading of a single joist).

Figure 51 shows that the beam pocket RH remained at 100% throughout these measurements. Similar to previous measurements, the cheek MC was lower (drier) than the joist end MC. The right joist pocket MC (FIRST-N-JoistRight) showed a seasonal rise and fall throughout the monitoring period (it was wetter in spring and summer and showed a general drying trend).

The joist pocket was insulated and air sealed in late March 2014; all MCs began to rise (consistent with cutting off drying to the interior seen in other joist pockets) and then exhibited a slight seasonal rise and fall pattern.

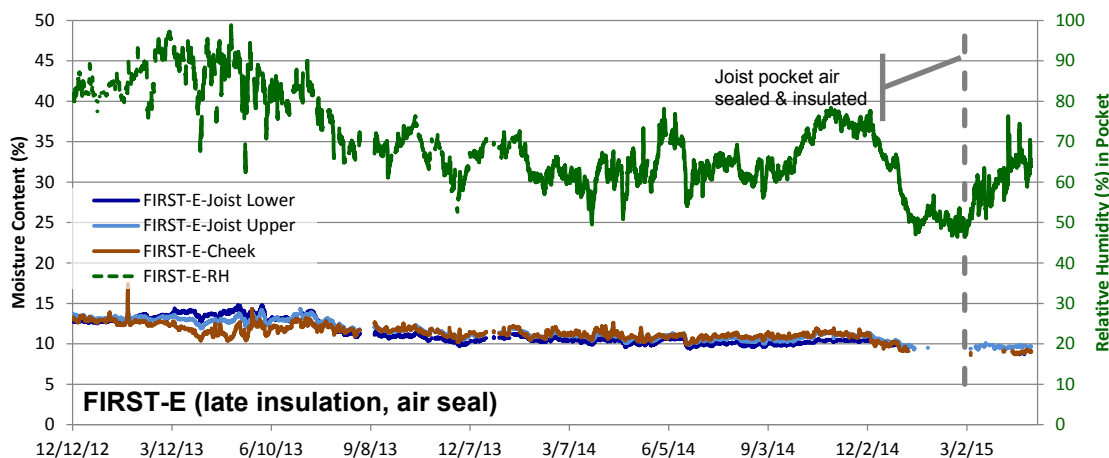
**Figure 52. First-E joist end moisture contents and RH**

The first-floor east (FIRST-E) sensors had low MCs of about 9%–15% (Figure 52); this joist was the softer brown wood (possibly a different species) noted earlier. However, the measured pocket RHs (45%–95%) were consistent with lower MC measurements. These low MCs occurred despite a high driving rain exposure on this orientation. This location had noticeably higher summertime temperatures (due to solar gain) than the east-facing joists on the basement level.

This joist pocket was insulated and air sealed late in construction (February 2015); an associated rise in pocket RH occurred, although the change could be associated with seasonal variations.

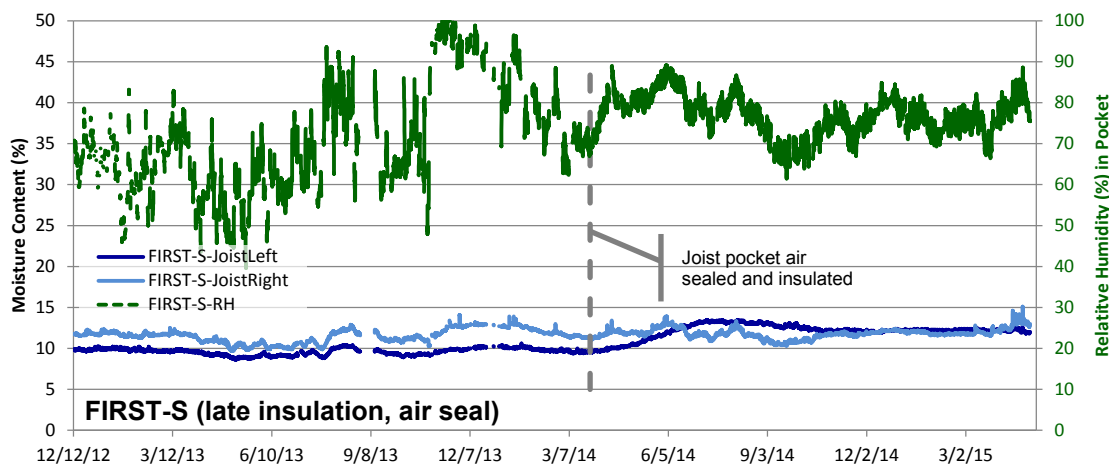
**Figure 53. First-S joist end MCs and RHs**

The south-facing joist MCs (Figure 53) were also low (9%–15%); RH measurements were consistent with MCs (50%–80% RH, brief spike to 100% in November 2013). This RH spike was checked against rain events, but no correlation was found. This joist had no cheek measurement.

MCs rose slightly after the joist end was insulated and air sealed (March 2014); RH measurements became noticeably more stable after this work was completed.

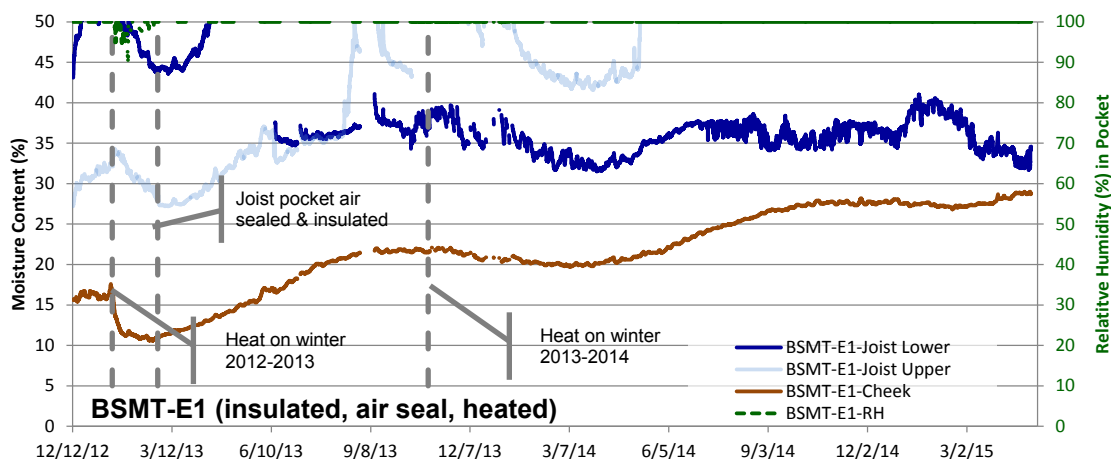
**Figure 55. BSMT-E1 joist end MCs and RHs**

The east-facing joist (BSMT-E1; Figure 55) showed some sudden changes in the joist end MC, which likely indicated a sensor electrical anomaly rather than a valid MC shift. These shifts were correlated against interior and exterior conditions, including calculated driving rain; no causes were obvious. Overall, BSMT-E1 Joist Upper had data that will be disregarded, but BSMT-E1 Joist Upper had data that looked reasonable after June 2013. The cheek measurement, however, looks reasonable; unfortunately, it shows a pattern of seasonally rising MCs (peaks in summer), of 10% to 29%.

Despite a low confidence in some of these MC measurements, the RH measurements (almost constant 100%) were consistent with high MCs. In terms of exposure, even though this joist faces east, this location is blocked from solar gain by the adjacent wing (see Figure 54).

Although the MC measurements exhibit uncertainty, some shifts can be correlated with various events. In January 2013, interior construction heating was started, and all MCs fell, especially at the joist cheek (which has the greatest exposure and the most drying available). The RH in the joist pocket also shifted slightly off 100%. However, after the joist pockets were air sealed and insulated with spray foam in February 2013, the RH increased back to a constant 100%, and the MCs began to rise again. The cheek MC also increased: it was buried within the spray foam insulation, so it was isolated from interior conditions.

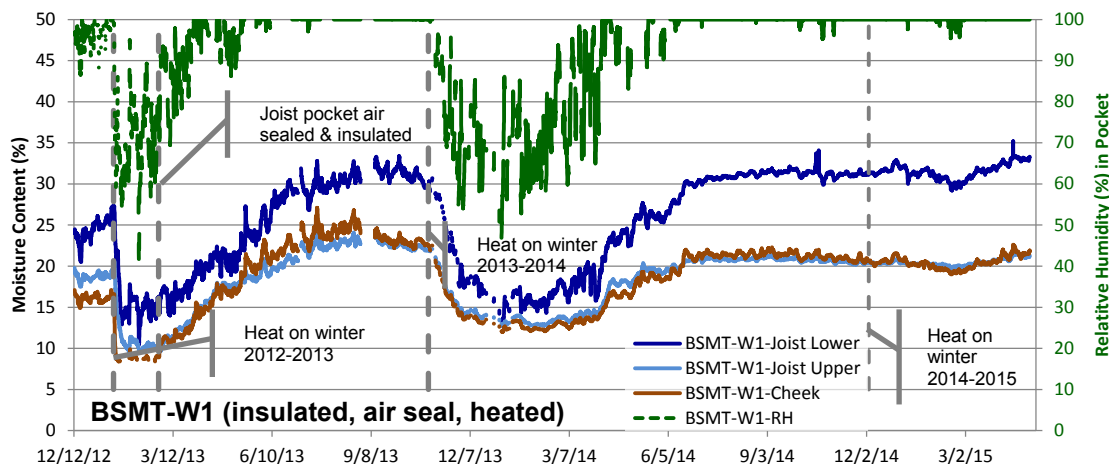
Figure 56. BSMT W1 joist end MCs and RHs

The west-facing joists (BSMT-W1 and W2) have similar—or even more pronounced—seasonal patterns (Figure 56 and Figure 57).

Similar to BSMT-E1, MCs showed a sharp decrease (drying) when construction heating was introduced in January 2013; RHs dropped simultaneously. Sealing the joist pocket (February 2013) correlated with a rise in MCs and RHs, but the rise was also consistent with the seasonal (summertime) pattern. Again, in winter 2013–2014, construction heating caused the joist ends to dry. In spring 2014, MCs and RHs rose again. However, in winter 2014–2015, the drying associated with wintertime heating was barely perceptible, if it was occurring. Part of this may have been due to the installation of interior gypsum board (ceiling and wall), which would have decoupled the insulated joist end further from the interior space.

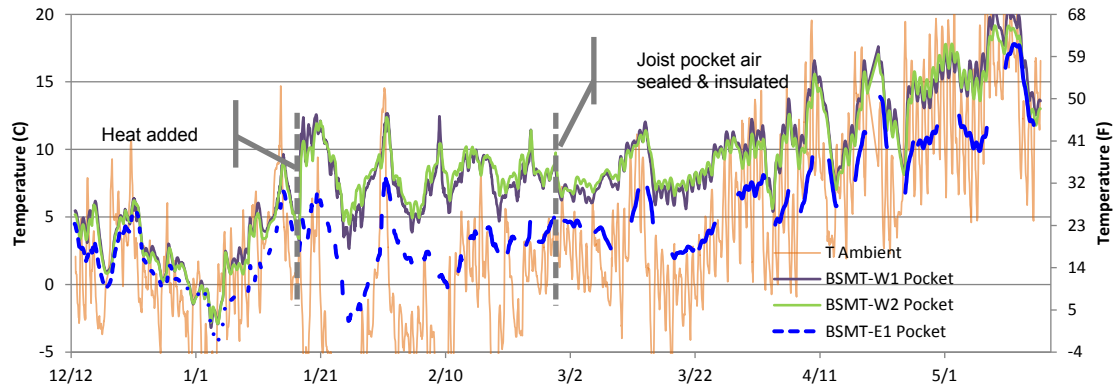
**Figure 58. Basement West and East joist end winter/spring temperature comparison**

The difference in RHs and MCs between east- and west-facing joists might be ascribed to the temperatures in the pocket (Figure 58).

The west-facing joist pockets were consistently warmer than the east-facing joist. The east-facing joist was shaded from solar gain by the adjacent parts of the building (see Figure 54); the west-facing joists were well exposed to the afternoon sun. This temperature difference increased as heat was added: the space heater for the front of the building was closer to the west-facing joists (front) than the east-facing joist. The temperature difference continued after the wintertime heating was shut off.

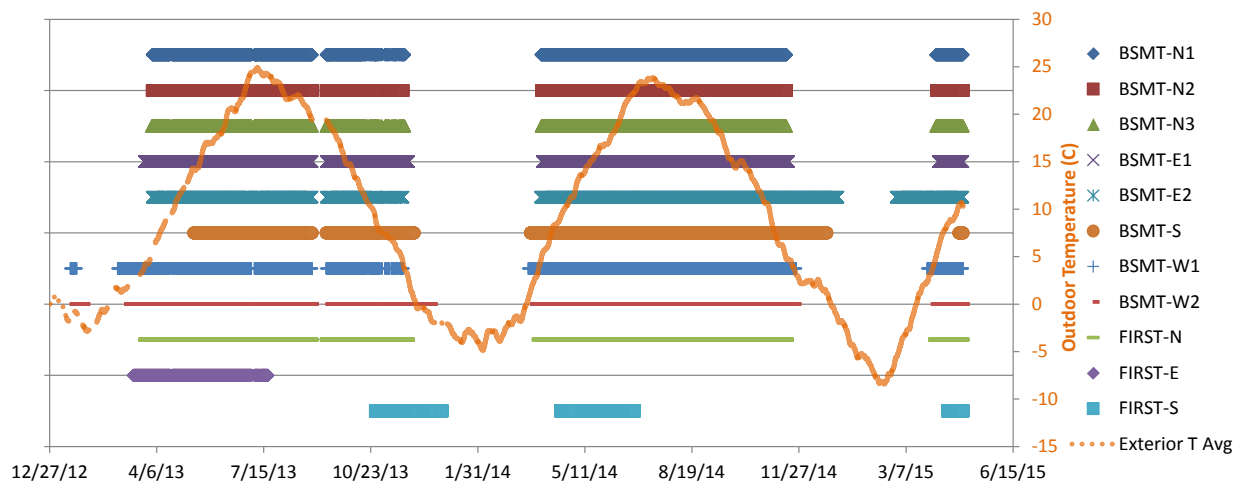
**Figure 59. ASHRAE 160 failing hours for joist ends, with exterior temperature 30-day average**

The results are plotted in Figure 59: hours that failed ASHRAE 160 are denoted by points; the outdoor temperatures (30-day rolling average) are plotted for reference.

The results are not surprising, given that many of the joist end pockets remain at a constant 100% RH throughout the monitoring period. Therefore, they fail ASHRAE 160 criteria whenever

temperatures are sufficiently warm to sustain mold growth. As shown in Figure 59, most joist ends have failure conditions at all times except during winter conditions when temperatures remain below 41°F (5°C). The discontinuity seen in August–September 2013 was a section of missing data, not a period of dry conditions.

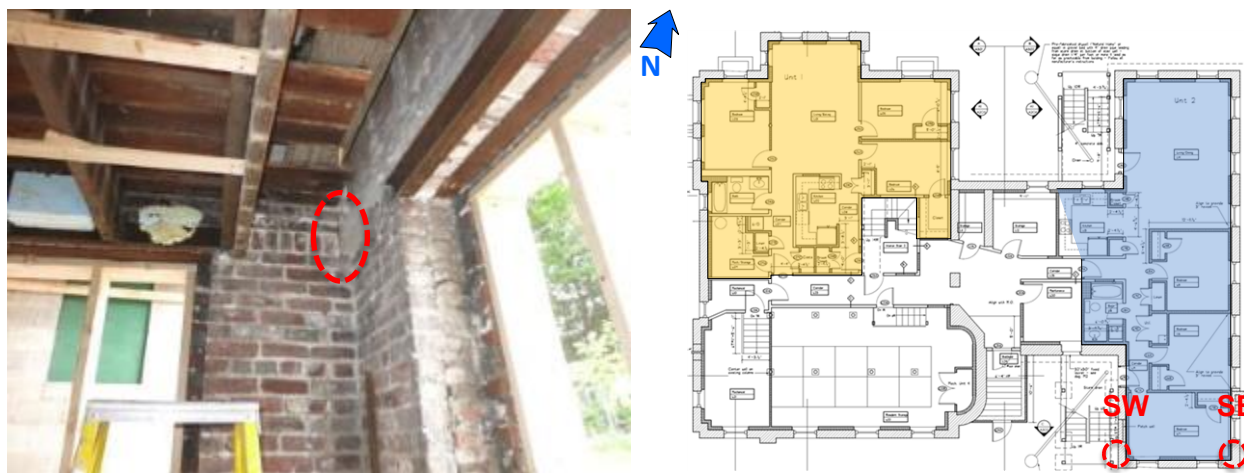
**Figure 60. Joist end stub in southeast corner (left), plan showing stub locations (right)**

Wood joist samples were collected in September 2014 to allow for species identification (and thus greater accuracy for resistance-based MCs). The samples came from two joist ends that remained embedded in the masonry wall in the rear addition section (Figure 60); sometime after May 2012 the construction crew removed the joist for structural and access reasons.

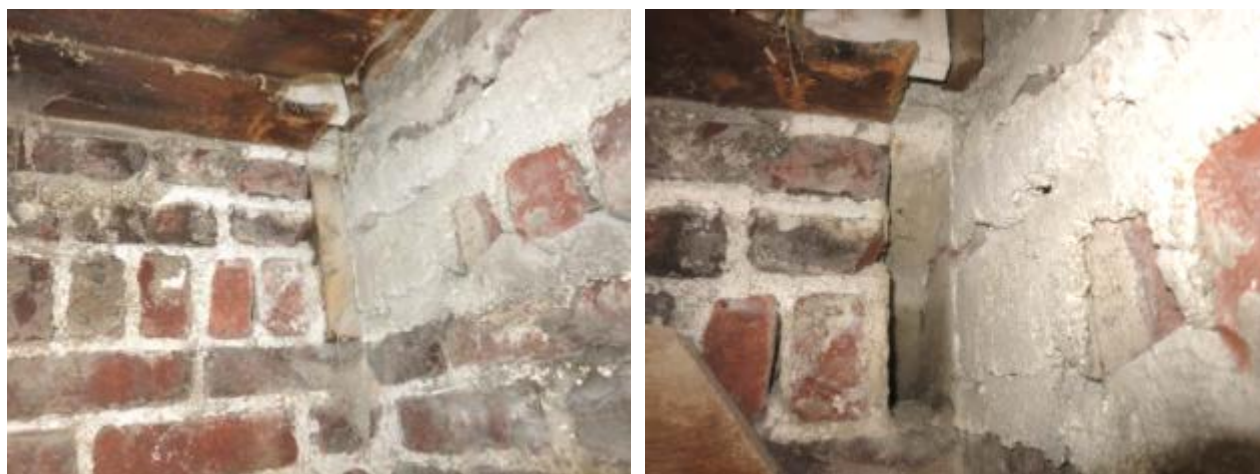
**Figure 61. Joist end stub embedded in wall (left); joist pocket showing mortar (right)**

The joist end stub that remained in the wall is shown in Figure 61, left; the wood was cut off flush with the masonry surface, and the removed joist was originally tight against the exterior south wall. The pockets are in the southwest and southeast corners. The joist pocket (Figure 61, right) shows that at least in this case, mortar was infilled around the fire cut (sloped) joist end, which left a minimal airspace around the joist pocket.

One of the two joist ends was damp to the touch and had a distinctly moldy odor when it was removed from the wall. However, when the wet joist end was probed with a screwdriver, it was structurally intact; it showed no evidence of rot, decay, or punkiness. Both joist ends had evidence of earlier water staining.

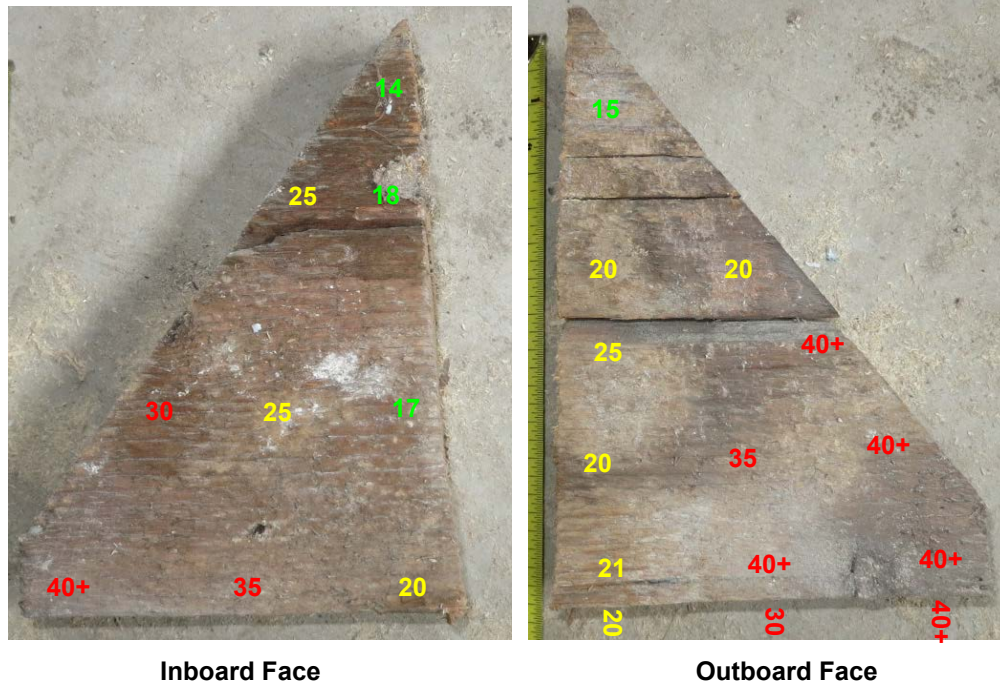
The MCs of these joist ends were measured with a resistance (pin-based) MC meter (Delmhorst BD-10) to examine the spatial MC pattern (Figure 62 and Figure 63). The MCs are color coded (red high risk, yellow some risk, green safe) in the photos. The MCs of the underside (horizontal bearing surface) of the joist ends are indicated by rotated text. Some MCs are notated 40%+; this is the upper measurement limit of the meter.

**Figure 62. Joist end stub MCs: southeast corner/east-facing (wetter)**

- Orientation had a significant impact on joist end MCs: the west-facing joists had dry MCs that were well within the safe range; the east-facing joists had MCs that would be considered at risk of failure. This is consistent with the patterns seen during the monitoring period, when orientation had a strong effect: the west-facing joists were generally much drier than the east-facing joists.

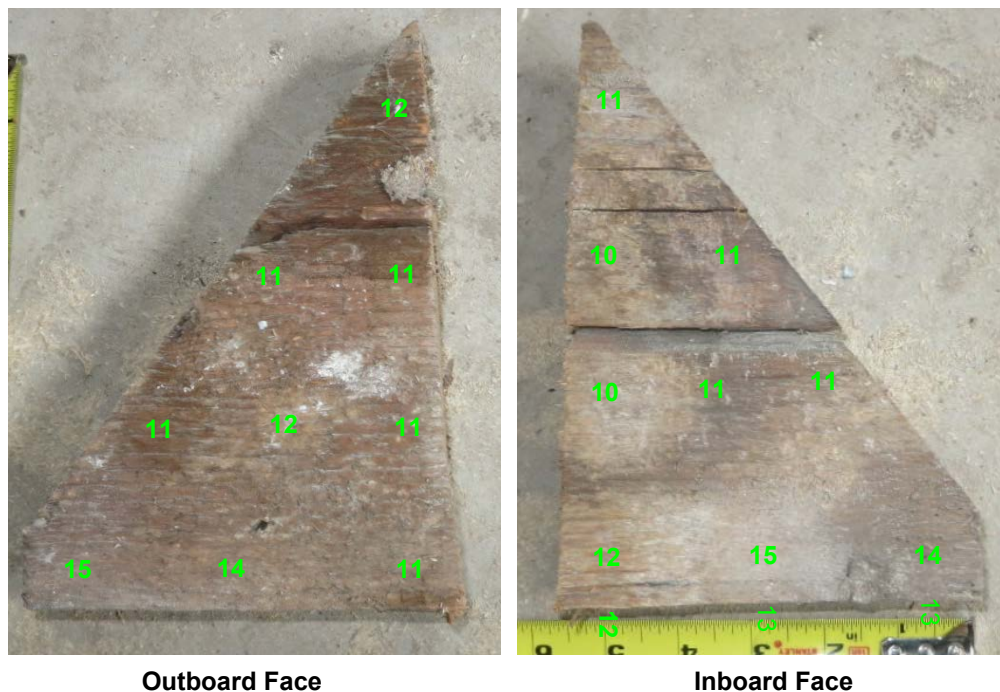
**Figure 63. Joist end stub MCs: southwest corner/west-facing (drier)**

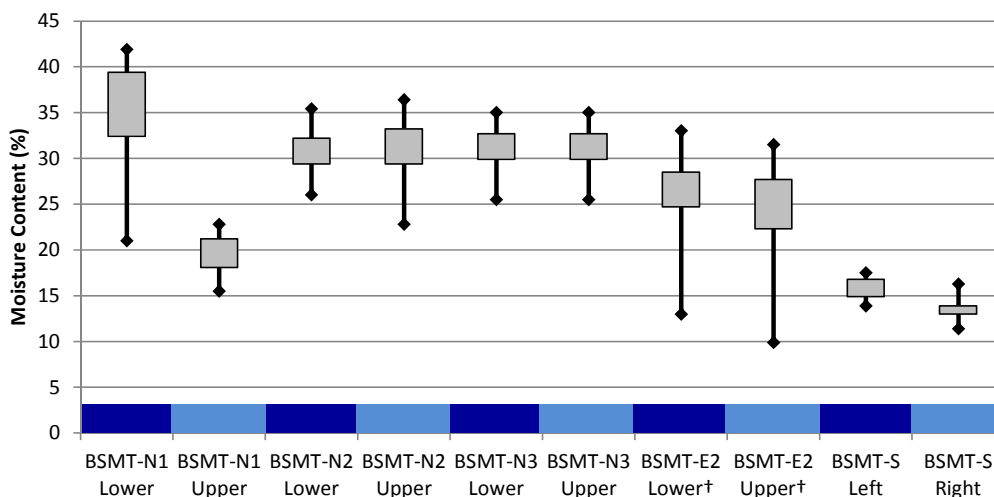
**Figure 64. Box/whisker plot for joist end MCs; minimally heated basement joists**

Many of the minimally heated basement joist ends (Figure 64) remain at high MCs (25%–35%) for much of the monitoring period; the joist pocket RH measurements were a constant 100% for north- and east-facing joist ends. The south joist end, however, had much lower MCs (with corresponding RH data), and remained well within the safe range. The east joist end was between the north and south behaviors.

The three north-facing joist ends (N1/foam insulation, N2/fiberglass insulation, N3/uninsulated) were set up to compare insulation strategies. However, the MCs overlapped significantly; drawing clear conclusions is difficult. Although the BSMT-N1 lower joist MC was wetter than others, the corresponding upper joist MC was the driest of the BSMT-N joists.

†: BSMT-E2: Data before October 12, 2013 are not plotted due to electrical anomalies.

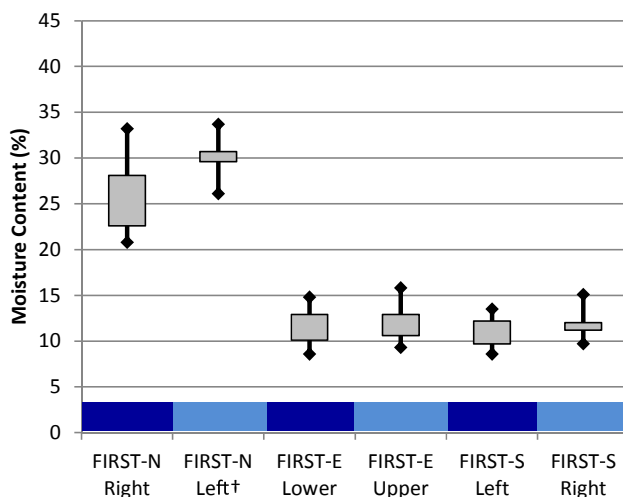
**Figure 65. Box/whisker plot for joist end MCs; unheated first-floor joists**

Figure 65 shows MC results for the first-floor unheated-area joists. This area was typically warmer than the basement due to solar gain through windows and the stack effect. The joist ends were embedded in hollow clay tile walls with some filler brick in contact with the wood.

†: FIRST-N Left: Data before March 30, 2014 are not plotted due to electrical anomalies.

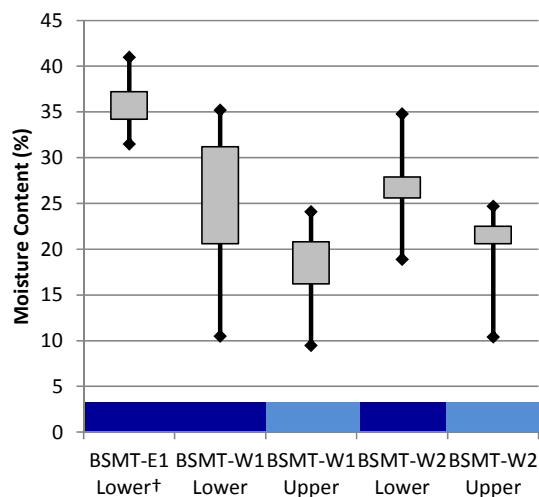
**Figure 66. Box/whisker plot for joist end MCs; heated basement joists**

†: BSMT-E1 Lower: Data before October 14, 2013 are not plotted due to electrical anomalies.

These joist ends showed a quick wintertime MC drop when interior heating was added. These joist ends showed wide seasonal swings; summer conditions were wetter and winter conditions were drier. However, the west-facing joists did not dry in winter 2014–2015, unlike previous winters. The east-facing joist end was wetter than the west-facing joists; BSMT-E2 was shaded by the building geometry. Figure 65 also clearly shows the difference between the upper and lower joist end measurements.
