Field Testing of an Unvented Roof with Fibrous Insulation, Tiles, and Vapor Diffusion Venting

K. Ueno and J. W. Lstiburek
Building Science Corporation

February 2016

This report describes research about a test implementation of an unvented tile roof assembly in a hot-humid climate (Orlando, Florida; climate zone 2A); the roof was insulated with air-permeable insulation (netted and blown fiberglass). Given the localized moisture accumulation and failures seen in previous work, the U.S. Department of Energy's Building America research team Building Science Corporation theorized that installation of diffusion vents might allow for the wintertime release of moisture to safe levels. Diffusion vents are open slots at the roof's highest points (the ridge and hips) that are covered with a water-resistant but vapor-open (500+ perm) air barrier membrane.

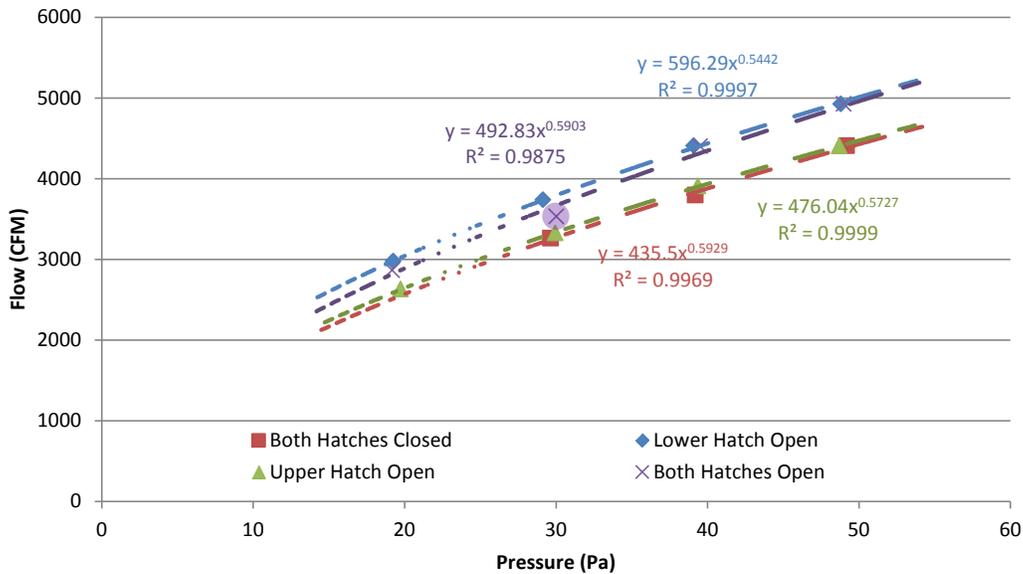
Figure 35. Hatch open/hatch closed multipoint testing with curve fits

Opening the lower attic hatch resulted in a substantial (+583 CFM 50/13%) increase in leakage; opening the upper hatch caused a minimal (+44 CFM 50/1%) increase. This suggests substantial air leakage from the lower attic to outside.

The final test (both hatches open) was first calculated to be more airtight than the one hatch open test (an unreasonable result). However, after removing an outlier data point (highlighted in Figure 35, “select data” in Table 3), the results of the two tests were almost identical.

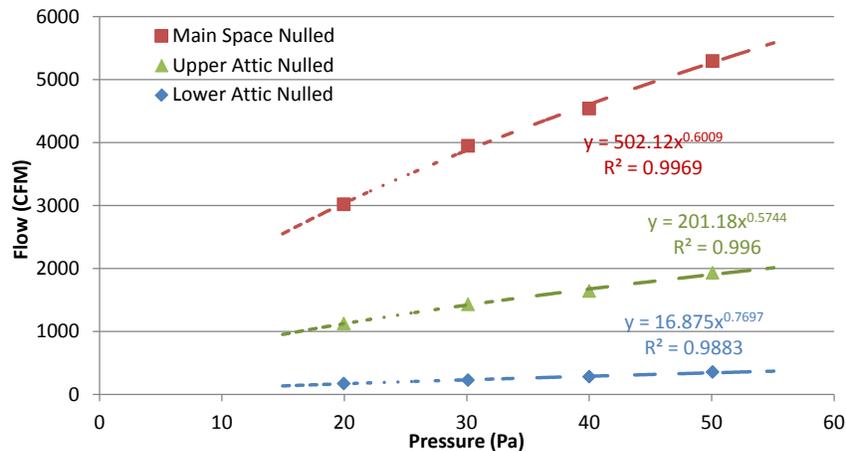
Figure 39. Multipoint testing of zones (main house and two attics) with simultaneous fans (nulled)

The calculated results are shown in Table 6; as would be expected, the air leakage through the attic zones drops significantly between these two tests, because the interior-to-attic leakage was eliminated. The upper attic drops by 1180 CFM 50 (–78%), and the lower attic by 1975 CFM (51%). The EqLA connected to the exterior (“Ext. EqLA”) was calculated from these measurements, and then the EqLA connecting the zone to the interior (“Int. EqLA”) was calculated by subtraction.

The results indicate significant leakage (196 in.² EqLA) from the lower attic to the exterior and relatively low leakage (35 in.² EqLA) from the upper attic to the exterior.

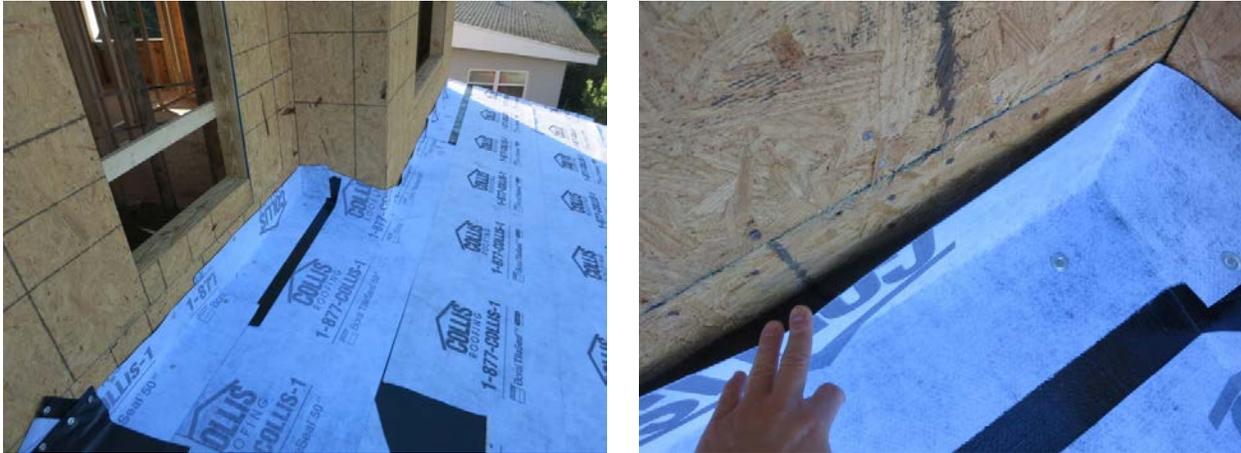
Figure 46. Construction image of roof-wall interface self-adhered membrane (Location E)

The presence of roof-wall leakage was originally puzzling, given the use of a self-adhered roof membrane that laps onto the wall sheathing. However, examination of construction photos (taken at Location E; Figure 46) showed that membrane adhesion to the vertical wall surface was not consistent; gaps and openings sometimes occurred. Although this detail would provide excellent service for rain control (assuming shingle lapping of the house wrap onto the roof membrane), it was apparently not sufficient for air barrier detailing.

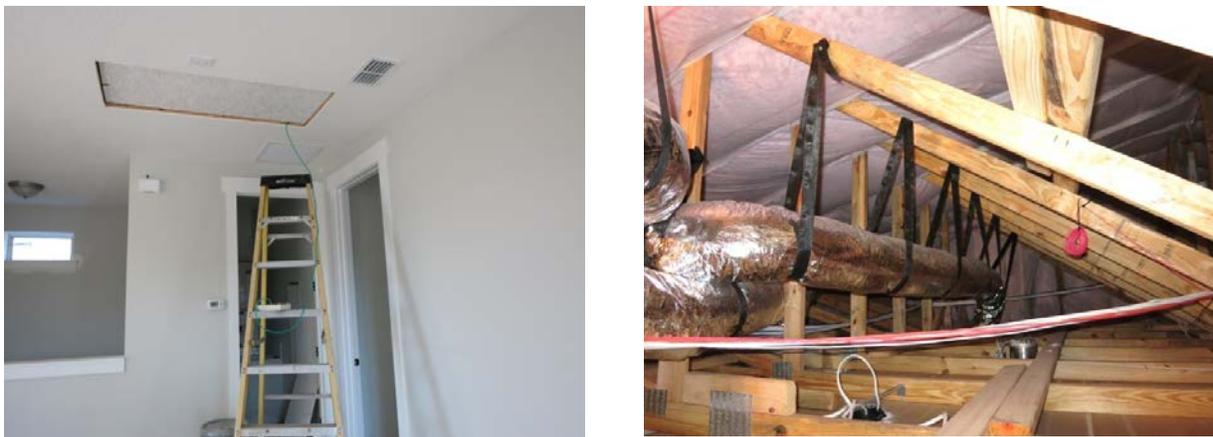
Figure 47. Upper attic ΔP measurement (left); ductwork located in upper attic (right)

The baseline (fan off) measurements of attic pressure (with respect to the main space) varied from 0 Pa to -0.1 Pa. The measurements after turning on the air handling unit were essentially unchanged (0 Pa typical), indicating that any pressurization or depressurization caused by air handling unit operation in this house is minor.

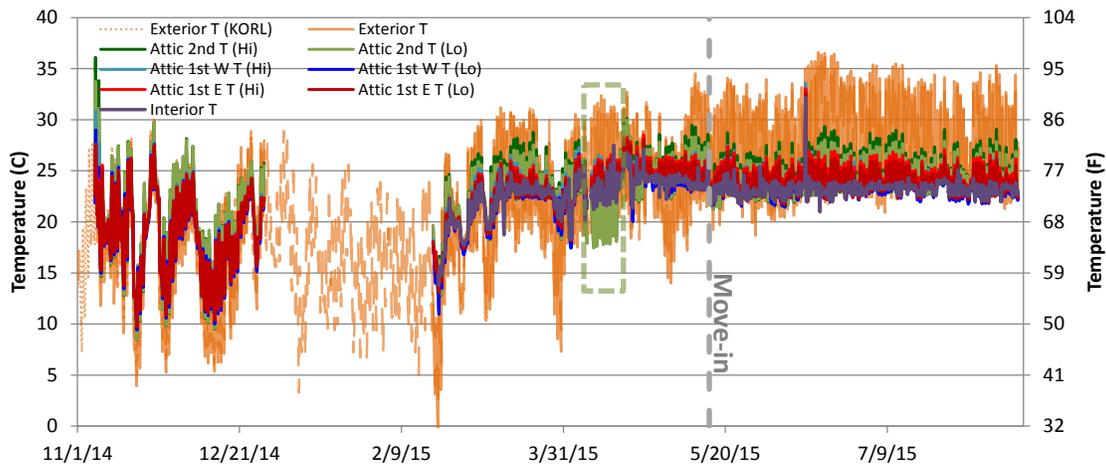
Figure 48. Exterior, attic, and main conditioned space temperatures

There was a temperature anomaly in April 2015, when the second-floor attic (“Attic 2nd T”) temperatures dropped to near-ambient conditions (highlighted in green in Figure 48). This was ascribed to painting work with open windows and an open attic hatch (per the site supervisor).

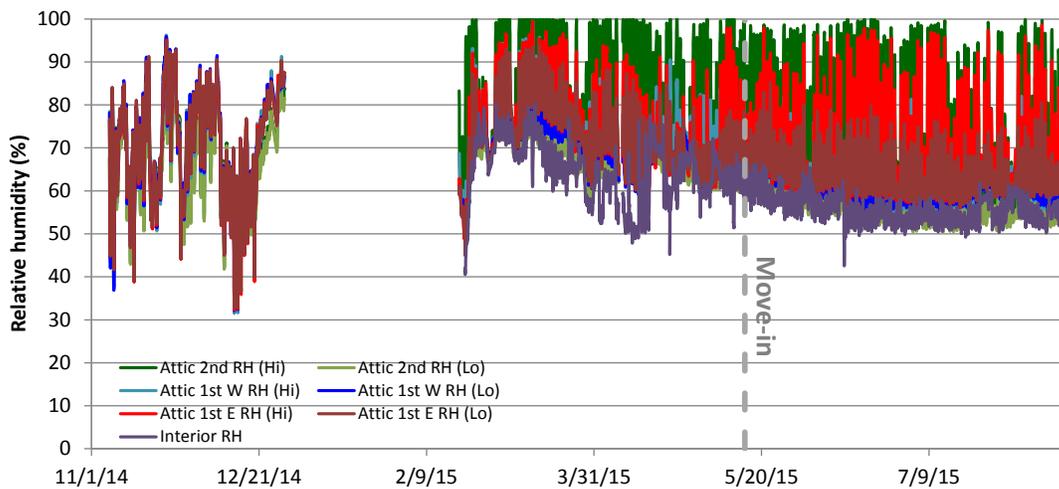
Figure 51. Attic and main conditioned space RH

Interior RH is plotted in Figure 51; after the data gap (post mid-February 2015). Attic RHs oscillate between very high (90%–100%) and lower (75%–80%) levels on a diurnal cycle. This period includes conditioned and unconditioned periods; the thermostat was apparently set for cooling only, and the system was operated intermittently (see interior temperatures in Figure 48). After the cooling system was put in operation, interior space RH dropped slowly over time (from roughly 70% to 50%–60%). However, attic peak RHs still cycled up to the 90%–100% range.

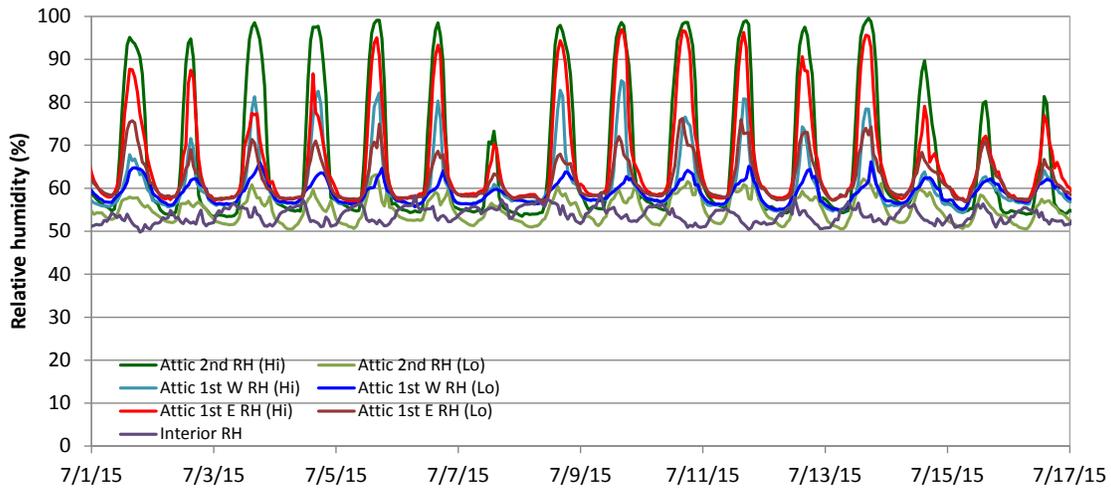
Figure 52. Attic and main conditioned space RH, July 2015 detail

A detail of July RH data (Figure 52) shows that interior RHs are well controlled (50%–60%), but several attic sensors have daily peaks up to 90%–100% RH. The highest RH readings are associated with sensors capturing the upper one-third of attic air conditions (Hi sensors). In contrast, lower one-third (Lo) sensors have less pronounced peaks. These patterns are discussed further below.

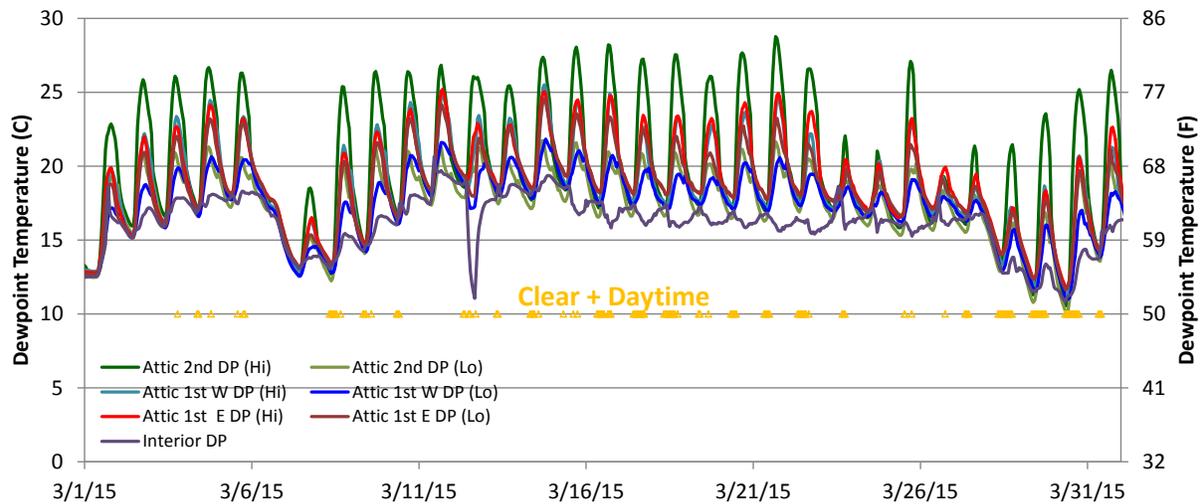
Figure 54. Attic and main space dew point temperatures (March 2015) with sky conditions

A close-up of March 2015 dew point data is shown in Figure 54: interior dew points exhibit a diurnal cycle; the peaks in these data are typically at 5–6 p.m., which is a rough match to sunset.

The diurnal moisture cycling also highlights differences between the three attic locations; the highest dew points are seen at attic 2nd (high). In any given high/low pairing, the high measurement has a higher dew point. These observations are consistent with moisture stratification and buoyancy within the attics, as described by Lstiburek (2014). The high dew points in the second-floor attic are due to a combination of greater airtightness (as measured previously), and location at the highest point of the conditioned space. The dew points of attic 1st west (W) are the lowest and show little stratification (high/low difference). It is the shortest attic, with only 19 in. between the high and low sensors. Interior dew points are the driest, because this space receives direct space conditioning (and therefore dehumidification during cooling).

The diurnal cycles are not consistent day to day; some days have much more pronounced dew point spikes. Weather data (from KORL) were plotted with marker points on hours with “Clear” sky conditions during daylight hours (“Clear + Daytime”; gold dots) in Figure 54. This figure shows days with minimal dew point spikes were typically overcast conditions (e.g., March 24 and March 25). This is consistent with dew point rise being caused by moisture driven out of the roof sheathing by solar gain and temperature rise.

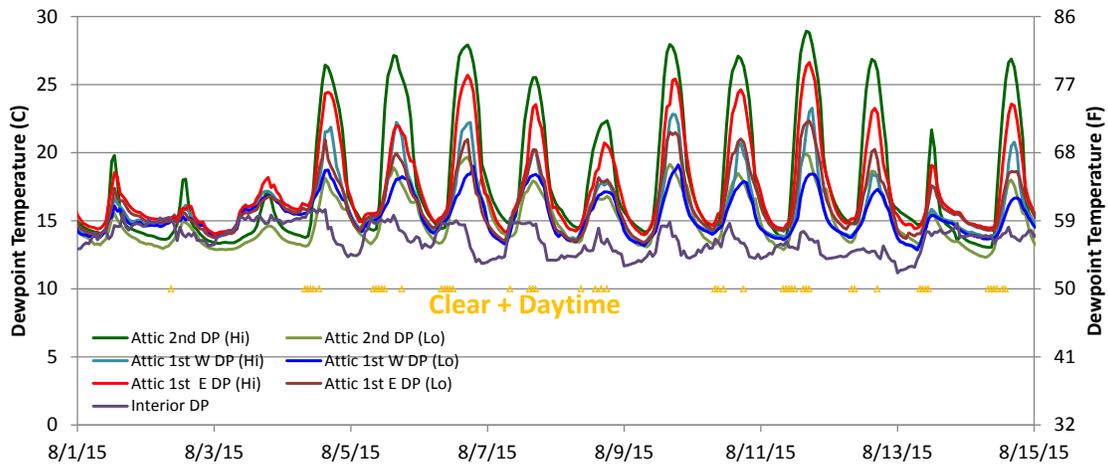
Figure 55. Attic and main space dew point temperatures (August 2015) with sky conditions

This pattern is also seen in summertime data, such as an August excerpt (Figure 55). Large dew point spikes typically coincided with clear daytime conditions. The same relative attic dew point patterns are seen. The effect of solar gain could also be gauged by plotting roof sheathing temperature.

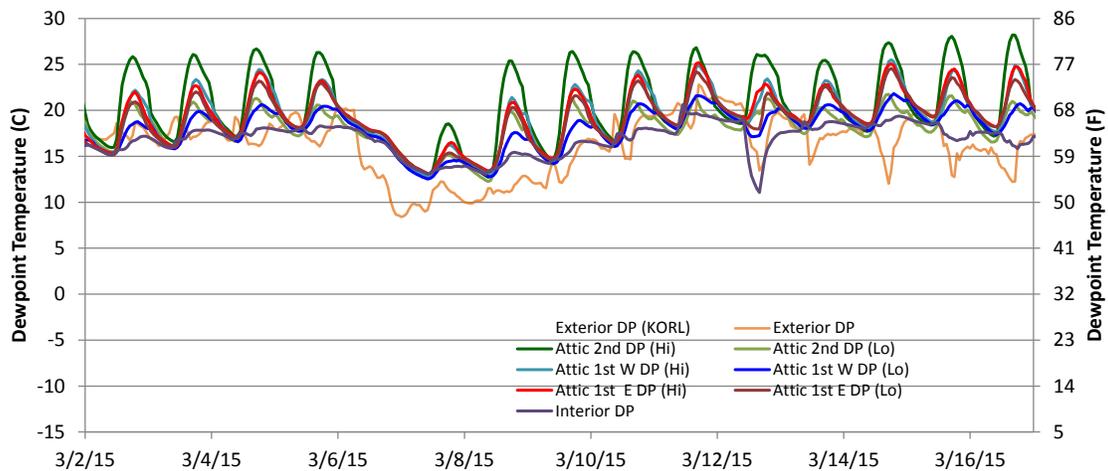
Figure 56. Interior and exterior dew point temperatures, March 2015 detail

Figure 56 shows typical March dew point conditions, including the previously described diurnal cycling and attic stratification. Exterior dew point is consistently lower than interior conditions, but there is significant overlap. March 2015 was early after close-in, so interior dew points likely reflect construction moisture retained inside.

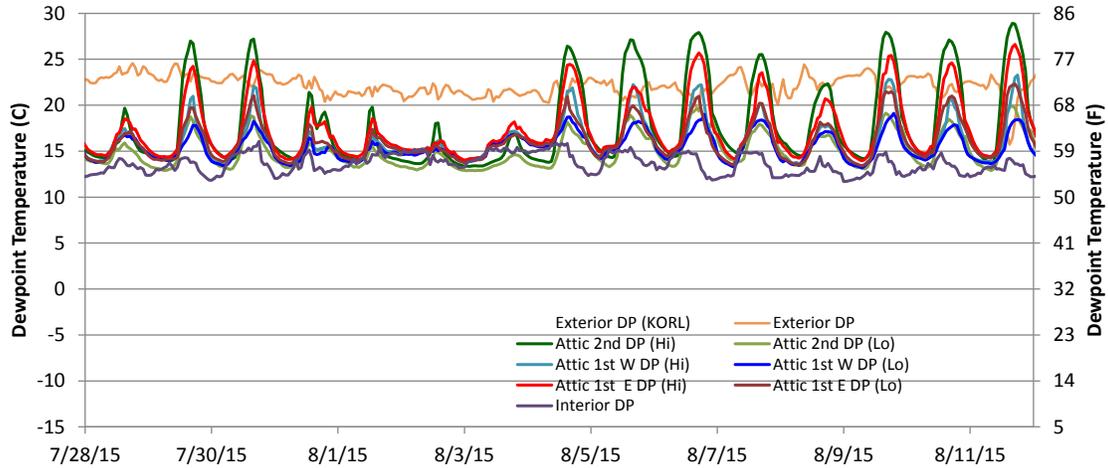
Typical August dew point conditions are shown in Figure 57; exterior dew point is consistently higher (wetter) than interior main space conditions and typical attic conditions. However, the

daily dew point spikes are higher than exterior conditions. This indicates that high moisture in unvented attics is not solely due to air leakage; interior-sourced moisture and adsorbing and desorbing moisture play an important role.

Figure 57. Interior and exterior dew point temperatures, August 2015 detail

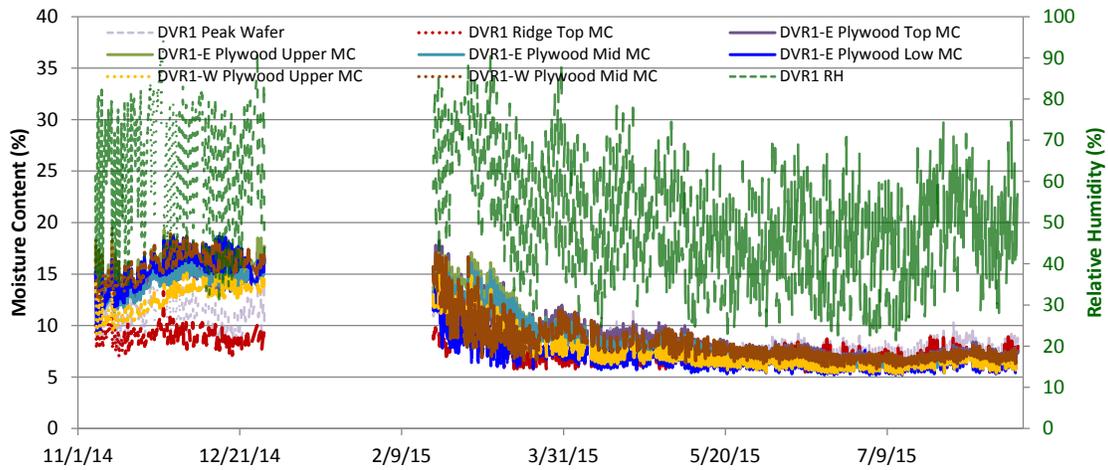
MC and RH measurements for the diffusion vent roof ridges are plotted in Figure 60 (DVR1, upper attic), Figure 61 (DVR2, upper attic), and Figure 62 (DVR3, lower attic).

Although the MCs increased after the data gap (i.e., cold weather; addition of interior construction moisture), accumulation was nowhere near levels seen in UVR1 (almost all were lower than 20%). Peak RHs were also drier: they did not hit the 95%–100% levels seen in UVR1. The MCs dropped in the spring, correlating with warmer weather; all were much lower than 10% during the summer. The RH levels did not show such a steep drop into the spring as UVR1. RH levels oscillated noticeably at the ridge compared to UVR1.

Figure 60. Diffusion vent ridge (DVR1) MC and RH measurements (upper/second-floor attic)

The ridge top MCs (red dotted data) are among the driest in the diffusion vent roofs but one of the wettest in the unvented roof (Figure 59). This is consistent with interior-sourced moisture accumulation at the ridge (in UVR1) versus high localized drying directly under the permeable roof membrane (in DVR1/2/3).

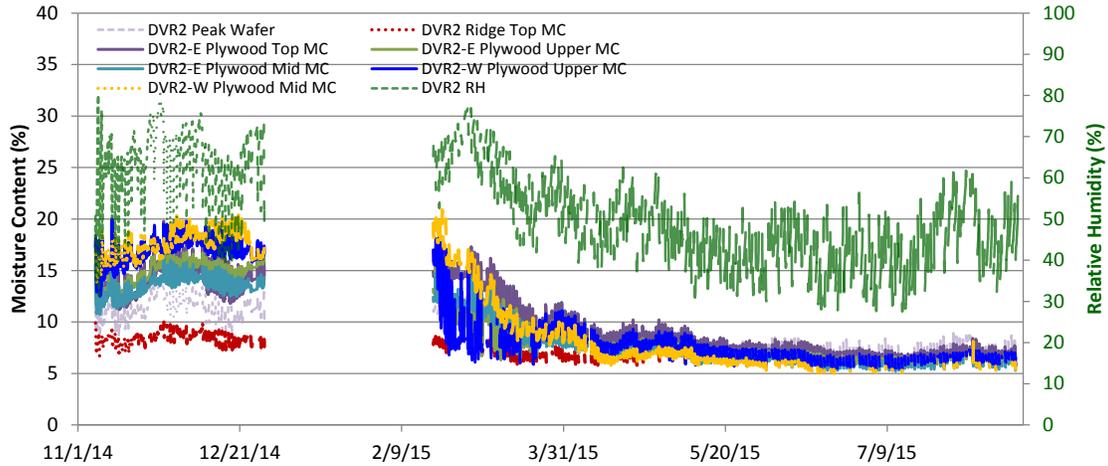
Figure 61. Diffusion vent ridge (DVR2) MC and RH measurements (upper/second-floor attic)

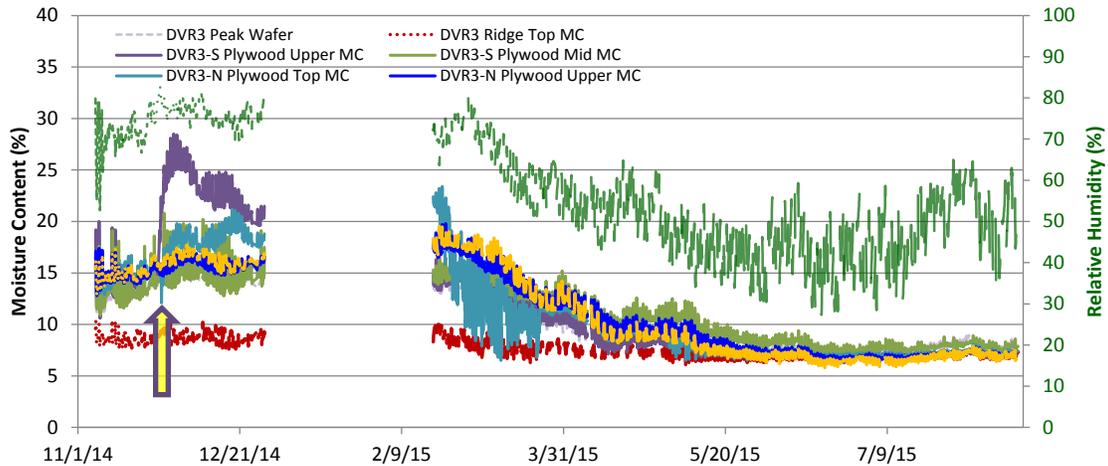
Figure 62. Diffusion vent ridge (DVR3) MC and RH measurements (lower/first-floor attic)

One anomaly was seen at the south plywood upper MC of DVR3 (yellow/purple arrow in Figure 62): MC jumped suddenly in late November 2014; the moisture then dried to safe levels in the spring. This is suspected to be rain leakage; a thunderstorm in the weather data coincided with the jump. However, MC jumps (i.e., further water leakage) did not recur.

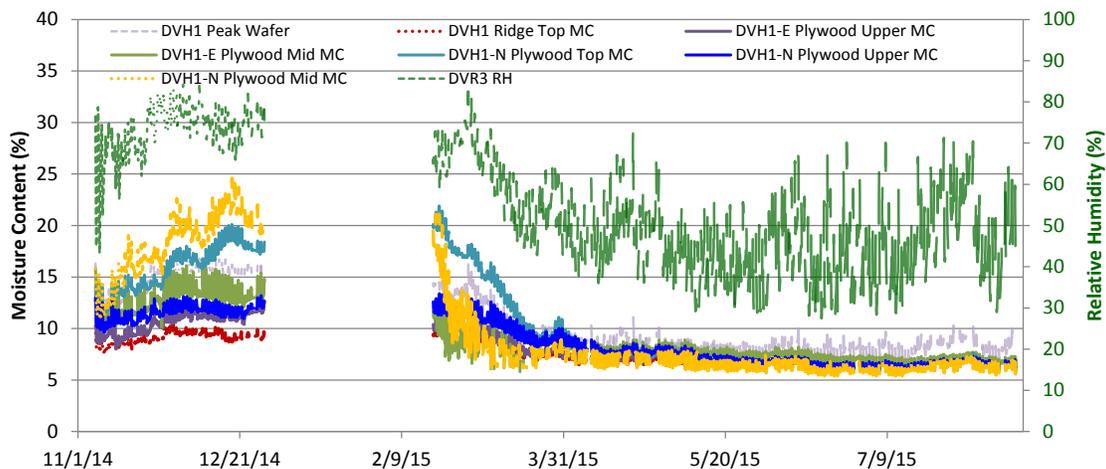
MC and RH measurements for the diffusion vent hips are plotted in Figure 63 (DVH1, lower measurements) and Figure 64 (DVH2, upper measurements). Both of these packages are in the lower/first-floor attic.

Figure 63. Diffusion vent roof hip (DVH1; lower) MC and RH measurements

A similar pattern to the diffusion vent ridges was seen with high MCs after the data gap, but they were not as wet as the unvented roof. Peak MCs were in the 18%–23% range; MCs then dried as outdoor temperatures increased. RH measurements followed a similar pattern; peak RHs were about 85%.

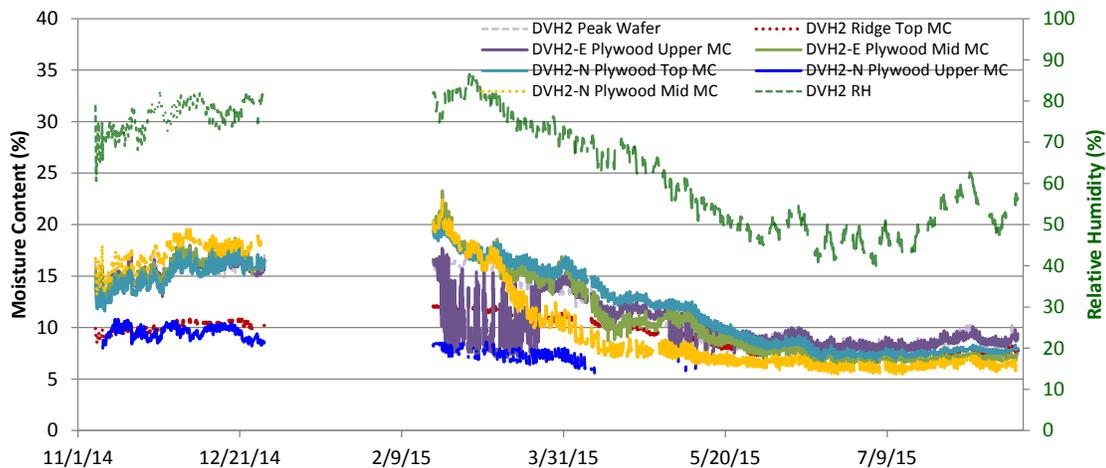
Figure 64. Diffusion vent roof hip (DVH2; upper) MC and RH measurements

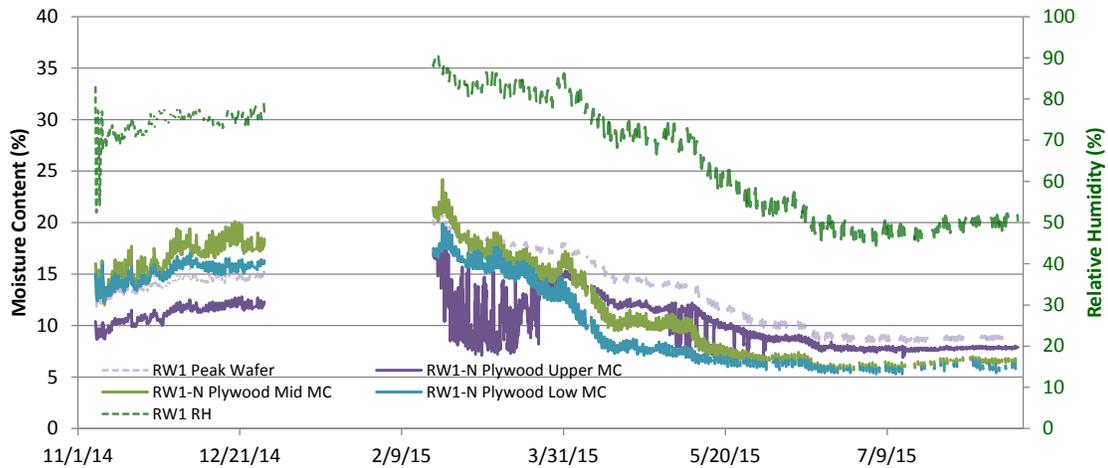
MC and RH measurements for the roof-wall interfaces are plotted in Figure 65 (RW1, significant downhill roof area below) and Figure 66 (RW2, minimal downhill roof area below). Both are located in the lower attic. The roof-wall conditions are measured because this location has no diffusion vents, but it is the top termination of rafter bays (and therefore has the potential for moisture accumulation). The difference in downhill area was that moisture adsorption and desorption from the sheathing may affect the degree of moisture accumulation at the ridge.

Similar patterns were seen of higher wood MCs after the data gap, which then dried in the spring. However, absolute values of MCs were higher more than 20% higher than the previous diffusion vent measurements. This might be ascribed to either the geometry (no diffusion vent) or possibly shading issues (discussed in Section 4.8.3). Similarly, RH levels were slightly higher than previous diffusion vent measurements.

No clear differentiation was seen between the two measurements, which would indicate the effect of downhill contributory roof area. RW1 shows a clear pattern of vertical moisture stratification in the springtime MC measurements.

Figure 65. Roof-wall (RW1) MC and RH measurements (downhill area)

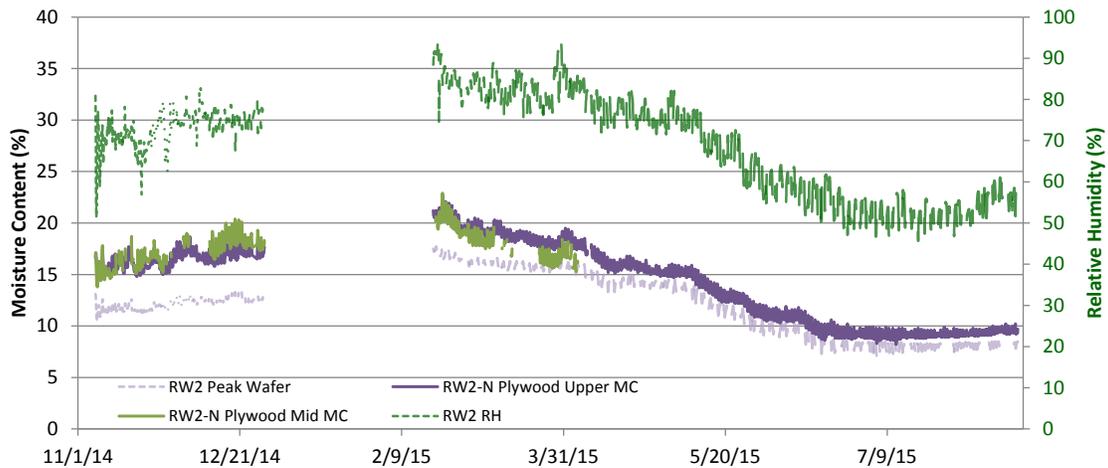
Figure 66. Roof-wall (RW2) MC and RH measurements (no downhill area)

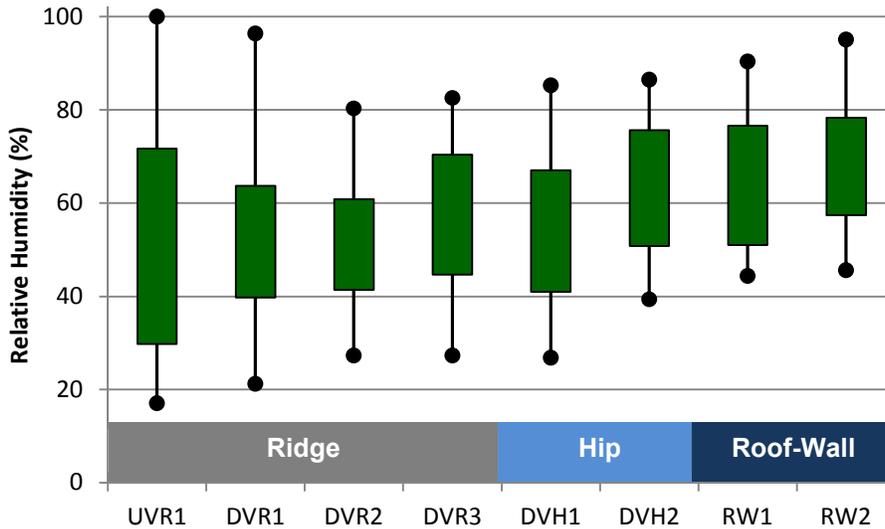
Figure 68 shows the distribution of ridge RH measurements; the unvented roof (UVR1) is the only one that reaches 100% RH. The diffusion vent roofs are demonstrably drier than the unvented roof. Most of the roofs have hours that exceed 80% RH; however, given the discontinuity (gap) in the data, an ASHRAE 160 analysis (ASHRAE 2009, 2011) does not provide useful information based on a 30-day rolling average.

Therefore, the number of hours exceeding 80% RH is shown in Table 8: it includes the number of hours and the percentage of the total recording period higher than 80% RH. It shows that most diffusion vent ridges had minimal (0%–3%) time higher than 80% RH, while the unvented roof had significant (13%) time higher than that level. However, several roofs (DVH2, RW1, and RW2) had extended periods higher than 80% RH; they also had distributions on the high end of the scale (Figure 68). The reason for this behavior is covered in more detail below.

Figure 68. Box/whisker plot of roof peak RH measurements

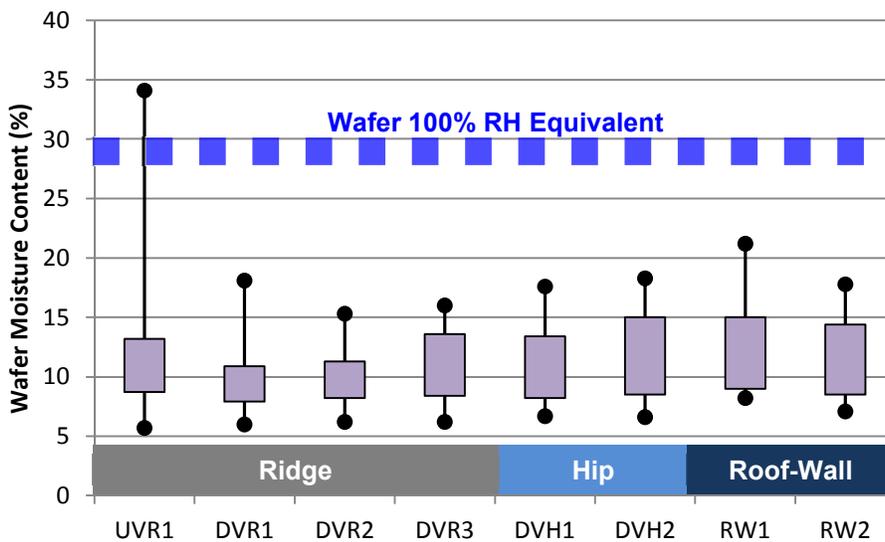
As another comparison, the peak wafer MCs are plotted for the roofs in Figure 69; they show a pattern that is analogous to the previous RH measurements.

Figure 69. Box/whisker plot of roof peak wafer MC measurements

However, the unvented roof is clearly differentiated; periods of wafer measurements exceed the 100% RH-equivalent (28%–30% MC) level. All other roofs have MCs well in the safe range

(almost all lower than 20%). But again, roofs DVH2, RW1, and RW2 are noticeable outliers with higher moisture levels.

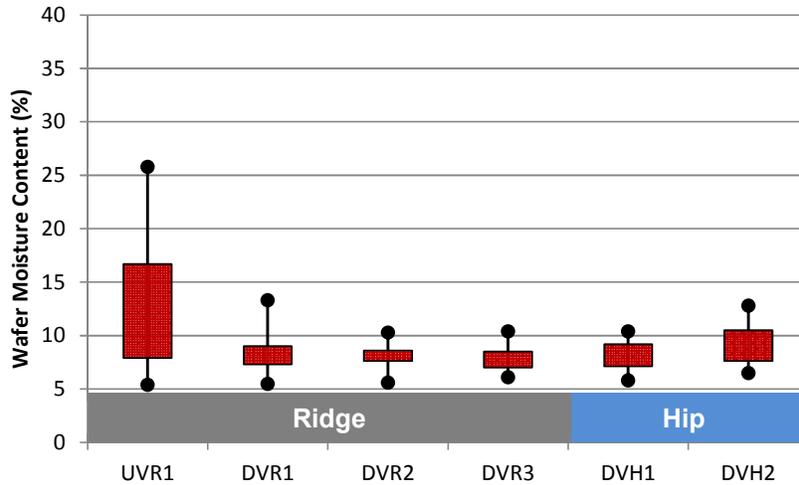
Earlier plots demonstrated that the wood ridge at the ridge and hips was the driest location of the diffusion vent roofs, but the dampest in the unvented roof. This is shown in the box and whisker plot in Figure 70. It demonstrates the localized drying available at the ridge of the diffusion vent roof compared to the moisture accumulation (lack of drying) at the unvented roof. The unvented roof had peak MCs higher than 25%.

Figure 70. Box/whisker plot of ridge top wood MC measurements

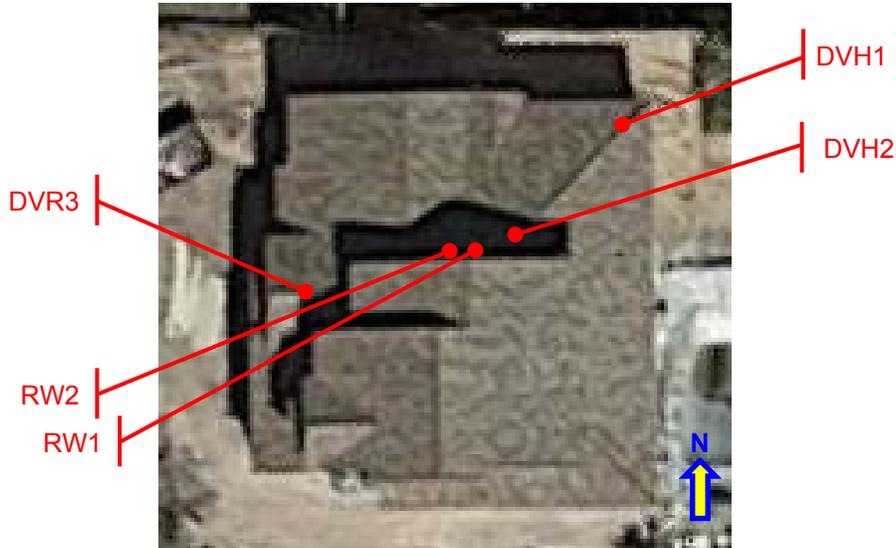
One possible explanation for moisture conditions at DVH2, RW1, and RW2 is the shading patterns created by the building (Figure 71).

The lower diffusion vent hip measurement (DVH1) is fully exposed to the sun, while the upper measurement (DVH2) is shaded by the adjacent second story and roof. The roof-wall interfaces (RW1 and RW2) lie directly north of the wall in shadow. DVR3 (diffusion vent at the front of the house) is shaded for part of the day (morning), depending on the season and sun position. All these observations are consistent with higher RHs and MCs seen at RW1, RW2, and DVH2.

Figure 71. Overhead view of roof shading with key sensor locations

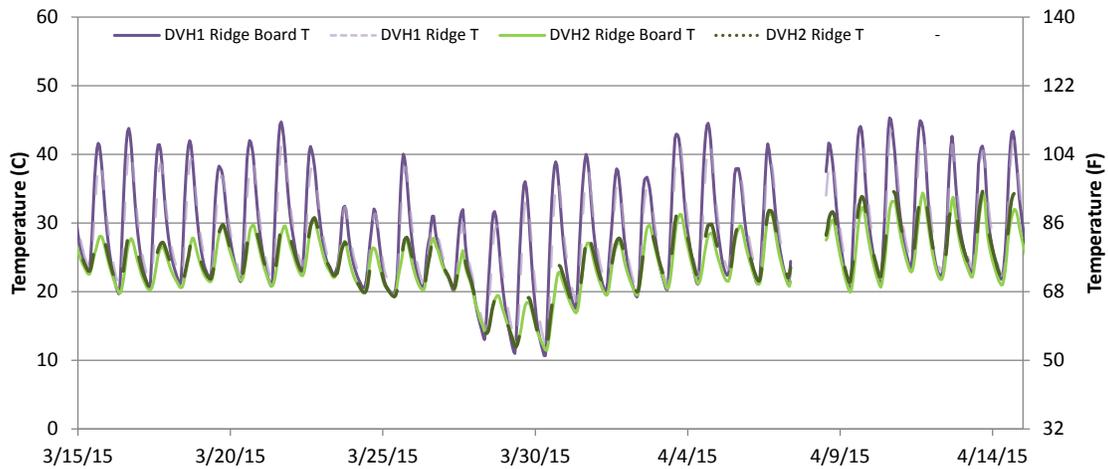
To confirm this theory, the temperature at the ridge is plotted for DVH1 and DVH2 in Figure 72 (March–April). It shows that the upper diffusion vent hip measurement had much cooler peak temperatures than the lower measurement (e.g., 95°F versus 115°F peak ranges), because the upper measurement was shaded.

Figure 72. DVH1 versus DVH2 ridge and ridge board temperatures, March–April 2015

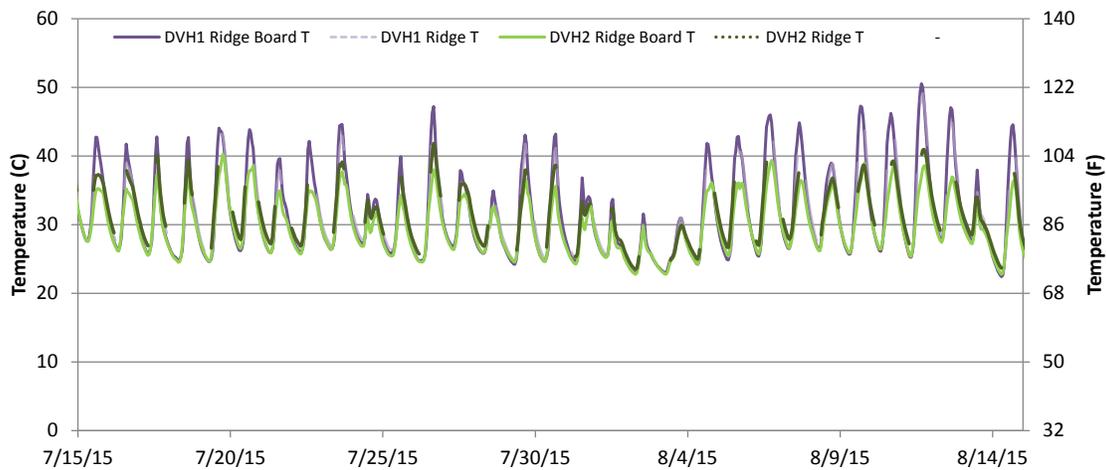
However, the temperature difference becomes much smaller during the summer, as shown by July–August data (Figure 73); this is due to the higher summertime sun angle, which reduces the shading provided by the second floor.

Figure 73. DVH1 versus DVH2 ridge and ridge board temperatures, July–August 2015
