Public Housing: A Tailored Approach to Energy Retrofits

J. Dentz, F. Conlin, D. Podorson, K. Alaigh,
and T. Davis

February 2016

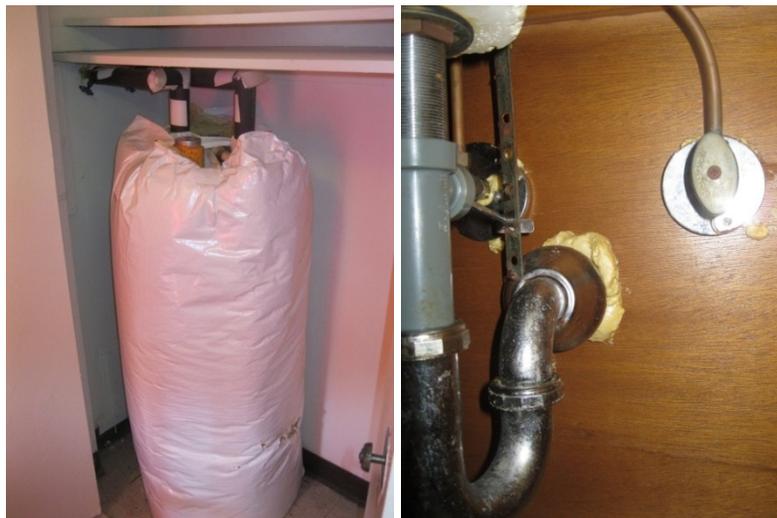
Figure 3. Electric storage water tank with insulation wrap (left); foamed plumbing penetrations (right) at IHA

IHA staff members were trained on the protocols during a 3-hour on-site training session. After the training, they implemented the protocols in each unit that was undergoing turnover (Figure 3 and Figure 4). ARIES conducted before and after inspections and tests of five units, including the training unit, to measure implementation effectiveness and estimate costs.

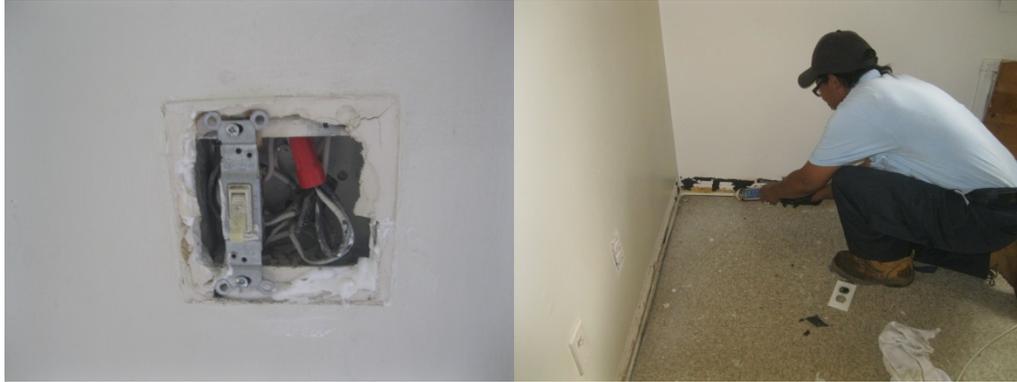
Figure 16. Newly caulked electrical outlet (left); caulking around base molding (right) at NHA

NHA staff was trained in the protocols in a 3-hour on-site training session at the King Kennedy unit. Most of the protocols were implemented immediately after the training (Figure 16 and Figure 17); some additional items, such as removing vinyl coves to seal bottom plates, were implemented after the session. ARIES conducted pre- and post-implementation testing to measure implementation effectiveness and estimate costs.

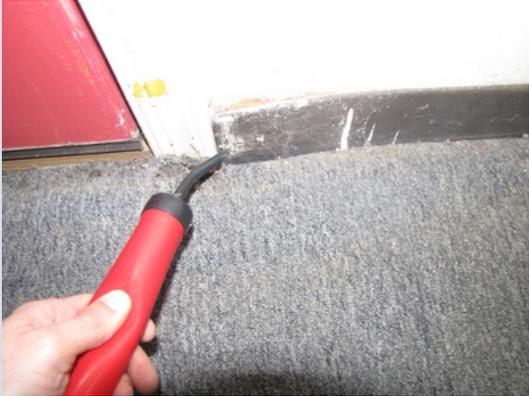
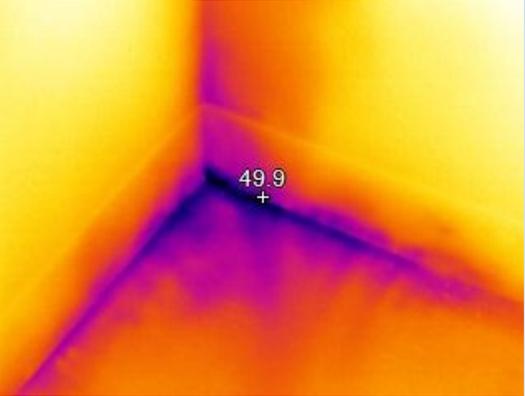
LOCATION	INSTRUCTIONS	MATERIALS	PHOTOS
INTERIOR AIR SEALING	1. Bottom of walls	In rooms without carpet, caulk bottom of wall to floor and/or base molding (may require removal and replacement of vinyl cove). If replacing carpet, caulk between bottom of wall and floor before new carpet is installed. Seal around baseboard heaters with caulk suitable for high temperatures.	Caulk, cove molding and adhesive

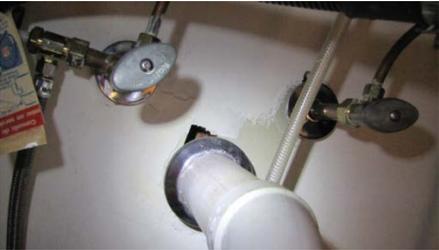
2. Plumbing penetrations (all walls)	Foam-seal plumbing penetrations	Foam
