# Report of the Condition of a General Electric Transportation Systems Gearbox

**Technical Report**  
NREL/TP-5000-76004  
Revised February 2022

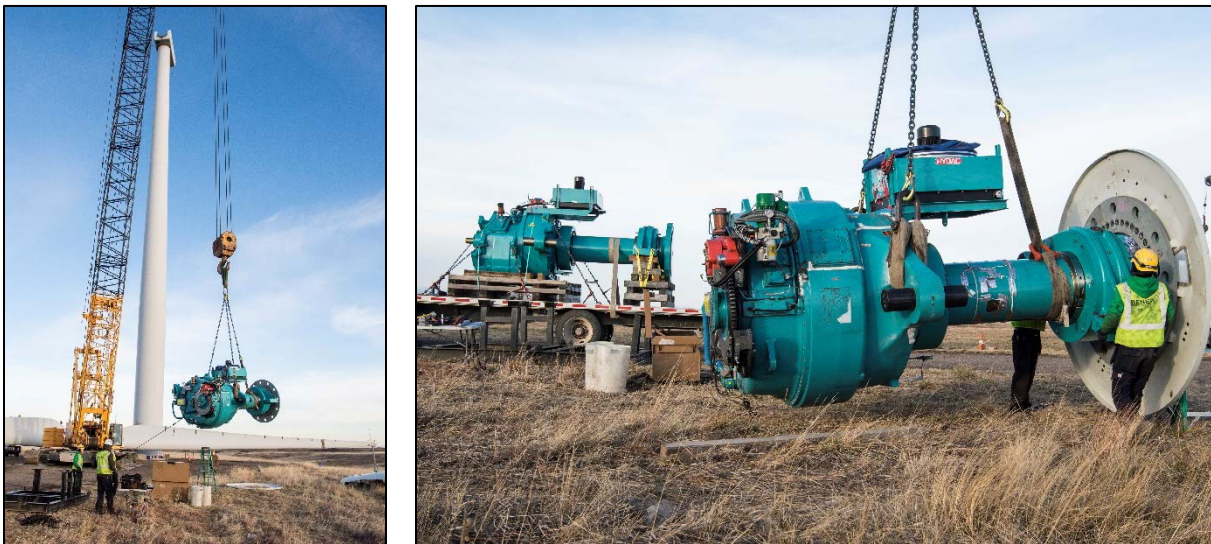
**Figure 1. GETS gearbox removal (left) and swap (right)**  
*Photos by Dennis Schroeder, NREL 49407 and 49418*

Since then, the DOE 1.5 was operated with the primary objective of supporting many DOE wind program and industry partner research initiatives. To enable a new research initiative for the investigation of bearing-axial-fatigue cracking in the gearbox and main bearing wear, the original drivetrain in the DOE 1.5 was swapped for a new, instrumented drivetrain on December 16, 2017 (Figure 1). The original drivetrain, consisting of a GE Transportation Services (GETS) gearbox, main shaft, and main bearing, had produced approximately 6-million kilowatt-hours (kWh) of energy in 14.17-thousand hours of grid operation time [20]. Full operational data from this original GETS gearbox was retained and will be used in ongoing research and analyses. It should be noted that the above time period represents approximately 8% of the minimum design life of the gearbox.
