William Sekulic, Chris Deline, Byron McDanold, Josh Parker

Main goal, identify how damaged modules change over time.

2022 Photovoltaic Reliability Workshop (PVRW)

NREL/PR-5K00-82248

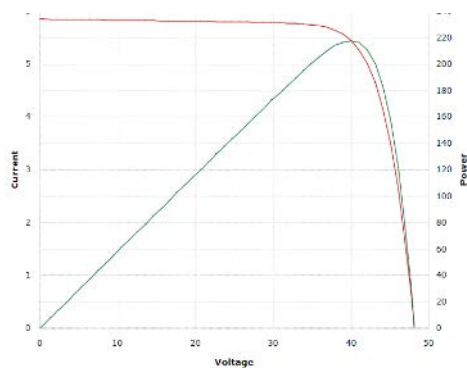
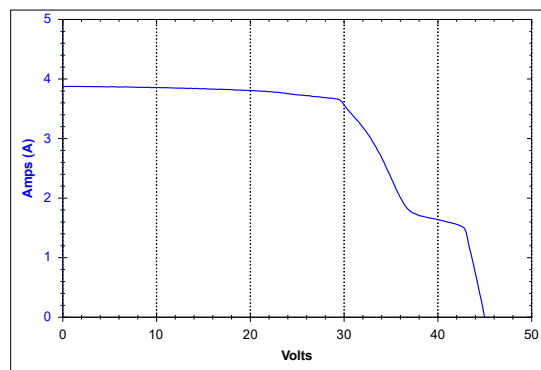
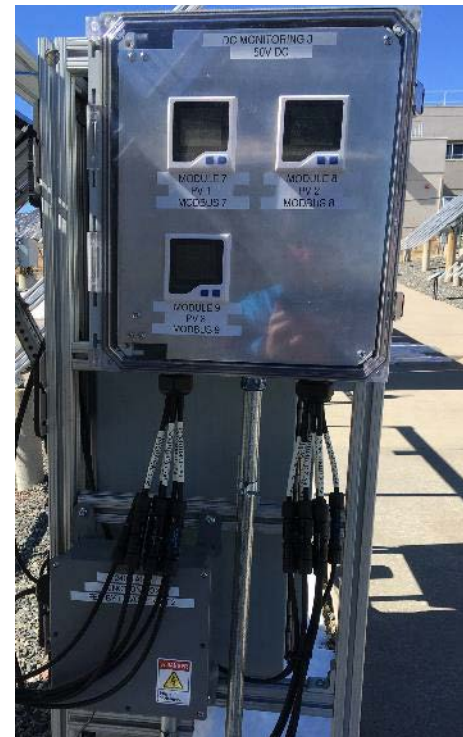
Defects Found:

Cracks, high resistance connections,
Impact damage, poor conduction.

Defect Causes?

Installation, weather, manufacturer defects,
vandalism
