# **Polybutylene Pipe Freeze/Thaw Reliability Testing**

**Robert B. Farrington**

**April 1987**

## POLYBUTYLENE PIPE FREEZE/THAW RELIABILITY TESTING

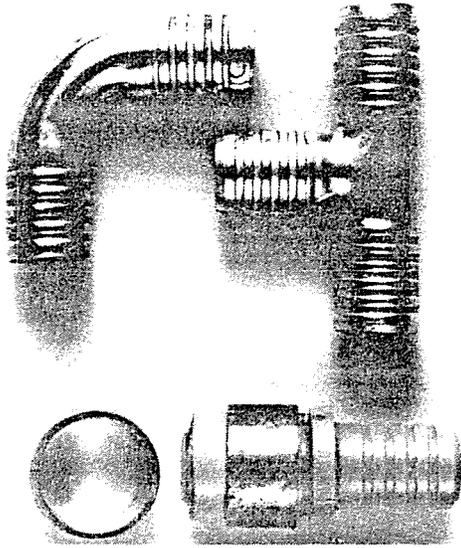
Fig. 2. Types of Compression Fittings

We constructed a test loop, as shown in Figure 1, with 18 m (60 ft) of nominal 1/2-in. polybutylene pipe that included 36 elbows, 10 tees, 8 brass couplings, and 3 polymer couplings. The types of fittings used, with the exception of a brass coupling, are shown in Figure 2. We later added eight more polymer couplings and replaced the three original polymer couplings with brass couplings. The length between fittings varied between 5 and 91 cm (2 and 36 in.). The pipe was plumbed in six parallel loops installed in 4.3 m<sup>3</sup> (15.1 ft<sup>3</sup>) chest freezer with penetrations as shown in Figure 1. A 1500-W, two-speed, two-heater-setting electric hair dryer was installed in the freezer for thawing the pipes. The freezer did not have an adjustable thermostat. The heater was set at medium heat and high blower speed.
