Thin Film PID Field Failures and Root Cause Determination

N.A. Olsson, M. Propst, C Richardson, J. Hevelone*

Pearllaboratories
2649 E. Mulberry St, Unit 15
Fort Collins, CO 80512

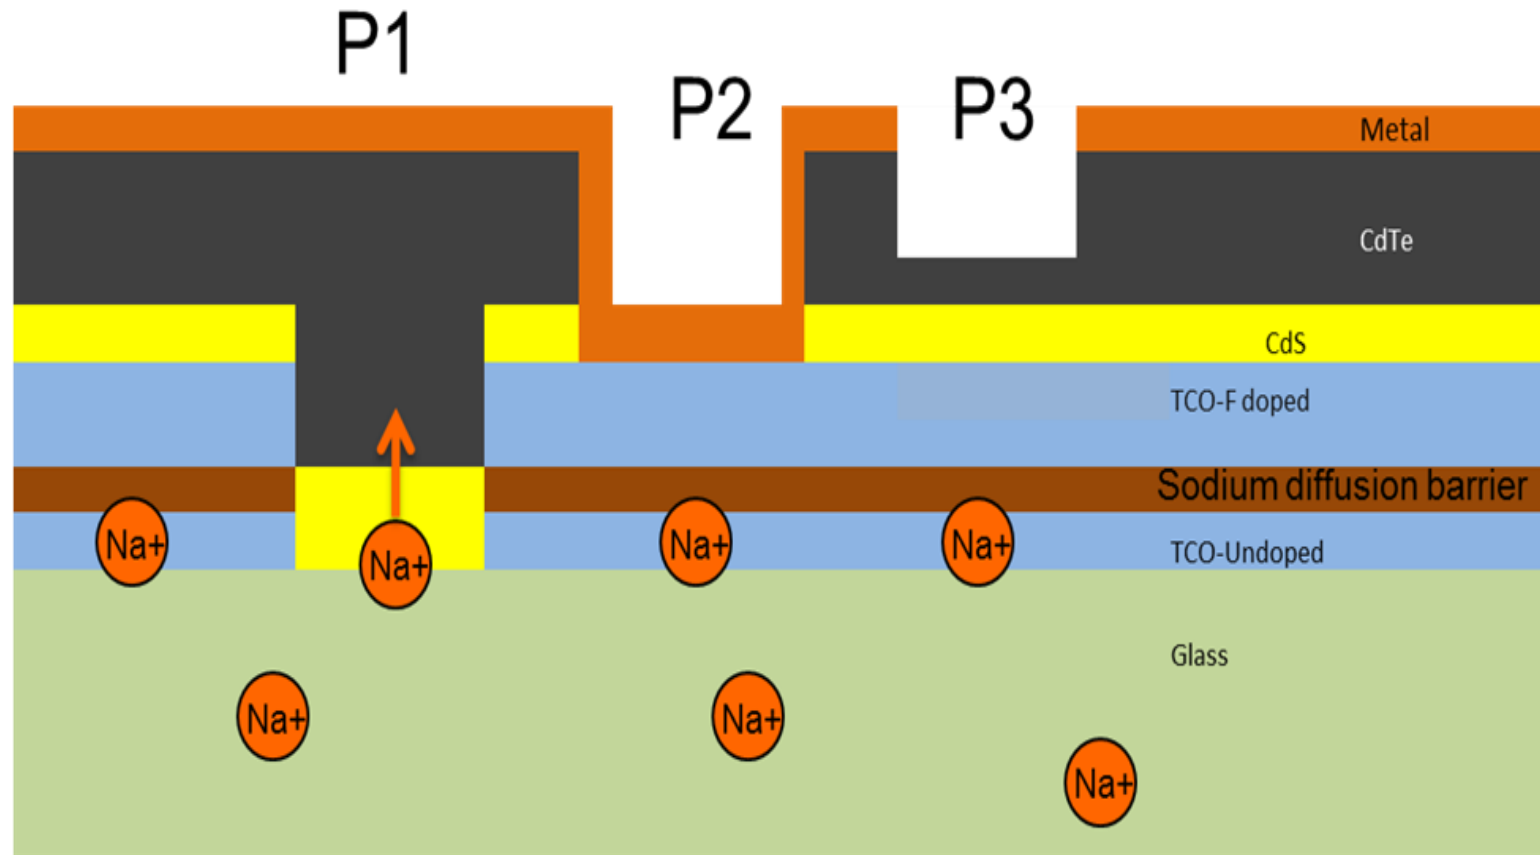
Degradation Model

- ▶ We have characterized a new type of reversible PID caused by field assisted diffusion of mobile ions into the P1 scribe lines in thin film modules.
